## **APPENDIX D**

### **Biological Resources Supporting Information**

Project Name: Estrella Substation and Paso Robles Area Reinforcement Project

# Avian Protection Plan For External Distribution

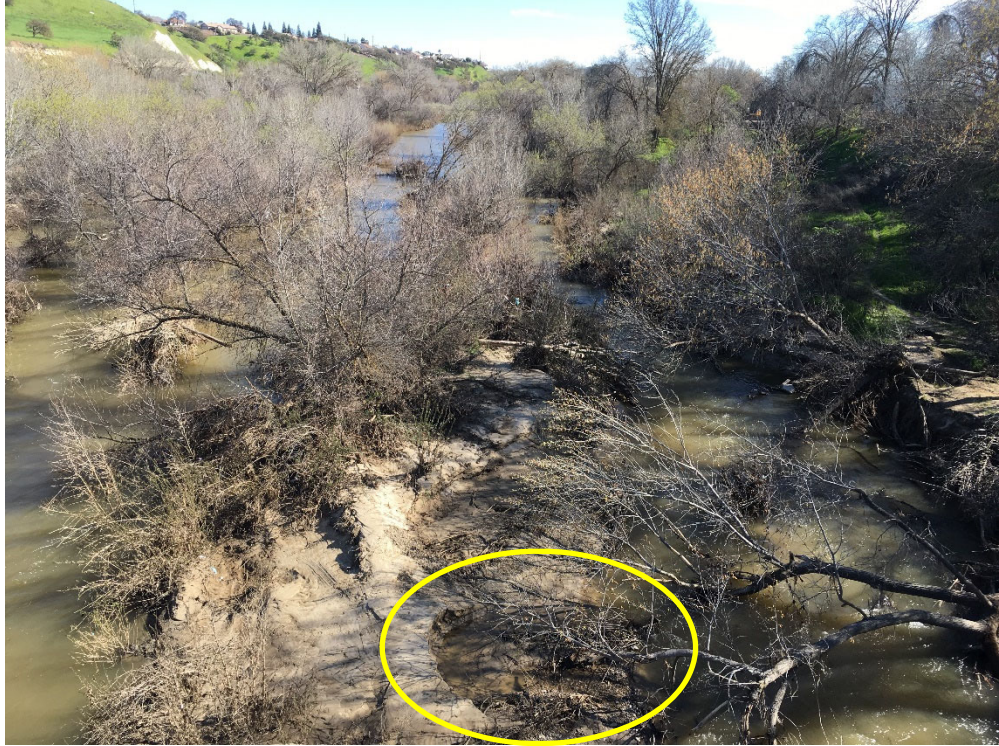
<b>Photo No. 1</b>	<b>Date:</b> 3/14/2019

<b>Description:</b> <i>Site S13a:</i> Salinas River facing south, upstream, from the 13 <sup>th</sup> Street Bridge. A side channel is visible in the foreground.

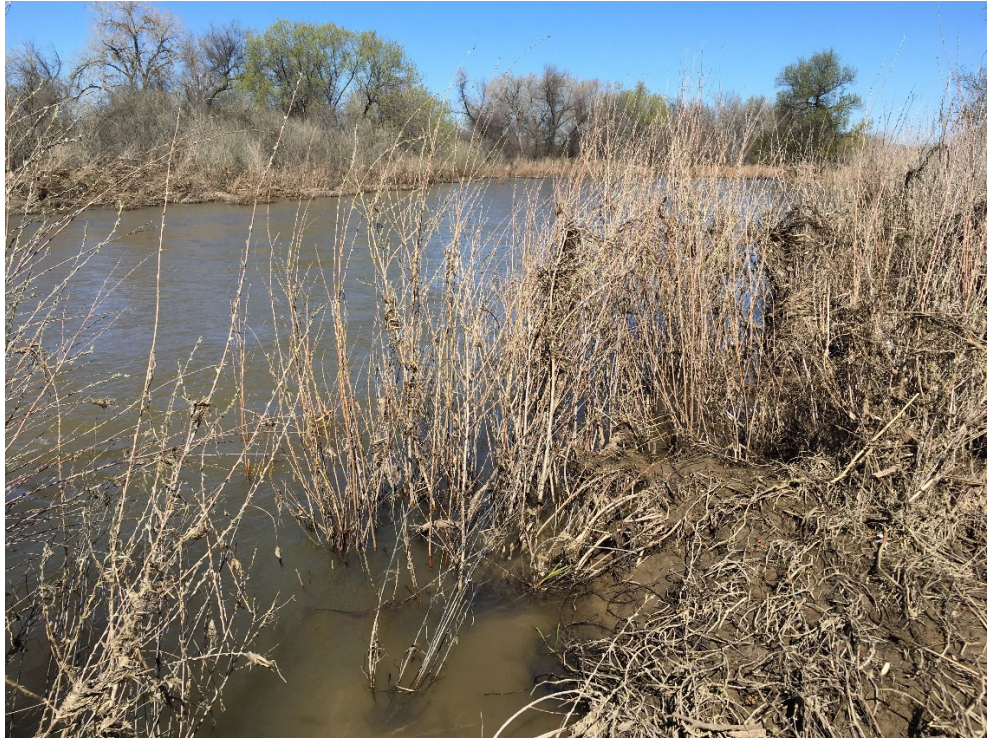
<b>Photo No. 3</b>	<b>Date:</b> 3/14/2019

<b>Description:</b> <i>Site S13b:</i> Salinas River at the mouth of Huerhuero Creek, facing northwest downstream of Salinas River. Emergent vegetation creates refugia from the increased channel velocity.		
<b>Photo No. 4</b>	<b>Date:</b> 3/14/2019

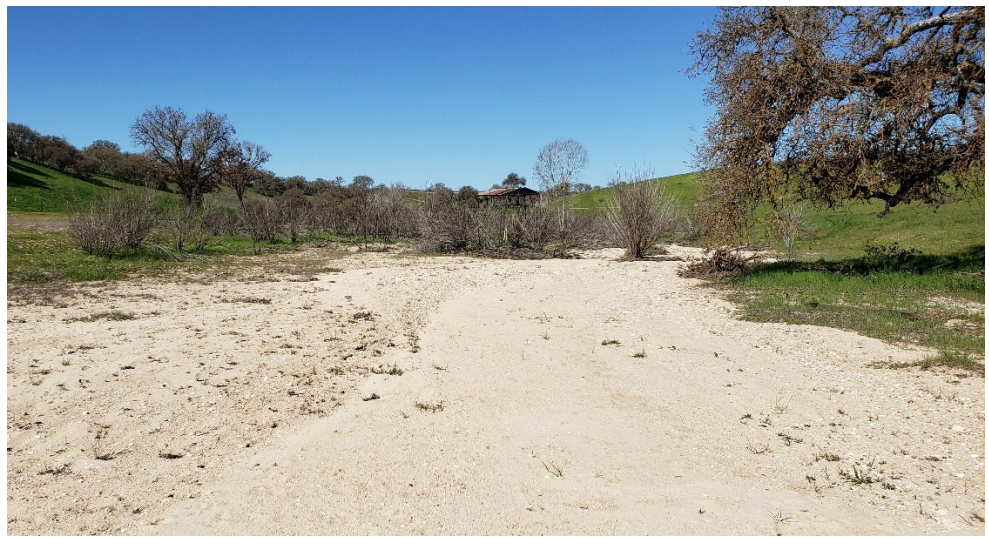
<b>Description:</b> <i>Site S3a:</i> Huerhuero Creek facing west, downstream.

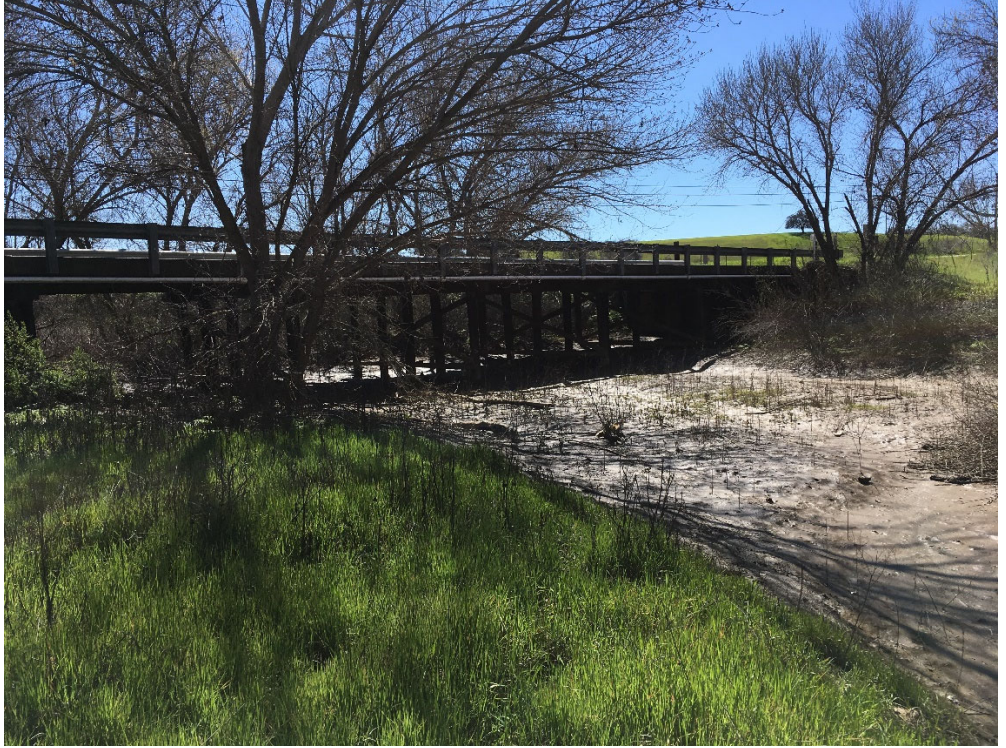
<b>Photo No. 5</b>	<b>Date:</b> 3/14/2019	<b>Description:</b> <i>Site S3b:</i> Mouth of Huerhuero Creek facing east, upstream. The channel bottom is saturated, but doesn't support substantial discontinuous pools.

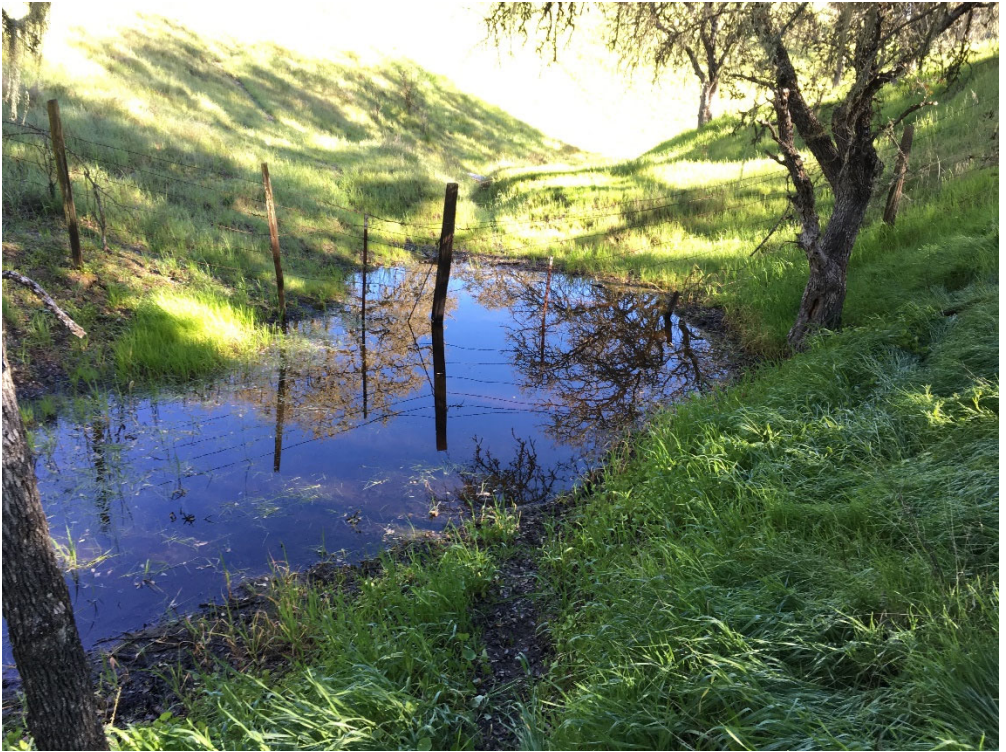
<b>Photo No. 6</b>	<b>Date:</b> 3/14/2019	<b>Description:</b> <i>Site S8b:</i> Unnamed unmaintained pond in a topographic valley, facing northeast, downhill.

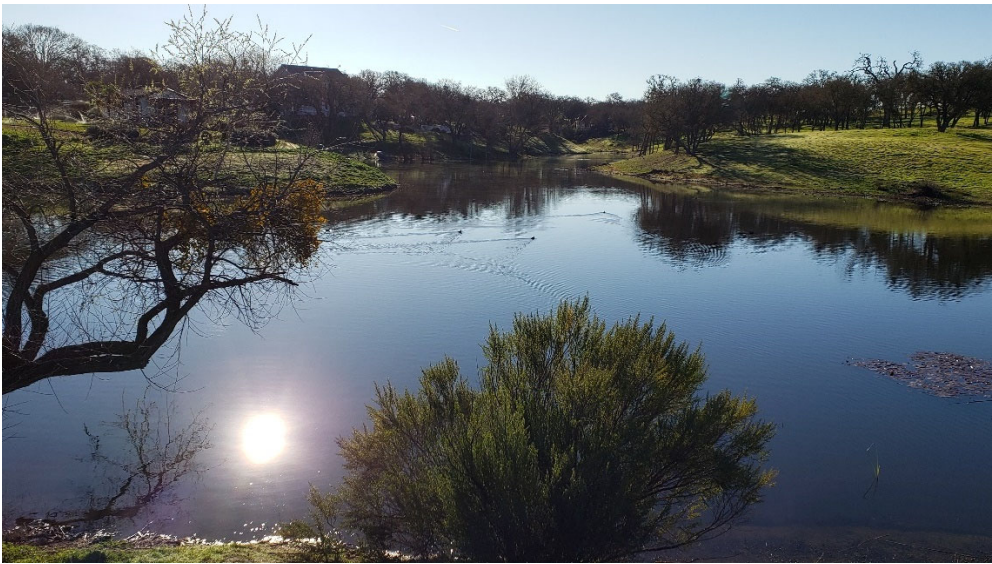
<b>Photo No.</b> 11	<b>Date:</b> 3/14/2019

<b>Description:</b> <i>Site S8a:</i> The lower pond in the Circle B Pond complex facing concrete-lined upper/lower pond connection segment. Photograph taken from northwestern extent of the feature facing southeast. Gradual slopes and partially maintained margins and surrounding uplands evident.		
<b>Photo No.</b> 12	<b>Date:</b> 3/14/2019

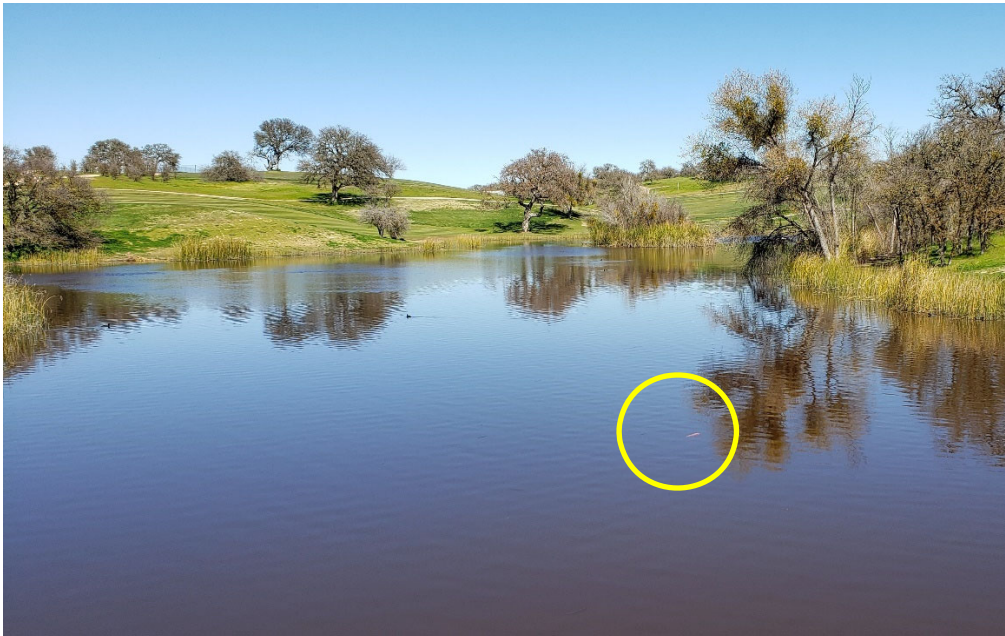
<b>Description:</b> <i>Site S4:</i> Large maintained pond in the Hunter Ranch Golf Course photographed from a bridge facing northeast. A carp and emergent vegetation are evident.

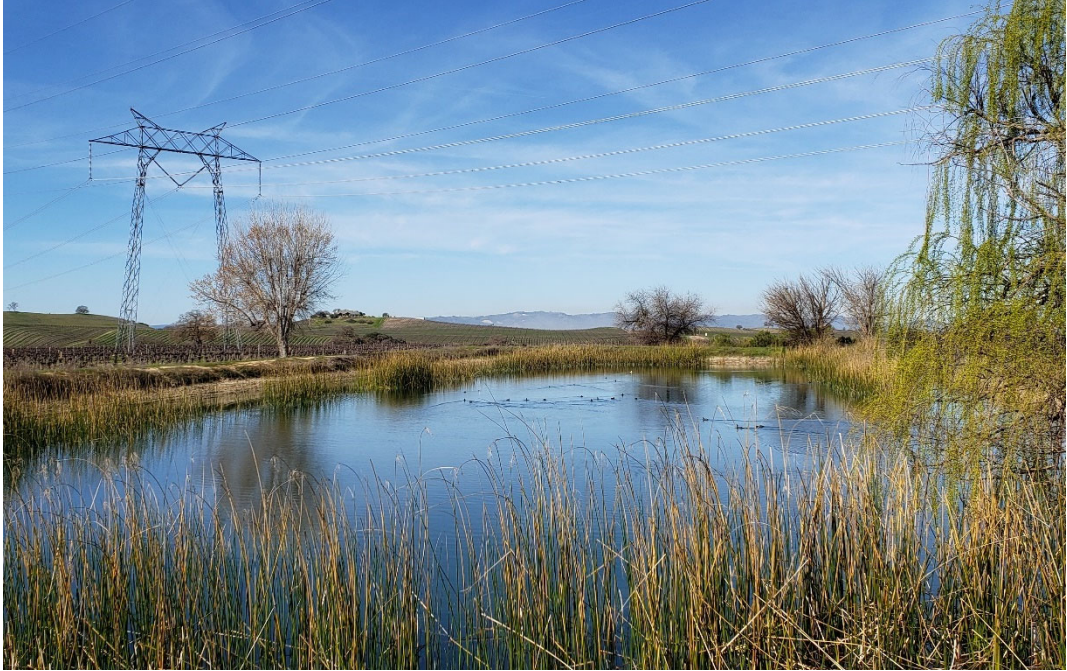
<b>Photo No.</b> 15	<b>Date:</b> 3/15/2019

<b>Description:</b> <i>Site S1b:</i> A manmade perennial irrigation pond within a vineyard facing west.		
<b>Photo No.</b> 16	<b>Date:</b> 3/14/2019

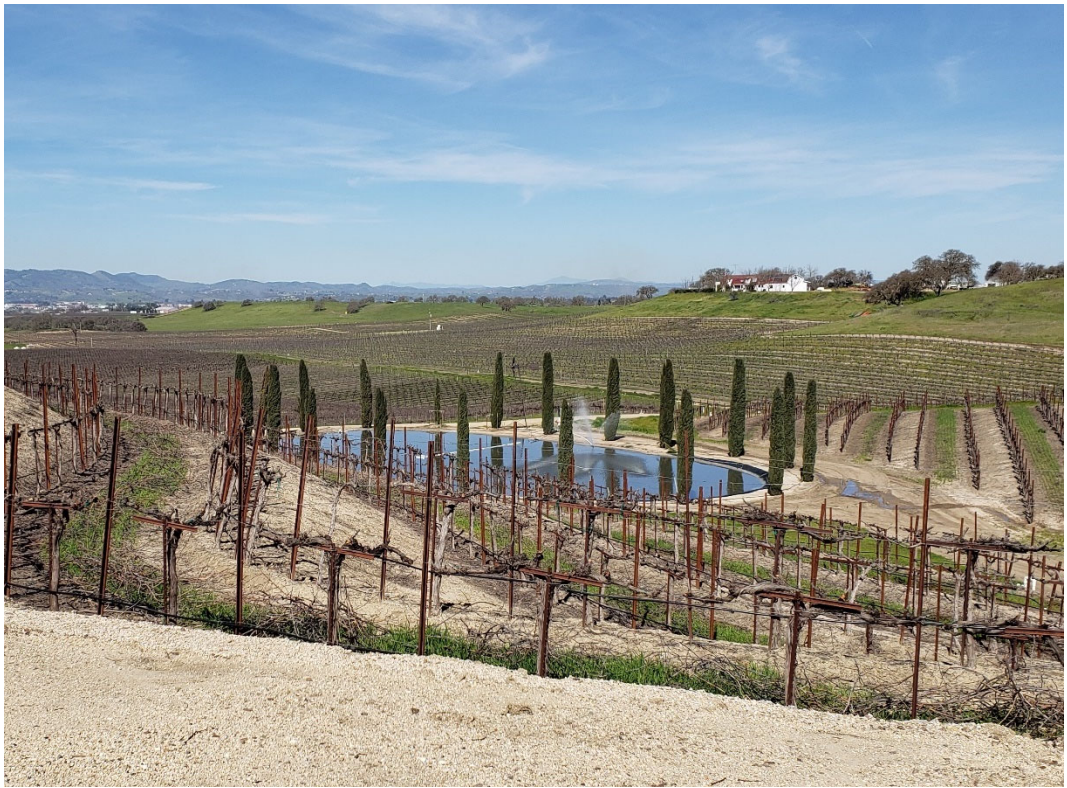
<b>Description:</b> <i>Site S2:</i> A manmade pond within a vineyard facing northwest. The pond is lined with plastic and exhibited a skimming mechanism, aeration device, and an odor suggesting poor water quality.

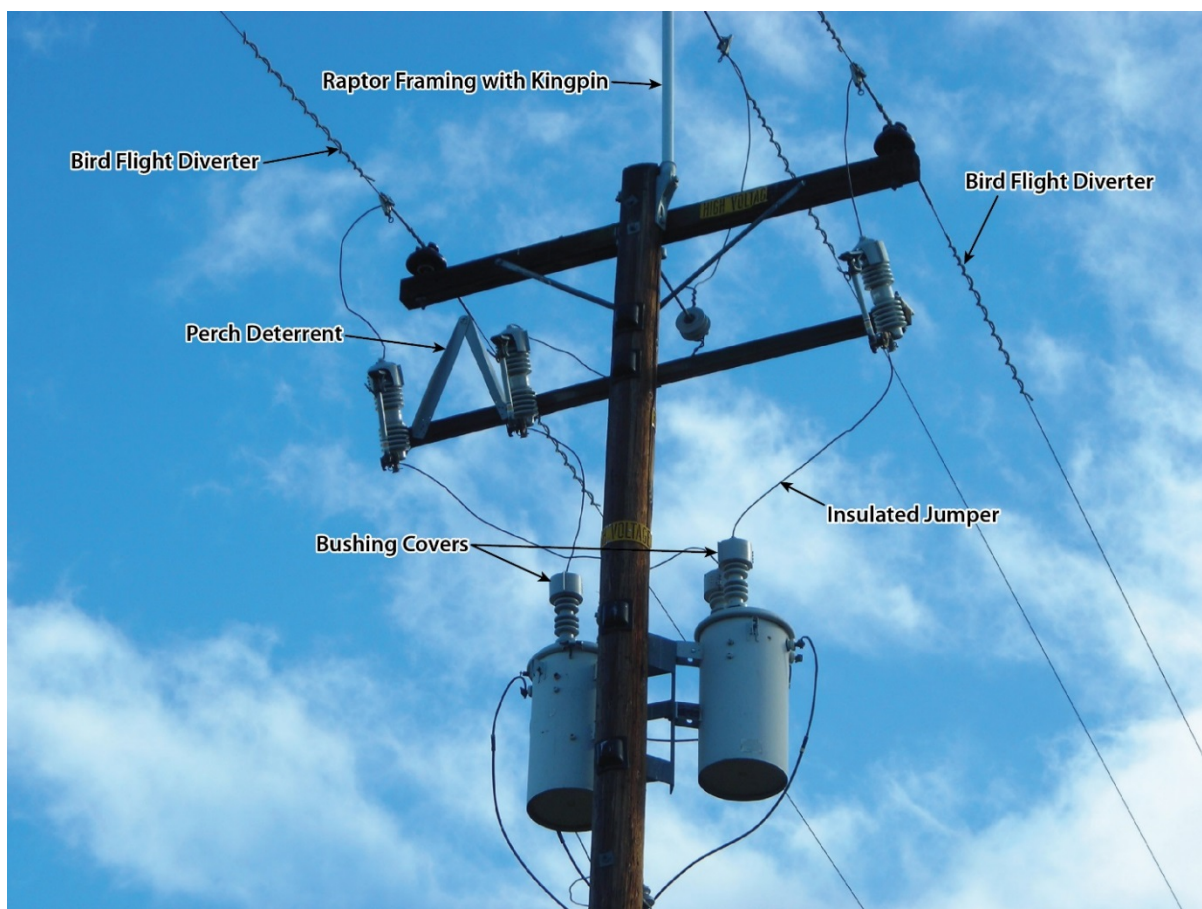
**Figure 3. Important Avian Protection Hardware on Electric Facilities**

PG&E's construction design standards are state-of-the-art and are based on APLIC's *Suggested Practices for Avian Protection on Power Lines: The State of the Art in 2006* (Avian Power Line Interaction Committee 2006).<sup>1</sup> PG&E has developed additional avian-safe construction details, clearance distance requirements for new construction, equipment prescriptions, and construction methods based on the APLIC practices. Avian-safe construction is based on two principles:

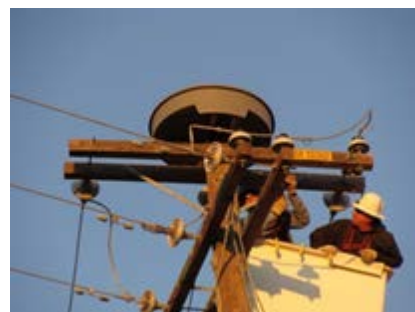
Installation of Osprey Nesting Platform

Native osprey (*Pandion haliaetus carolinensis*) populations are expanding in Northern California and often favor building their large nests on PG&E's power poles. PG&E developed a program to install osprey nest platforms to move osprey nests out of harm's way and to prevent fires from nests initiated on live power poles. Hundreds of osprey nest platforms have been installed throughout PG&E's service area.

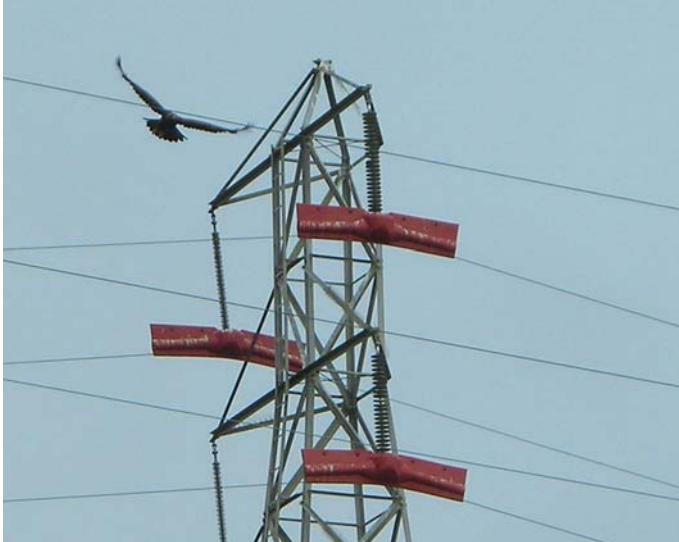
A golden eagle soars above a PG&E transmission tower near San Juan Bautista. Innovative new products, such as the red transmission line covers pictured (at left), protect eagles and greatly increase service reliability.

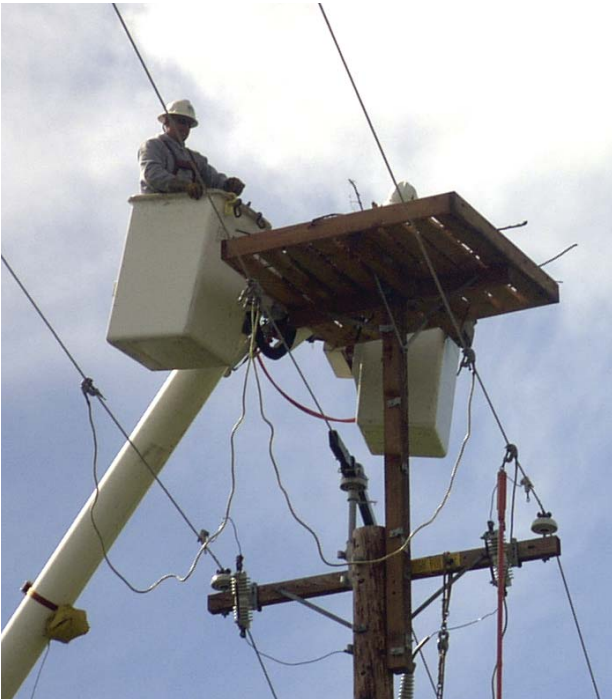
A PG&E crew installs a nest platform near Clear Lake. Nest platforms reduce outages and are preferred by large birds, such as ospreys.
