SDG&E SALT CREEK SUBSTATION PROJECT

CPUC MONITORING SUMMARY REPORT

October, 2016

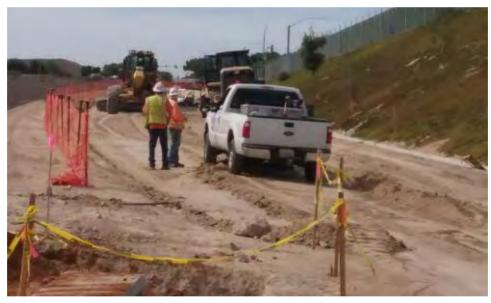
Summary of Two graders were observed idling unattended for at least 13 minutes. When the construction supervisor was

Caption Construction workers with idling graders in background.

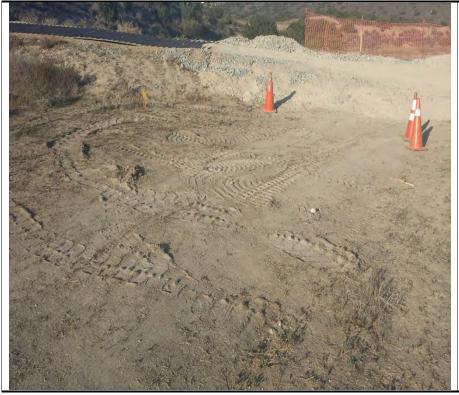
Photograph 1:

Incident Summary: In an effort to avoid incoming haul trucks while adjusting the rock apron at the construction entrance/exit, the skid steer operator drove outside of the limits of the access road into the highly disturbed area located just west of the access road. The LEI inspected the area and found little to no vegetation consisting primarily of weeds. As a result of this noncompliance, the crew was notified to stay within the boundary of the access road at all times.

Disturbed area located just west of the access road boundary where the skid steer drove within to avoid incoming haul trucks.

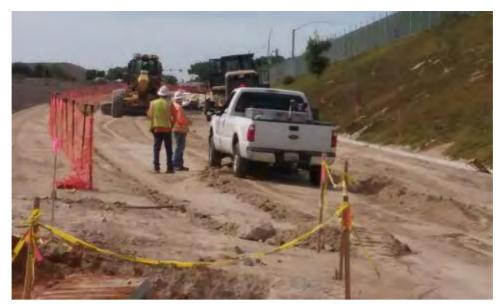
Two readers were observed idling unattended for at least 13 minutes. When the construction supervisor was informed, he immediately corrected the situation. All concerned parties were informed.

Construction workers with idling graders in background. Caption

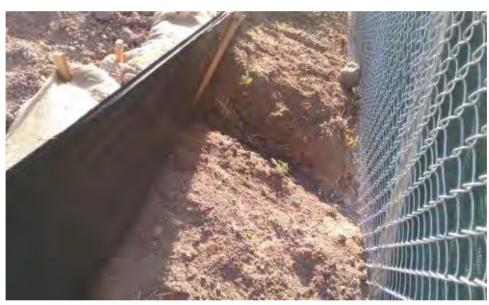
Caption Small erosional gully downhill from erosion control BMPs.

A small (< 1ft wide) erosion gully on the eastern edge of the site was observed, reported, and repaired.

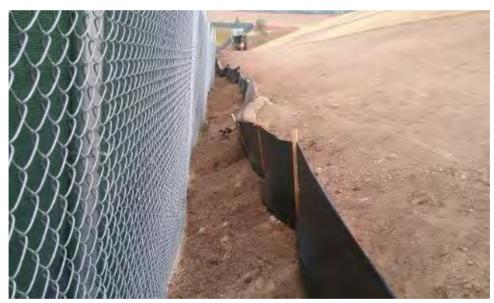
Caption Potentially weak area in erosion control fencing.

Q7 Notes	Dirt above northern brow ditch plus fiber roll, compromised southern slope silt fence and fiber rolls by trailer will be repaired today.
Q8 – Invasive Weed Control: Were procedures to prevent the spread of invasive weeds implemented adequately?	Met Requirements
Q9 – Hazardous Materials and Waste Management: (b) Were hazardous material waste disposed of appropriately? (c) Were any spills or leaks addressed adequately? (d) Was solid waste collected and disposed of adequately?	Corrections Required
Q9 Notes	New supply of sealant needs to be moved onto secondary containment.
Q10 – Fire Management: (a) Were fire prevention procedures implemented as required? (b) Was firefighting equipment available on site?	Corrections Required
Q10 Notes	Subcontractor truck parked on site without fire-fighting materials. Truck will be moved to acceptable location.
Q11 – Cultural, Paleontological, and Tribal Resources: (a) Were impact avoidance and minimization requirements for cultural, paleontological, and tribal resources implemented adequately? (b) If potential resources or human remains were inadvertently discovered, were response procedures and protocols implemented as required?	Met Requirements

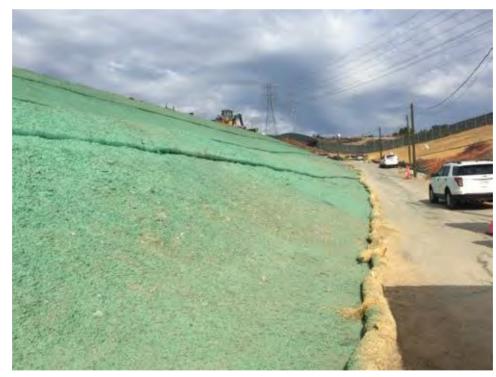
Caption BFM applied thinly on NE Slope.

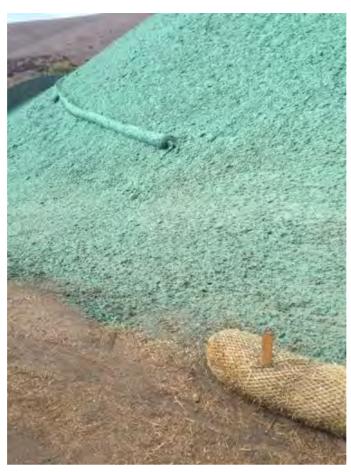
Caption Straw wattle not extended as requested by CPUC EM yesterday.

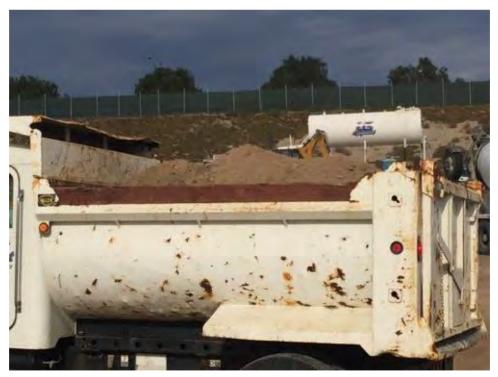
On October 28th, on two separate occasions, inspectors from AECOM and the CPUC observed a loaded dump truck that did not have the required two feet of freeboard clearance. SDG&E recorded this incident as a Level 2: Minor Problem.

and load was too high. Did not have 2 feet of freeboard. Andy Ringer instructed driver to adjust future loads or cover with tarp. Initially documented as Level 1 because truck drove slowly and only 100 feet on Hunte Parkway. Observed same truck with soil again loaded too high. Incident elevated to Level 2. SDG&E is filling the report.

Truck overloaded. APM AIR-1 requires load covering or at least 2 feet of freeboard. Caption

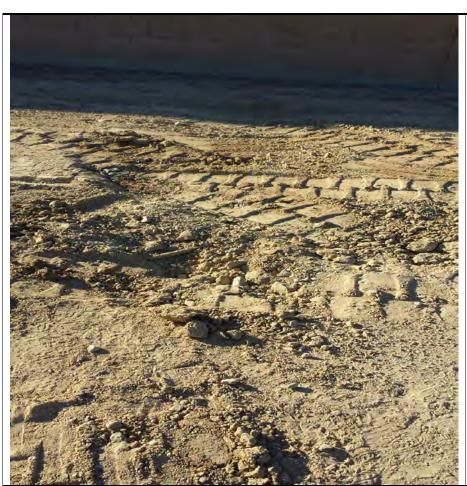
Photograph 2:

On October 21st, the LEI observed a spill of approximately 2 gallons of gasoline within the substation pad area. There were no equipment or vehicles in the immediate area that the spill could be attributed to, and crews working in the area said they did not know anything regarding the spilled gasoline. Crews cleaned up the spill and placed it in two sealed 55-gallon metal drums, and one large plastic bag, all of which were placed in secondary containment. SDG&E was notified of the spill and sent an SDG&E Hazardous Materials Team to the project site to remove and properly dispose the plastic bag and drums of contaminated soil from the Project site. SDG&E recorded the spill as a Level 1 Occurrence.

Stained soil area after it was cleaned up and stained soil placed in proper containers, October 21, 2016.

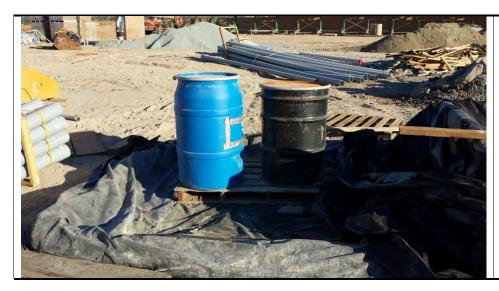
Photograph 3:

55-gallon containers with contaminated soil in secondary containment ready to be removed from the Salt Creek substation site, October 21, 2016.

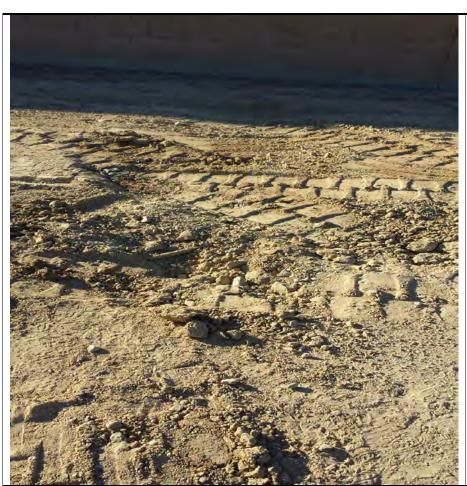
Photograph 2:

Stained soil area after it was cleaned up and stained soil placed in proper containers, October 21, 2016.

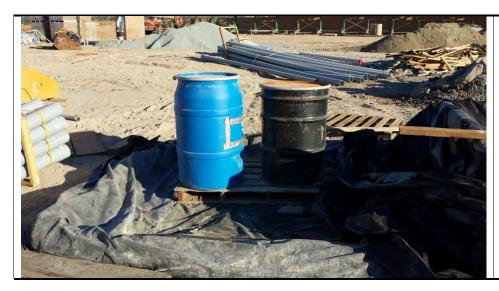
Photograph 3:

55-gallon containers with contaminated soil in secondary containment ready to be removed from the Salt Creek substation site, October 21, 2016.
