May 15, 2025

RE: April 2025 Monthly Summary Report for the Zayo's Prineville to Reno Fiber Optic Line Project

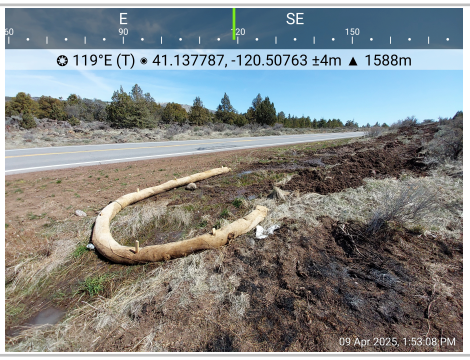
Observed activities of the day were conducted along relativity flat and dry area. Additional observations: immediately north of current activities, prior work disturbance within area wetted by an upland seep. Approximately 250 ft of rutted mud inundated with flow from upland seep. Temporary erosion and sediment transit control measures were observed: straw wattles installed at knick points to reduce discharged velocity into roadside ditch.

REPRESENTATIVE SITE PHOTOGRAPHS			
Date	Location	Photo	Description
04/09/2025	135		Overview of active work observed.
04/09/2025	135		view of flooded rut with temporary erosion control applied.
04/09/2025	135		view of scoured outflow with temporary erosion control applied.
04/09/2025	135

view of mitigated outflow at north end of the disturbance area.

it is recommended that additional erosion control measures be implemented ahead of follow-up disturbance area clean-up activities. BMP implementation should be installed to SWPPP standards.

The onsite monitor had issued a temporary stop-work recommendation and had further recommended the implementation of temporary erosion control.

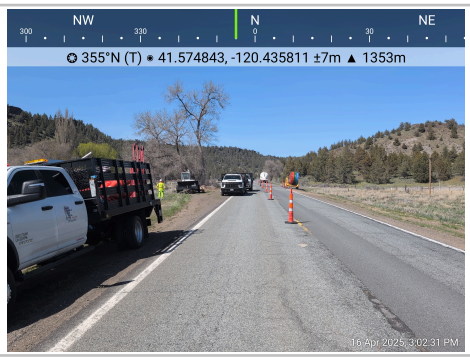
REPRESENTATIVE SITE PHOTOGRAPHS			
Date	Location	Photo	Description
4/16/25	M-31.1		Spread
4/16/25	M-31.1

Spread, closed lane

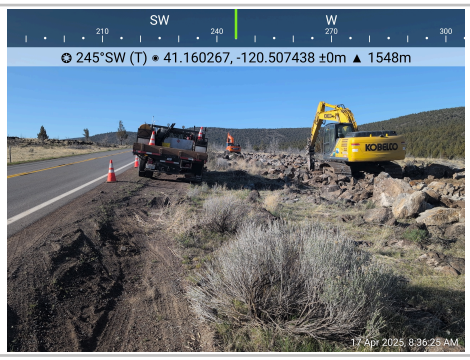
Spread
4/17/25	L-137.3

Spread
