Re: Monthly Report Summary #2 for the Manning 500/230 kV Substation Project

MANNING 500/230 KV SUBSTATION PROJECT

CPUC SITE INSPECTION FORM

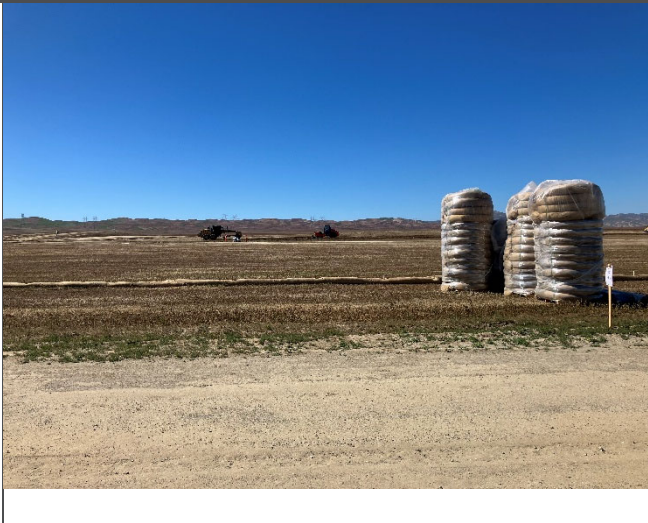
A photograph showing two large, cylindrical stacks of straw wattles wrapped in clear plastic. They are situated in a dry, open field under a clear blue sky. In the background, there are some distant structures and a dirt road.	Straw wattles, soil stockpile, grader, and vibratory roller.
3/11/26 Manning Substation site

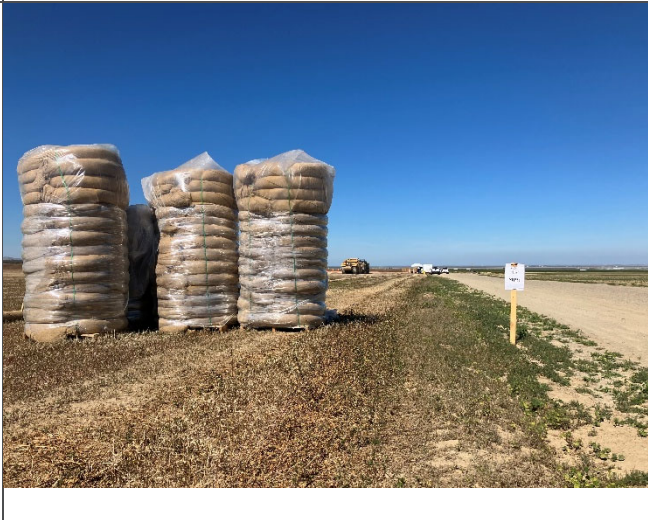
A photograph showing three large, cylindrical stacks of straw wattles wrapped in clear plastic. They are situated in a dry, open field. In the background, a yellow scraper is visible on a dirt road, and a white 15 MPH speed limit sign is posted on a wooden post.	Straw wattles, scraper, and 15 MPH speed limit sign.
3/11/26 Interconnection site (orchard)
