**Re: Monthly Report Summary #10 for Aliso Canyon Turbine Replacement Project**

## Aliso Canyon Turbine Replacement Project CPUC Site Inspection Form

Project:	Aliso Canyon Turbine Replacement	Date:	January 8, 2015
Project Proponent:	Southern California Gas Company and Southern California Edison	Report #:	VS039
Lead Agency:	California Public Utilities Commission	Project Phase/NTP:	Guard House and Road Widening Component (NTP-1). The New Admin/IM Building (NTP-2) and Central Compressor Site (NTP-3). P-41 and P-43 fill sites (NTP-2). PS-42 Fill Site and the PS-42 Rock Site and Temporary Fill Site. P-32 fill site (NTP-3) and the Natural Substation (NTP-3, NTP-A). TSP-45, San Fernando Substation and Wiley Canyon (NTP-A).
CPUC PM:	Andrew Barnsdale, Energy Division	AM/PM Weather:	Sunny with mild temps (68 degrees F), clear with a temp of 65 degrees F. Temp up to 72 degrees by mid afternoon.
E & E CM:	Lara Rachowicz	Start/End time:	0900 hrs to 1245 hrs within the Aliso gas field, 1300 hrs arrive at the San Fernando Substation, 1400 hrs arrive at Wiley Canyon.

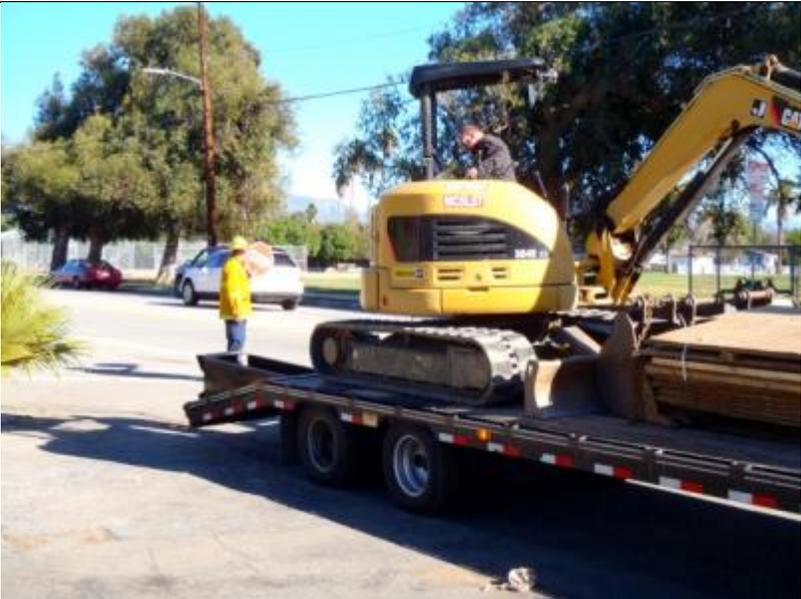
A yellow tracked excavator is being loaded onto a flatbed trailer. A worker in a yellow safety vest stands on the trailer, and another worker is on the excavator. The scene is outdoors with trees and a clear sky.	Equipment is being off loaded at the site. Fire crews are acting as traffic control personnel.
01/15/15	San Fernando Substation

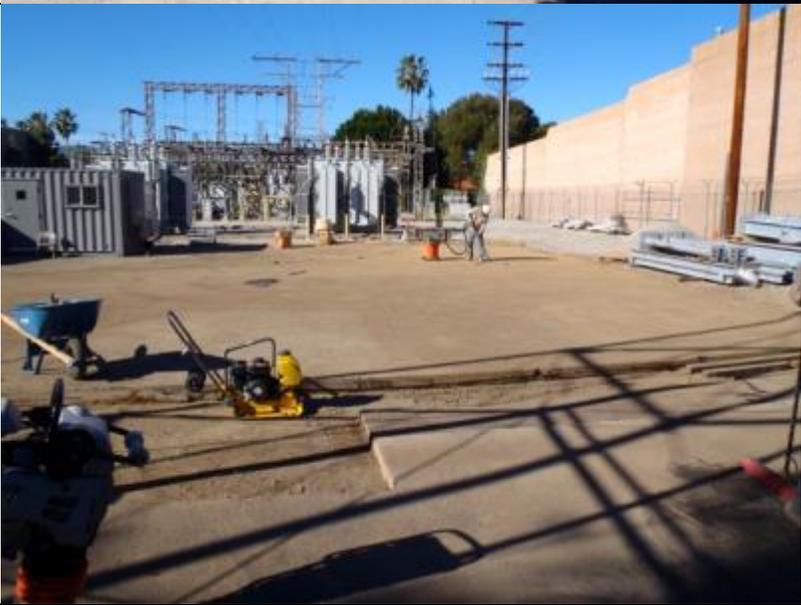
A wide view of a substation construction site. In the background, there are power lines and a large metal structure. In the foreground, there is a concrete area with some equipment and a worker. The sky is clear and blue.	The underground work has been completed and they are preparing to repave some of the area. Next up will be to "Fly" the poles for installation.

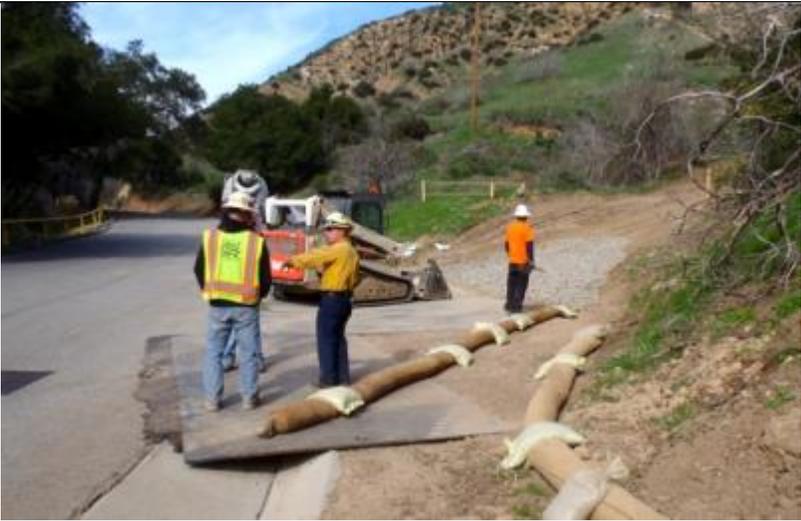
01/22/15	TSP 46 access road

A photograph showing three construction workers in safety gear standing on a road. The road surface is being prepared with gravel and steel plates. A small orange utility vehicle is visible in the background. The road is bordered by a dirt embankment and some trees.	The TSP 46 access road is being prepared with gravel and steel plates where it meets the main road.
01/22/15	San Fernando Substation

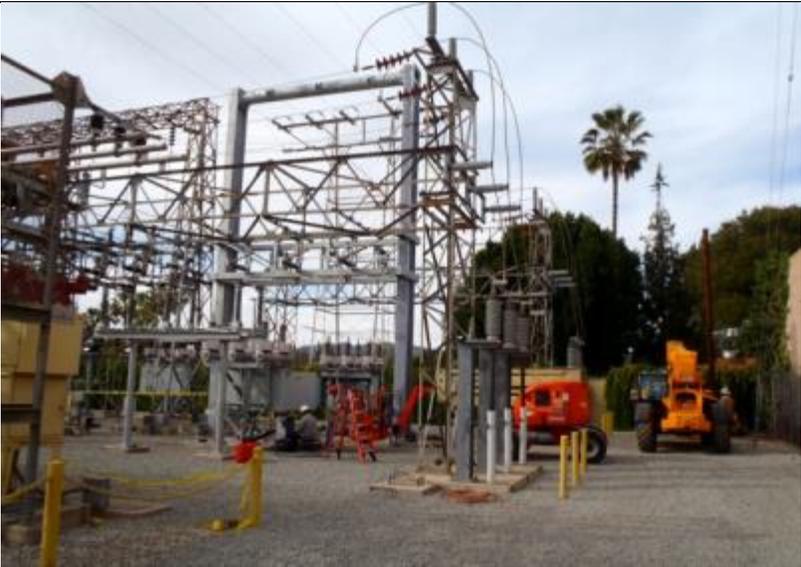
A photograph of an electrical substation under construction. Large metal structures for power lines are visible. A yellow crane and other construction equipment are present. The area is cordoned off with yellow safety tape. A palm tree is visible in the background.	Installation of the above ground structures has begun.
