Re: Monthly Report Summary #13 for the Mesa 500-kV Substation Project

ATTACHMENT 1

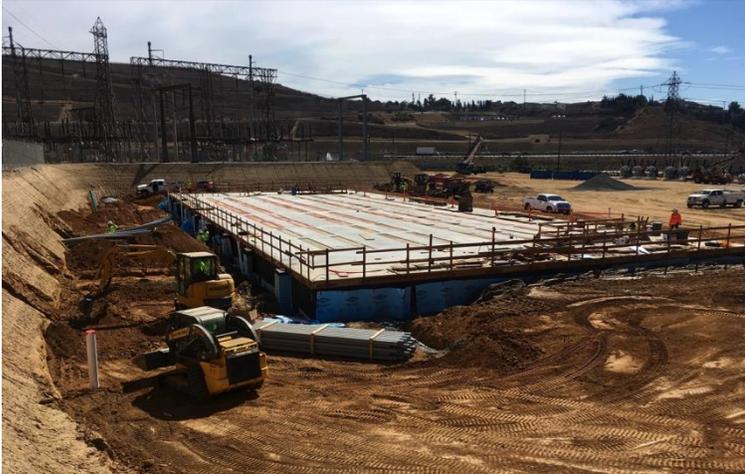
Photo 1 – The Senior MEER. Crews are conducting backfill work around the structure (photo depicts the first floor installation). Photo facing south.
10/1/18	Mesa substation

Backfilling around the Senior Mechanical Electrical Equipment Room (MEER) appeared complete, and gravel has been applied. Crews were in the process of installing the Senior MEER building walls – Photo 1.

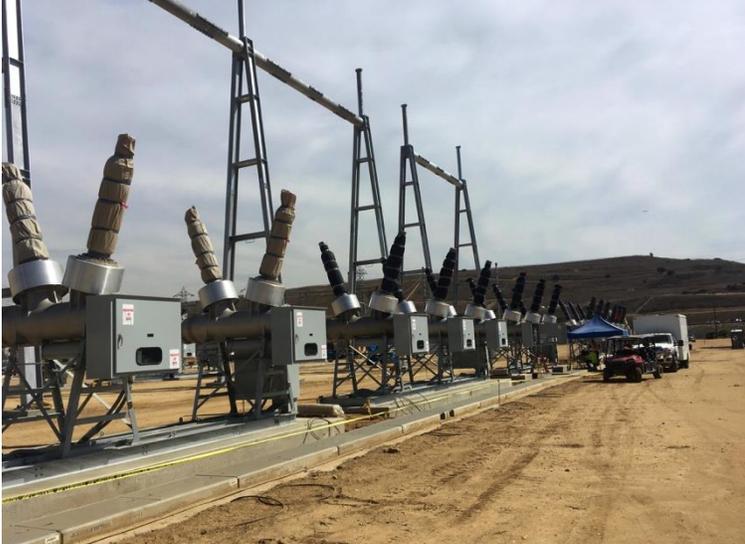
Photo 2 – Large metal structures being installed in the 220-kV rack area. Photo facing south

Installation of the metal aboveground structures continued within the 220-kV rack area – Photo 2.

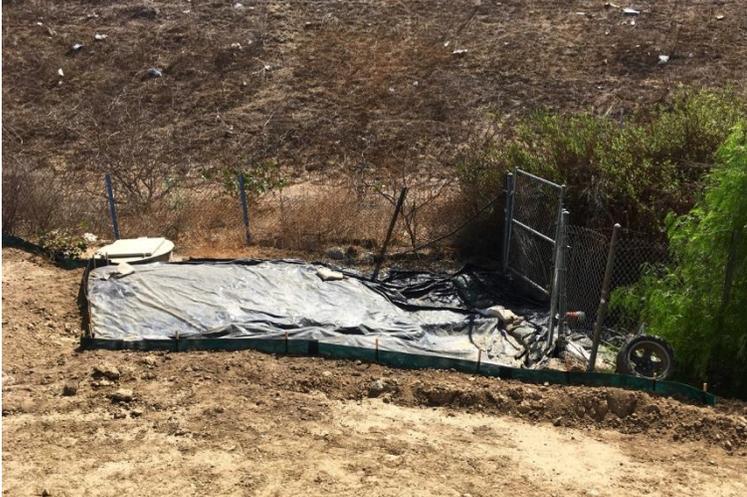
A photograph showing a Best Management Practice (BMP) installation. A large, rectangular area is covered with a grey tarp, bordered by a green plastic strip. The site is on a dirt slope with some sparse vegetation and a chain-link fence in the background.	Photo 6 – BMP installations at the inlet to the offsite drainage system.
10/1/18	Mesa substation

The offsite drainage channel was wet from recent flows from the Marketplace, though the channel was free of sediment – Photo 6. The final Marketplace drainage connection had been installed and slurried – Photo 11.

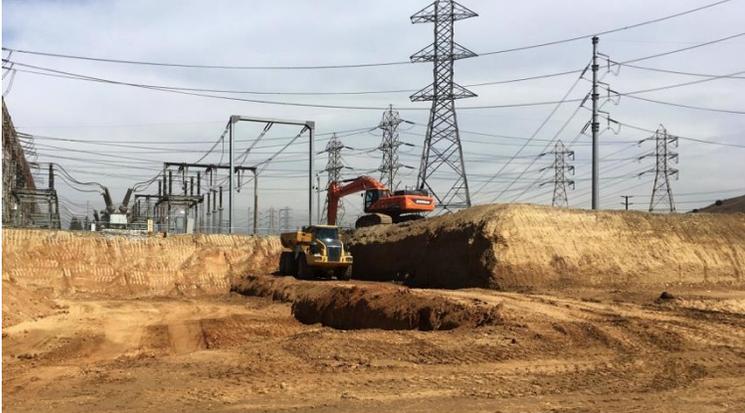
Photo 8 – Excavator removing dirt from an area west of the old substation. Photo facing east.
10/1/18	Mesa Substation

The dirt removal from the western side of the old substation site has been completed – Photo 8.

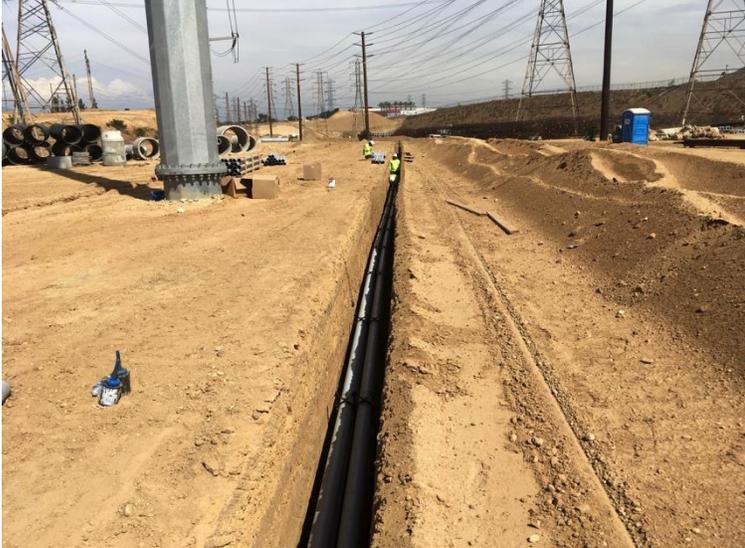
Photo 9 – Conduit installation. Photo facing east
10/1/18	Mesa Substation

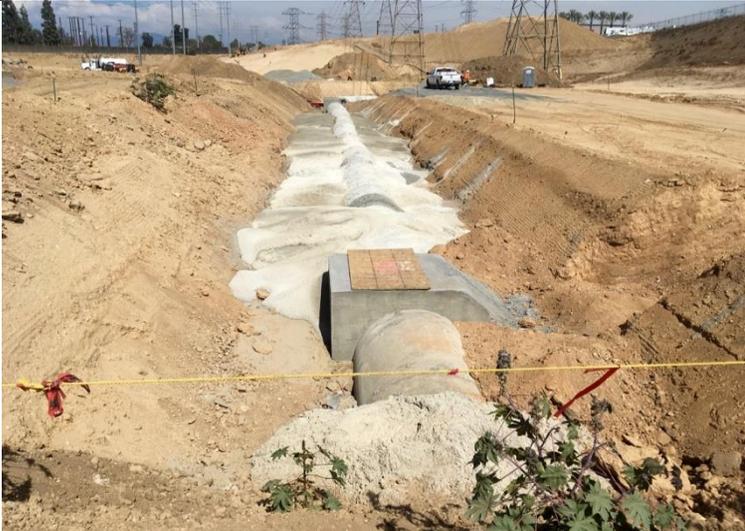
Photo 10 – Storm drain work near the southeast portion of the project. Photo facing east

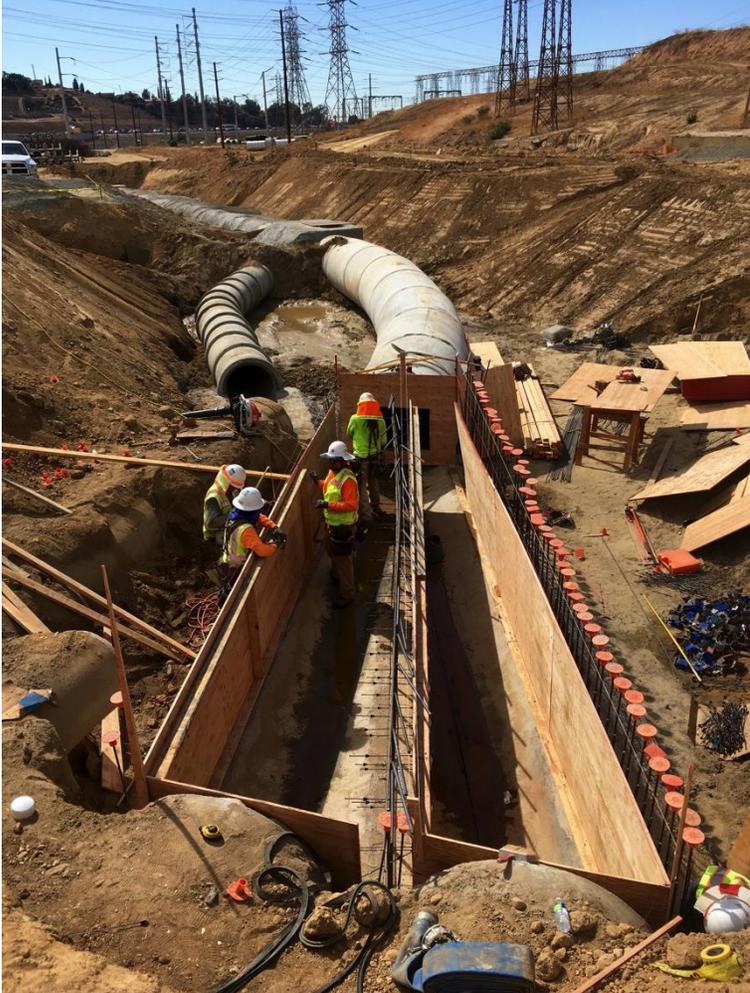
Photo 11 – Crews connecting the onsite stormdrain system to the Marketplace drain pipes. Photo facing west
10/1/18	Mesa Substation

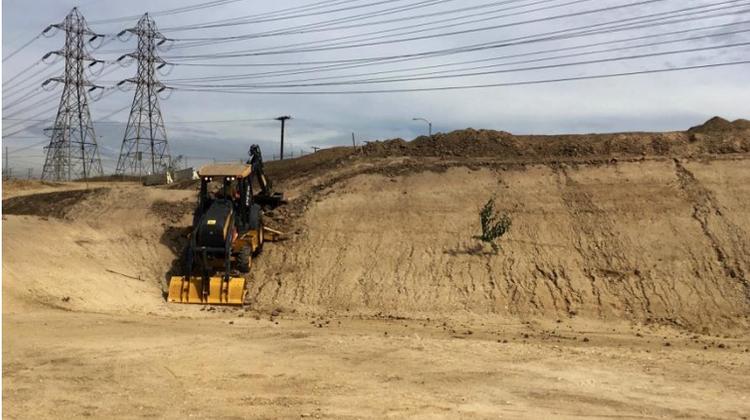
Photo 12 – “V” ditch installation along the southeastern corner of the project site. Photo facing east

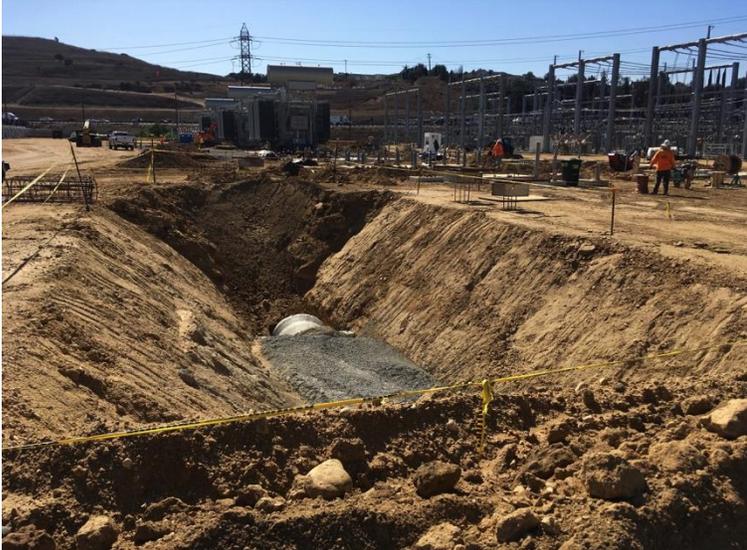
Photo 3 – Open portion of the storm drain system. Photo facing south.

There were at least 30 holes within the 220-kV rack area that were fully covered with plywood and sealed with dirt around the edges of the plywood – Photo 3.

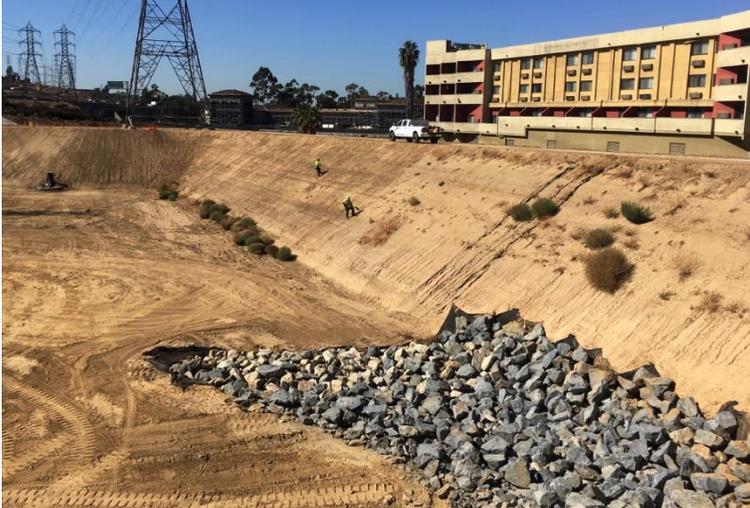
Photo 4 – Weed removal from the detention basin. Photo facing west.
10/12/18	Mesa substation

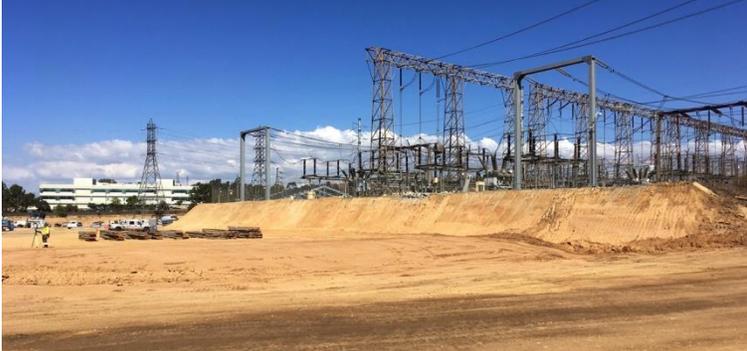
Photo 8 – Dirt removal has been completed west of the old substation. Photo facing northeast.
10/12/18	Mesa Substation

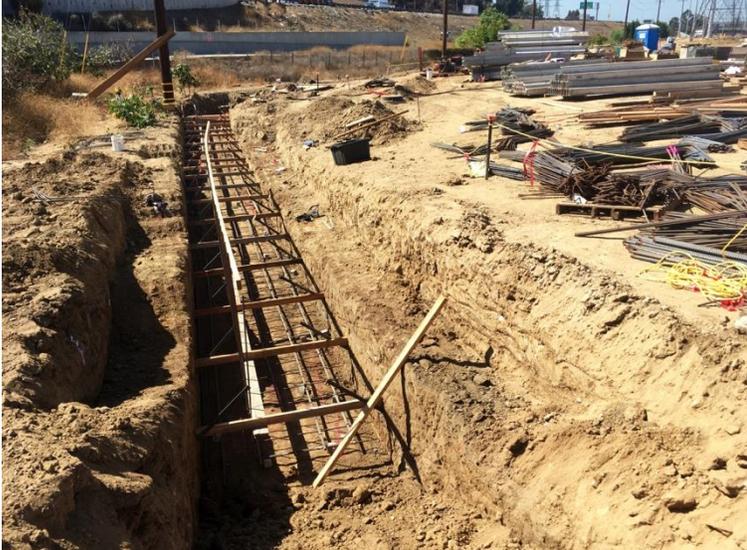
Photo 9 – Rebar installation for the southern border wall. Photo facing southwest.

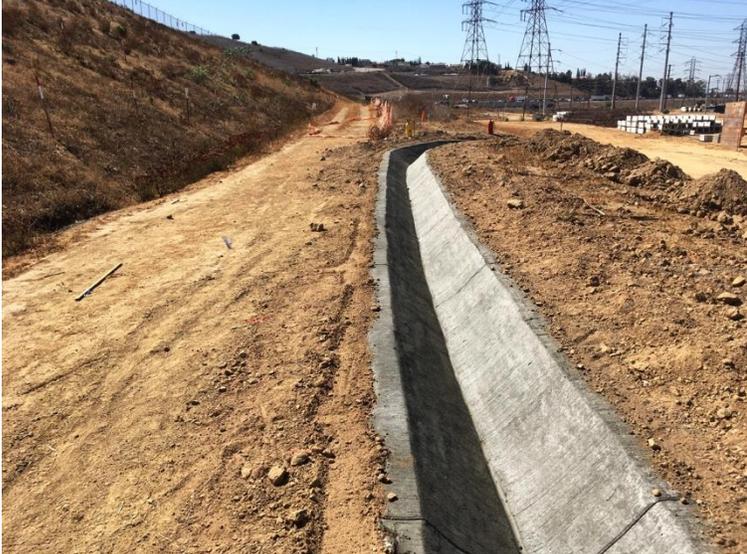
Photo 10 – “V” ditch completed near the coastal sage scrub ESA habitat. Photo facing west.
10/12/18	Mesa Substation

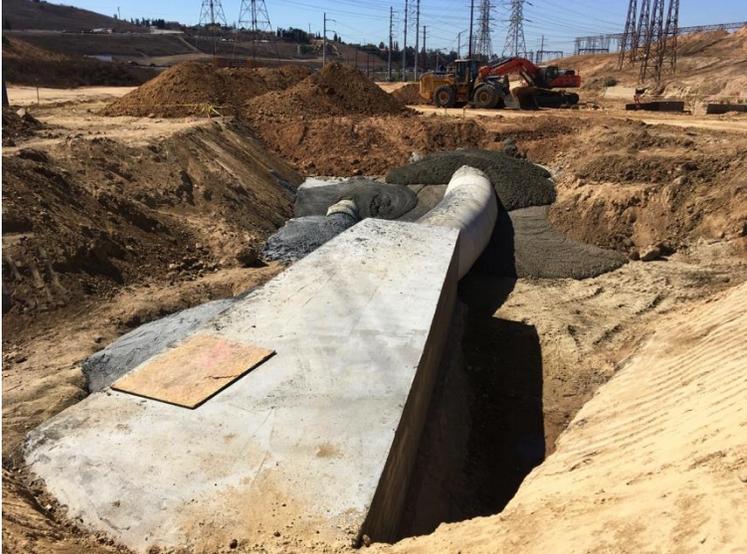
Photo 11 – Connection between the onsite storm drain system and the Marketplace storm drain pipes. Photo facing west.
10/12/18	Mesa Substation

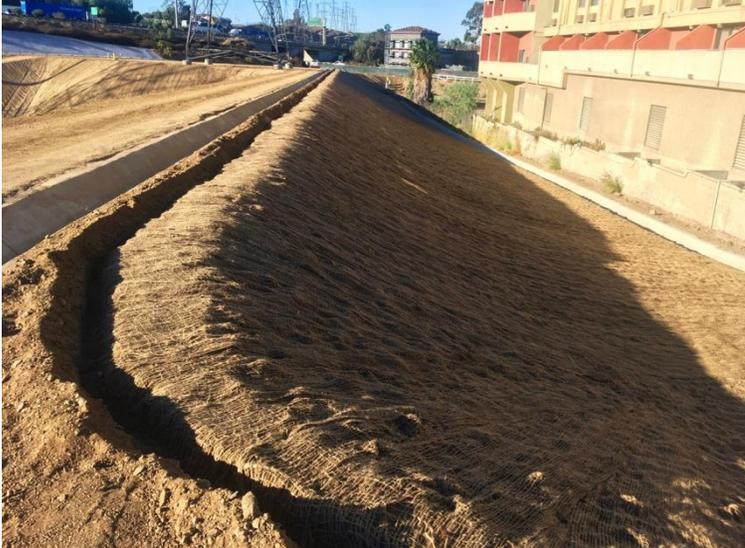
Crews are conducting restoration work along the north-facing slope between the detention basin and the Markland Hotel – Photo 5. Crews were laying and keying in jute netting along the top of the slope. This area will eventually be hydroseeded. Biological monitor Bob Huttar (ICF) explained that they plan to install jute netting to and hydroseed the entire detention basin. I inquired about weed removal within the telecommunications corridor south of Highway 60, but he had no new information regarding whether it would occur (MM BR-1, APM-BIO-03, APM-BIO-04, APM-BIO-06, MM BR-2).

Photo 5 – Jute installation between the detention basin and the offsite hotel. Photo facing west.

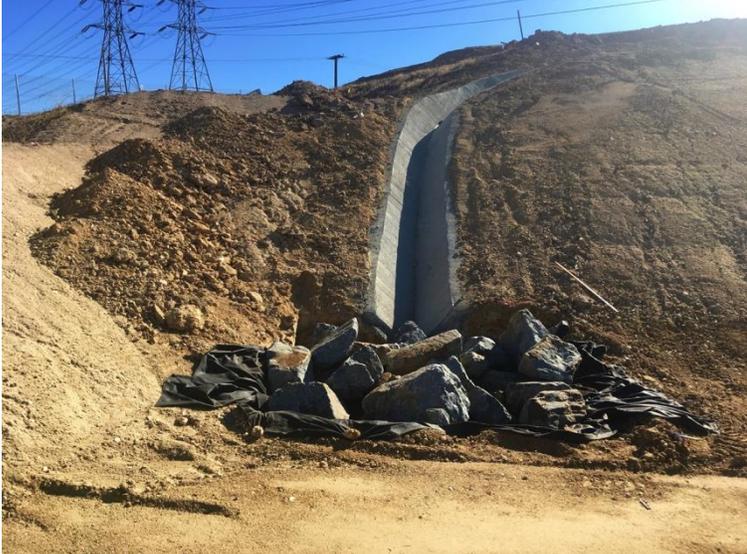
The “V” ditch near the sensitive coastal sage scrub habitat is completed. Riprap has been installed at the outflow locations – Photo 10.

Photo 10 – Riprap placed at the end of the “V” ditch.

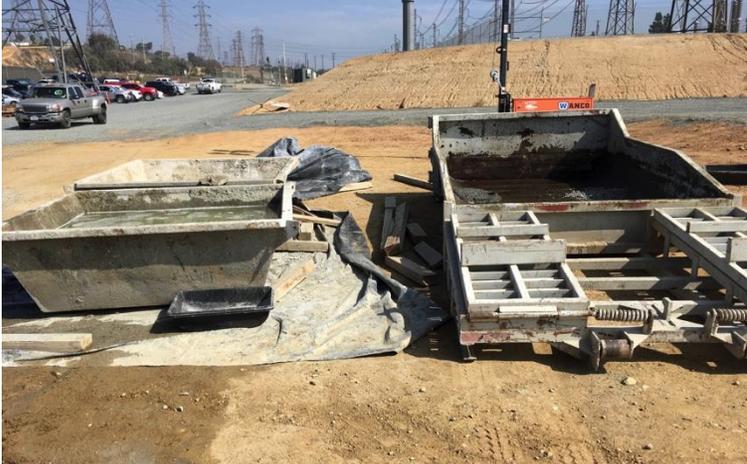
Photo 2 – Concrete washout bins. Photo facing east
10/25/18	Mesa substation

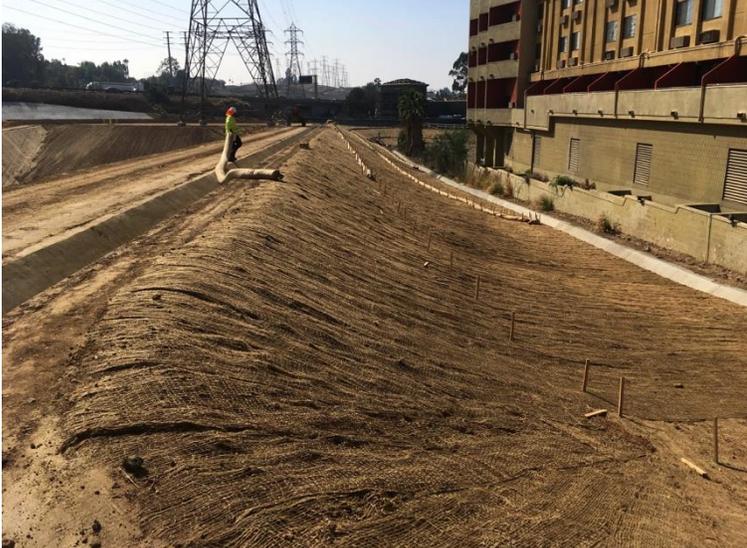
Photo 6 – Straw wattles being installed over the jute netting near the Markland Hotel. Photo facing west

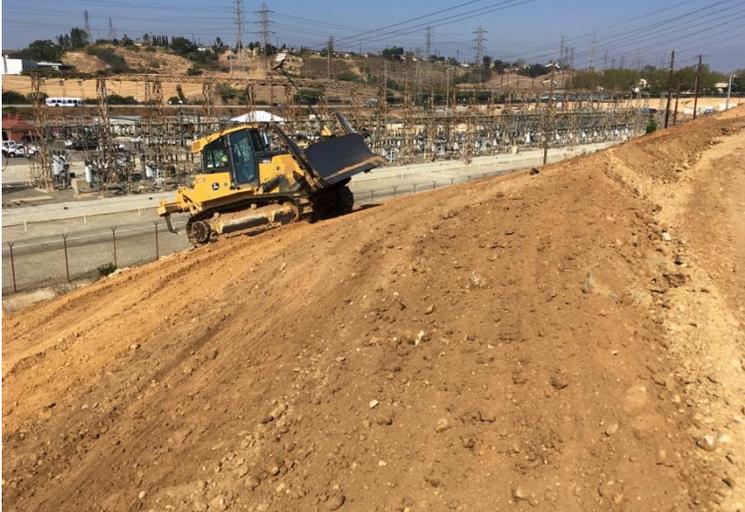
A yellow dozer is shown working on a large, reddish-brown earthen slope. The dozer is positioned on the slope, facing towards the right. In the background, there are power lines and a fence, indicating a construction site for a substation.	Photo 10 – A dozer track rolling the earthen slope immediately south of the old substation site. Photo facing north
10/25/18	Mesa Substation
