January 13, 2020

Re: Monthly Report Summary #18 for the Mesa 500-kV Substation Project

This report provides a summary of the compliance monitoring activities that occurred during the period from **March 1 to 31, 2019**, for the Mesa 500-kilovolt (kV) Substation (Mesa Substation) Project in Los Angeles County, California. Compliance monitoring was performed to ensure that all project-related activities conducted by Southern California Edison (SCE) and their contractors comply with the requirements of the Final Environmental Impact Report (Final EIR) for the Mesa Substation Project, as adopted by the California Public Utilities Commission (CPUC) on February 9, 2017.

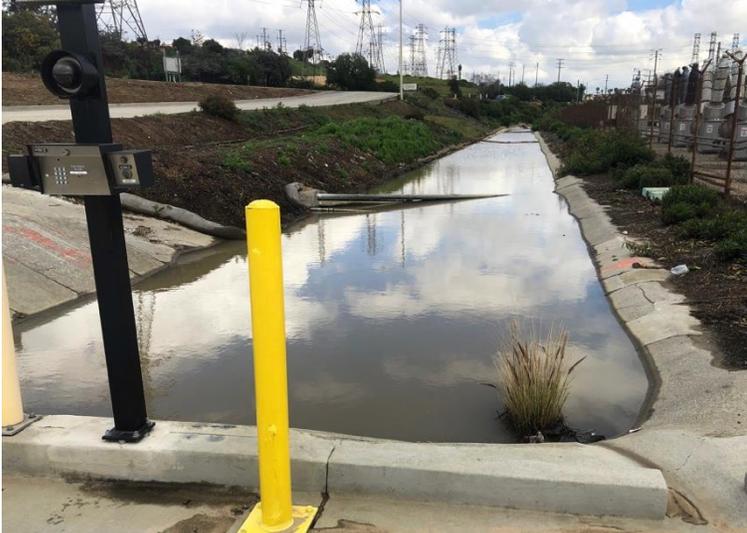
Photo 1 – Rainwater runoff is filling the channel around the substation. Photo facing east.
3/07/19	Mesa Substation

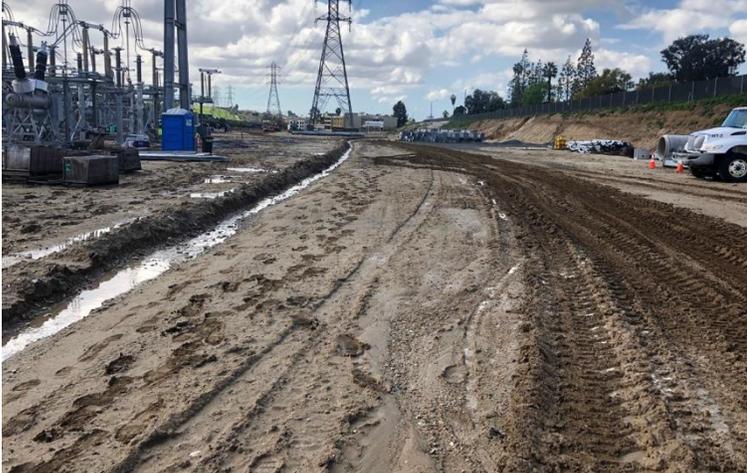
Photo 3 – Muddy conditions onsite. Photo facing west.

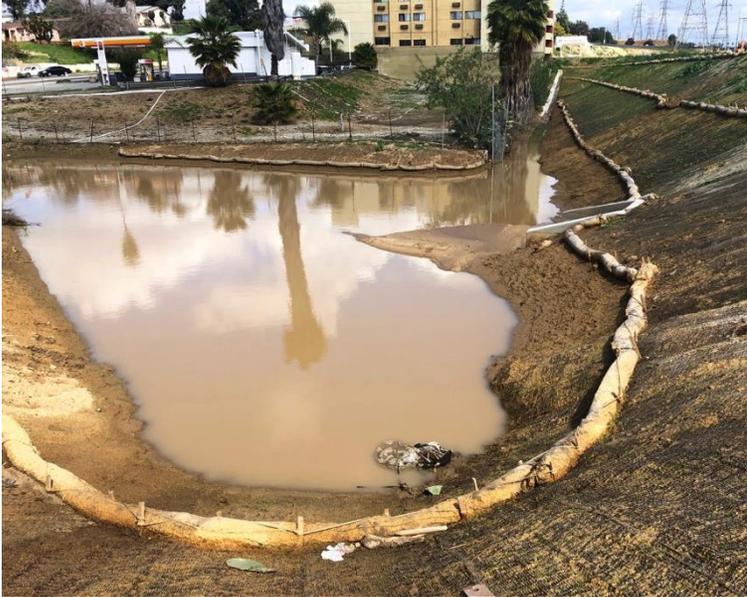
Photo 5 – Triangular retention basin. Photo facing northeast.
3/07/19	Mesa Substation

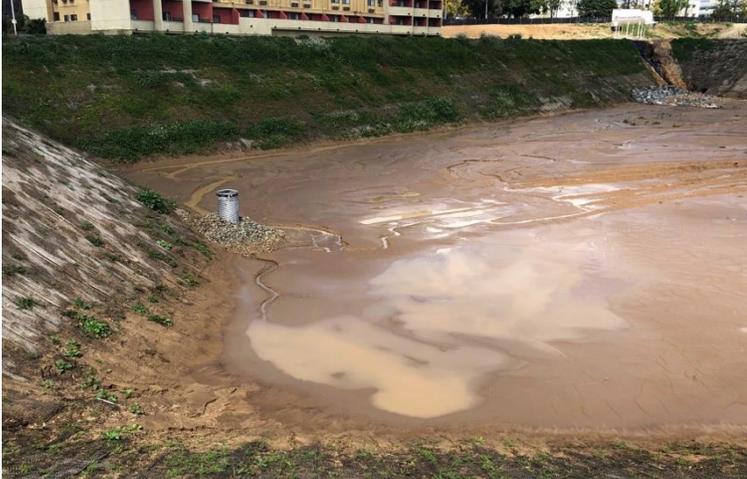
Photo 6 – Detention basin. Photo facing north.

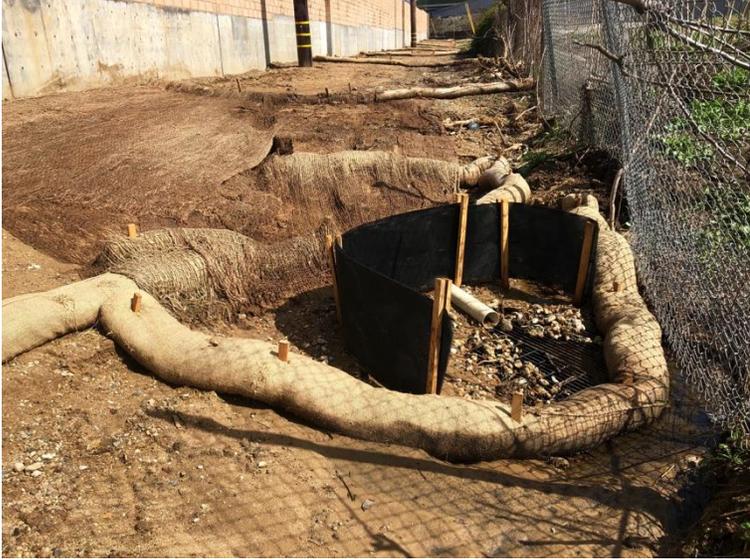
Photo 8 – BMPs along the outside of the southern boundary wall. Photo facing east.

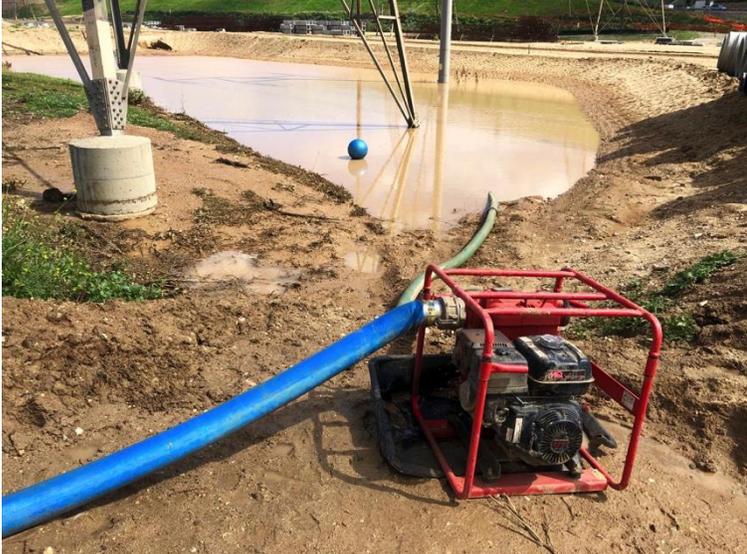
Photo 11 – Pumping of ponded water under a lattice work tower. Photo facing southeast.
3/07/18	Mesa Substation

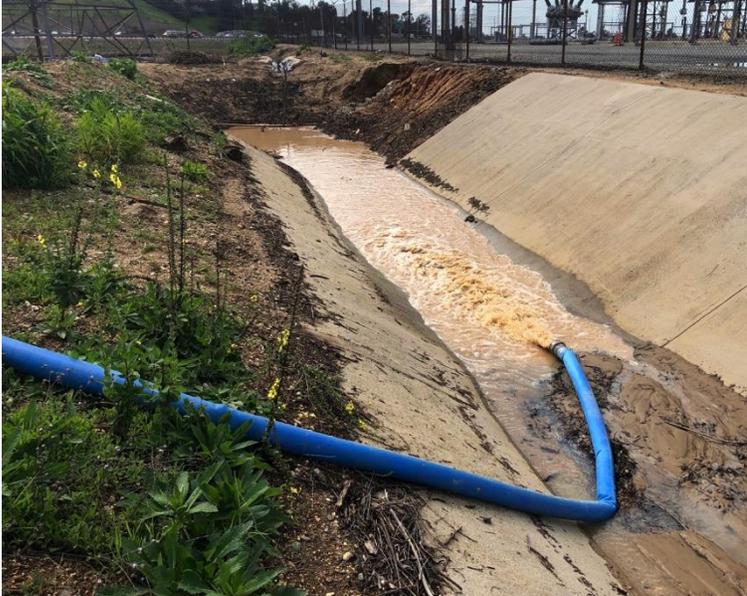
Photo 12 – Pumping project runoff into the channel around the substation. Photo facing west.

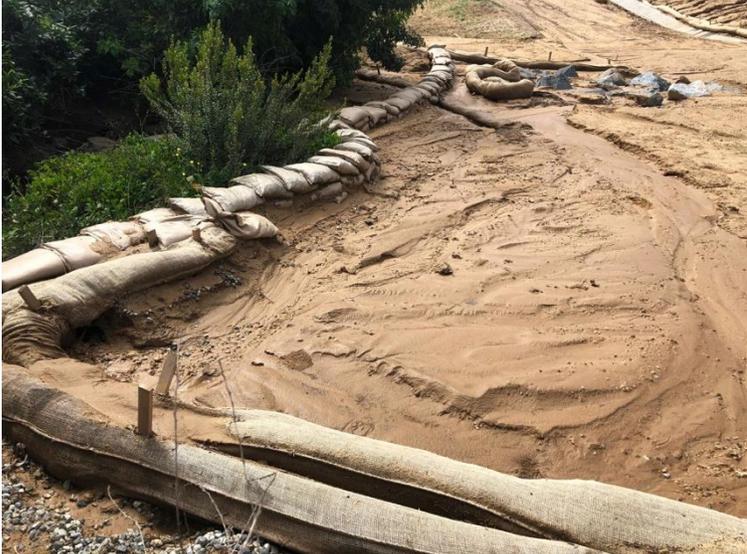
Photo 13 – BMPs within the telecommunications corridor north of Potrero Grande. Photo facing west.
3/07/19	Mesa Substation

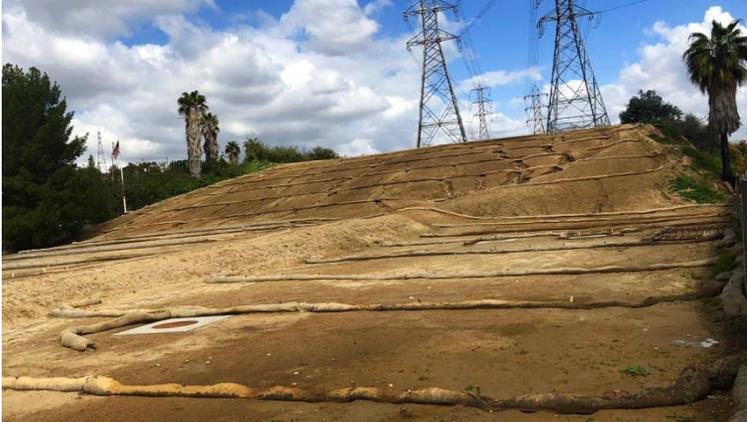
Photo 14 – BMPs within the telecommunications corridor north of Potrero Grande. Photo facing northeast.

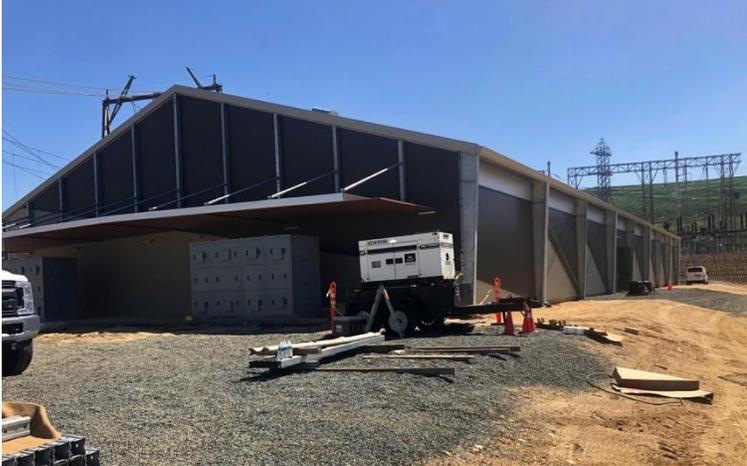
Extensive construction work continued within the Senior Mechanical Electrical Equipment Room (MEER) building – Photo 1.

Photo 1 – Senior MEER. Photo facing south.
3/13/19	Mesa Substation

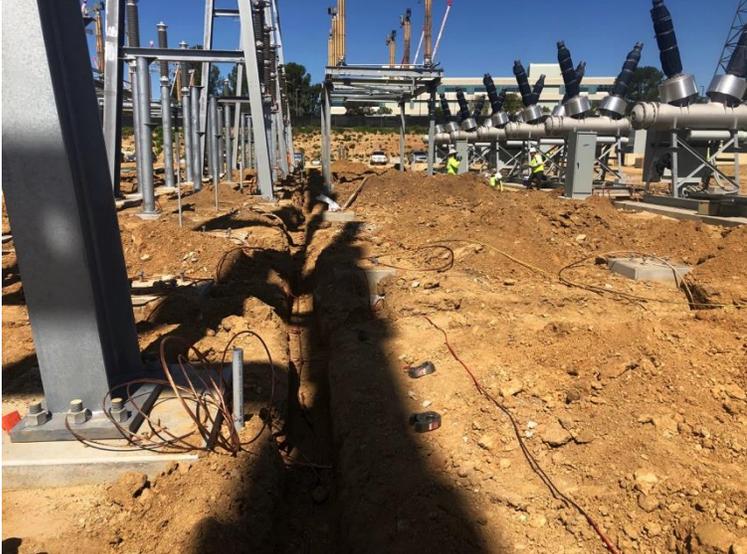
The foundation work continued within the 220-kilovolt (kV) switchrack area, and concrete trucks were pouring the foundations – Photo 3. There were many shallow trenches open near the 220-kV switchrack area, as crews were installing copper cable to ground the equipment – Photo 4.

Photo 4 – Installation of grounding cables within the 220-kV switchrack area.
3/13/19	Mesa Substation

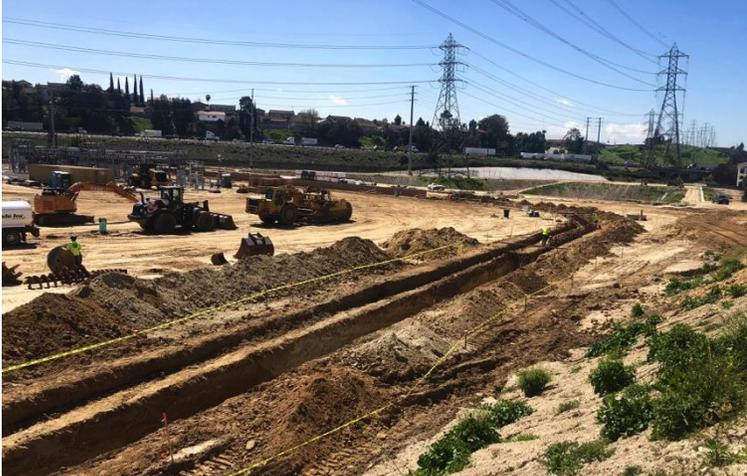
A large trench had been dug around the northwestern corner of the new substation for the boundary wall – Photo 5. Crews were installing rebar in the trench and pouring the wall foundation. Crews continued to install brick at several locations along this boundary wall – Photo 8.

Photo 5 – Trenching for the boundary wall foundation. Photo facing southwest.
3/13/19	Mesa Substation

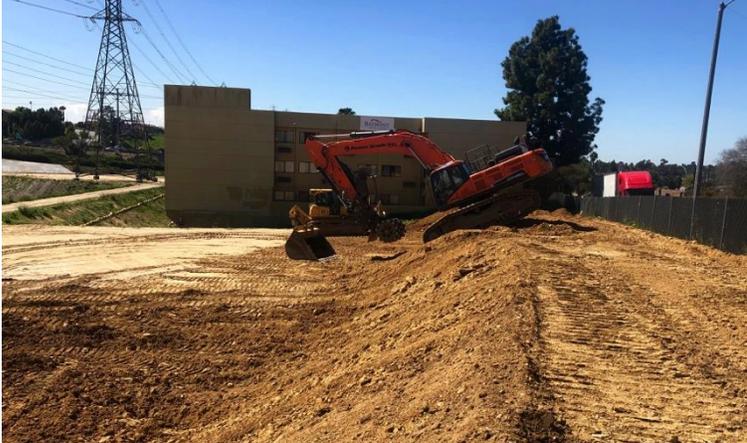
A crew was using an excavator and bulldozer on the northern slope of the project site – Photo 6.

Photo 6 – Equipment working on the northern side of the project site. Photo facing west.

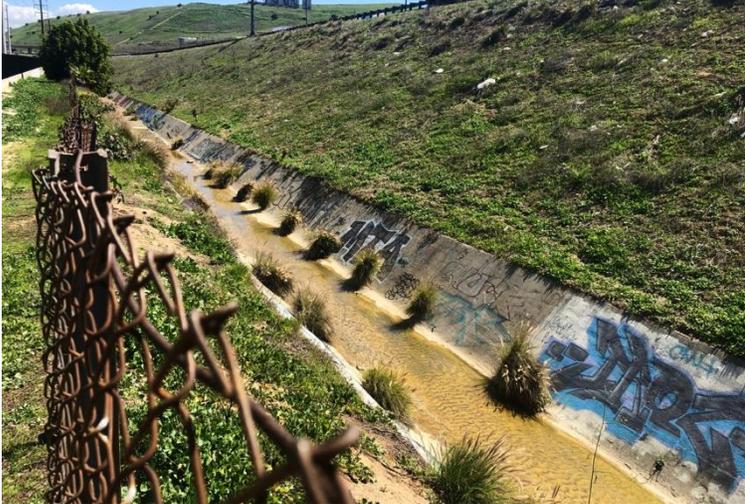
I inspected the Caltrans channel running along the southern boundary of the project site – Photo 7. The channel appeared to have clear water flowing through it. The water was entering from the project site inlet. A bushtit nest located in a tree growing next to the Caltrans channel was found by project biologists. This was reported in FRED. A small buffer was set up around the tree and signs were posted – Photo 9.

<p>Photo 7 – Caltrans channel below the project inlet pipe. Photo facing southeast.</p>
3/13/19	Mesa Substation

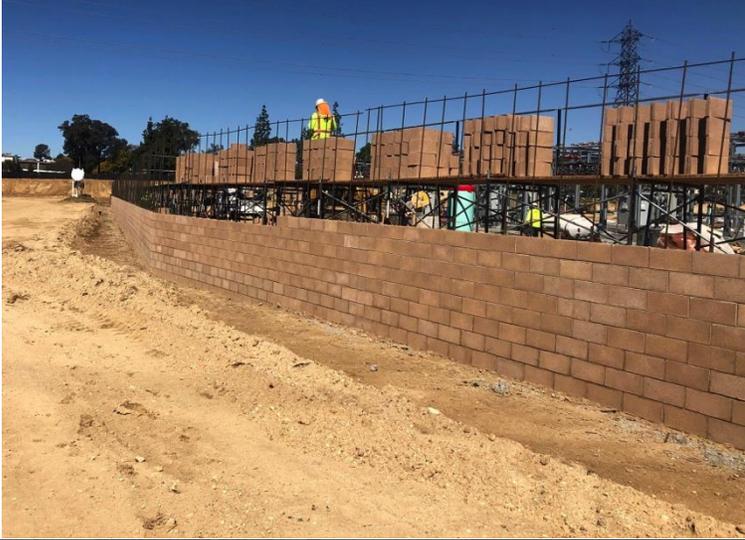
<p>Photo 8 – Brick installation on the western portion of the boundary wall. Photo facing north.</p>
3/13/19	Mesa Substation

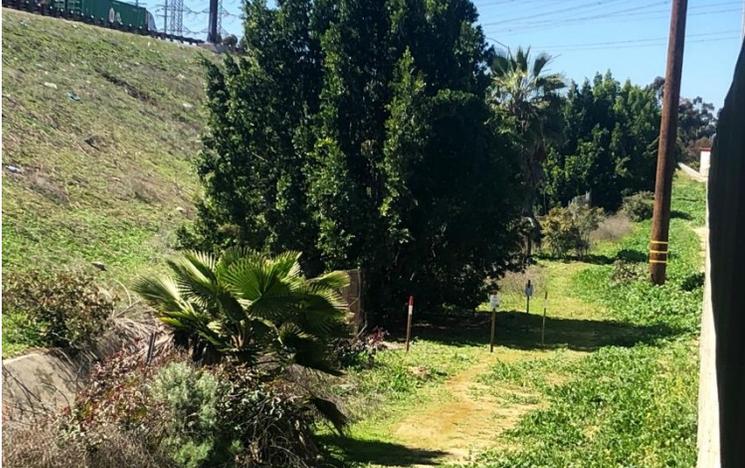
<p>Photo 9 – Bird buffer signs around a tree, located along the Caltrans channel. Photo facing west.</p>

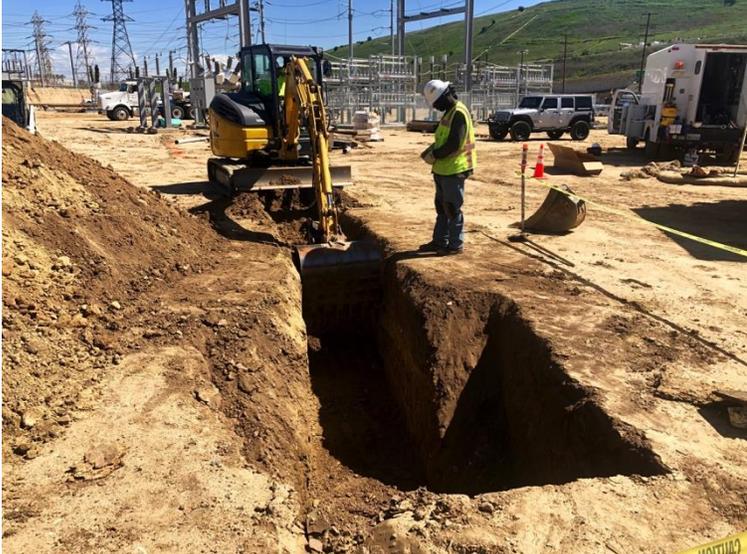
A variety of small excavation activities were underway throughout the project – Photo 10. Wire pulling was being completed through the newly installed conduit along the southern portion of the project – Photo 11.

Photo 10 – Excavation activity. Photo facing east.
3/13/19	Mesa Substation

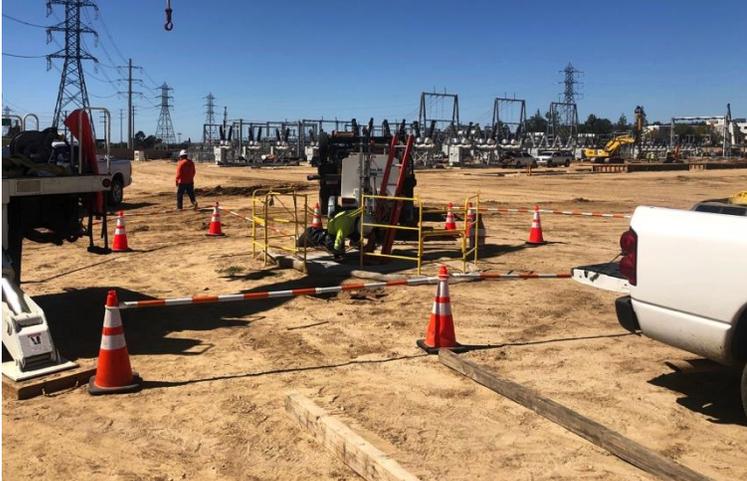
Photo 11 – Wire stringing in the conduit. Photo facing west.
3/13/18	Mesa Substation

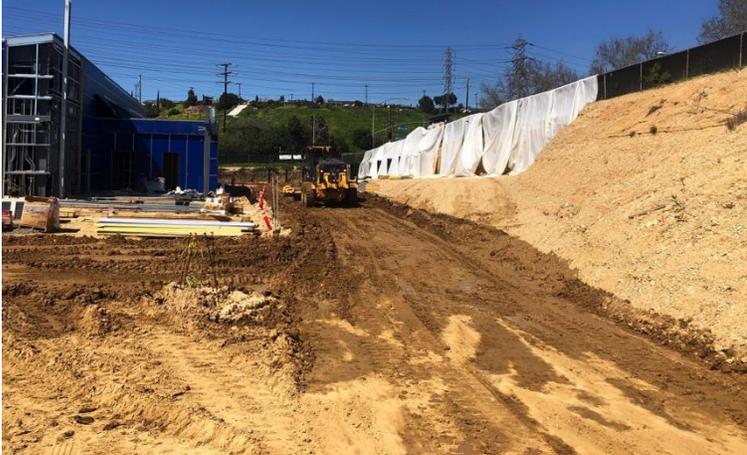
My last stop was at the Mesa Operations Building. The wall work continued along the northern and eastern portion of the site, although no work was being conducted while I was onsite. A motor grader was working between the new building and the wall and was smoothing out the muddy ground – Photo 13. Muddy water continued to drain into a ground level standpipe located just west of the new building – Photo 14. I have contacted the Storm Water Pollution Prevention Plan (SWPPP) inspector, Lucy Cortez-Johnson (CASC), about whether this spot may need a type of sediment trap; however, she has not responded as of the date of this site visit.

Photo 13 – Wall construction and grading activities around the Mesa Operations Building. Photo facing north.
3/13/19	Mesa Substation

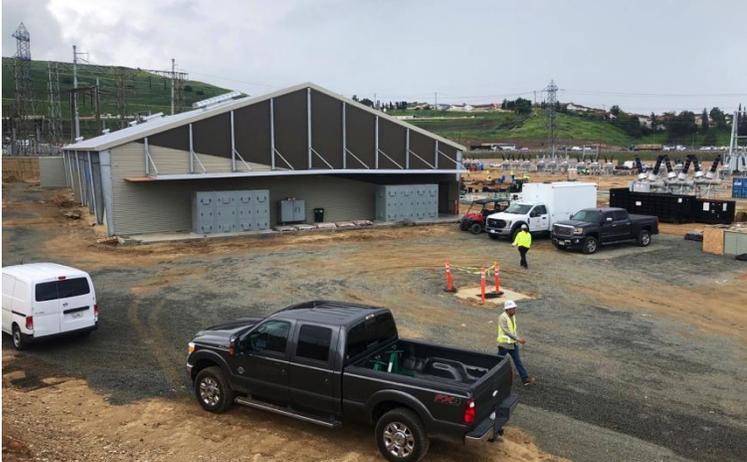
Construction work continued at the Senior Mechanical Electrical Equipment Room (MEER) building – Photo 1.

Photo 1 – Senior MEER. Photo facing south.
3/20/19	Mesa Substation

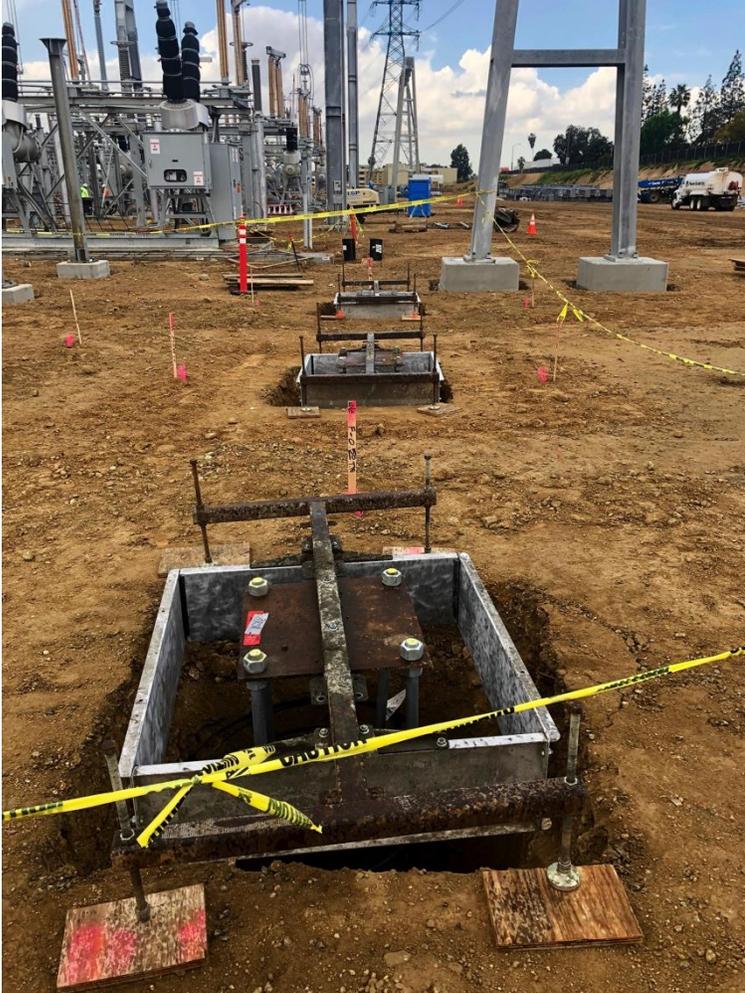
Foundation work and trenching activities continued at the 220-kilovolt (kV) switchrack area – Photos 3 & 4.

Photo 3 – Foundation work continues. Photo facing west.
3/20/19	Mesa Substation

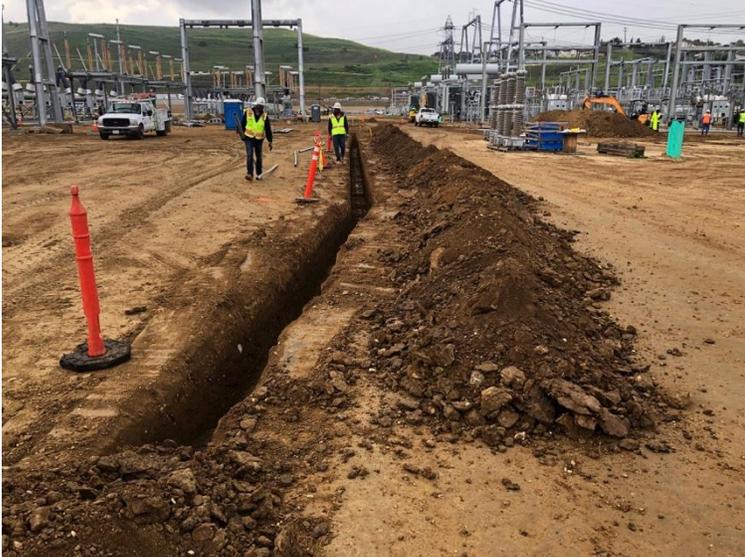
Photo 4 – Trenching work within the 220-kV switchrack area. Photo facing south.

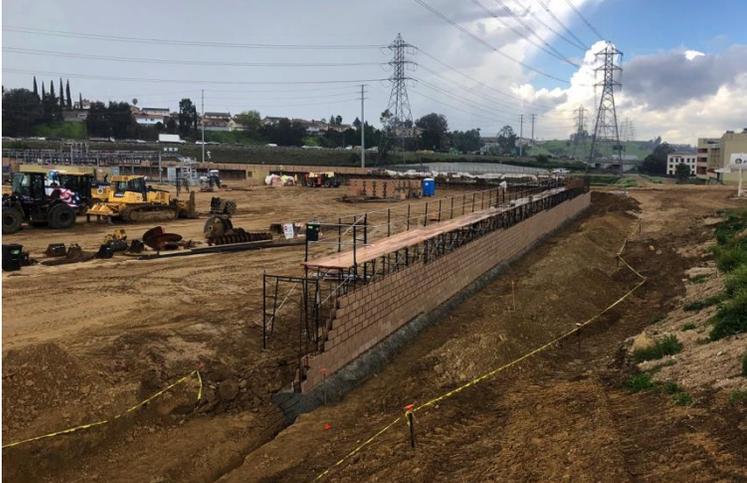
Construction work on the boundary wall was being finalized around the northwestern portion of the New Mesa Substation. Crews appeared to be primarily engaged with brick installation work – Photo 5.

Photo 5 – Brick installation on the boundary wall. Photo facing southwest.
3/20/19	Mesa Substation

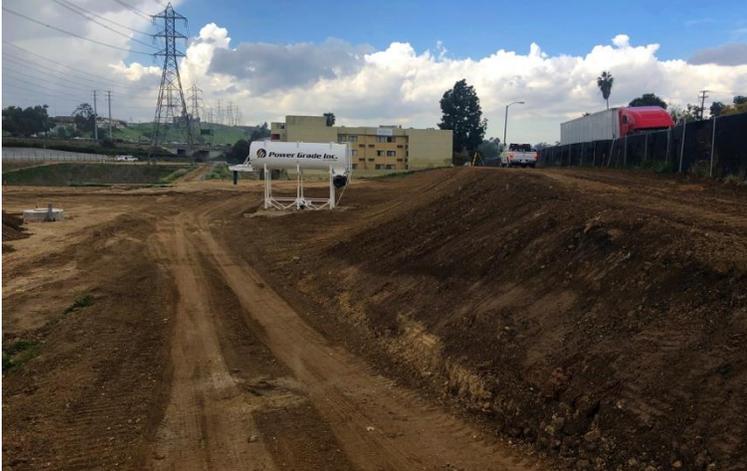
A survey crew was working along the northern boundary above the earthen bank; it appeared that additional earth work (laying back this slope) had been completed during the previous week – Photo 6.

Photo 6 – Earth work along the northern edge of the project site. Photo facing west.
3/20/19	Mesa Substation

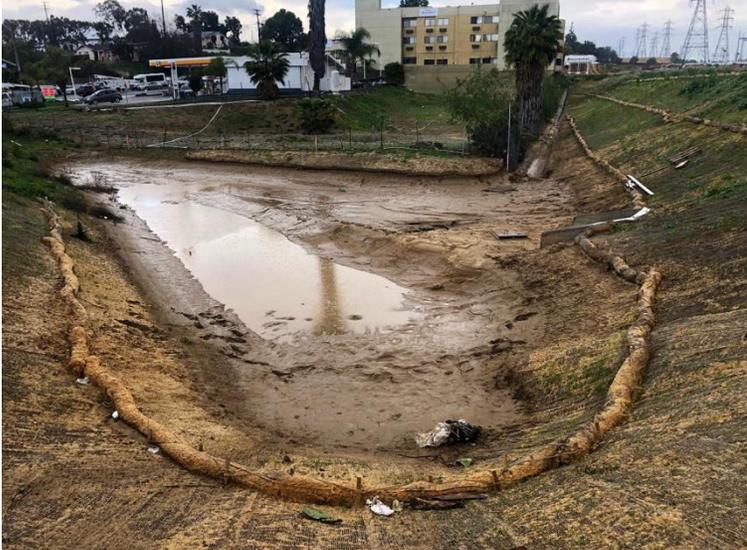
The small “triangular” retention basin appeared to have been pumped out – Photo 7 – and the water transferred into the larger detention basin.

Photo 7 – Retention basin has been pumped out. Photo facing northeast.

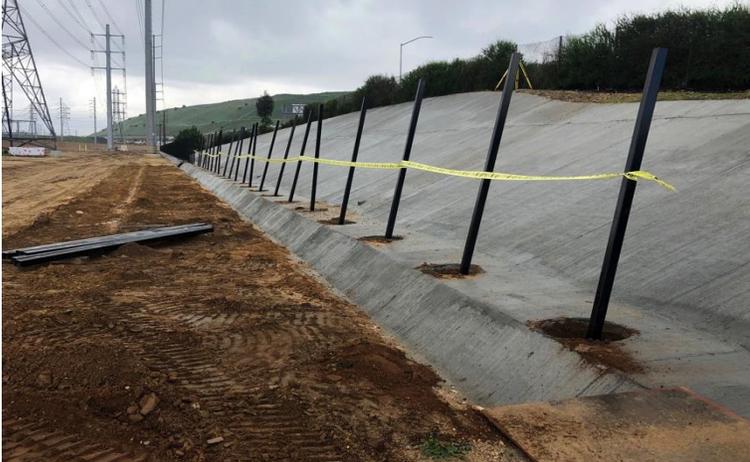
Photo 9 – Fence installation. Photo facing southeast.
3/20/19	Mesa Substation

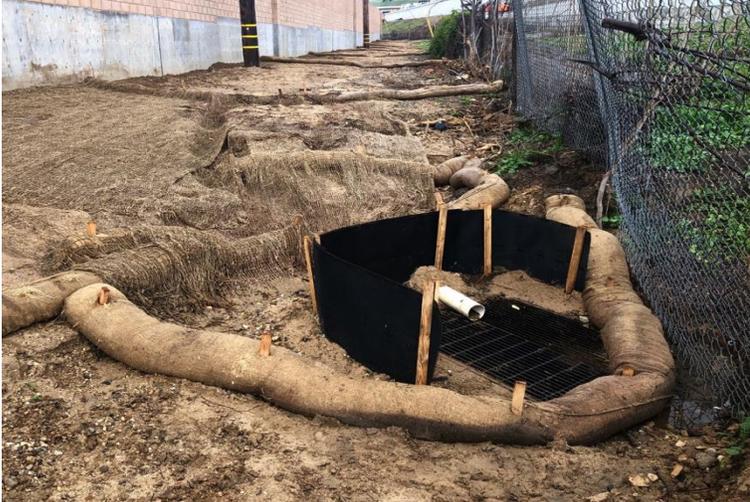
Photo 10 – BMP maintenance work outside of the southern boundary wall. Photo facing east.

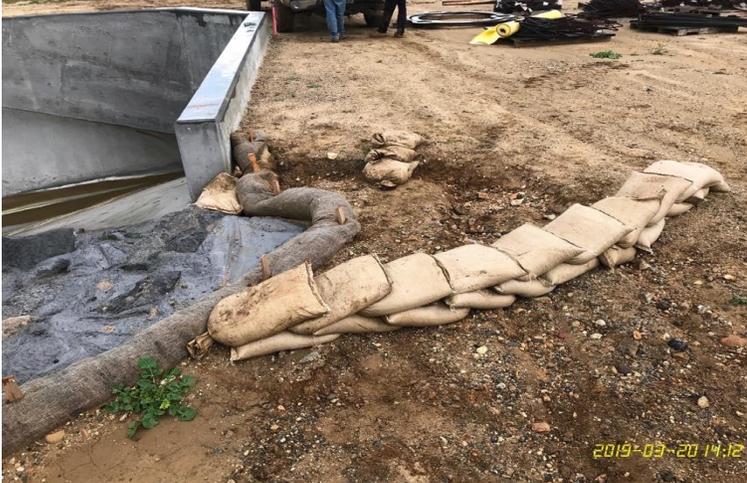
Photo 13 – Sent to me by Lucy Cortez-Johnson showing upgraded BMPs.
3/20/19	Mesa Substation

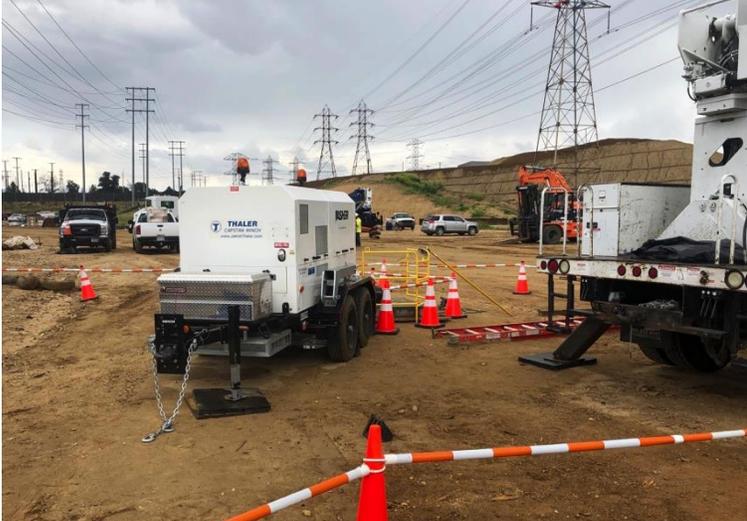
Wire pulling continued through the newly installed conduit along the southern portion of the project site – Photo 14.

Photo 14 – Wire installation in the conduit vaults. Photo facing east.
3/20/19	Mesa Substation

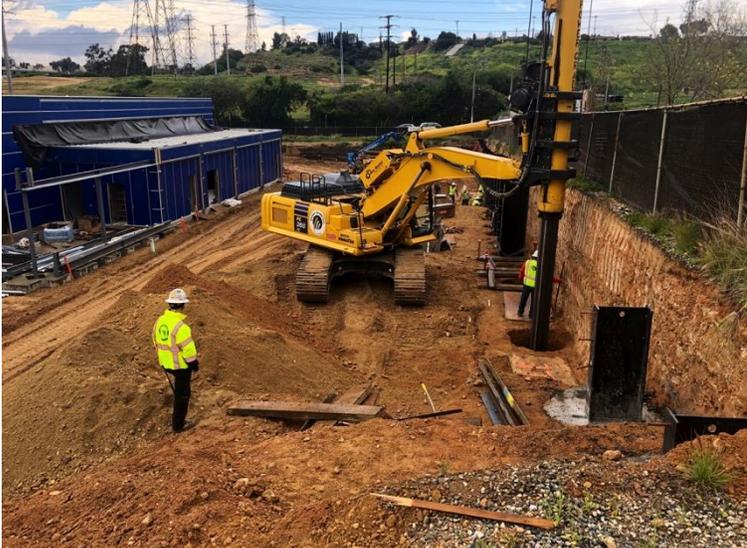
Photo 15 – Mesa Operations Building wall installation. Photo facing north.

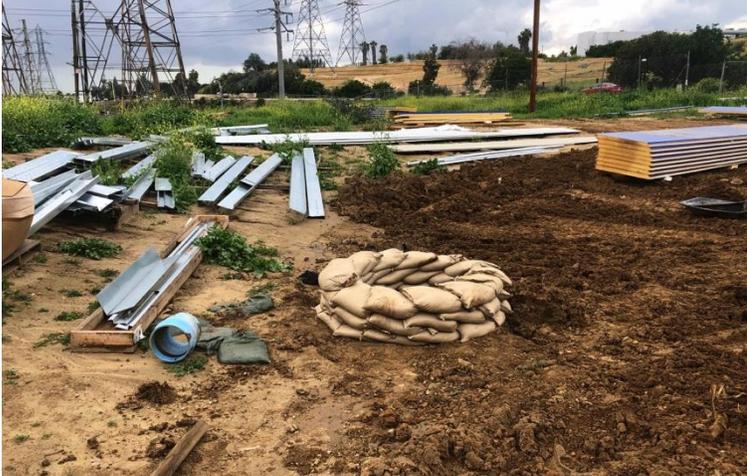
Photo 16 – New BMPs added to the Mesa Operations Building stormwater drain system. Photo facing northwest.
3/20/19	Mesa Substation

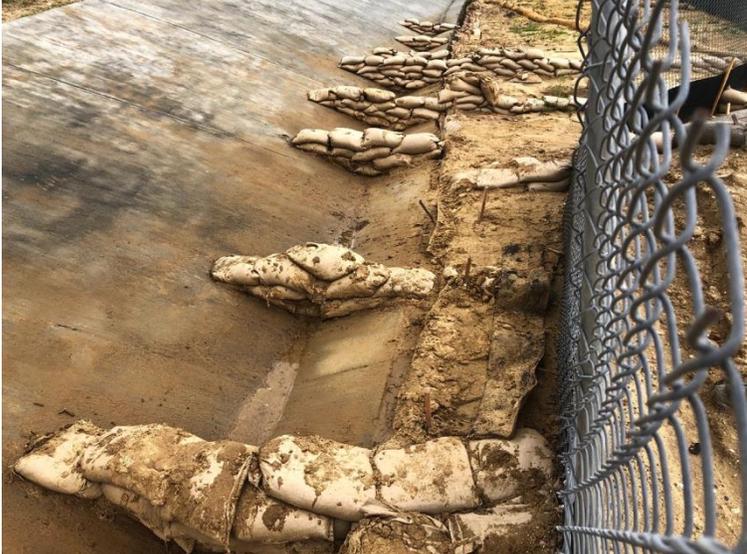
Photo 21 - BMPs within the telecommunications corridor north of Potrero Grande. Sediment behind the gravel check dams was removed.

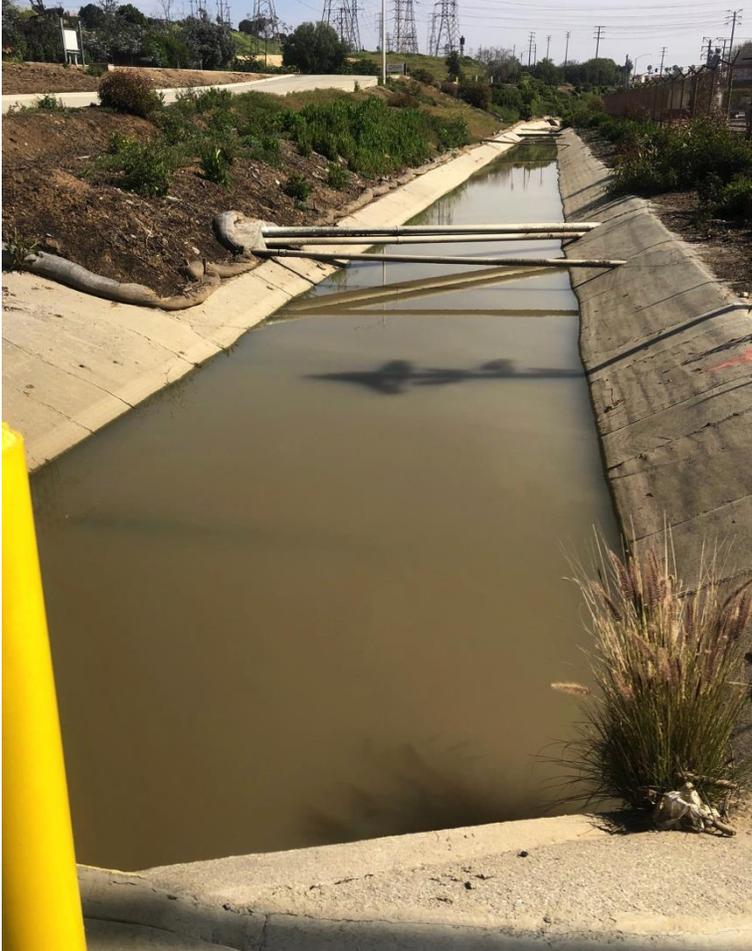
Photo 1 – Rain water runoff in the substation channel. Photo facing east.
3/27/19	Mesa Substation

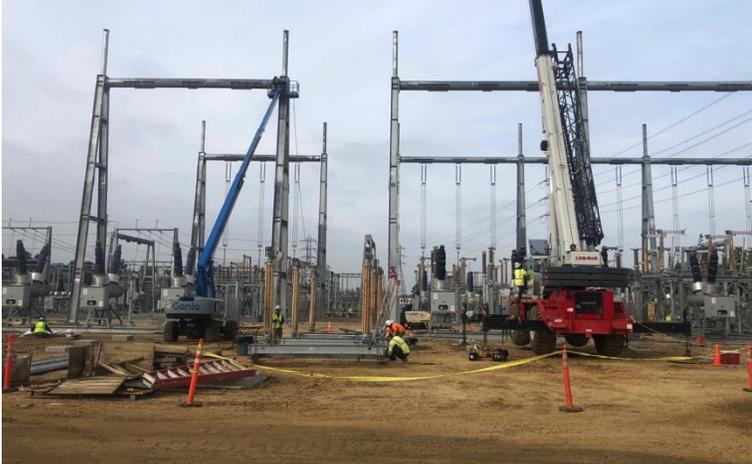
Photo 2 – Installation of above ground equipment in the 220-kV switchrack area. Photo facing west.

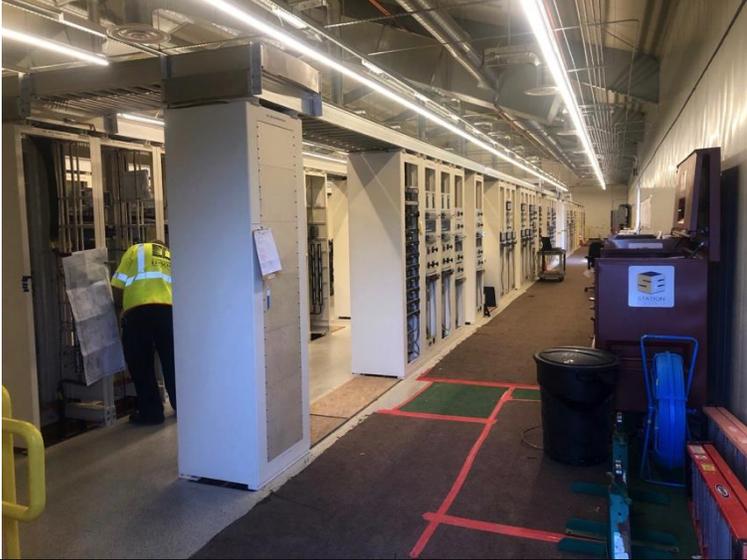
Photo 3 – Inside the Senior MEER.
3/27/19	Mesa Substation

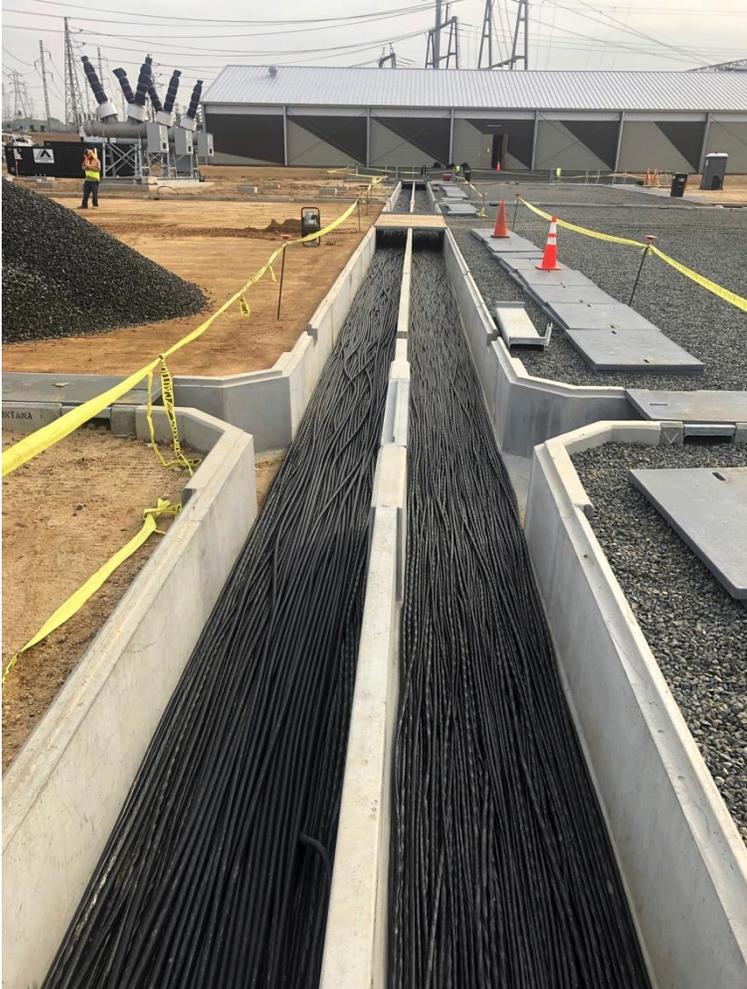
Photo 4 – Cables running into and out of the Senior MEER. Photo facing east.

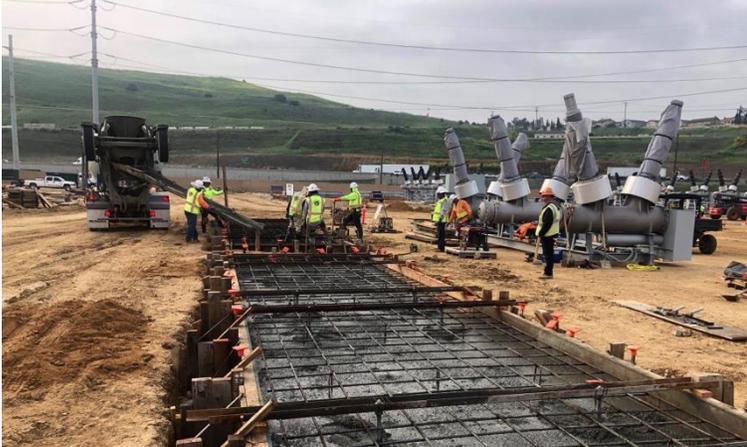
Photo 5 – Pouring foundations within the 220-kV switchrack area. Photo facing south.
3/27/19	Mesa Substation

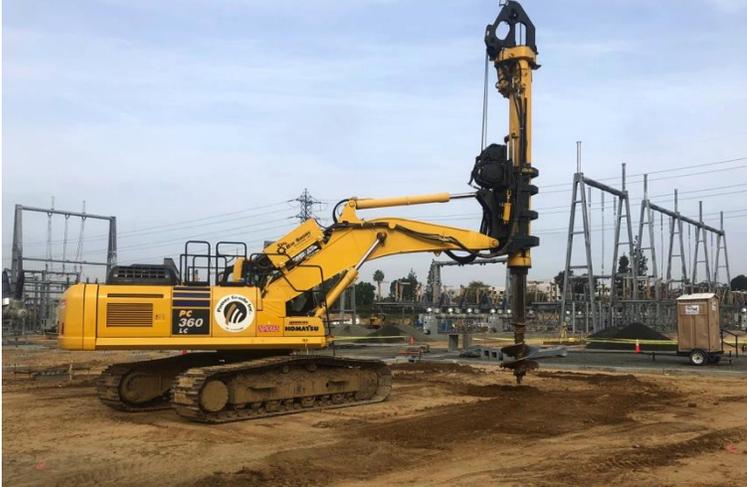
Photo 6 – Drilling foundation holes within the 220-kV switchrack area. Photo facing north.
3/27/19	Mesa Substation

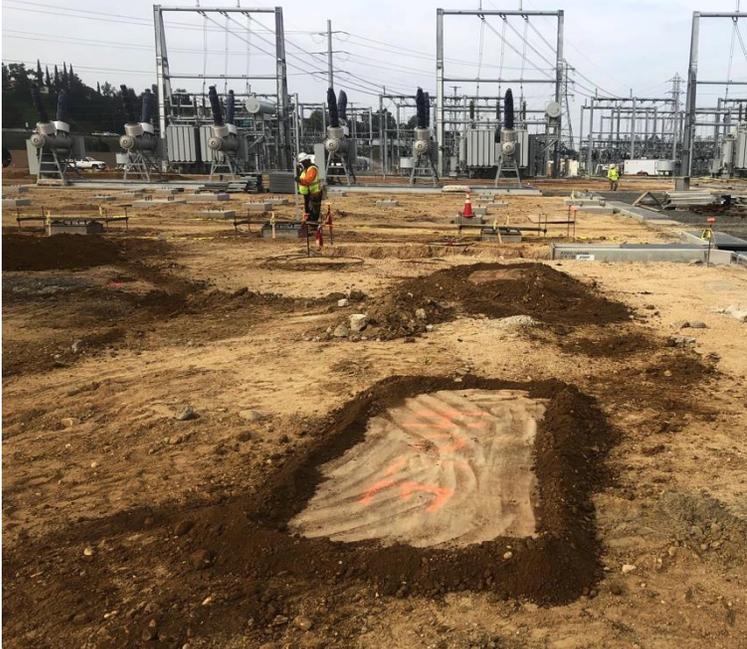
Photo 7 – Foundation holes covered with plywood and sealed with dirt. Photo facing west.

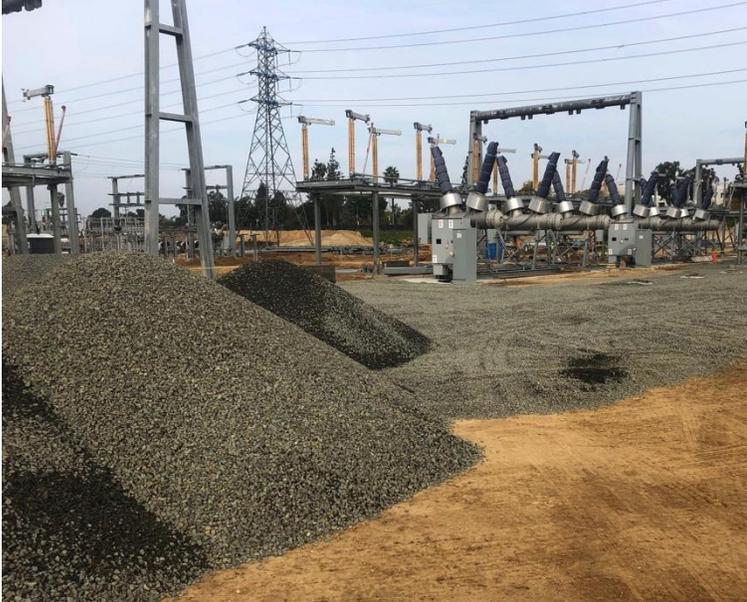
Photo 8 – Spreading gravel at the 220-kV switchrack area. Photo facing northwest.
3/27/19	Mesa Substation

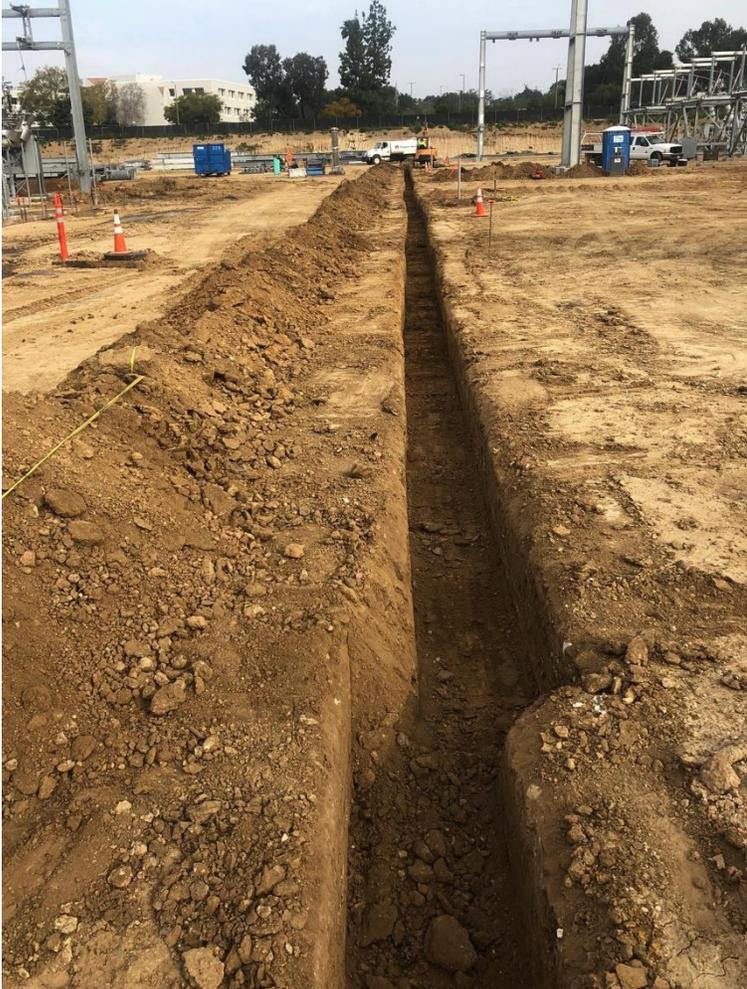
Installation of the 220-kilovolt (kV) equipment continued – Photo 2. Work continued at the Senior Mechanical Electrical Equipment Room (MEER) building – Photo 3. Many cables ran between the Senior MEER and 220-kV switchrack area – Photo 4. Foundation work continued within the 220-kV switchrack area – Photo 5. The concrete washout area was moved over to the southeastern portion of the project site, and concrete trucks were exiting the site through the eastern exit – Photo 16. Other construction activities at the 220-kV switchrack area included foundation drilling – Photo 6 – which was sealed with plywood and dirt – Photo 7 – gravel spreading – Photo 8 – and trenching – Photo 9. I spoke to Power Grade foreman Willie Clark about project activities.

Photo 9 – Trenching within the 220-kV switchrack area. Photo facing north.

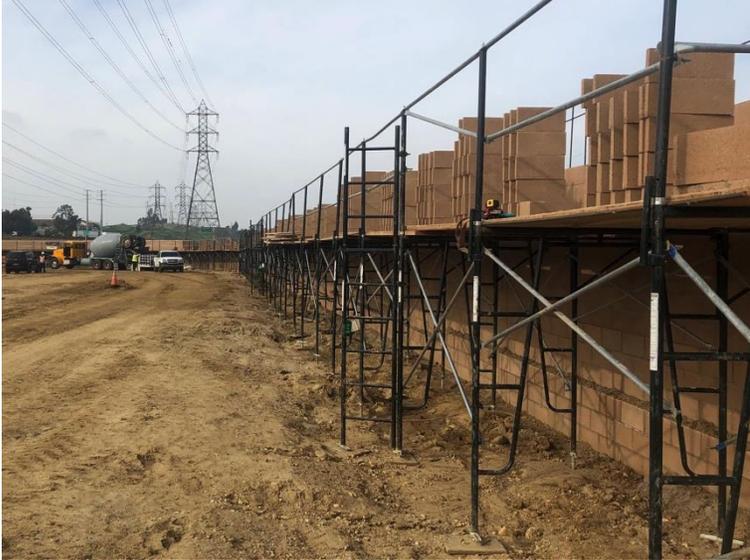
Fence work was being completed at three locations: the interior brick boundary wall – Photo 10; the brick boundary wall along Potrero Grande Drive – Photo 11; and the metal fence near Markland Avenue – Photo 12.

<p>The photograph shows a long, narrow construction site. On the right side, a wall is being built, supported by a complex system of black metal scaffolding. The wall appears to be made of concrete blocks or panels. In the background, there are several high-voltage power line towers and a dirt road with some construction equipment. The sky is overcast.</p>	Photo 10 – Wall work. Photo facing west.
3/27/19	Mesa Substation

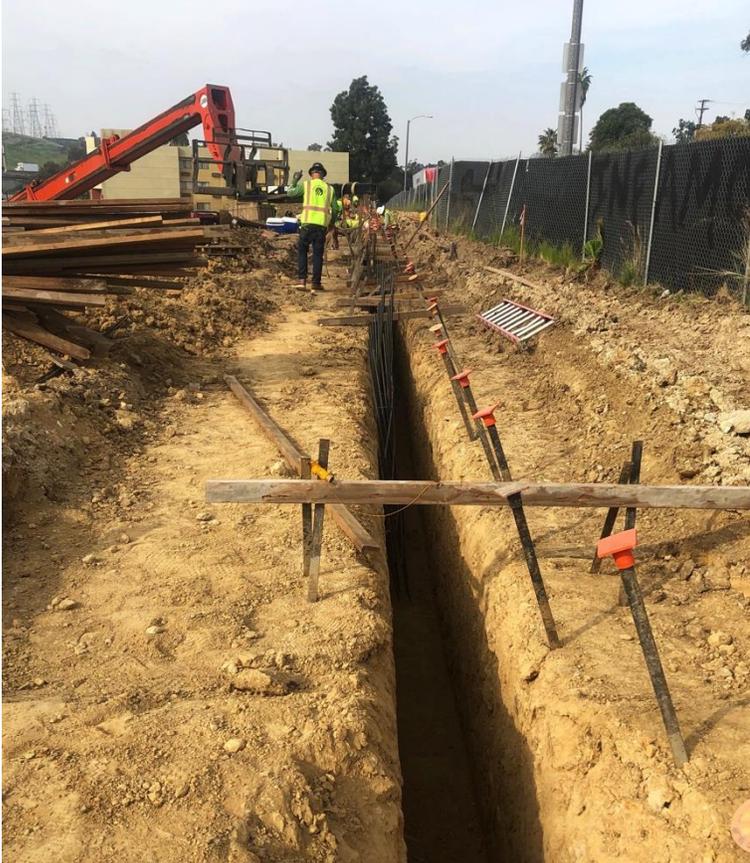
<p>The photograph shows a deep, narrow trench that has been excavated. The trench is lined with wooden shoring on both sides. Several vertical steel rods (shoring) are visible, supporting the walls of the trench. In the background, a red excavator is parked near a pile of wooden beams. A worker in a yellow safety vest is standing in the trench. A chain-link fence runs along the right side of the site. The sky is overcast.</p>	Photo 11 – Foundation work for the northern perimeter wall. Photo facing west.

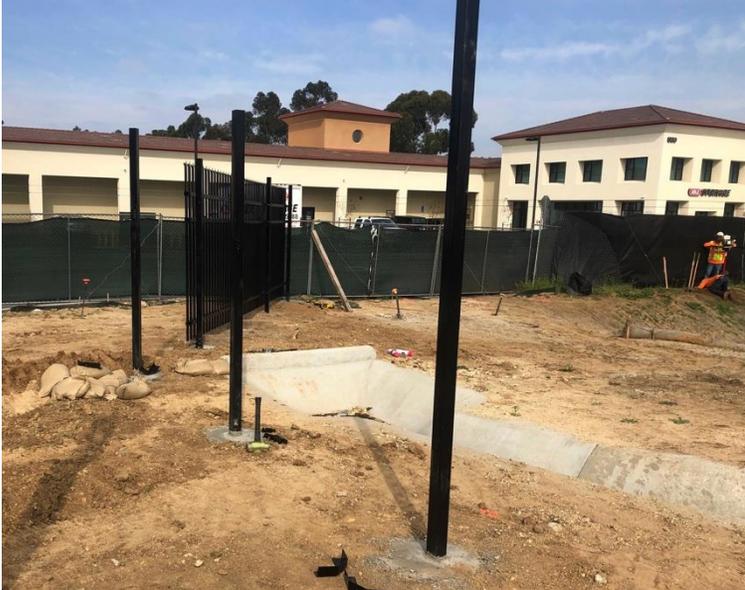
Photo 12 – Metal fence installation near the western boundary of the project site. Photo facing west.
3/27/18	Mesa Substation

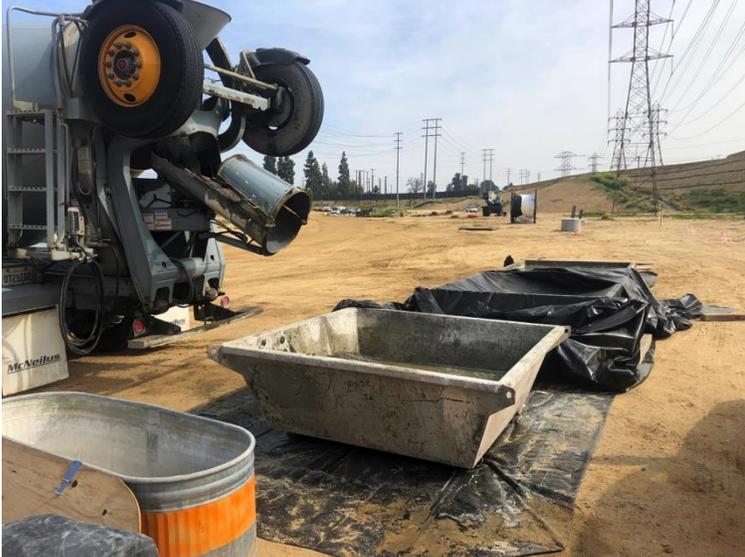
Photo 16 – Concrete truck washout station. Photo facing east.

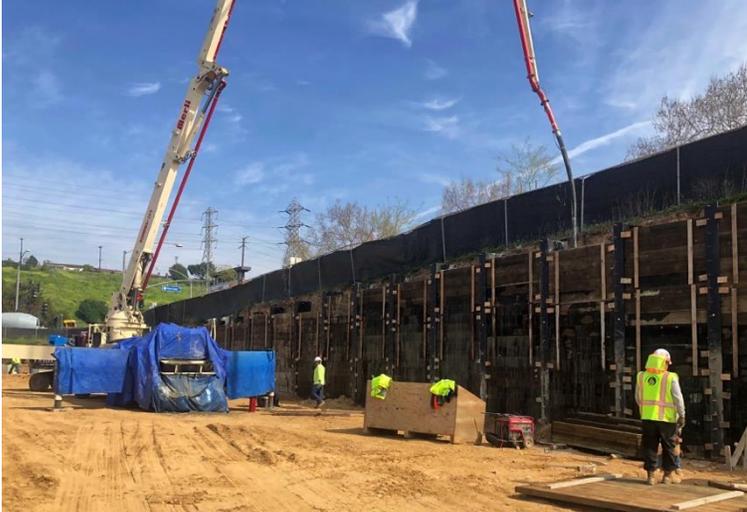
At the Mesa Operations Building, crews poured slurry behind the eastern wall – Photo 17. Rainwater runoff was ponded around the gravel bag berm installed around the drain inlet – Photo 18.

Photo 17 - Pouring slurry for the Mesa Operation Building's eastern wall. Photo facing northeast.
3/27/19	Mesa Substation

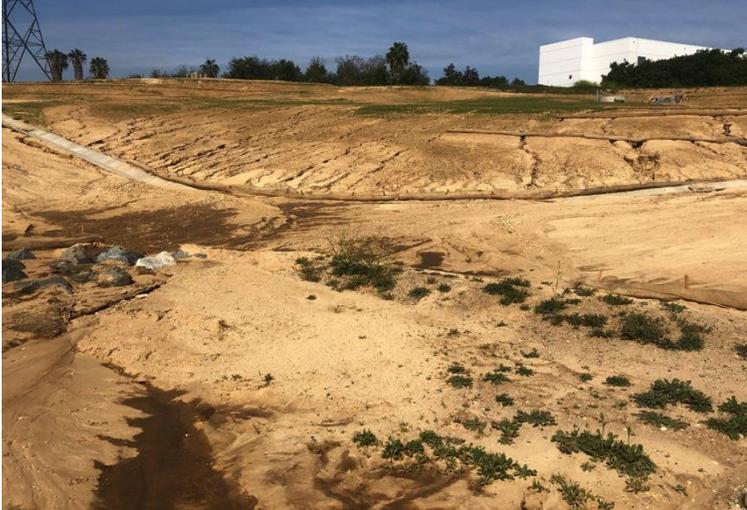
Best management practice (BMP) repairs were not completed within the telecommunication corridor north of Potrero Grande Drive, and more sediment was noted at the bottom of the slopes – Photos 19 & 20.

Photo 19 - BMPs within the telecommunications corridor north of Potrero Grande. Photo facing north.
