January 13, 2020

Re: Monthly Report Summary #18 for the Mesa 500-kV Substation Project

This report provides a summary of the compliance monitoring activities that occurred during the period from **March 1 to 31, 2019**, for the Mesa 500-kilovolt (kV) Substation (Mesa Substation) Project in Los Angeles County, California. Compliance monitoring was performed to ensure that all project-related activities conducted by Southern California Edison (SCE) and their contractors comply with the requirements of the Final Environmental Impact Report (Final EIR) for the Mesa Substation Project, as adopted by the California Public Utilities Commission (CPUC) on February 9, 2017.

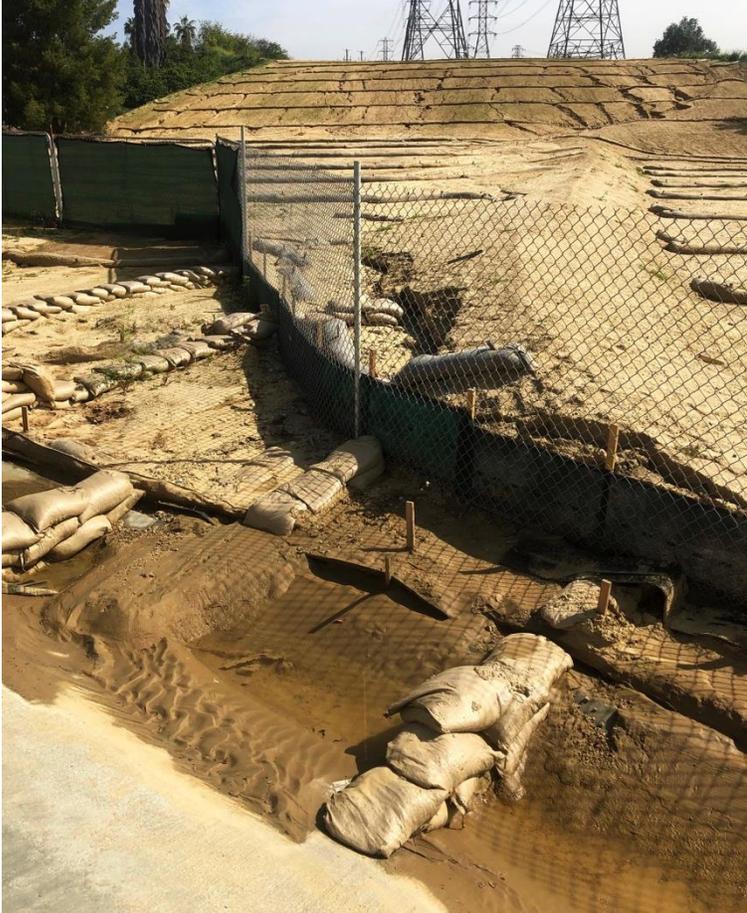
Best management practice (BMP) repairs were not completed within the telecommunication corridor north of Potrero Grande Drive, and more sediment was noted at the bottom of the slopes – Photos 19 & 20.

Photo 20 - BMPs within the telecommunications corridor north of Potrero Grande. Photo facing east.
