Re: Monthly Report Summary #24 for the Mesa 500-kV Substation Project

CPUC Site Inspection Reports
September 5, 18, and 25, 2019

Mesa 500–kV Substation Project CPUC Site Inspection Form

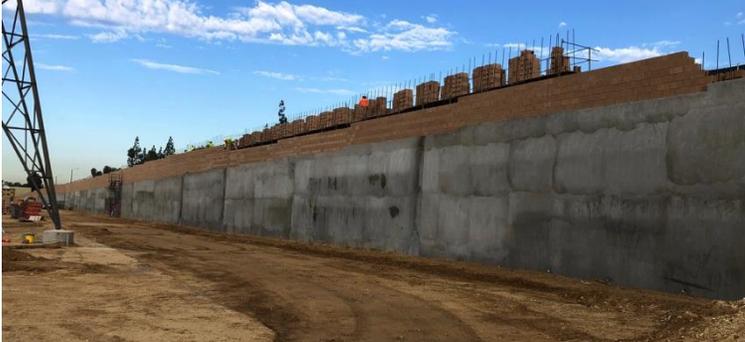
<p>Photo 3 – Brick installation continued at the boundary wall above the northern retaining wall. Photo facing northwest.</p>

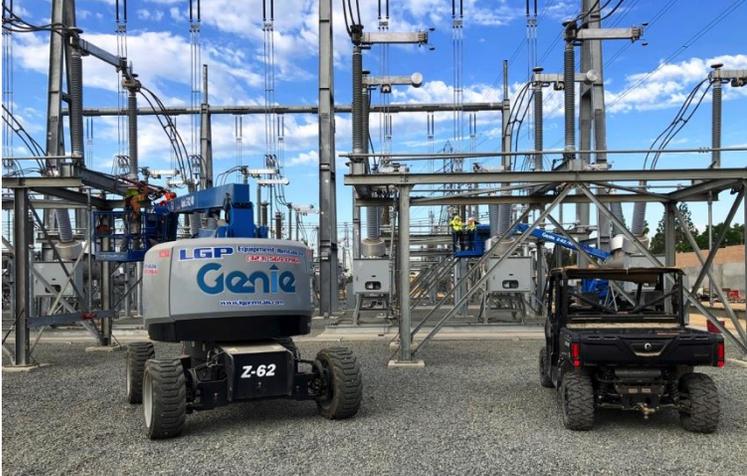
Photo 4 – Wire installation and equipment connections within the 220-kV switchrack area. Photo facing west.
9/05/19	Mesa Substation

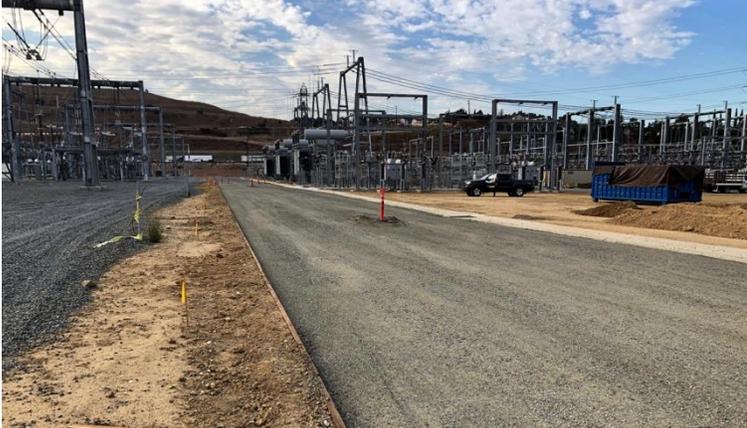
Photo 5 – Road base installation continued between the 16-kV and 66-kV switchrack areas. Photo facing south.
9/05/19	Mesa Substation

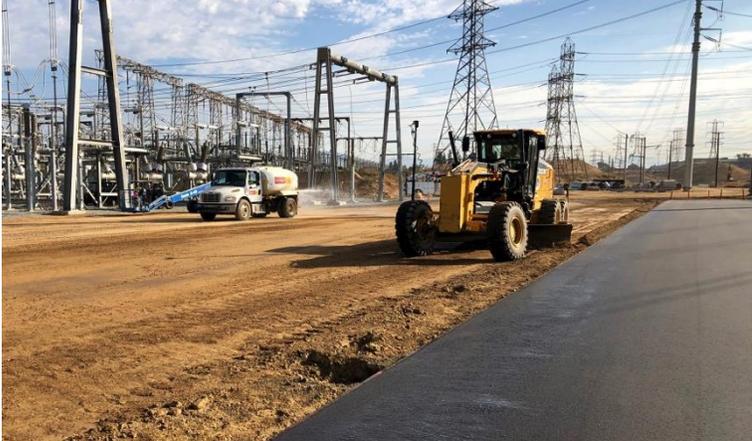
Photo 10 – Final dirt work being completed along the new asphalt road – Photo facing east.
9/05/19	Mesa Operations Building

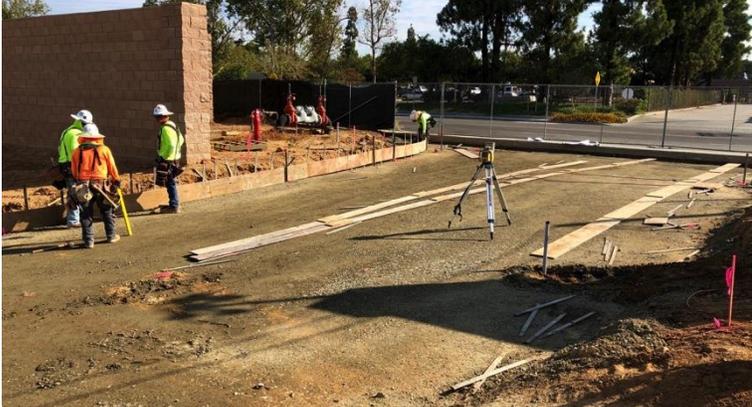
Photo 11 – Road work being completed at the eastern project entrance – Photo facing east.
9/05/19	Mesa Operations Building

The eastern project entry was near complete – Photo 11. Conduit work continued near the Mesa Operations Building – Photo 12, and forms were in place in order to pour the road curb around the building – Photo 13.

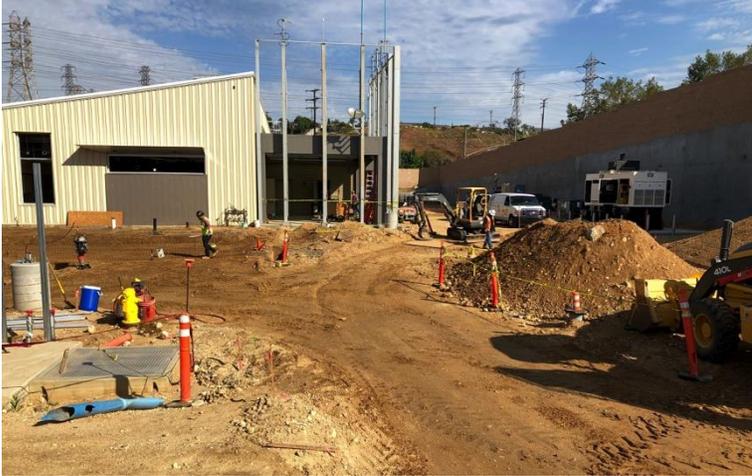
Photo 12 – Dirt work being completed around the Mesa Operations Building in preparation for paving. Photo facing north.

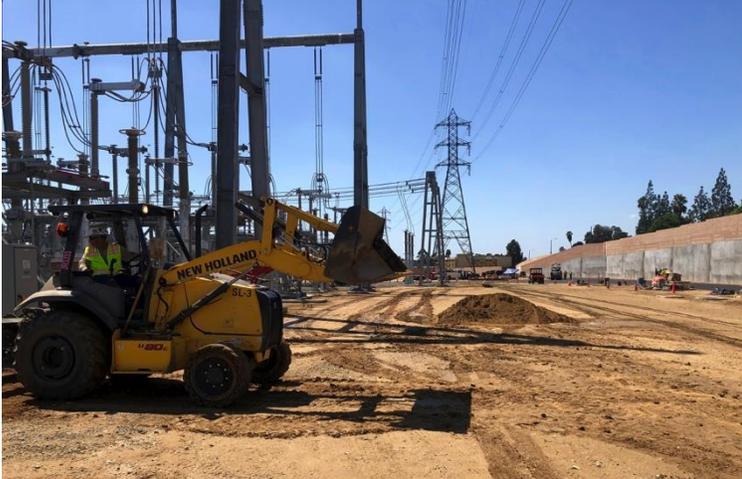
Photo 3 – Final dirt work near the switchrack areas. Photo facing west.

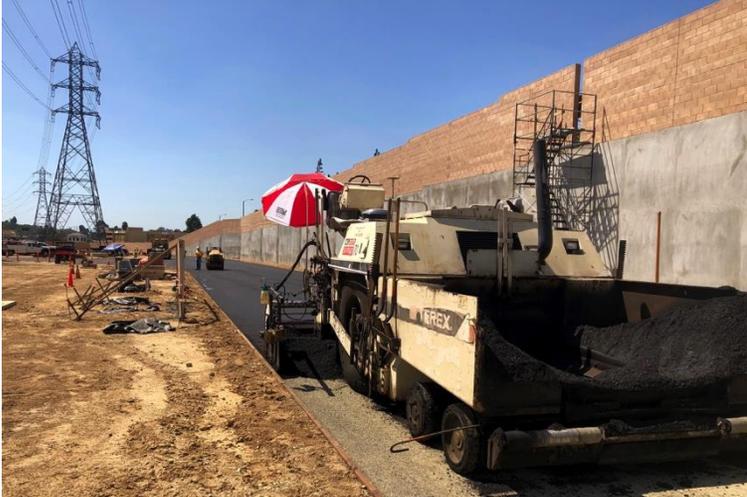
Photo 4 – Asphalt installation continued along the northern retaining wall. Photo facing west.
9/18/19	Mesa Substation

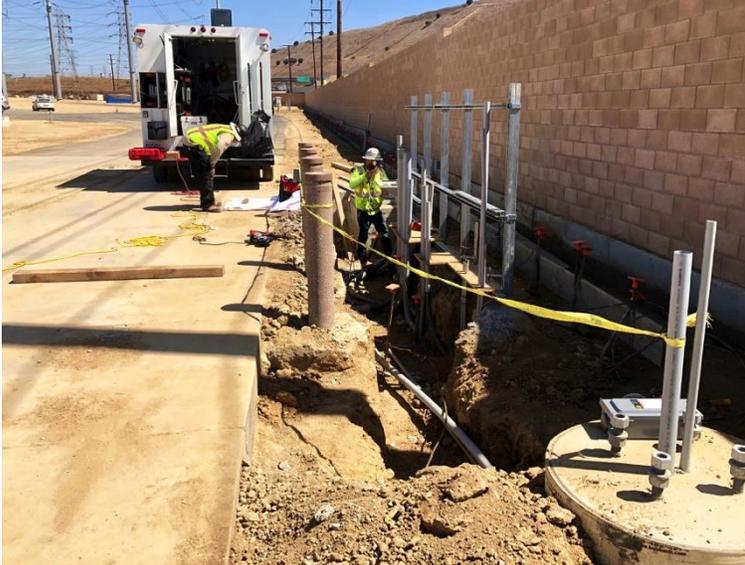
Protective barrier installation and electrical work continued at several project locations along the southern boundary wall – Photos 7 and 9. Equipment installation and wire connection work continued at several locations within the new 220-kV switchrack area – Photo 8.

<p>Photo 7 – Protective barriers placed along the roadway near the southern boundary wall. A crew was working on the electrical equipment. Photo facing east.</p>
9/18/19	Mesa Substation

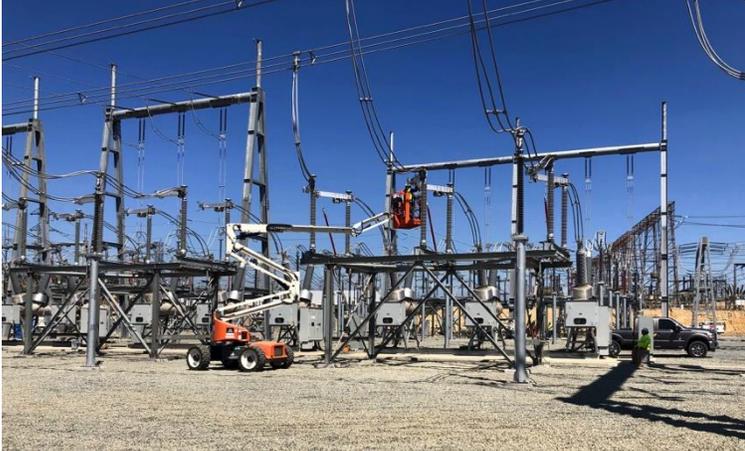
<p>Photo 8 – Wire installation and equipment connection work continued within the 220-kV switchrack areas. Photo facing north.</p>
9/18/19	Mesa Substation

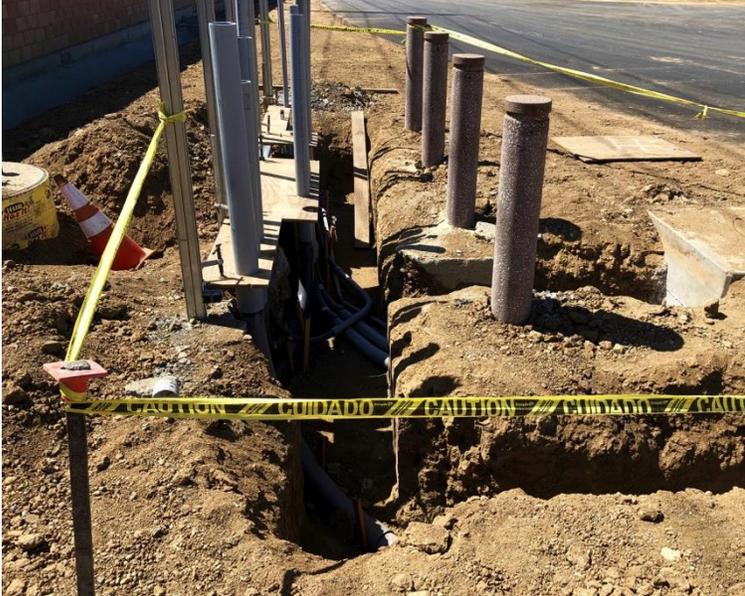
<p>Photo 9 – Protective barriers placed along the roadway near the southern boundary wall. Photo facing east.</p>

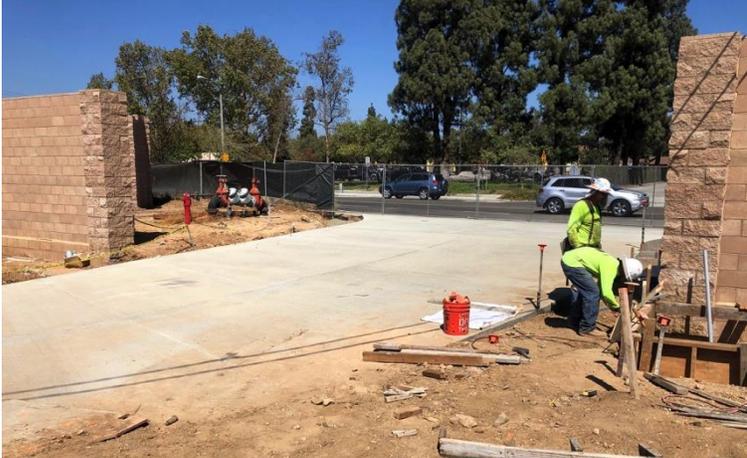
Photo 11 – Work on the eastern project entrance – Photo facing east.
9/18/19	Mesa Operations Building

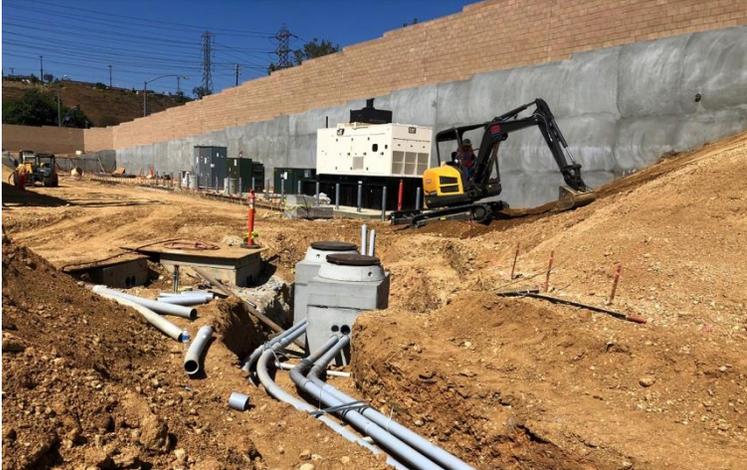
Photo 12 – Dirt work being completed around the Mesa Operations Building. Photo facing northeast.

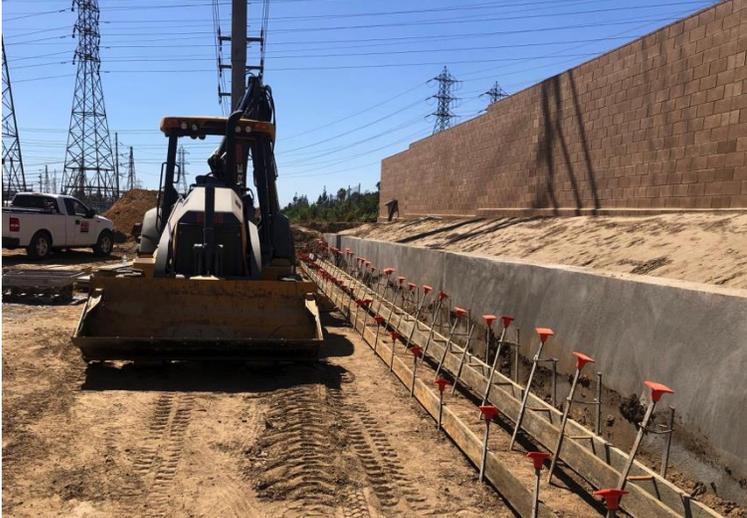
Photo 13 – Roadwork being completed near the Mesa Operations Building’s northern wall.
9/18/19	Mesa Substation

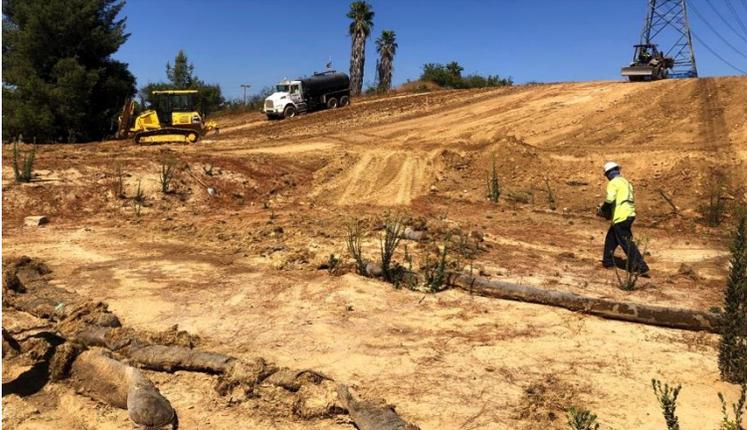
A crew was removing all old and degraded best management practices (BMPs) and re-grading the Transmission Corridor north of Potrero Grande Drive – Photo 14.

Photo 14 – Re-grading of the Telecommunications Corridor north of Potrero Grande. Photo facing northeast.

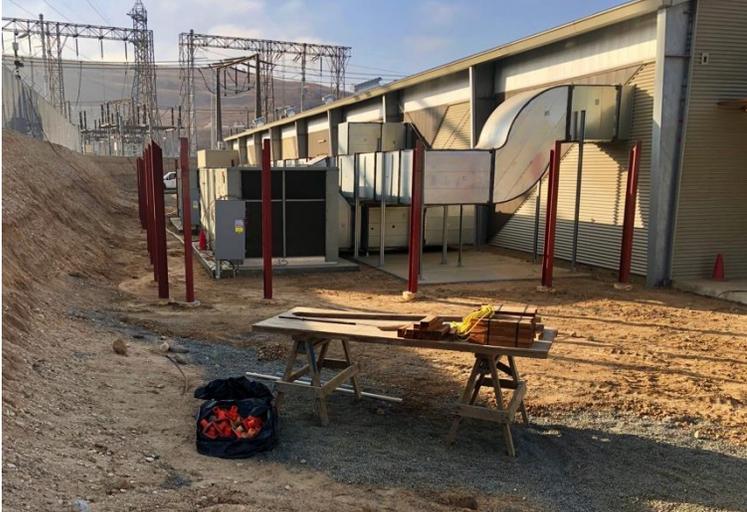
I inspected the Senior Mechanical Electrical Equipment Room (MEER), where construction work related to barrier fencing continued near the building to the east – Photo 2.

<p>Photo 2 – Fence installation around portions of the Senior MEER. Photo facing south.</p>
9/25/19	Mesa Substation

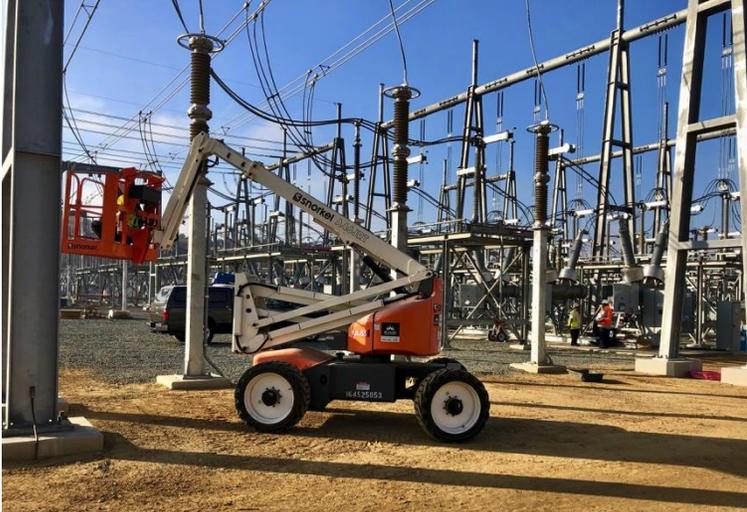
<p>Photo 3 – Wire installation and equipment connection work continued within the 220-kV switchrack area. Photo facing south.</p>

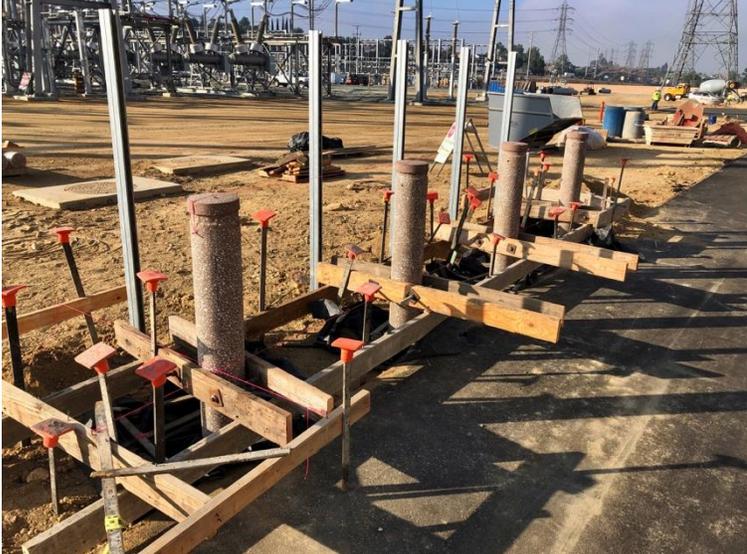
Protective concrete barriers (ballards) were being installed at several locations along the paved roads to protect sensitive equipment. At one location, the open holes around the ballards were covered with plastic – Photo 4. At a second location, Wayne Woodroof (Noreas) and I inspected the holes prior to ballard placements – Photo 5. A crew excavated a trench for the electrical equipment at a third location, near the western boundary wall– Photo 7.

Photo 4 – Protective barrier installation. Photo facing west.
9/25/19	Mesa Substation

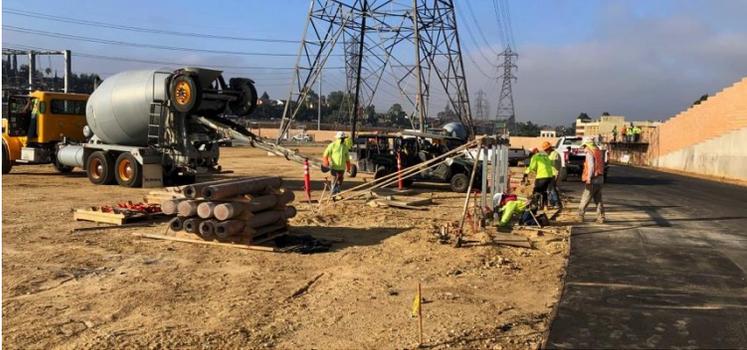
Photo 5 – More protective barrier installation - biological monitor was inspecting the holes. Photo facing west.
9/25/19	Mesa Substation

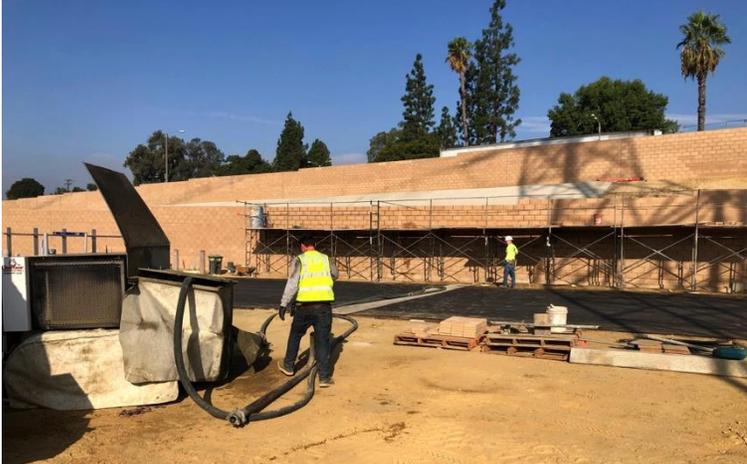
The last portion of the northern boundary wall was installed, and crews were pumping slurry into the brick – Photo 6.

Photo 6 – Slurry pour into the brick of the northern barrier wall. Photo facing north.

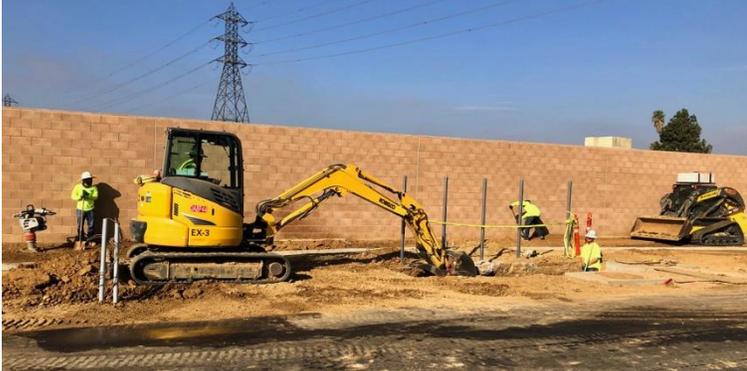
Photo 7 – Excavation for a protective barrier along the roadway near the western boundary wall. Photo facing west.
9/25/19	Mesa Substation

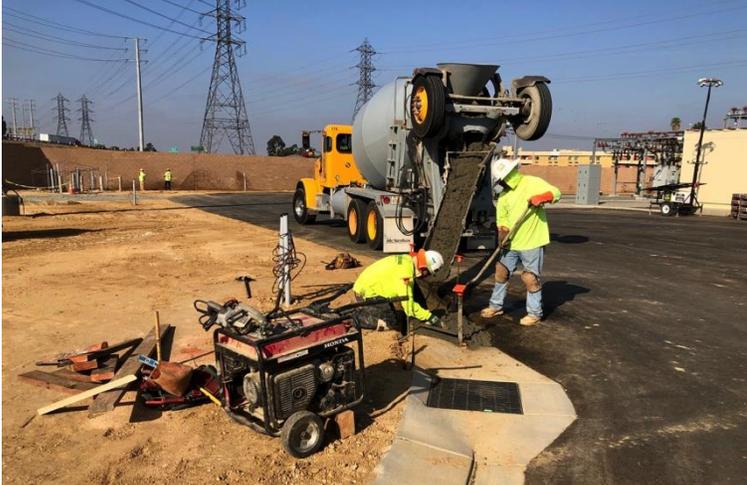
A crew was working on the road curbs by pouring around the road drains – Photo 8.

Photo 8 – Concrete work on the road curb. Photo facing west.
9/25/19	Mesa Substation

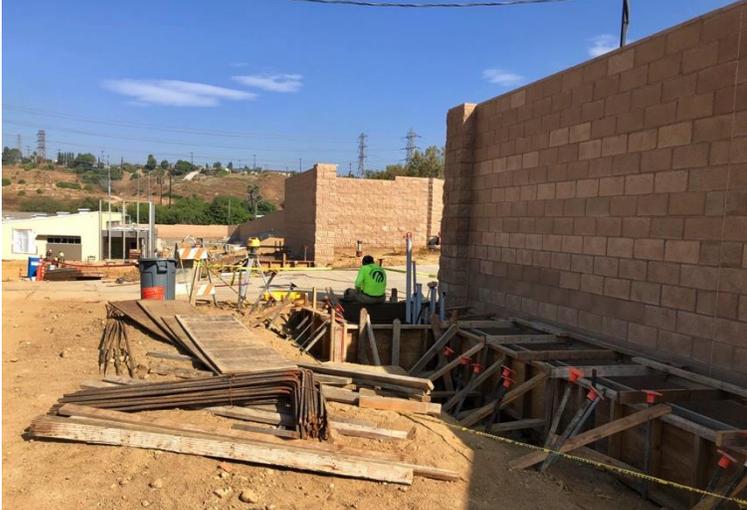
The eastern project entry way still under construction near the Mesa Operations Building – Photo 10. Conduit work continued, and excavated areas had proper climbing structures installed – Photo 11. I noted what appeared to be a washout near the site drain inlet; this area needed to be cleaned, and best management practices (BMPs) needed to be upgraded prior to the rainy season – Photo 12.

Photo 10 – Work on the eastern project entrance. Photo facing northeast.
9/25/19	Mesa Operations Building

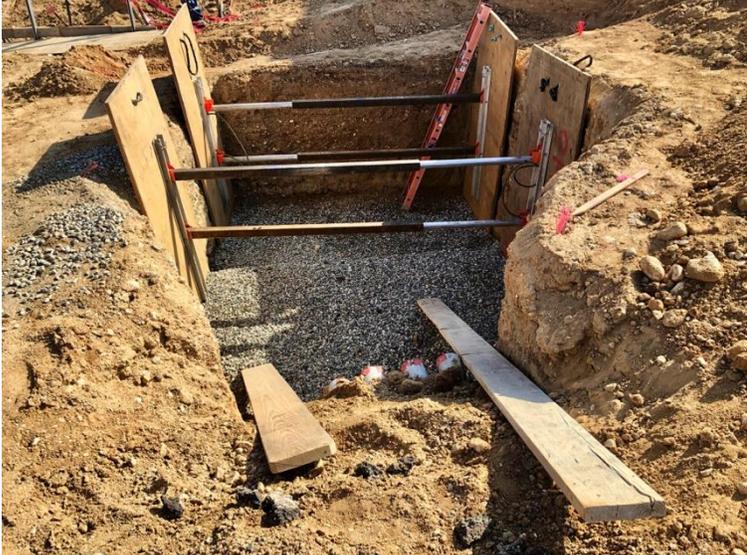
Photo 11 – Conduit trench with climbing structures installed.
9/25/19	Mesa Operations Building

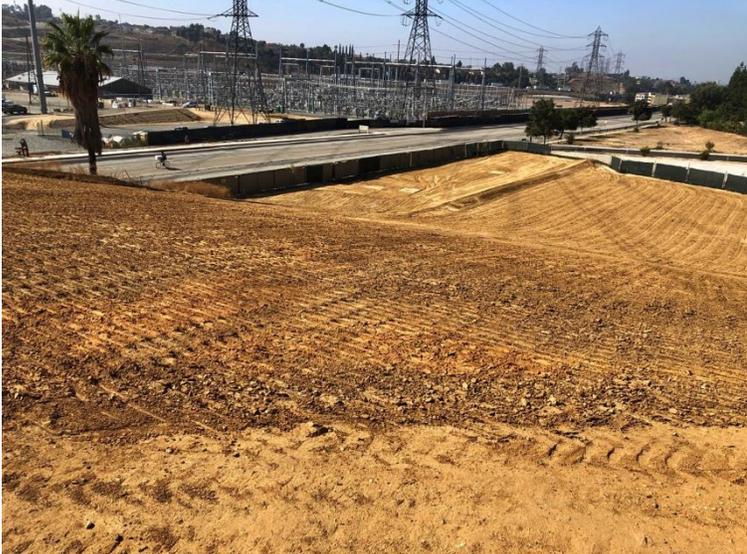
Re-grading of the Transmission Corridor north of Potrero Grande Drive continued – Photo 13. I noted ponded water and sediment flow in the central portion of the corridor – Photo 14. I notified biological monitor Matt Daniele (ICF) of my concerns.

<p>Photo 13 – Re-grading of the Telecommunications Corridor, located north of Potrero Grande. Photo facing southwest.</p>
9/25/19	Mesa Substation
