January 15, 2020

**Re: Monthly Report Summary #26 for the Mesa 500-kV Substation Project**

SITE INSPECTION CHECKLIST (Based on monitor's observations during site visit; responses do not imply that monitor observed all staff, crews, and parts of the project during this inspection)

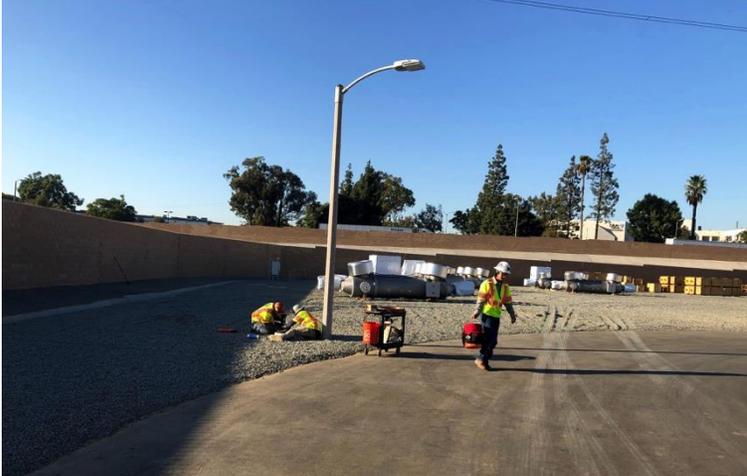
Photo 1 – Electrical wire work continued around the light poles. Photo facing north.
11/05/19	Mesa Substation

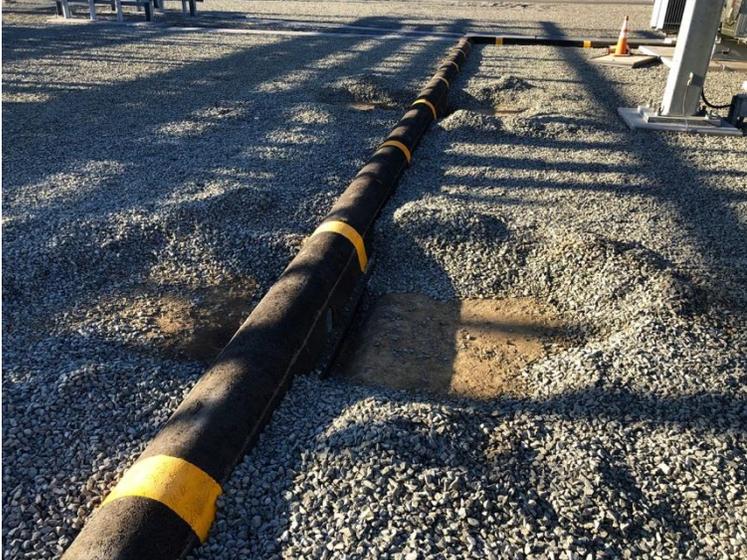
Photo 2 – Containment berm within the 16-kV switchrack area. Photo facing north.
11/05/19	Mesa Substation

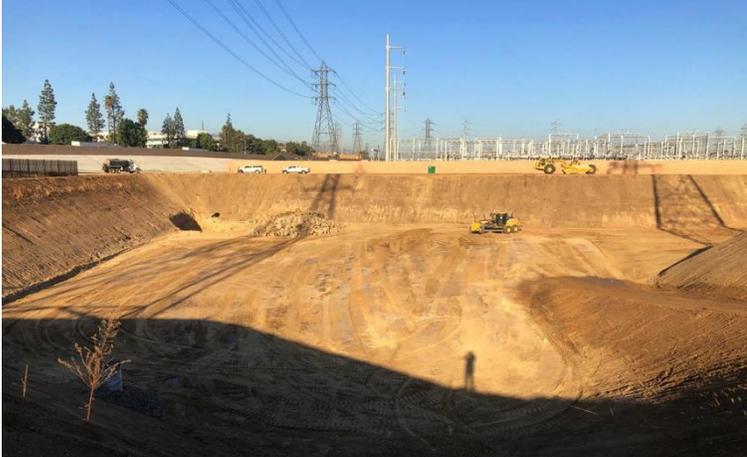
Photo 3 – Earthwork within the large detention basin. Photo facing east.

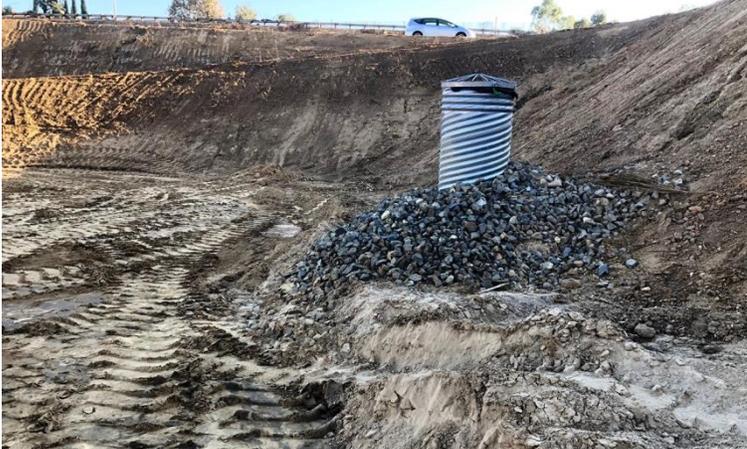
Photo 5 – Removal of sediments around the standpipe. Photo facing south.
11/05/19	Mesa Substation

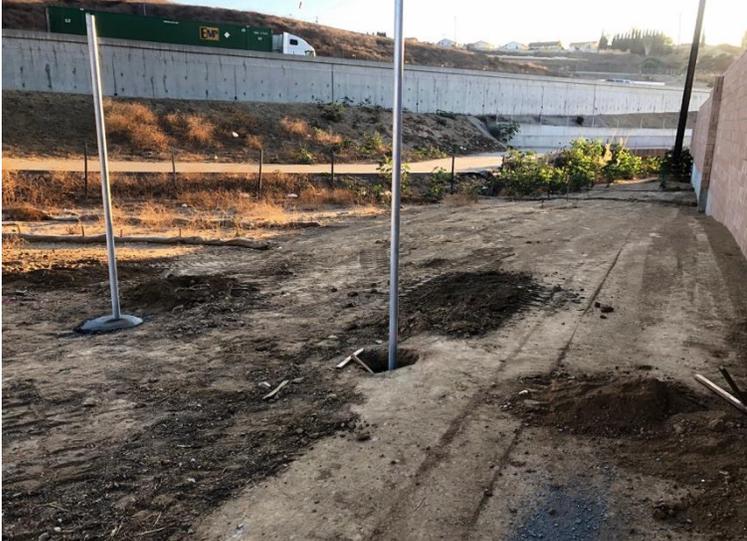
Photo 6 – Fence installation outside of the southern boundary wall. Photo facing southwest.

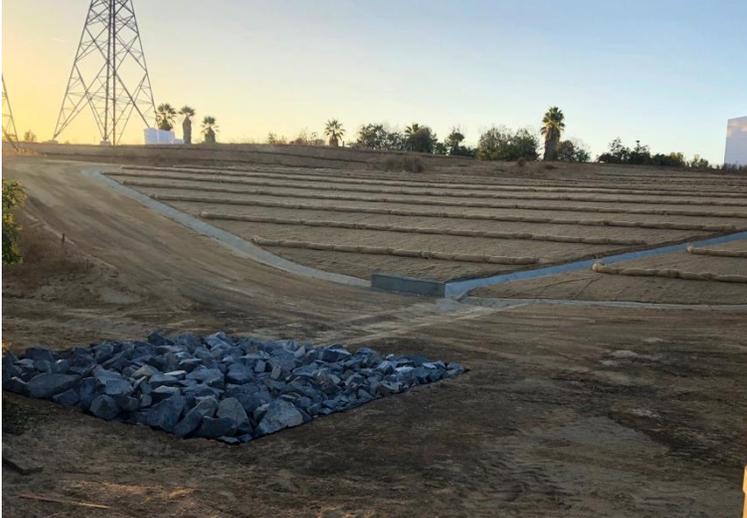
Photo 7 – BMP installation continued within the Transmission Corridor, located north of Potrero Grande Drive. Photo facing north.
11/05/19	Mesa Substation

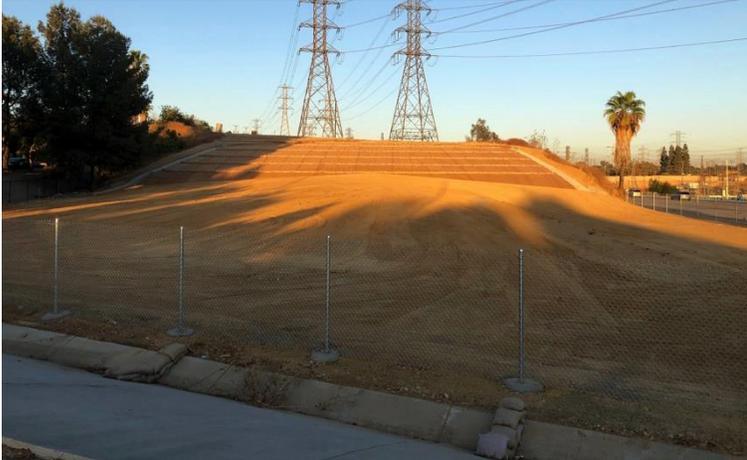
Photo 8 – BMP installation continued within the Transmission Corridor, located north of Potrero Grande Drive. Photo facing east.

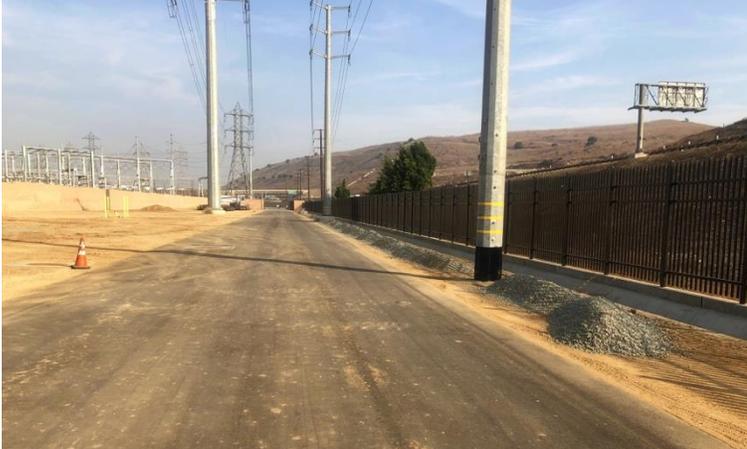
Photo 1 – Gravel is being placed along the southern boundary fence. Photo facing east.
11/13/19	Mesa Substation

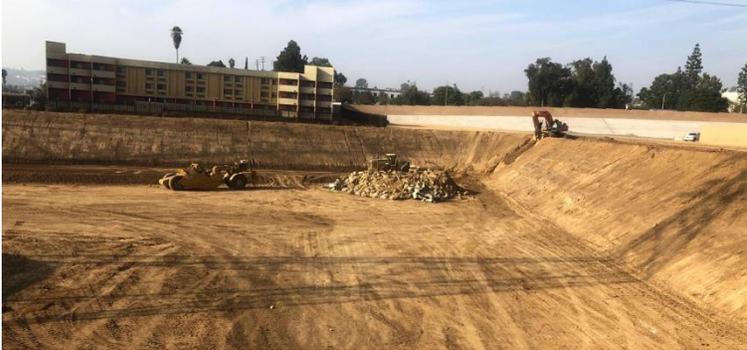
Photo 2 – Earthwork within the large detention basin. Photo facing north.
11/13/19	Mesa Substation

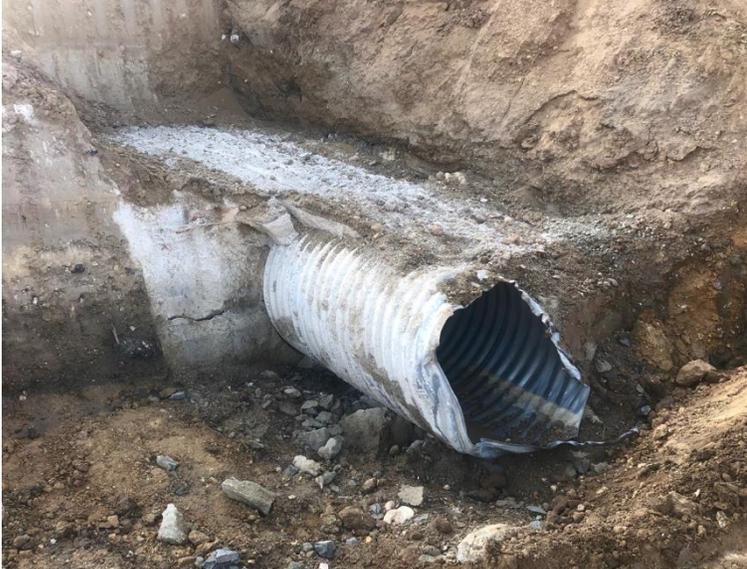
Photo 3 – The standpipe in the retention basin was removed.

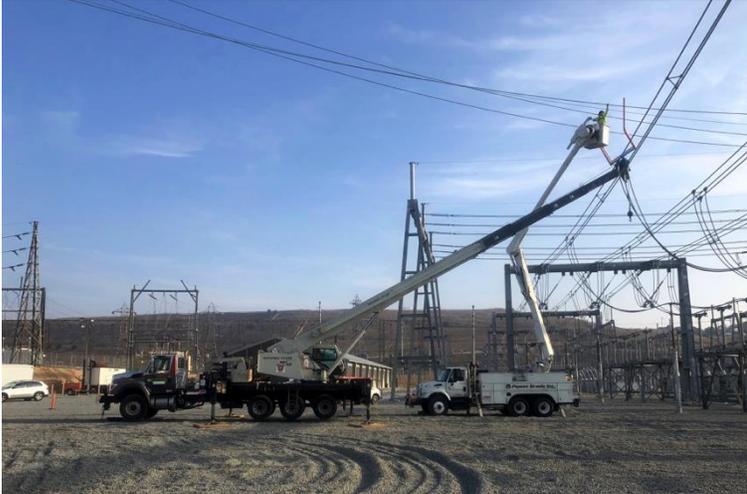
Photo 7 – Wire stringing along the 220-kV switchrack area. Photo facing south.
11/13/19	Mesa Substation

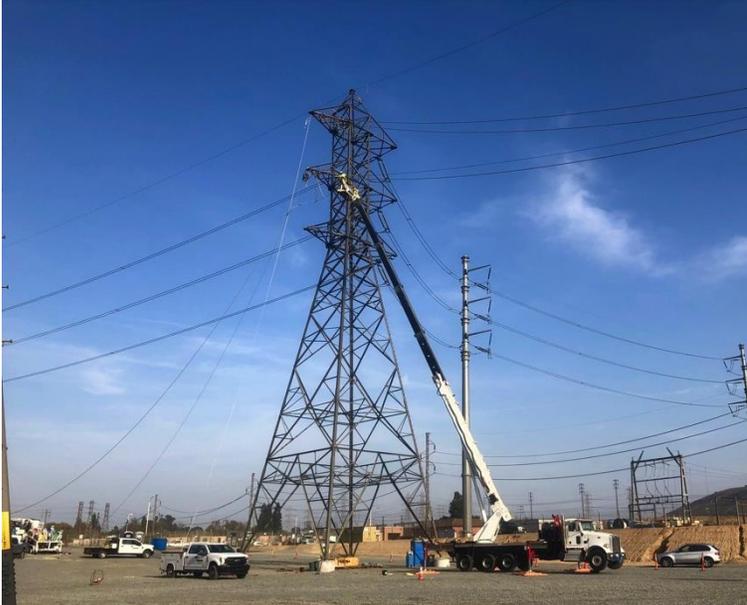
Photo 8 – Wire stringing along the 220-kV switchrack area. Photo facing southeast.

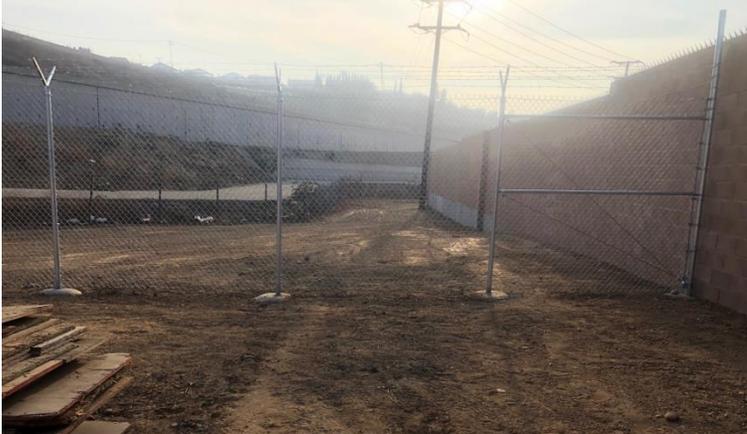
<p>Photo 9 – Chain link fence installed along the southern boundary of the site. Photo facing southwest.</p>
11/13/19	Mesa Substation

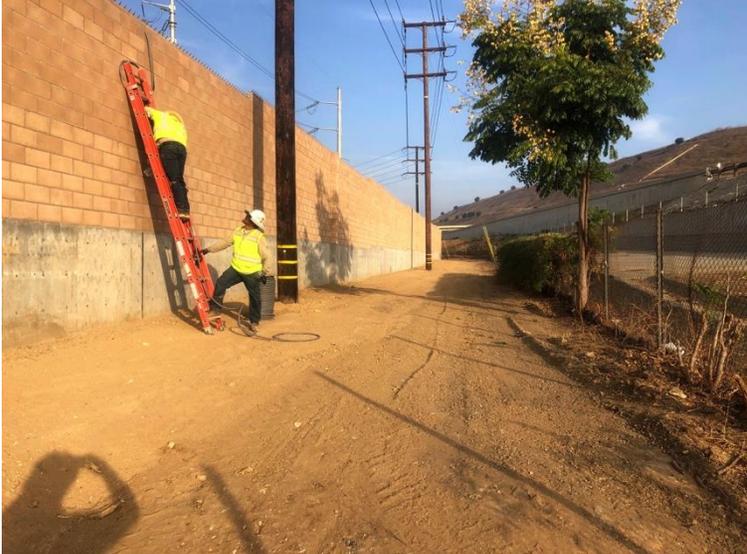
Crews were working on the wall installation – Photo 11.

<p>Photo 11 – Crews worked on the southern wall. Note - the area has been regraded, cleared of BMPs and vegetation. Photo facing east.</p>

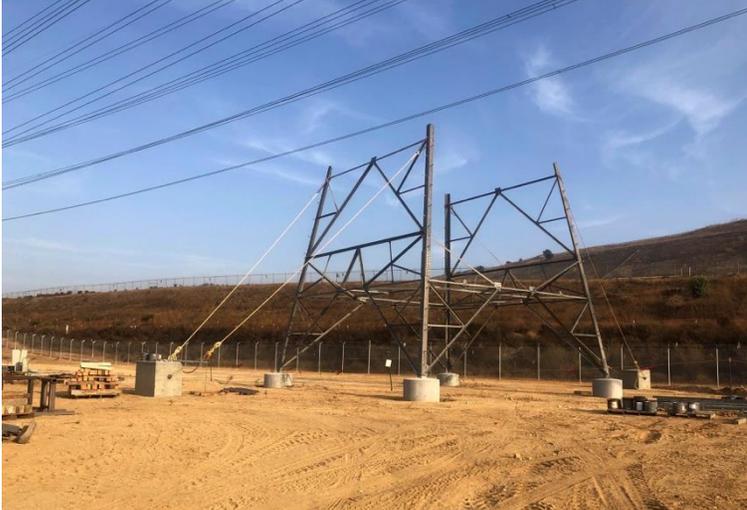
Photo 12 – Construction and installation of lattice work towers. Photo facing southeast.
11/13/19	Mesa Substation

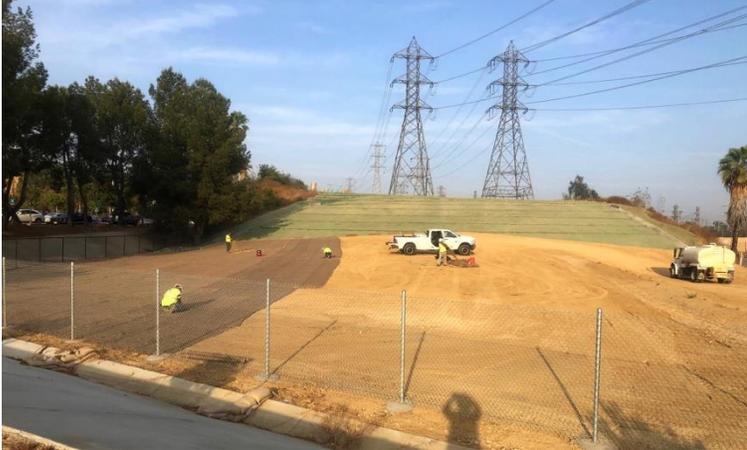
Photo 13 – BMP installation continued within the Transmission Corridor, located north of Potrero Grande Drive. Photo facing east.

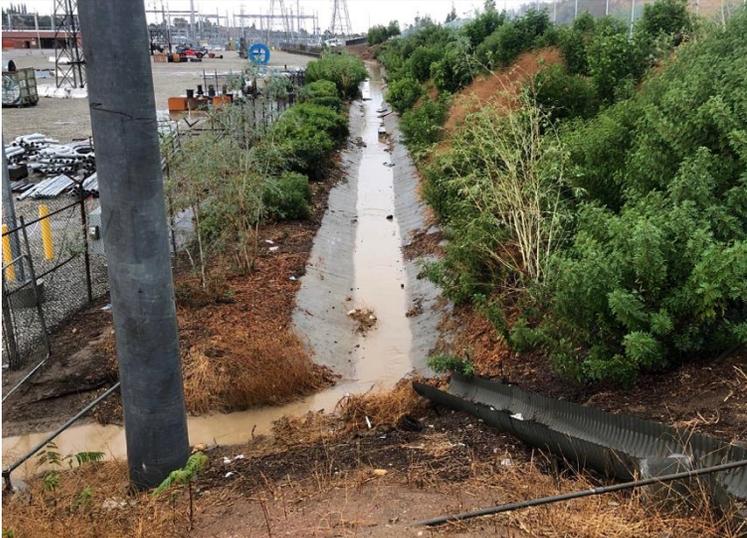
At the Mesa Operations Building, one of the outside drains was plugged; thus, water was ponding near the northwest corner of the building – Photo 16. The concrete-lined channel below the Mesa Operations Building was full of water and would need to be drained – Photo 17. Last winter, crews pumped this water directly onto the project site and it flowed into the detention basin via an earthen bermed channel. Sediment, vegetative debris, and trash had accumulated in this channel. This channel would need to be cleaned out.

Photo 17 – Drainage channel outside of the Mesa Operations Building. Photo facing west.
11/20/19	Mesa Substation

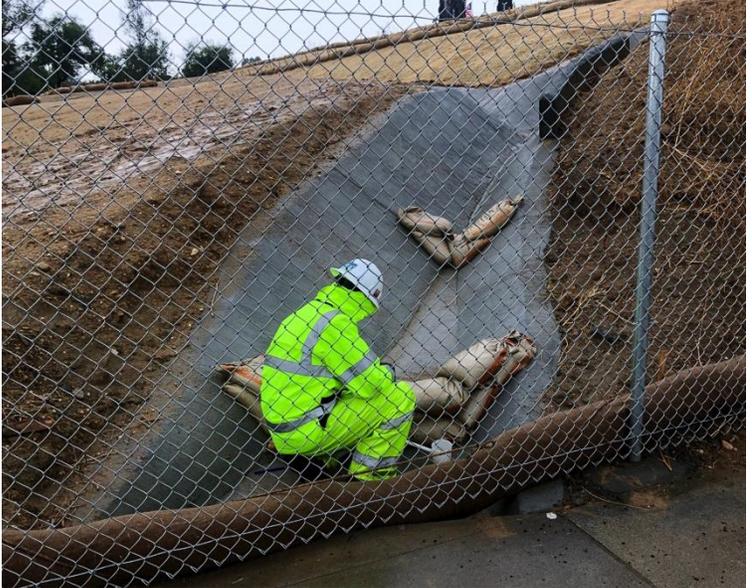
Photo 20 – SWPPP inspector taking water samples within the “V” ditch, located north of Potrero Grande Drive.

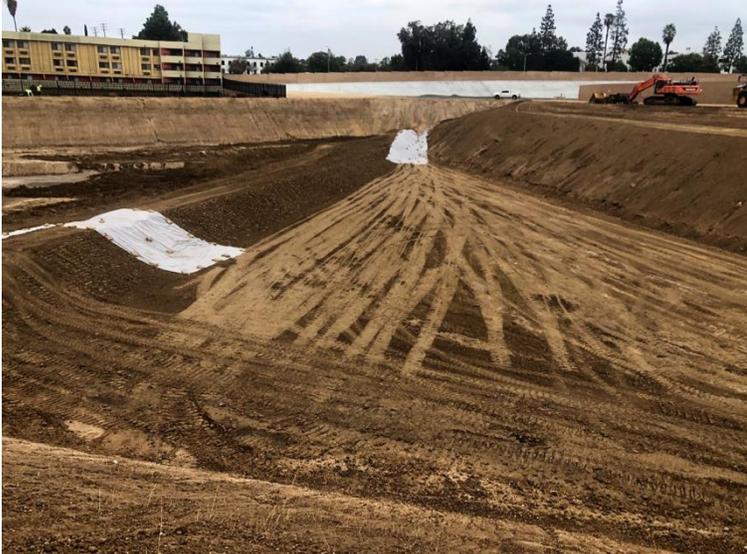
Our first stop was at the large detention basin. The basin was reconfigured into two basins to hold the project's rainwater runoff – Photo 1. Water entering the detention basin would be held in the eastern basin, with an overflow channel into the western basin. Even if water filled the western basin, it would not leave the site, as the outflow culvert was plugged – Photo 2.

Photo 1 – Reconfigured detention basin. Photo facing north.
11/27/19	Mesa Substation

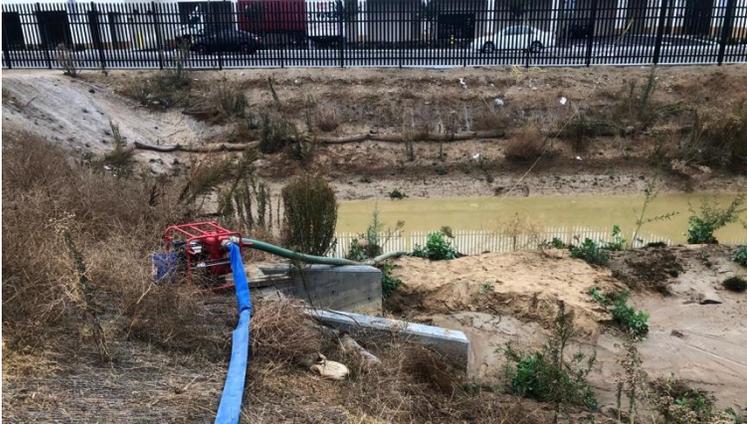
A crew was pumping water from the small “triangular” retention basin into the larger detention basin – Photo 3. Crews placed the gas-powered water pump on the concrete outflow structure without a containment device. Power Grade safety inspector Craig Pernot was working with this crew, and I notified him about the lack of a drip pan placed under the gas-powered water pump. He directed the crew to put the engine in a containment structure.

Photo 3 – Crews were pumping the water captured in the small triangular retention basin into the large detention basin. Photo facing northeast.

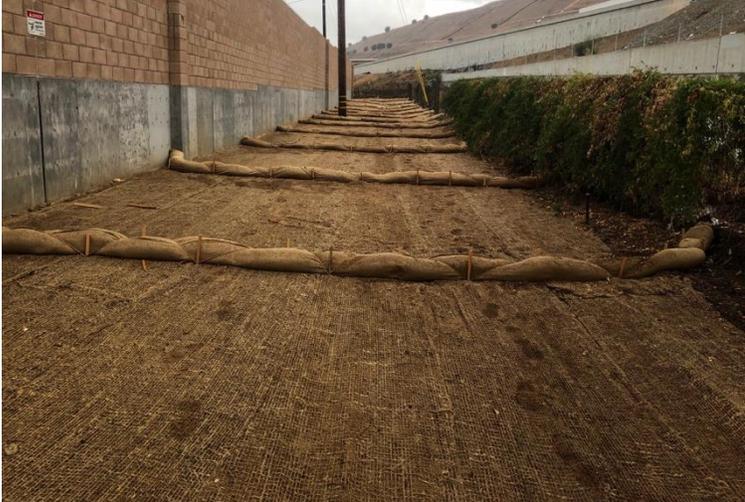
I inspected the area outside of the southern boundary wall, where most of the water from the southeastern portion of the project site was entering. Crews had constructed additional gravel bag check dams and straw wattles and had secured the wattles with a type 2 anchoring system – Photos 4 & 5. Without diverting some of the stormwater runoff or installing a catch basin, the best management practices (BMPs) installed outside of the southern boundary wall are not expected to slow the runoff and will allow project-related sediment to drop out. The runoff flows through a large staging area and parking area, where drip containment has been inadequate during my recent site visits.

<p>Photo 5 – Upgraded BMPs outside of the southern boundary wall. Photo facing east.</p>
11/27/19	Mesa Substation

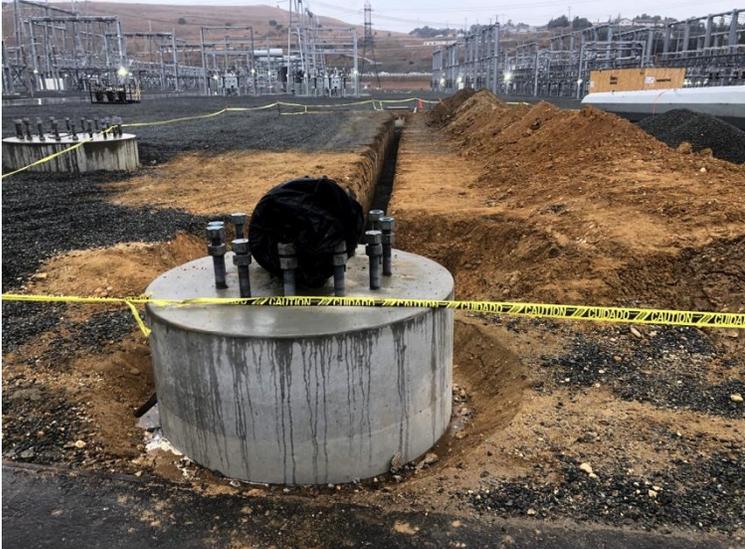
I noted trenching activities within the switchrack areas – Photo 6. This trench had wooden climbing structures in place.

<p>Photo 6 – Trenching for installation of a tubular steel pole (TSP). Photo facing south.</p>

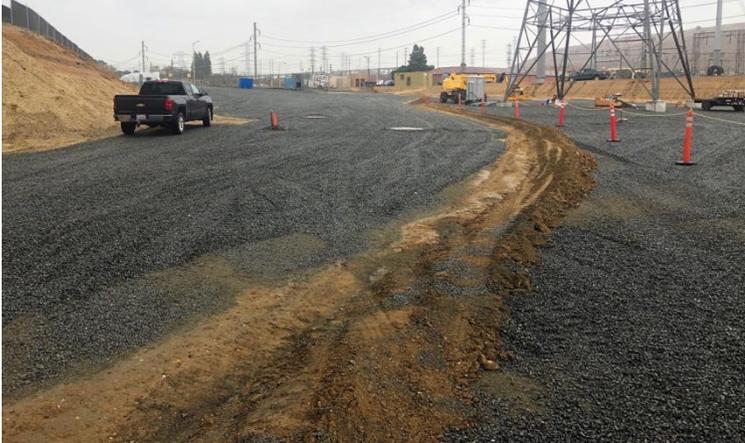
A diversion berm was cut near the northern entrance to the project site – Photo 7. This berm redirects water coming from the Existing Mesa Substation and from the concrete channel surrounding it – Photo 8.

<p>Photo 7 – Diversion channel to direct rainwater runoff away from the switchrack areas. Photo facing east.</p>
11/27/19	Mesa Substation

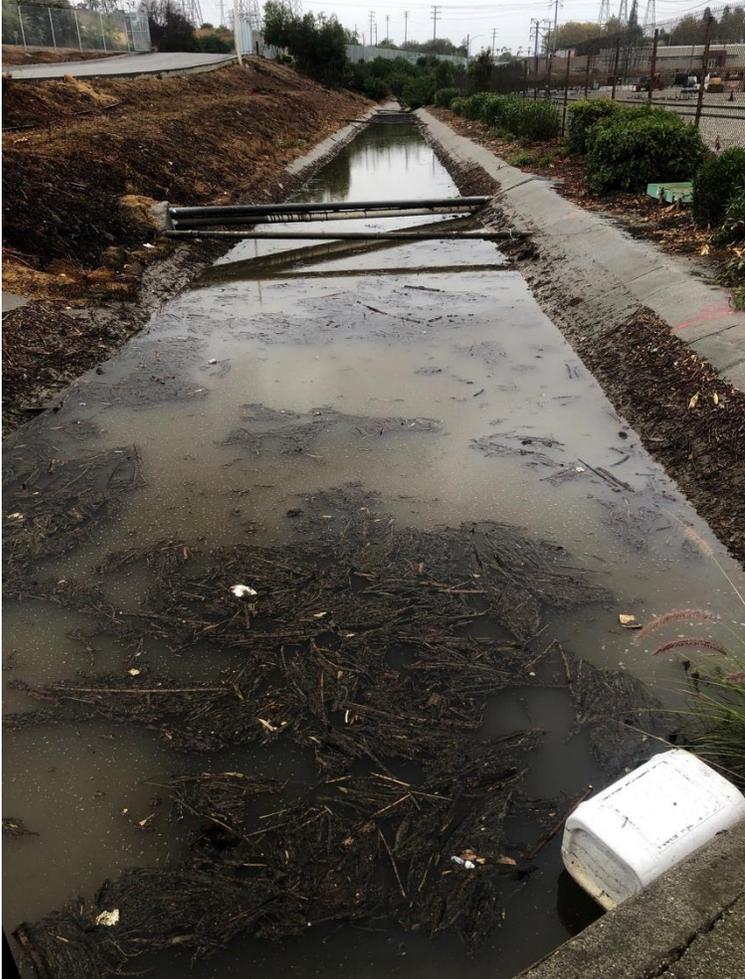
<p>Photo 8 – Rainwater runoff from the Mesa Operations Building and the Existing Mesa Substation accumulated in a concrete lined channel. This water enters the large detention basin. Photo facing east.</p>
