Re: Monthly Report Summary #27 for the Mesa 500-kV Substation Project

Mesa 500–kV Substation Project CPUC Site Inspection Form

Project:	Mesa 500-kV Substation Project	Date:	December 4, 2019
Project Proponent:	Southern California Edison	Report #:	VS098
Lead Agency:	California Public Utilities Commission	Monitor(s):	Vince Semonsen
CPUC PM:	Connie Chen, Energy Division	AM/PM Weather:	Light rain and cool temperatures with a light breeze
E & E CM:	Silvia Yanez	Start/End Time:	1430 to 1600
Project NTP(s):	NTP-1, NTP-2

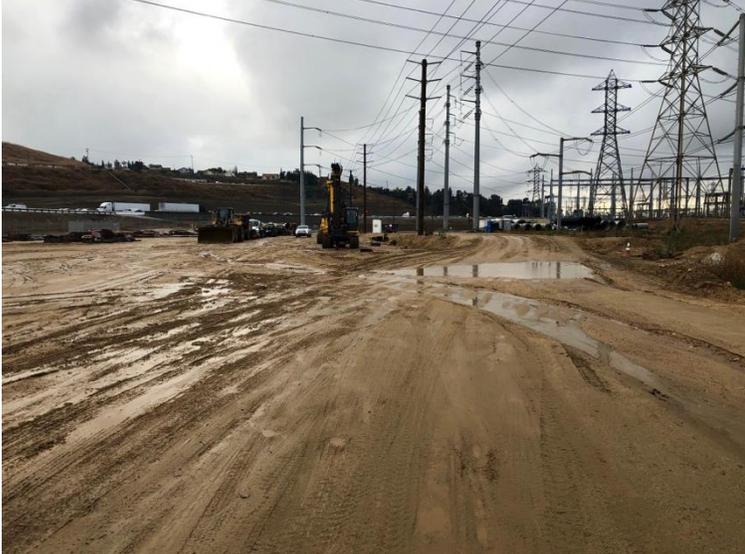
<p>Photo 4 – Southeastern portion of the project, water from here drains to the outside of the southern boundary wall. Photo facing west.</p>
12/04/19	Mesa Substation

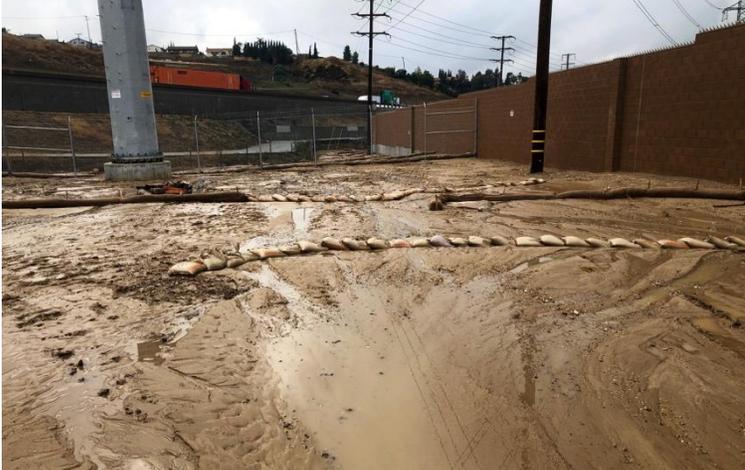
<p>Photo 5 – Upgraded BMPs outside of the southern boundary wall. Photo facing southwest.</p>
12/04/19	Mesa Substation

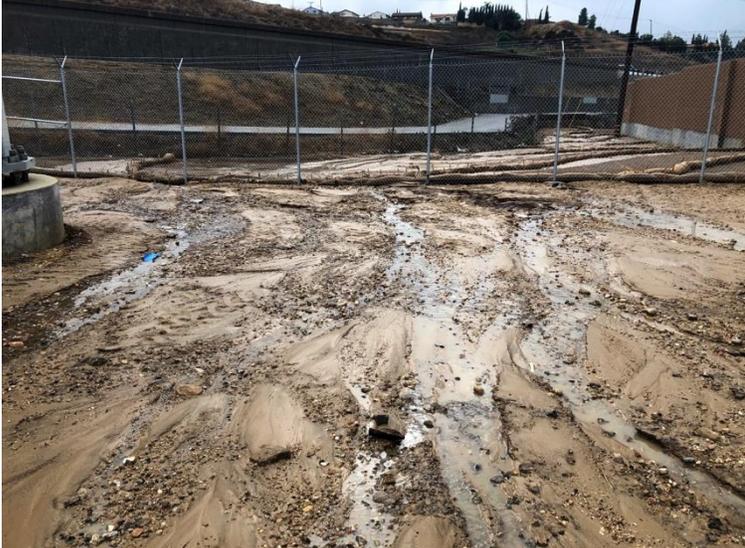
<p>Photo 6 – Upgraded BMPs outside of the southern boundary wall. Photo facing southwest.</p>

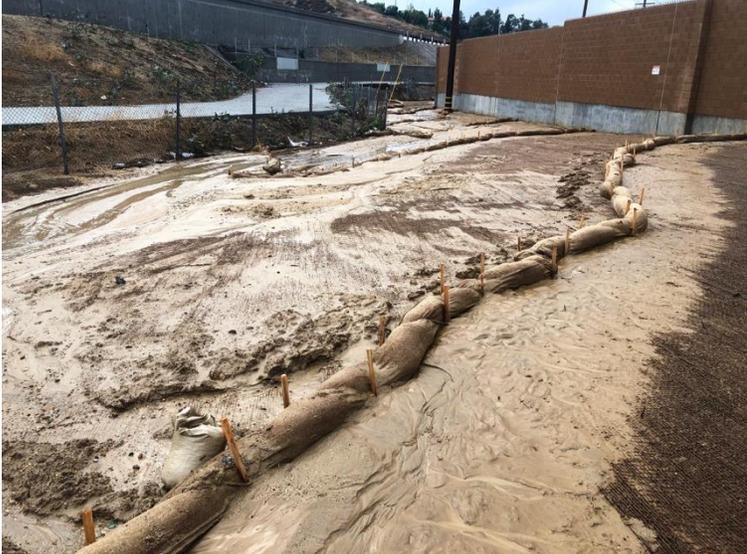
<p>Photo 7 – Upgraded BMPs outside of the southern boundary wall. Photo facing southwest.</p>
12/04/19	Mesa Substation

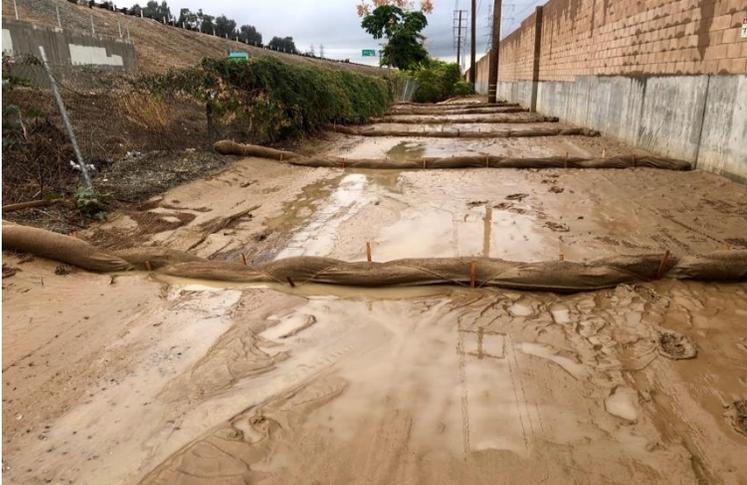
<p>Photo 8 – Upgraded BMPs outside of the southern boundary wall. Photo facing southwest.</p>
12/04/19	Mesa Substation

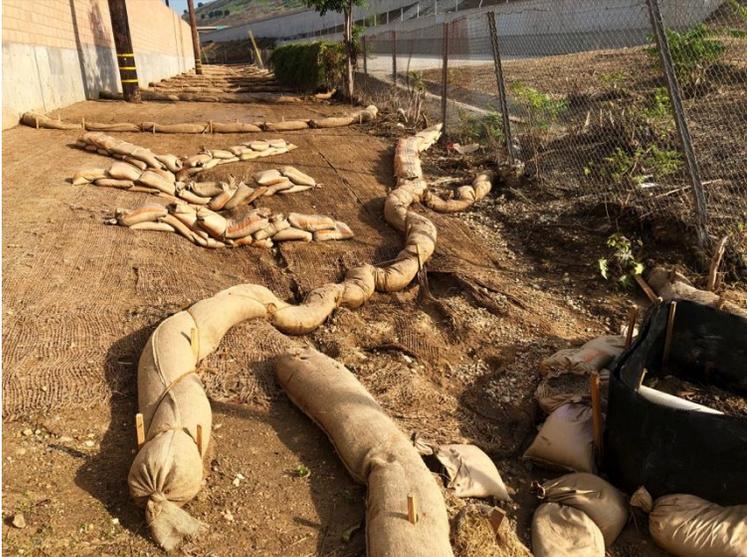
Photo 3 – BMPs along the outside of the southern boundary wall. Photo facing east.

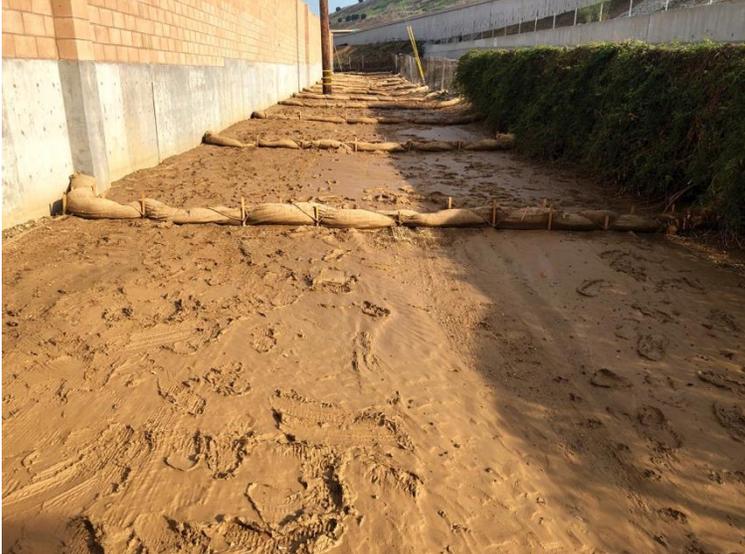
Photo 4 – BMPs along the outside of the southern boundary wall. Photo facing east.
12/11/19	Mesa Substation

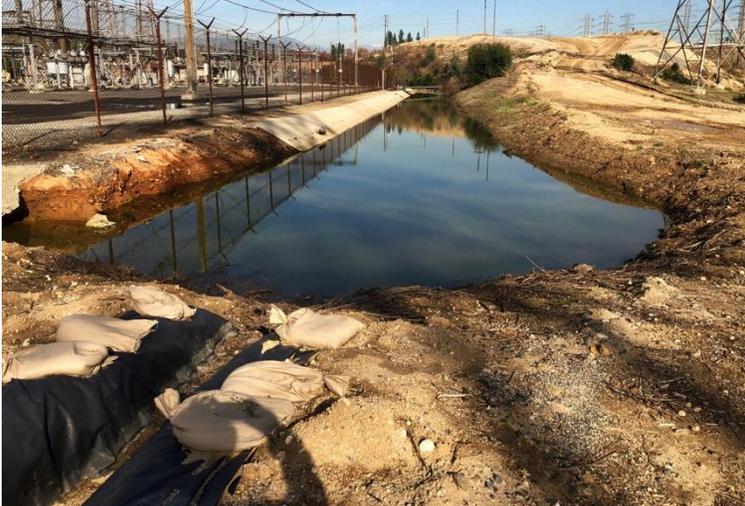
The concrete channel draining the southern portion of the Existing Mesa Substation remained full – Photo 5.

Photo 5 – Rainwater runoff from the Existing Mesa Substation. Photo facing east.

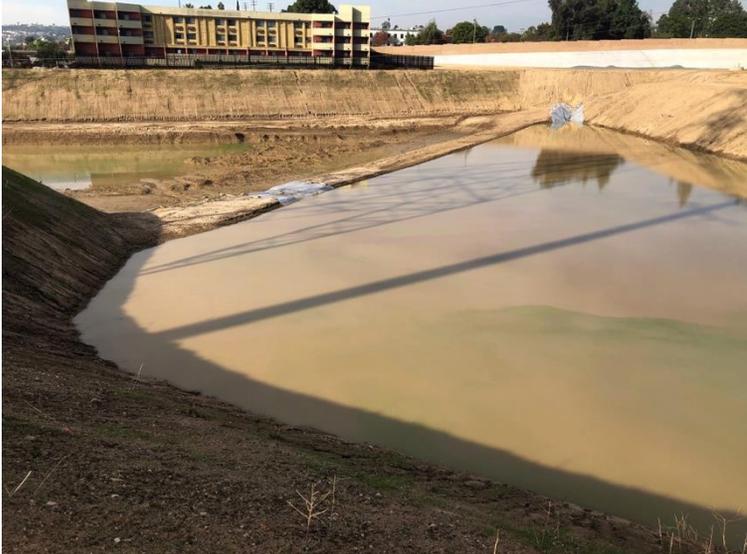
Photo 6 – Poned water inside of the large detention basin. Photo facing north.
12/11/19	Mesa Substation

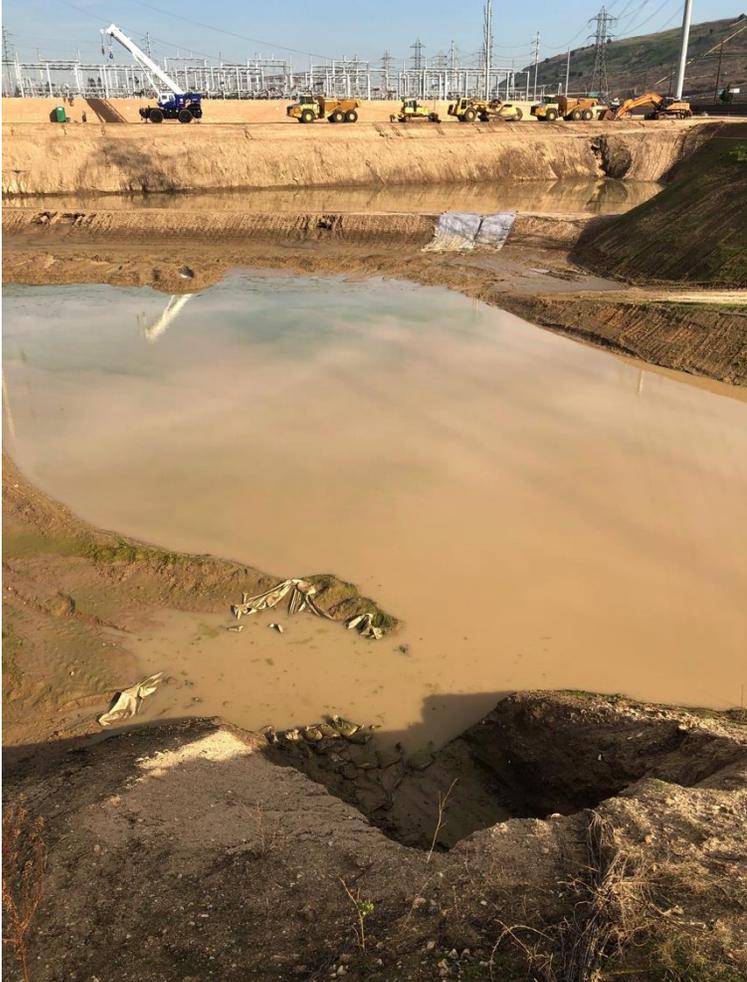
Photo 7 – Accumulated water inside of the large detention basin. Photo facing east.

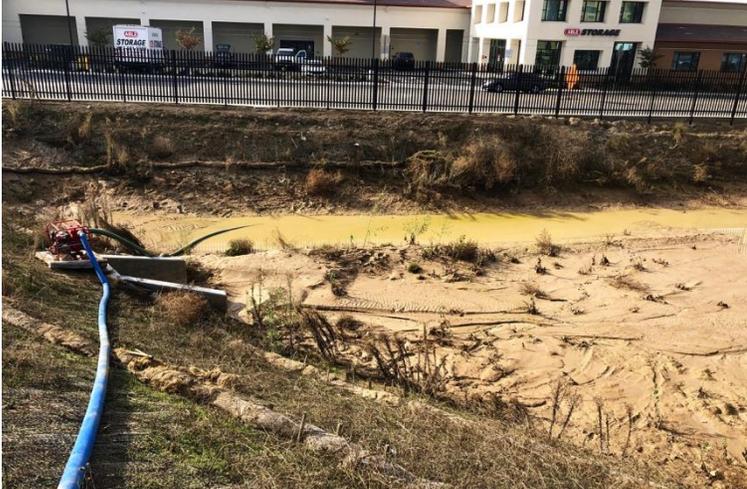
The small “triangular” retention basin was pumped into the western portion of the large detention basin – Photo 8. The pump was left within the small basin and placed in a plastic-lined containment system.

Photo 8 – Small triangular retention basin. Photo facing west.
12/11/19	Mesa Substation

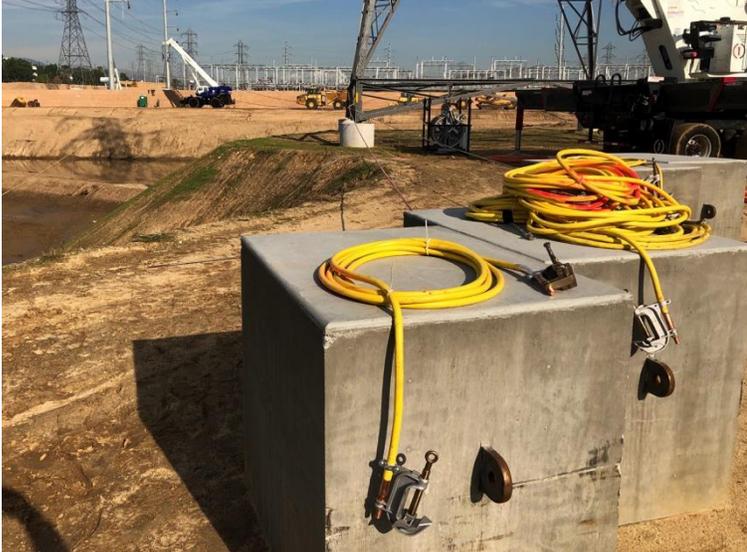
Some equipment remained onsite near the detention basin for pulling wire – Photo 9.

Photo 9 – Wire pulling equipment. Photo facing east.
12/11/19	Mesa Substation

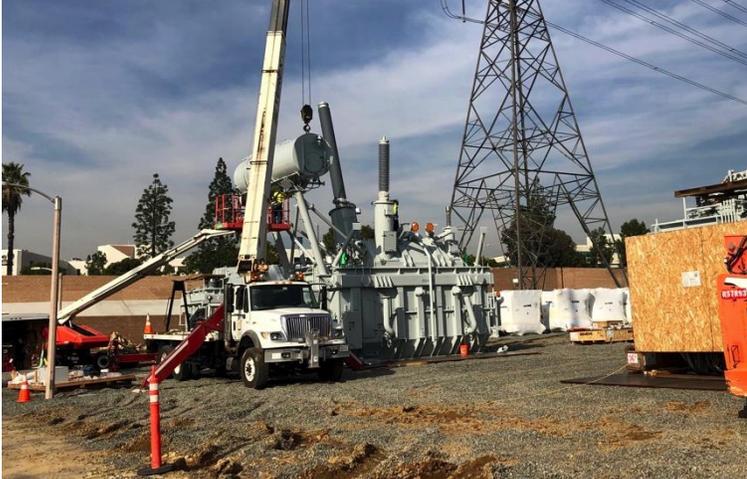
A crew was working on assembling the large substation equipment near the 66-kilovolt (kV) switchrack area – Photo 10.

Photo 10 - Substation equipment being installed near the 66-kV switchrack area. Photo facing north.

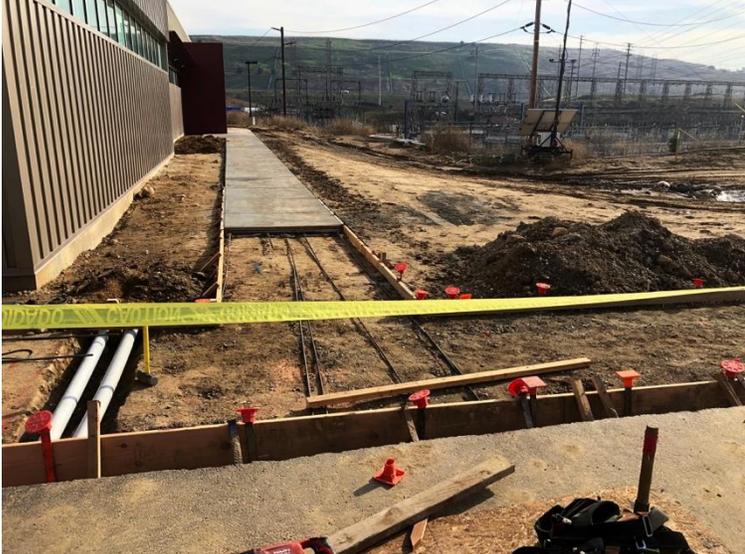
At the Mesa Operations Building, construction crews were installing sidewalks around the building – Photo 11. Drainage from this site entered drain inlets that deposit water into the concrete channel that runs along the eastern and northern sides of the Existing Mesa Substation – Photo 12. This water eventually flows along the northern area of the project site before entering the storm drain system and the large detention basin.

Photo 11 – Sidewalk construction around the Mesa Operations Building. Photo facing south.
12/11/19	Mesa Substation

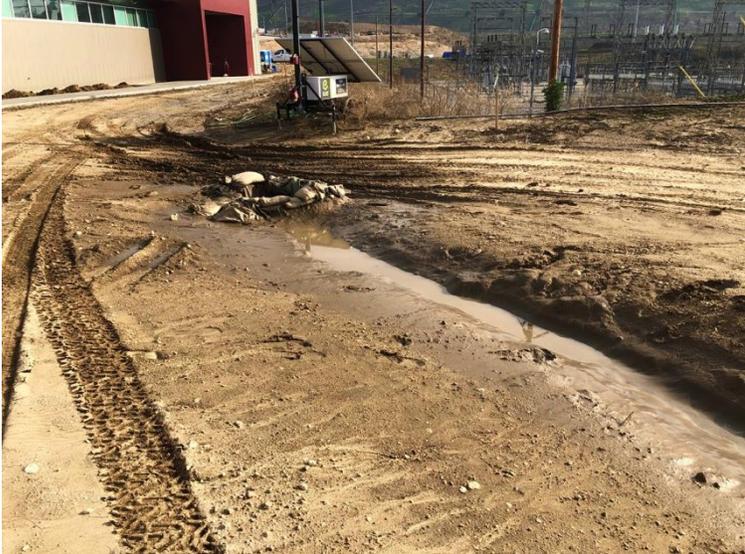
Photo 12 – Drain inlet northwest of the Mesa Operations Building. Photo facing south.
12/11/19	Mesa Substation

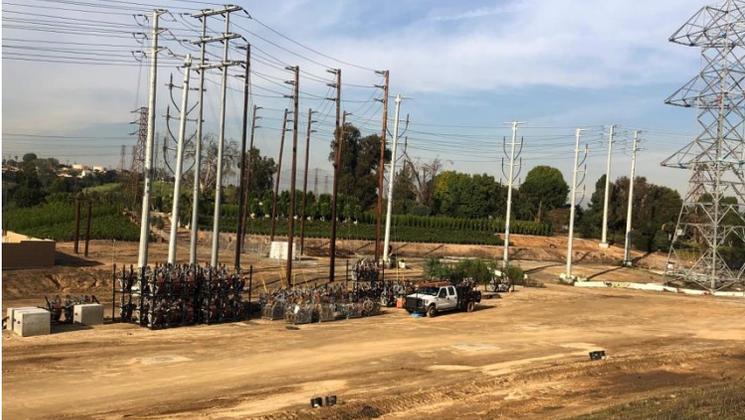
The staging area near the project trailers appeared to be well maintained – Photo 13.

Photo 13 – Staging area at the eastern end of the project site. Photo facing northeast.

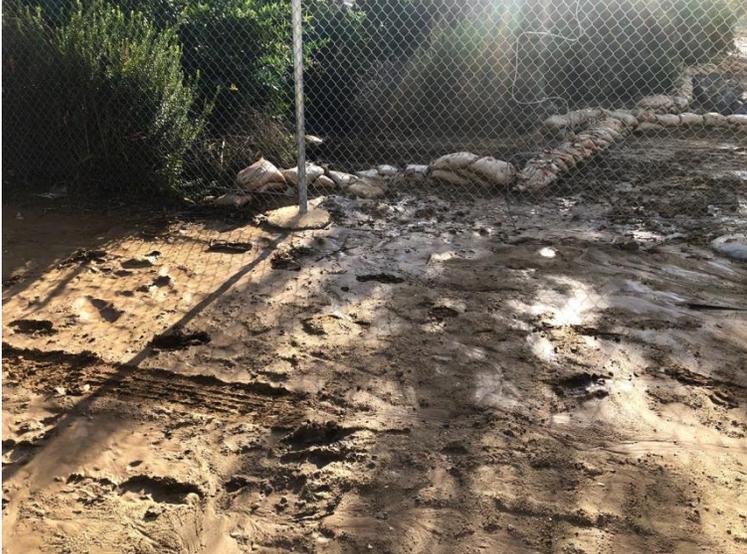
I inspected two segments of the Transmission Corridor located north of Potrero Grande Drive; both areas seem to be holding up well and are keeping sediments onsite – Photo 14. Mud was accumulating near the road culvert below the central portion of the Transmission Corridor – Photo 15.

Photo 14 – BMPs and sediment from the transmission Corridor located north of Potrero Grande Drive.
12/11/19	Mesa Substation

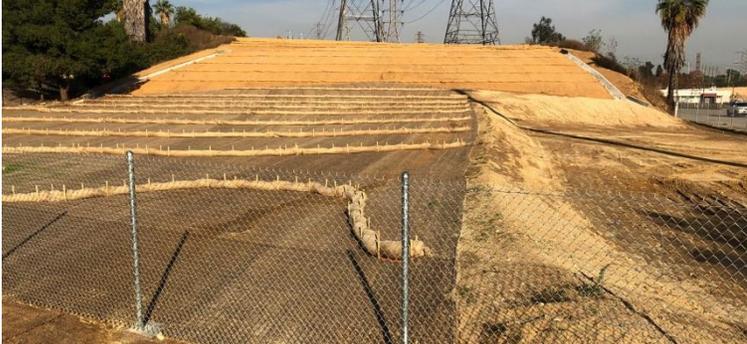
Photo 15 – BMPs within the Transmission Corridor located east of Potrero Grande Drive. Photo facing east.

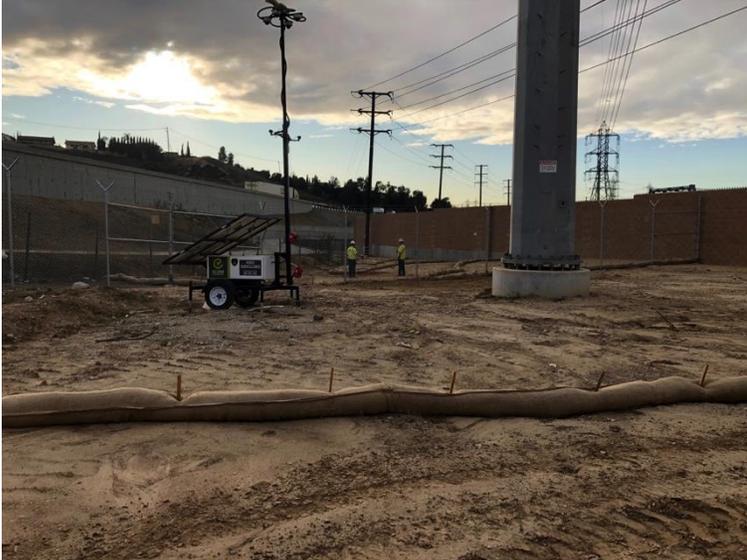
A crew was working on the BMPs along the outside of the southern boundary wall – Photo 2. Crews were digging out the sediment trapped behind the wattles; there appeared to be little upgrades implemented in this area.

<p>Photo 2 – BMP maintenance being completed outside of the southern boundary wall. Photo facing southwest.</p>
12/18/19	Mesa Substation

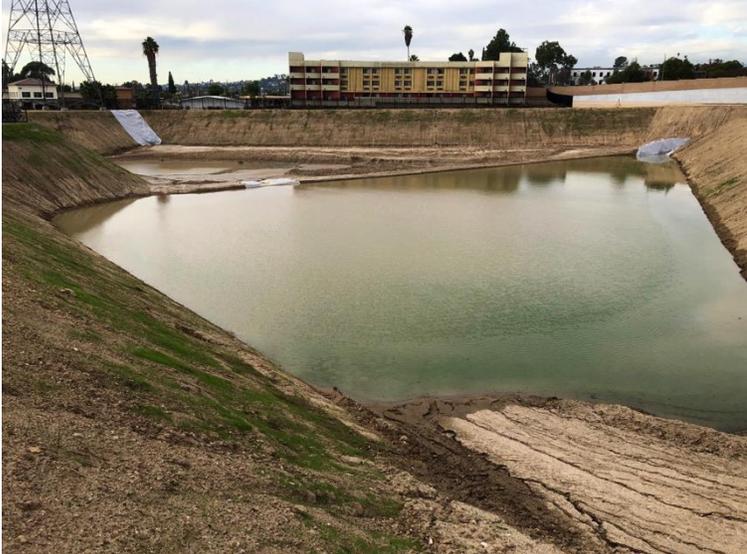
The reconfigured large detention basin had the two catch basins – Photo 3. The eastern basin was full, while the western basin had drained out leaving an area of ponded water that was below the level of the outfall pipe – Photo 4. I walked down to the outfall pipe with Power Grade foreman Craig Pernot and another foreman from Power Grade – Photo 5. Craig Pernot mentioned that crews attempted to seal the pipe with filter fabric, plastic, and gravel bags. However, water was still draining. They were planning to seal the pipe inlet soon, as several storms were predicted over the holiday week.

<p>Photo 3 – Large pond in the detention basin. Photo facing northwest.</p>

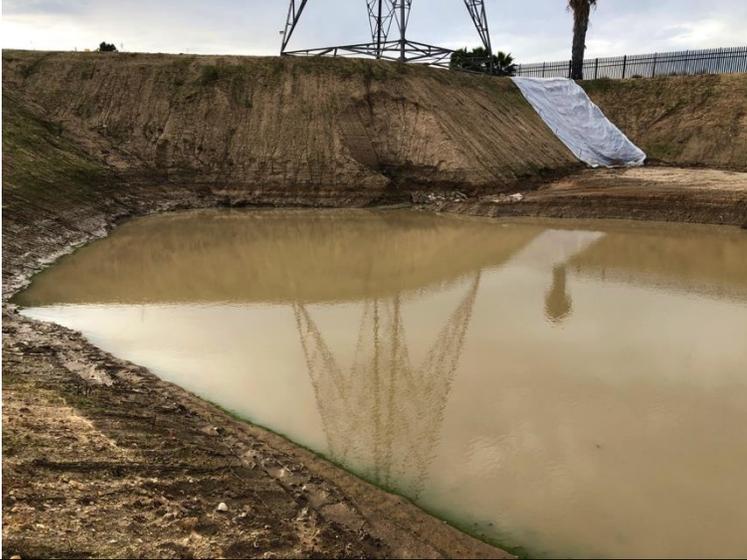
Photo 4 – Poned water in the western portion of the large detention basin. Photo facing northwest.
12/18/19	Mesa Substation

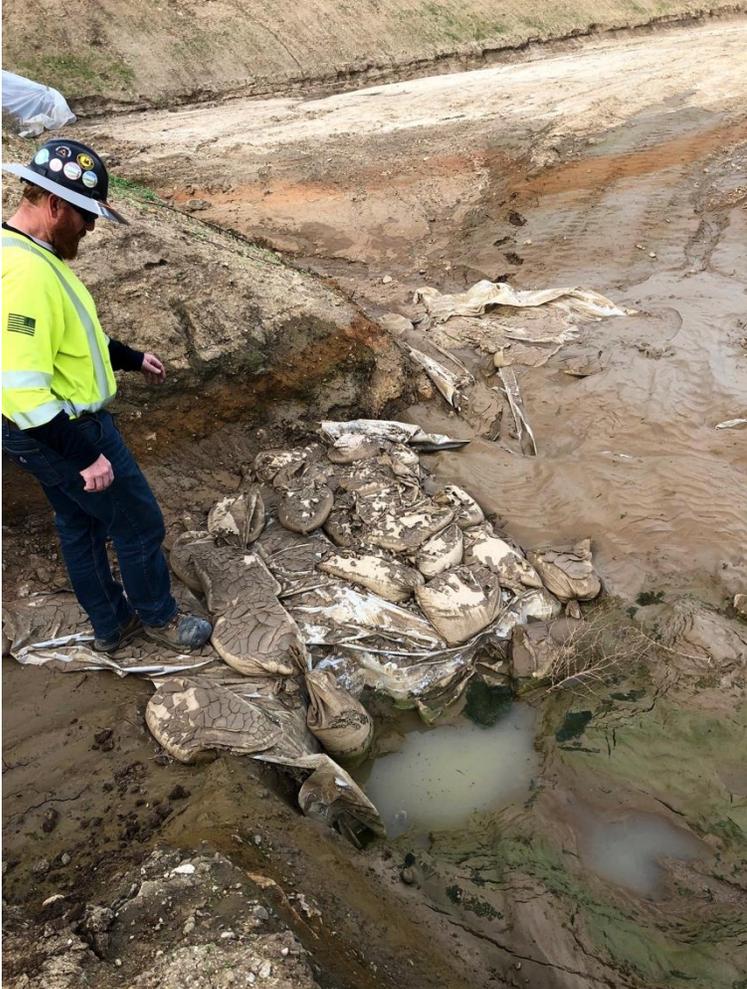
Photo 5 – Drain inlet at the large detention basin.

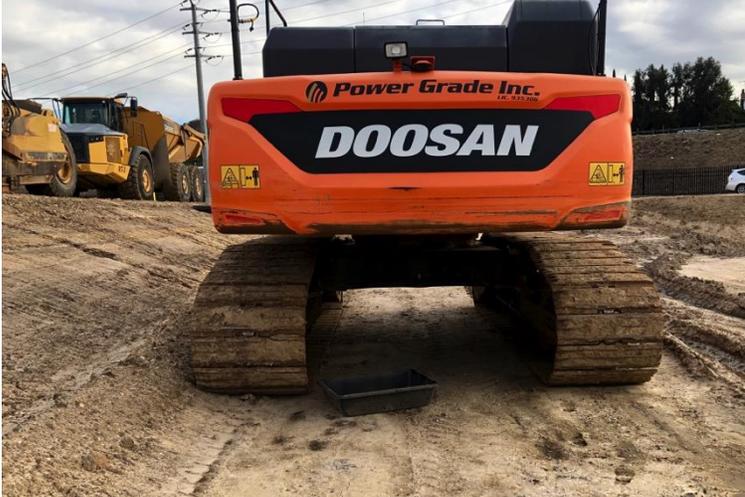
Photo 6 – Secondary containment under a large excavator.
12/18/19	Mesa Substation

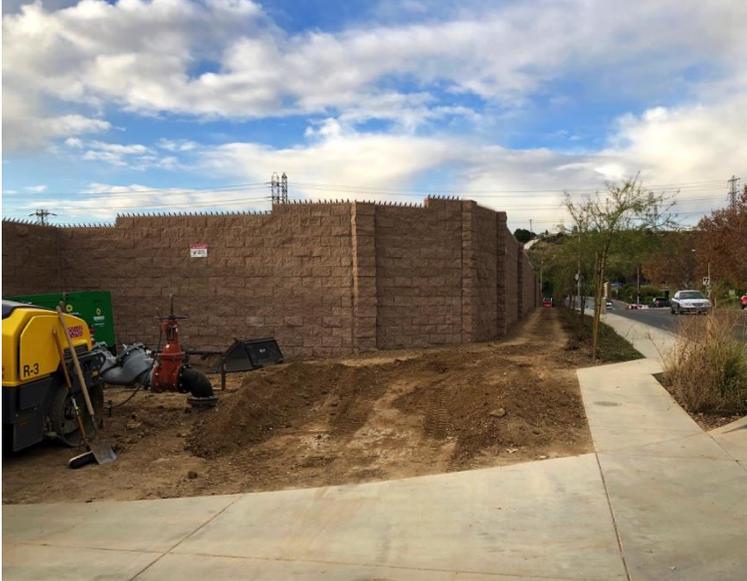
A landscaping crew was working around the Mesa Operations Building. There were several construction activities occurring outside of the eastern boundary wall – Photo 9. In addition, mulch piles were delivered to the impacted area located along the building access road – Photo 10.

<p>Photo 9 – Landscaping work being completed directly outside of the eastern boundary wall. Photo facing north.</p>
12/18/19	Mesa Substation

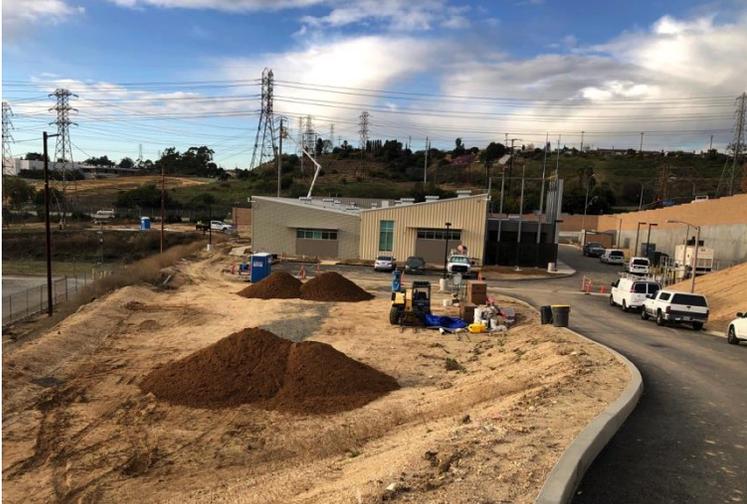
<p>Photo 10 – Mulch delivered into the area where the construction trailers were parked for the Mesa Operations Building. Photo facing north.</p>
12/18/19	Mesa Substation

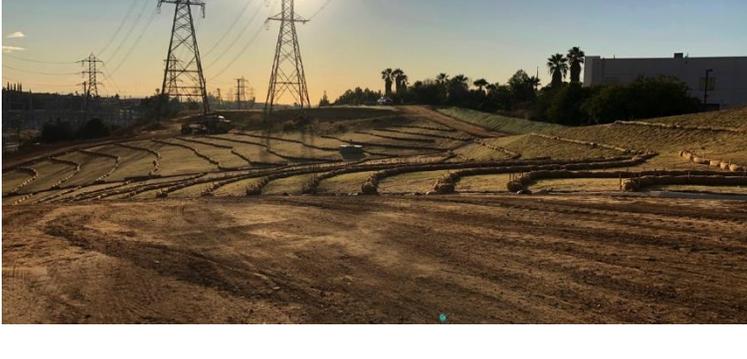
Regrading and hydro-mulching was being completed along the Transmission Corridor located north of Potrero Grande Drive – Photo 11.

<p>Photo 11 – BMP work within the Transmission Corridor, located east of Potrero Grande Drive. Photo facing west.</p>
