February 23, 2021

Connie Chen
Project Manager
California Public Utilities Commission
505 Van Ness Avenue
San Francisco, CA 94102

Re: Monthly Report Summary #28 for the Mesa 500-kV Substation Project

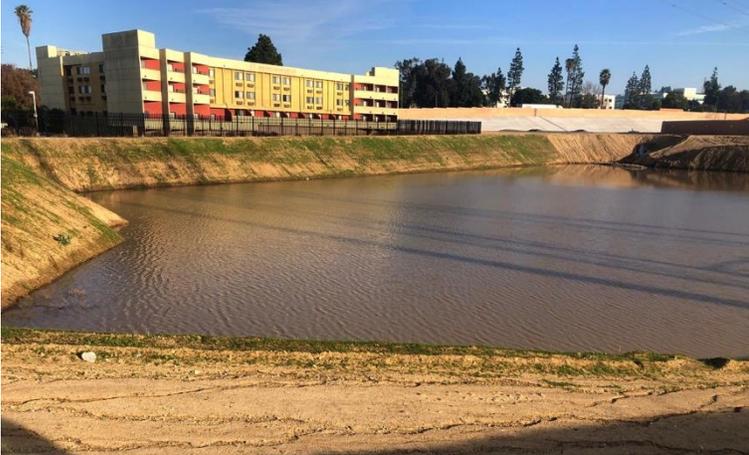
Photo 9 – Water within the large retention basin. Photo facing north.
1/02/20	Mesa Substation

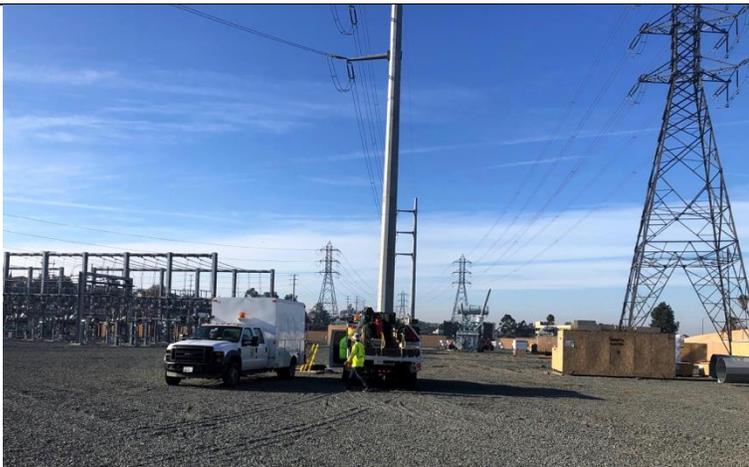
Photo 12 – Vault work being performed by a SCE crew. Photo facing west.
1/02/20	Mesa Substation

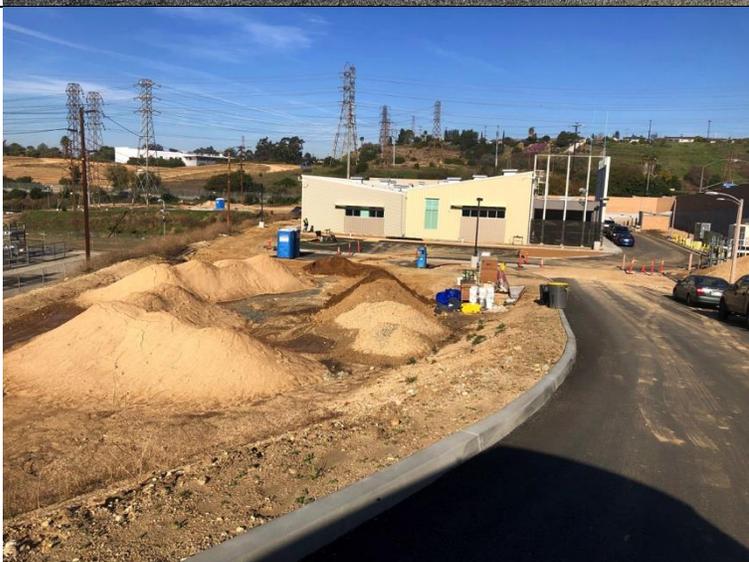
Photo 13 – Landscaping work near the Mesa Operations Building. Photo facing north.
1/02/20	Mesa Substation

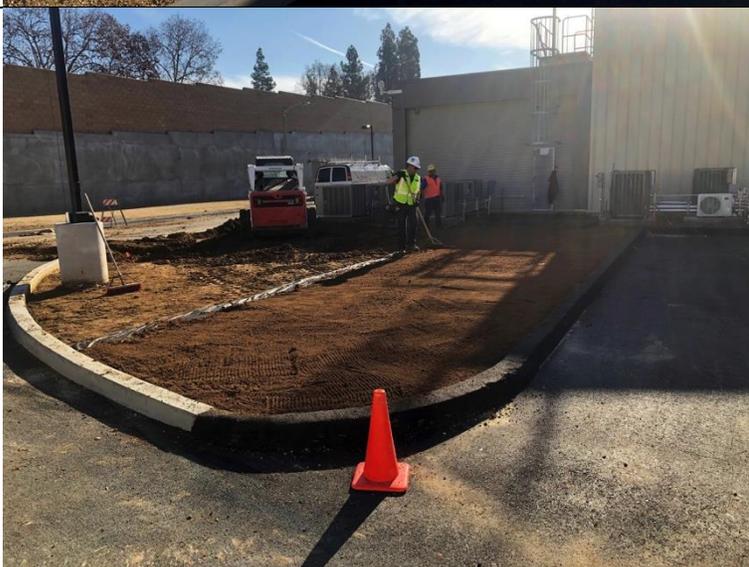
Photo 14 – Landscaping work near the Mesa Operations Building. Photo facing southeast.

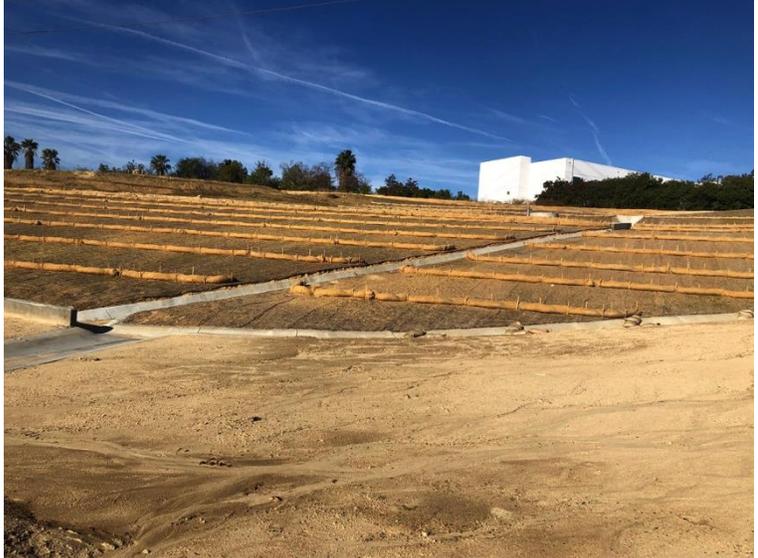
Photo 15 – BMP work within the Transmission Corridor east of Potrero Grande Drive. Photo facing north.

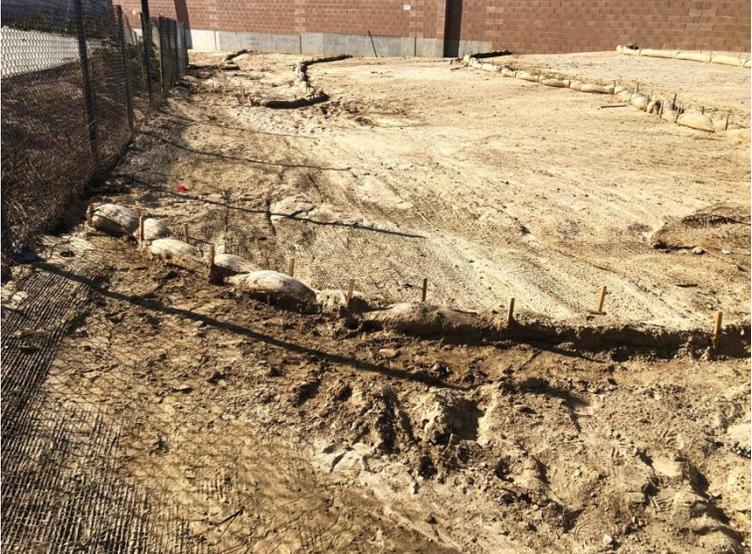
No rain had occurred since my last site visit and crews are doing some maintenance work on the stormwater runoff BMPs outside of the southern boundary wall. The crews were shoveling the captured sediment away from the wattles, but leaving it nearby (Photo 1). Removing the sediment from the area is essential to the efficiency of the BMPs during the next rain event; just shoveling the sediment a couple of feet away from the wattles will prevent the BMPs from being effective. Some of the gravel bag check dams have been upgraded near the drain inlet (Photo 2).

Photo 1 – BMP maintenance outside of the southern boundary wall. Photo facing west.
1/09/20	Mesa Substation

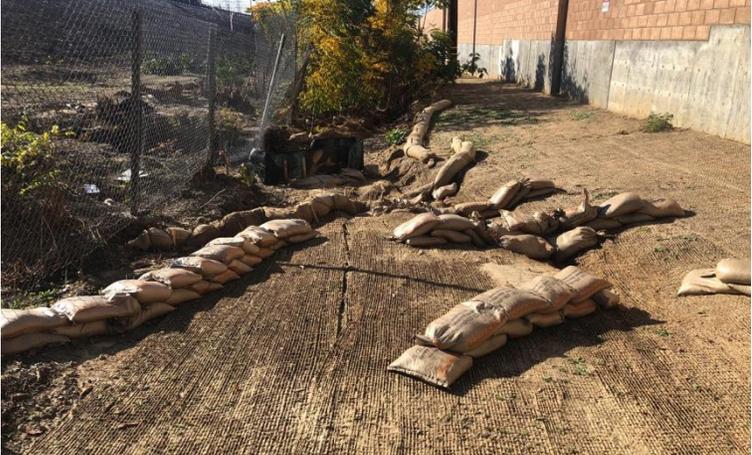
Photo 2 – BMP maintenance outside of the southern boundary wall. Photo facing west.
1/09/20	Mesa Substation

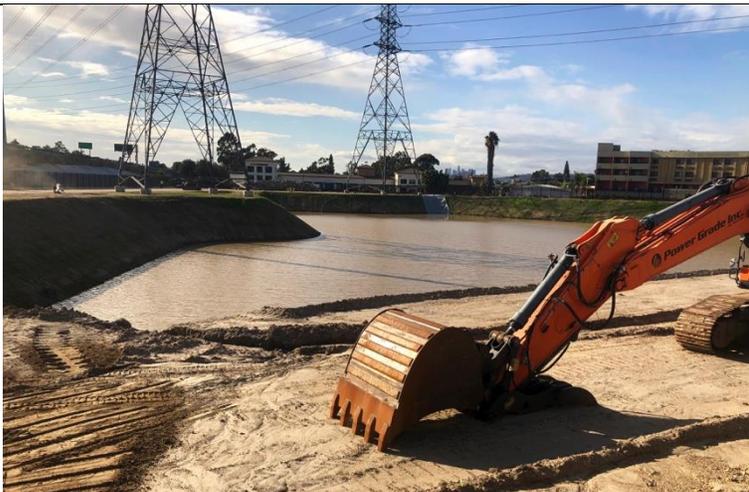
The large retention basin remains nearly half full of water indicating that the outlet drainage pipe has been adequately sealed (Photo 4).

Photo 4 – Water within the large retention basin. Photo facing northwest.
1/09/20	Mesa Substation

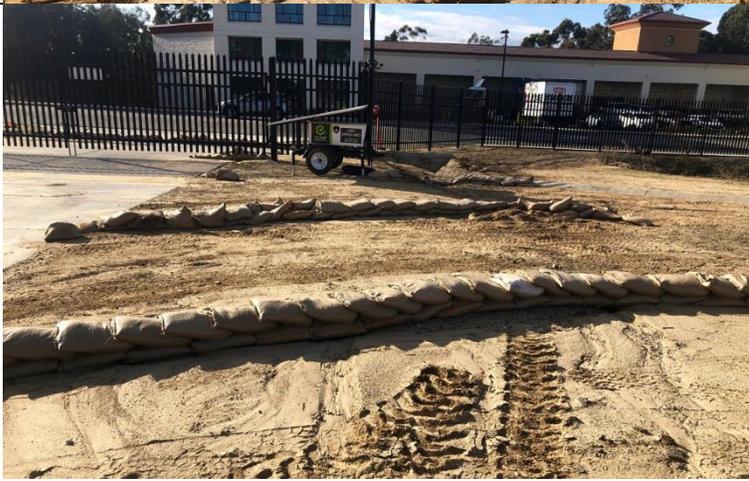
Some BMP upgrades have been added to the area around the drain inlet that leads to the small triangular detention basin (Photo 5). The two drain inlets in this area have now been cleaned out (Photo 6). Large quantities of sediment-laden runoff continue to enter this detention basin, filling in much of the basin (Photo 7). Captured sediment appears to have accumulated to the height of the standpipe, and the standpipe is nearly clogged with debris and vegetation (Photo 8).

Photo 5 – Gravel bag BMPs at the west end of the project site near Markland Avenue. Photo facing west.
1/09/20	Mesa Substation

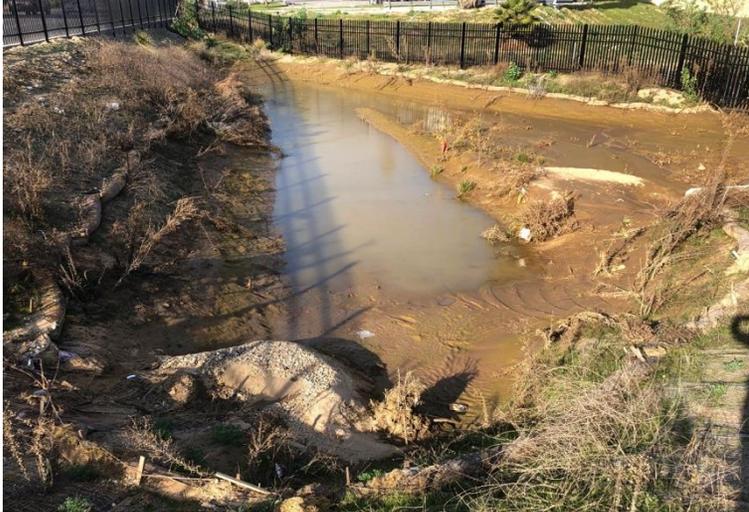
Photo 7 – Water in the small triangular basin has been pumped into the large retention basin. Photo facing north.
1/09/20	Mesa Substation

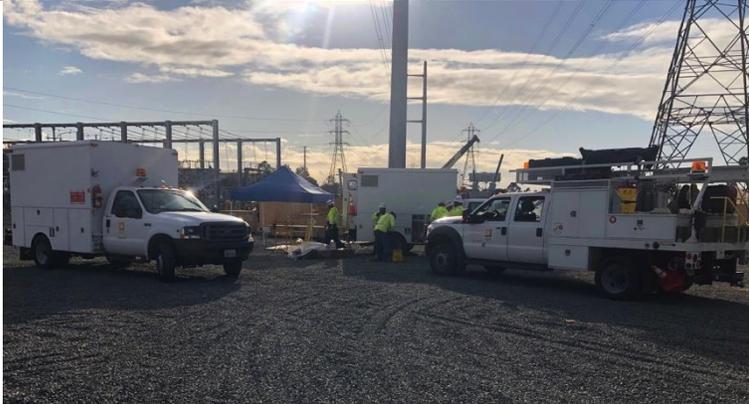
A small SCE crew continues to work within some vaults near the 16-kV and 66-kV rack areas (Photo 9), and also up in the towers along the project roadway (Photo 10).

Photo 9 – Vault work being performed by SCE crews. Photo facing west.

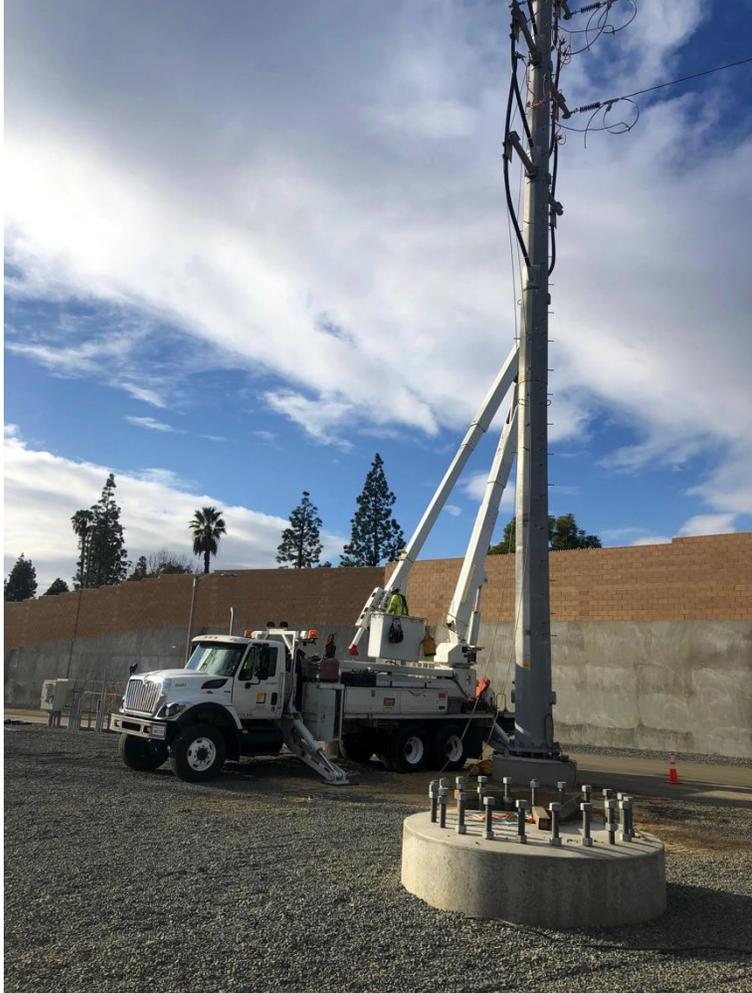
Photo 10 – Ongoing tower work. Photo facing northwest.

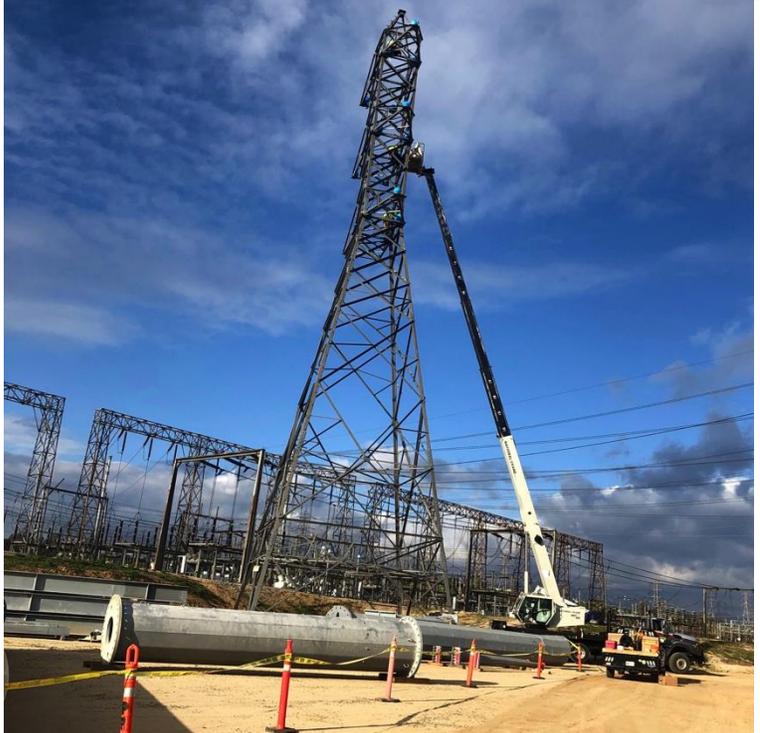
Ben Smith was onsite overseeing the crews working in the towers installing inflatable balls to discourage raptor nesting (Photo 11). Southern California Edison (SCE) has asked the avian biologists to direct this work since they know where raptors would possibly nest.

Photo 11 – Tower work, placing balls in potential raptor nesting locations. Photo facing northeast.
1/09/20	Mesa Substation

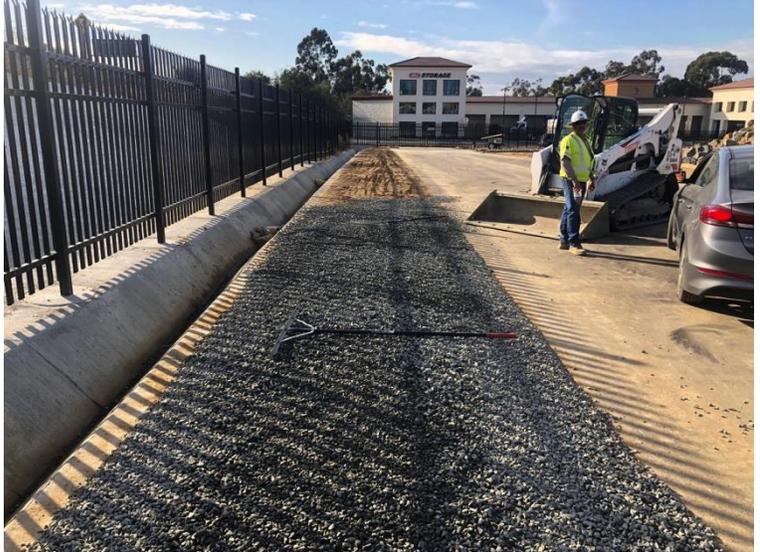
A crew was spreading gravel along the southern boundary fence (Photo 12).

Photo 12 – Gravel installation along the “V” ditch. Photo facing west.

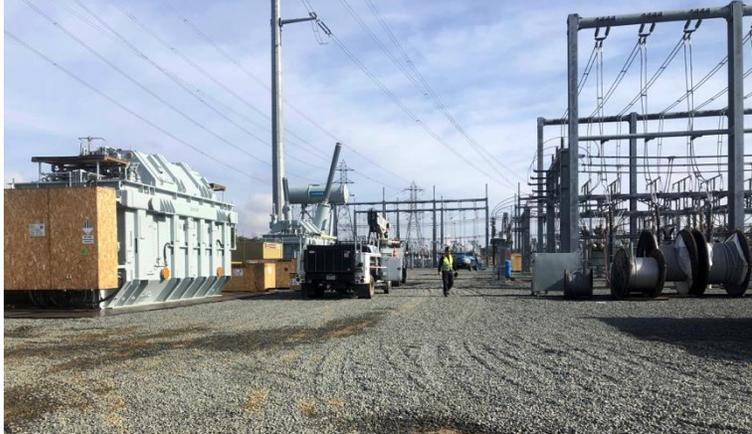
Work on equipment installation was being performed within the various rack areas (Photo 4).

Photo 4 – Work within the rack areas. Photo facing east.
1/17/20	Mesa Substation

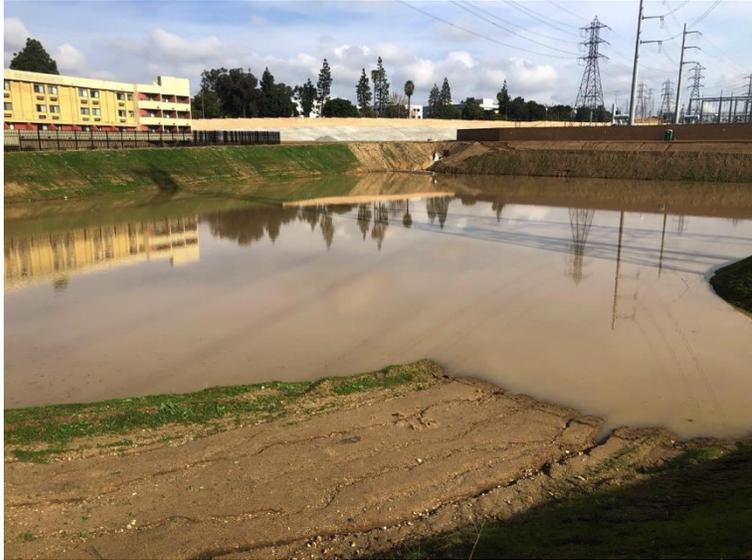
The large retention basin remains about half full of water, so there was not much rainwater runoff from the latest storm (Photo 5). The small triangular basin was empty, with the water having been pumped into the large retention basin (Photo 6). No work has been completed to remove any of the sediment or debris.

Photo 5 – Rainwater runoff in the large detention basin. Photo facing northeast.
1/17/20	Mesa Substation

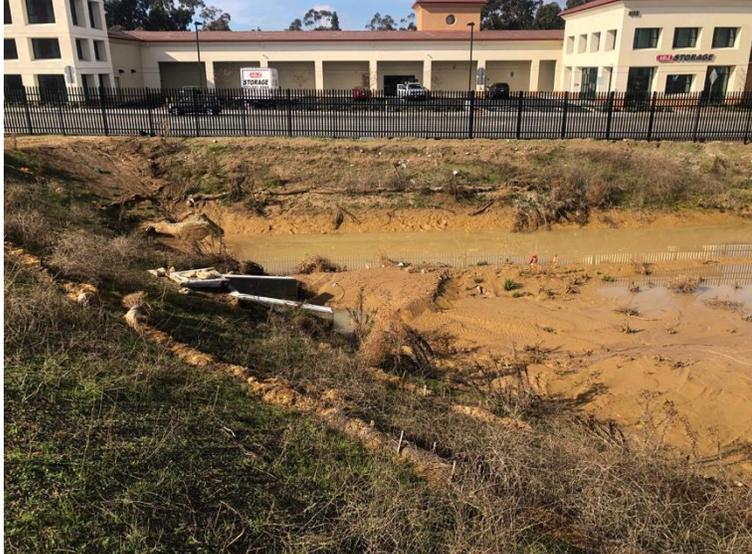
Photo 6 – Water in the small triangular basin has been pumped into the large retention basin. Photo facing west.

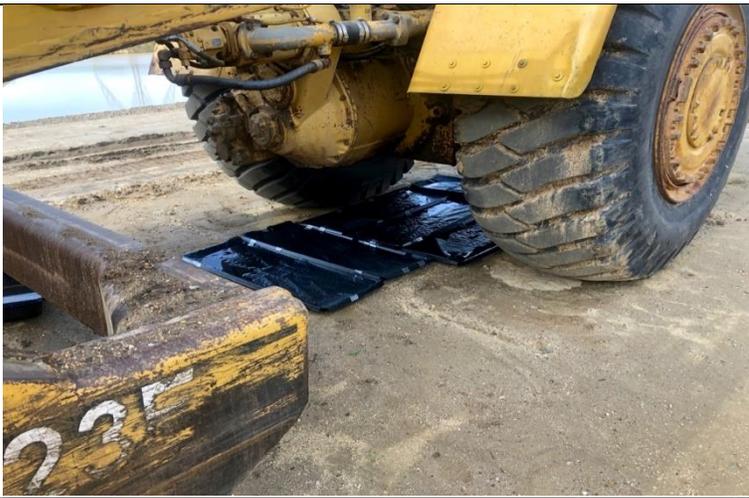
The new secondary containment pans remain in place under a few pieces of equipment, but most of the machinery continue to only have the smaller pans (Photo 7).

Photo 7 – Secondary containment pans.
1/17/20	Mesa Substation

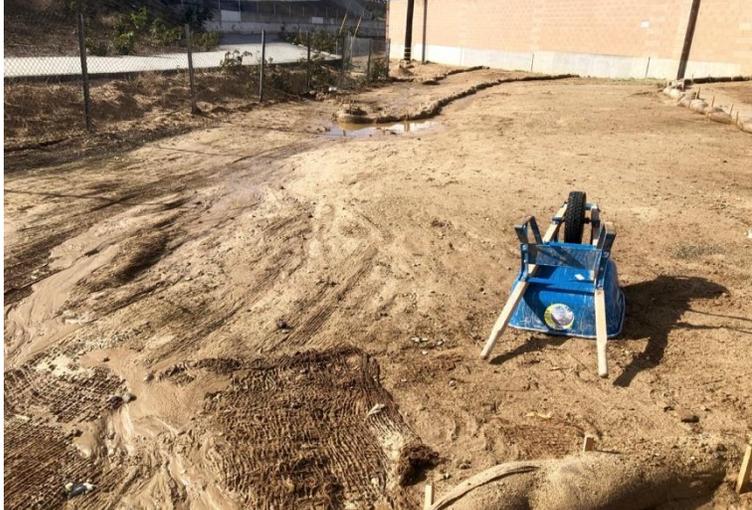
The quarter inch of rain created some muddy conditions, but did not seem to generate much rainwater runoff. The area along the southern portion of the project site that drains down along the outside of the southern boundary wall was extremely muddy (Photos 8 and 9). Sediment-laden runoff coming through this area overwhelms the BMPs and then leaves the site (Photos 10 and 11). Another solution is needed here to keep project sediment onsite.

Photo 10 – BMP area outside of the southern boundary wall. Photo facing west.
1/17/20	Mesa Substation

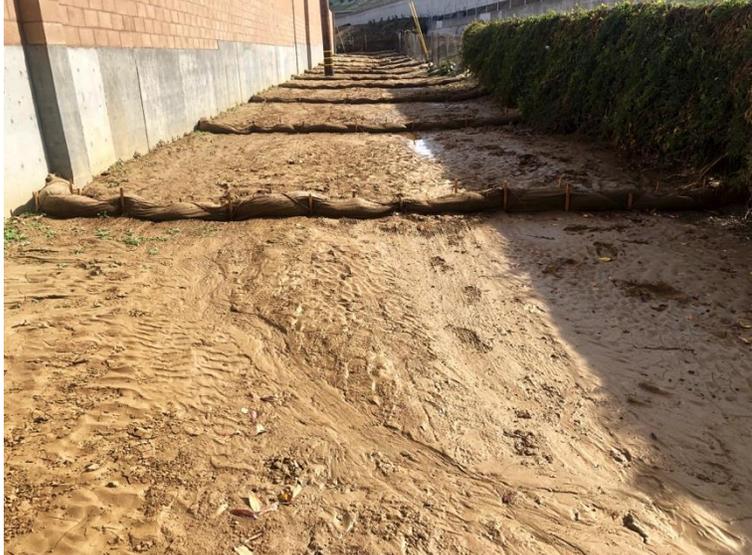
Photo 11 – BMP area outside of the southern boundary wall. Photo facing east.
1/17/20	Mesa Substation

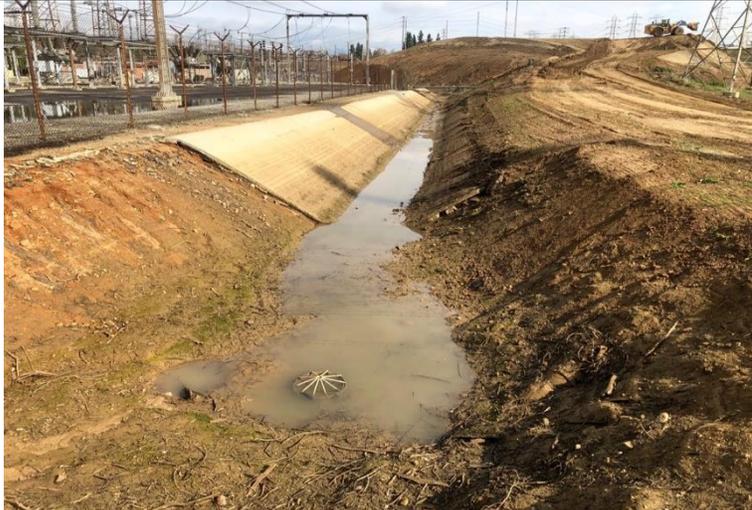
The southern section of the concrete channel that surrounds the old substation has been pumped out (Photo 12).

Photo 12 – Concrete channel draining the old substation has been pumped out. Photo facing east.

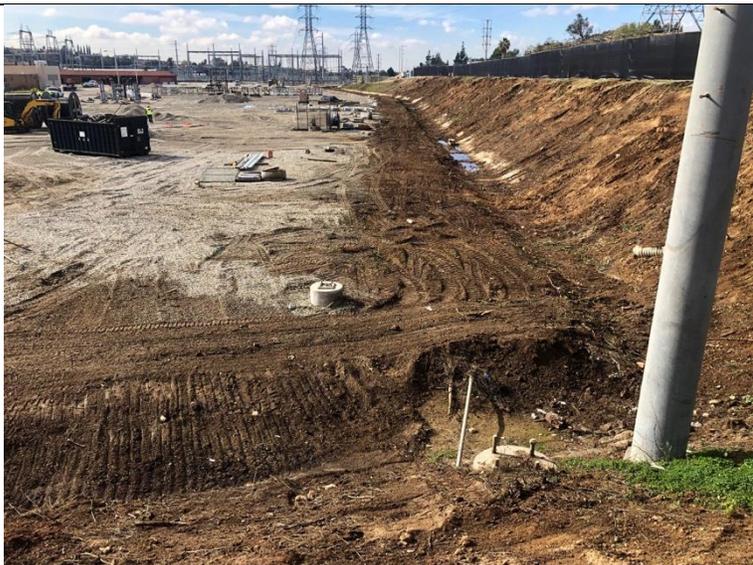
Vegetation has been removed from the areas surrounding the old substation (Photo 13). They have removed some of the fencing around the substation and have also removed some of the equipment from in the old substation.

Photo 13 – Vegetation has been cleared along the north side of the old substation; fences and equipment have been removed. Photo facing west.

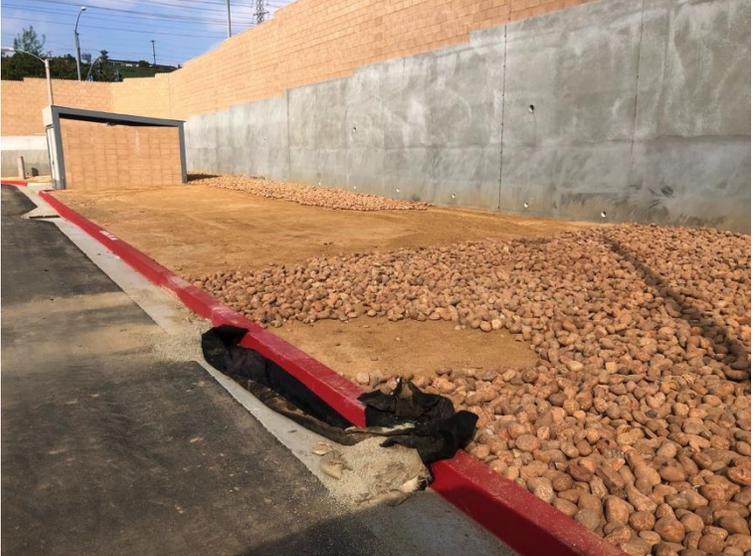
Photo 1 – Landscape work around the Mesa Operations Building. Photo facing northeast.

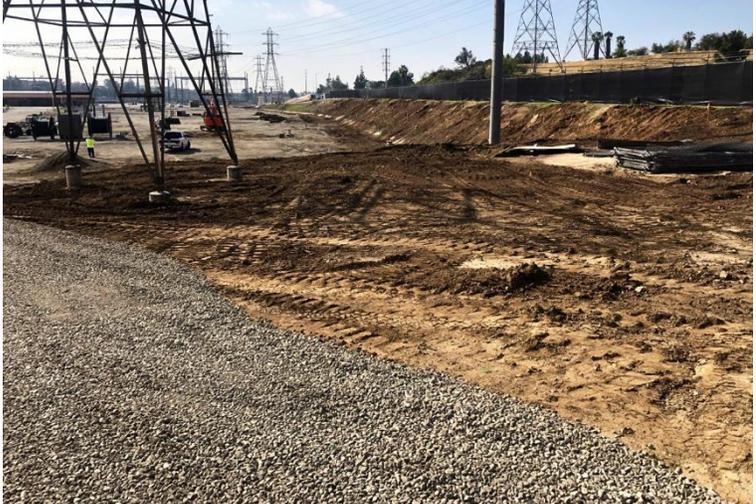
Photo 2 – Looking west from the Mesa Operations building toward the old substation. Photo facing west.
1/22/20	Mesa Substation

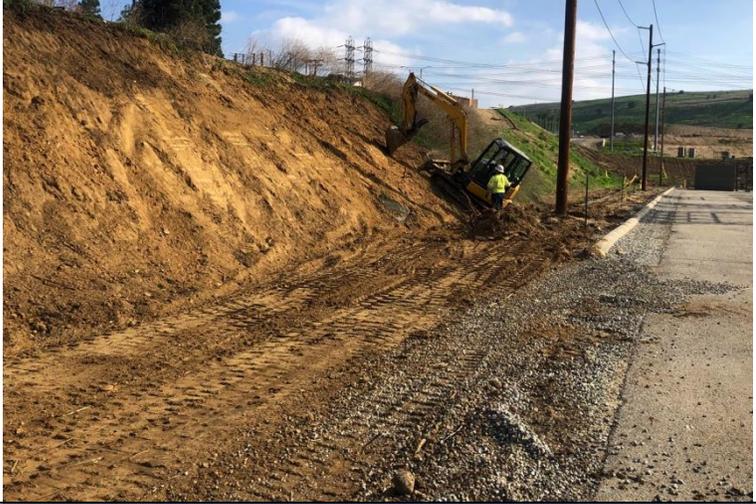
Photo 3 – Vegetation clearing around the old substation in preparation for Phase three grading. Photo facing south.
1/22/20	Mesa Substation

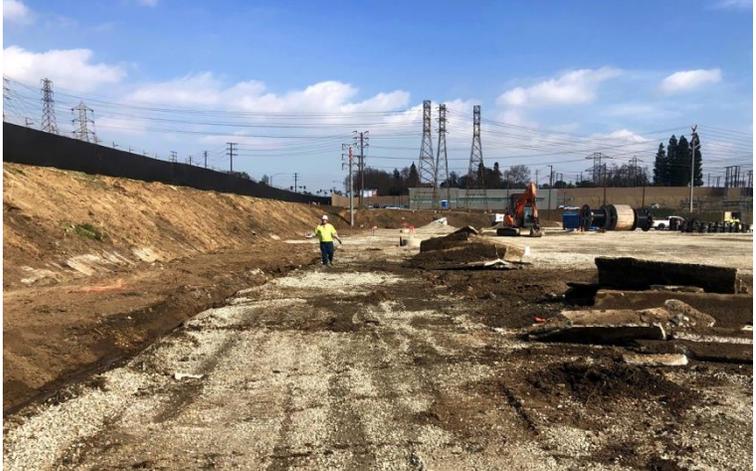
Photo 4 – Concrete removal work within the old substation. Photo facing east.

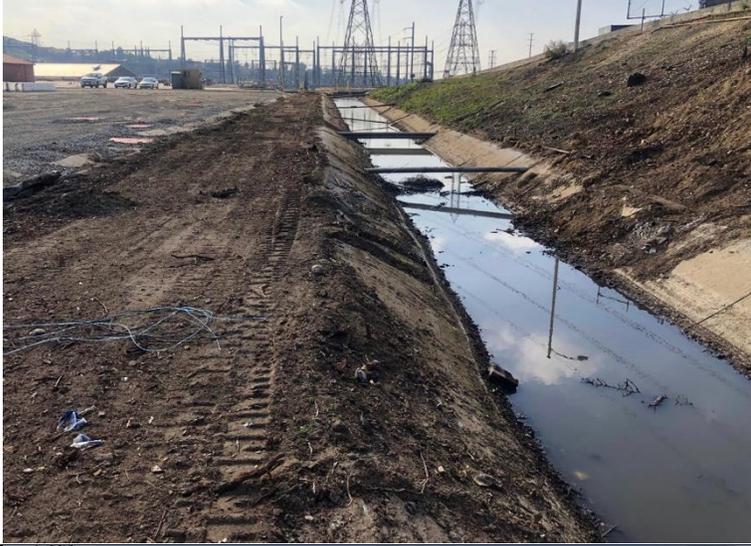
Photo 5 – Vegetation removal completed around the substation drainage channel. Photo facing west.
1/22/20	Mesa Substation

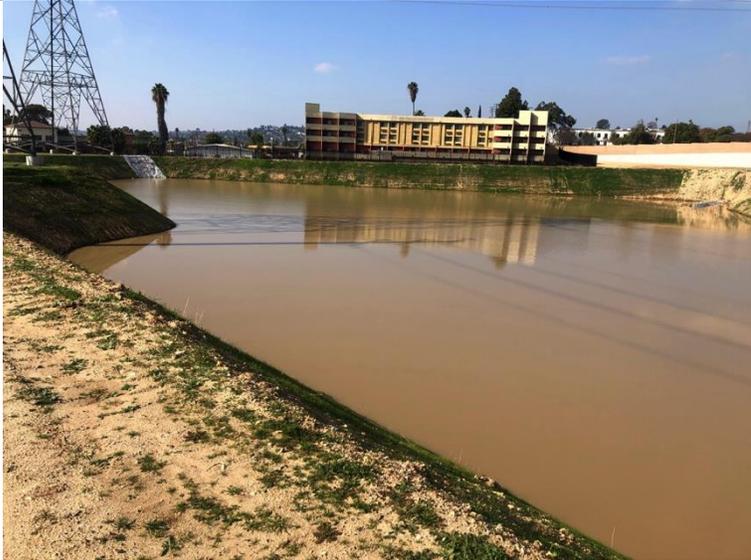
Photo 6 – Water in the large retention basin. Photo facing northwest.
1/22/20	Mesa Substation

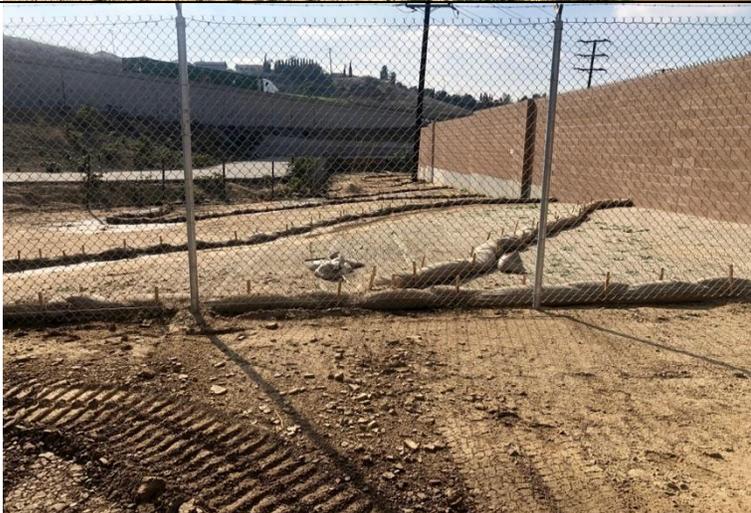
Photo 7 – BMP area outside of the southern boundary wall. Photo facing west.

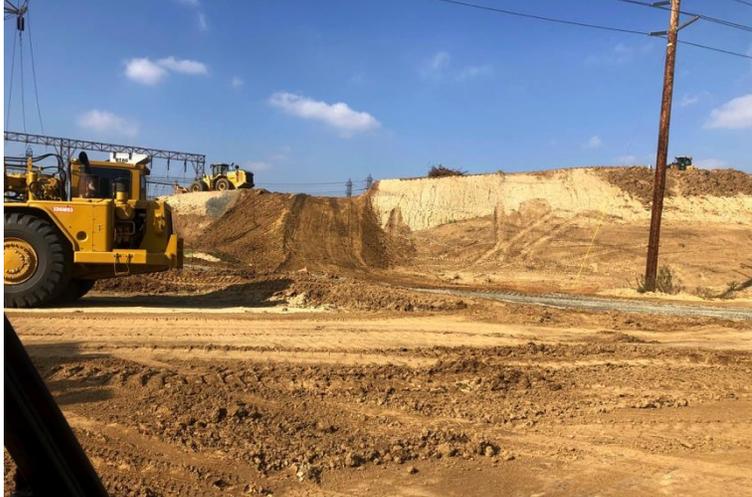
Photo 8 – Grading work beginning on the hill just south of the old substation. Photo facing north.
1/22/20	Mesa Substation

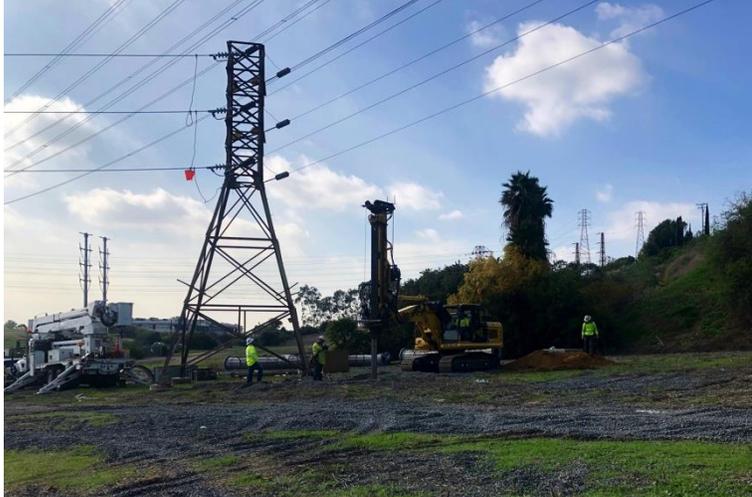
Photo 9 – Drilling work for TSP foundations within the telecommunications corridor north of Potrero Grande Drive. Photo facing west.

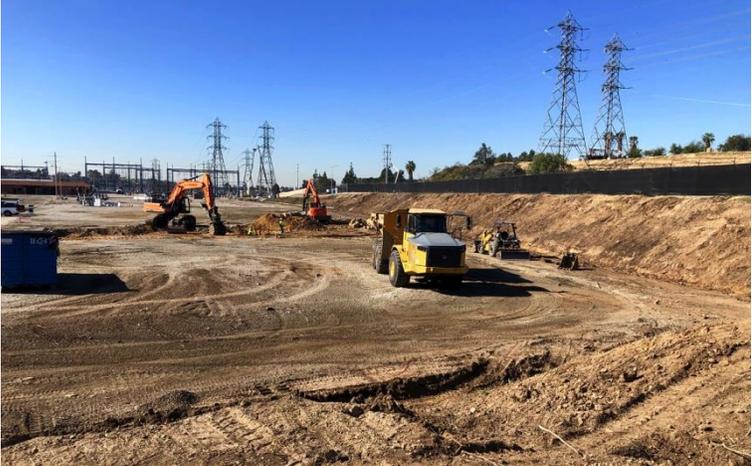
Photo 1 – Phase 3 grading activity in the old substation. Photo facing west.
1/29/20	Mesa Substation

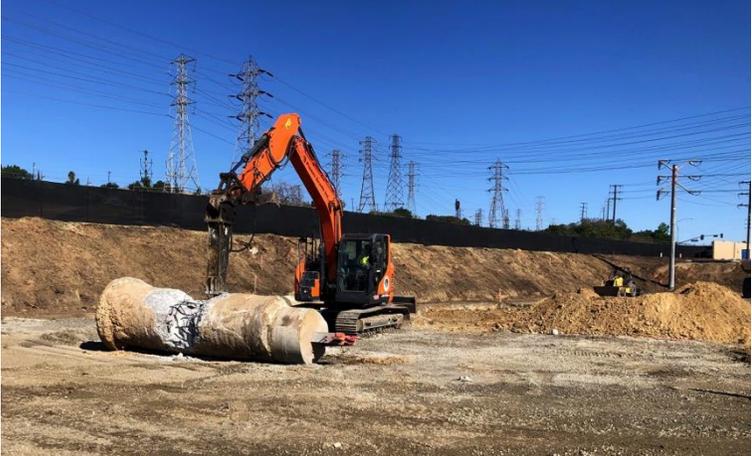
Photo 2 – Foundation removal work within the old substation. Photo facing northeast.
1/29/20	Mesa Substation

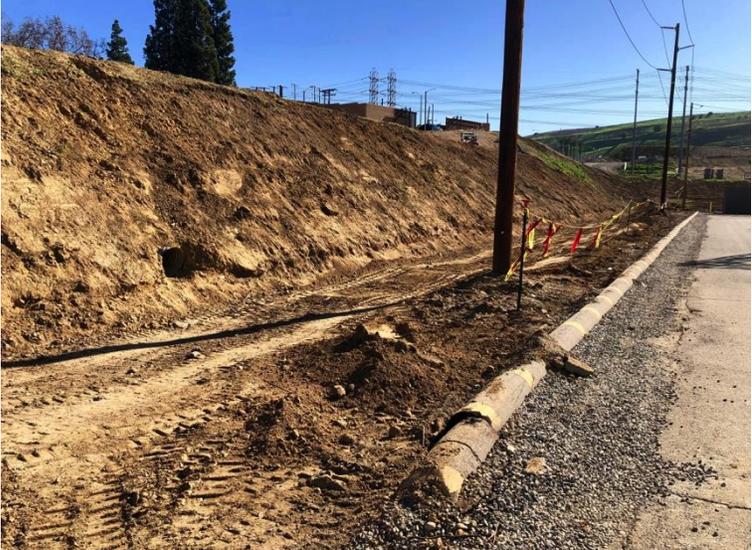
Photo 3 – The vegetation has been cleared and the concrete-lined channel removed along the eastern end of the old substation. Photo facing south.

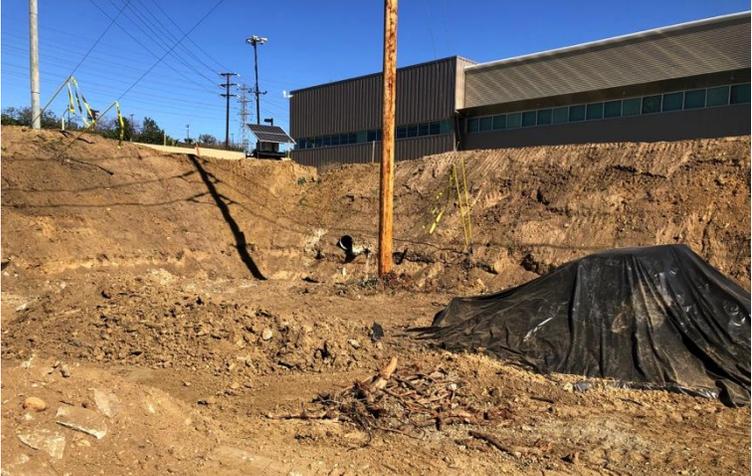
Photo 4 – The vegetation has been cleared and the concrete-lined channel removed below the Mesa Operations Building. Photo facing northeast.
1/29/20	Mesa Substation

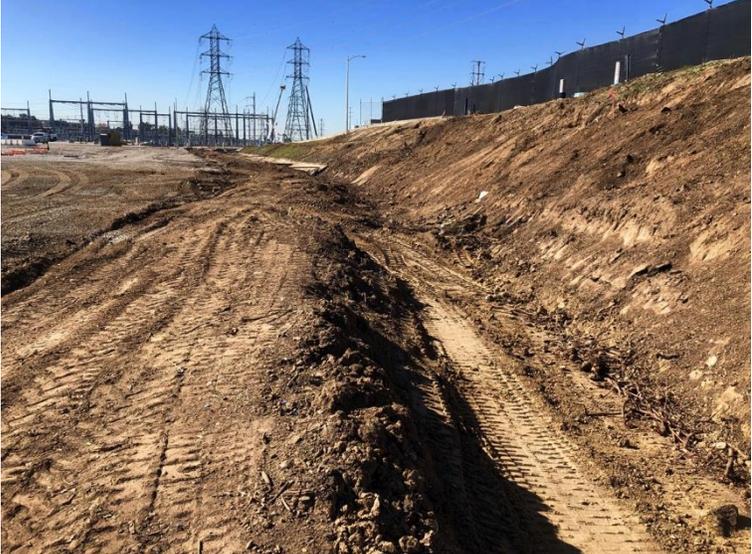
Photo 5 – The vegetation has been cleared and the concrete-lined channel removed along the northern side of the old substation. Photo facing west.
1/29/20	Mesa Substation

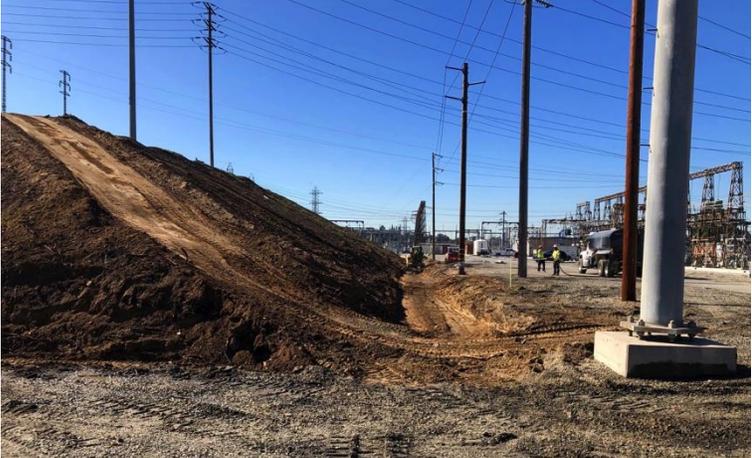
Photo 6 – The vegetation has been cleared and the concrete-lined channel removed along the southern side of the old substation. Photo facing west.

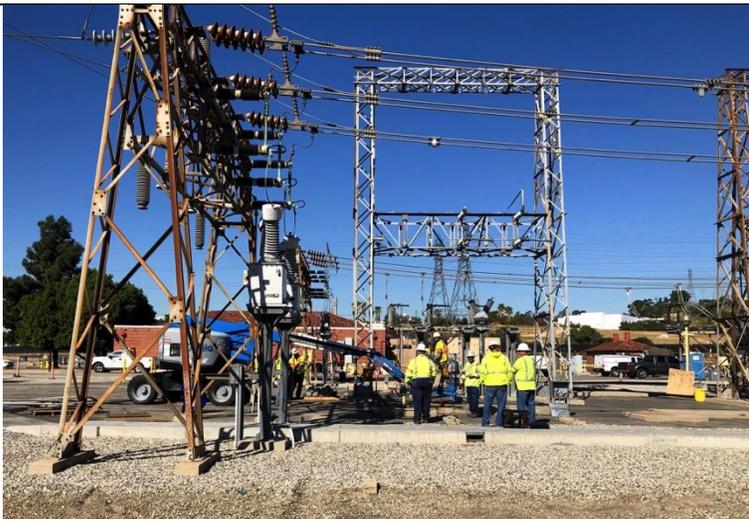
Photo 7 – Equipment removal within the old substation. Photo facing north.
1/29/20	Mesa Substation

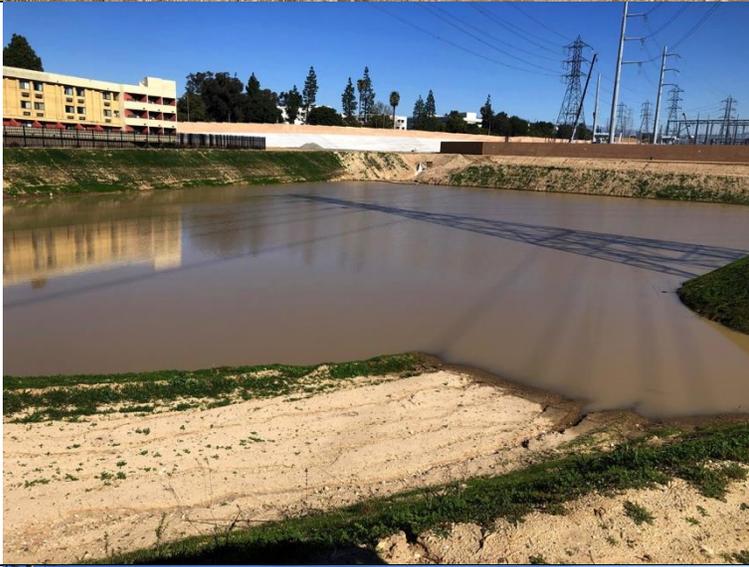
Photo 8 – The detention basin. Photo facing north.
1/29/20	Mesa Substation

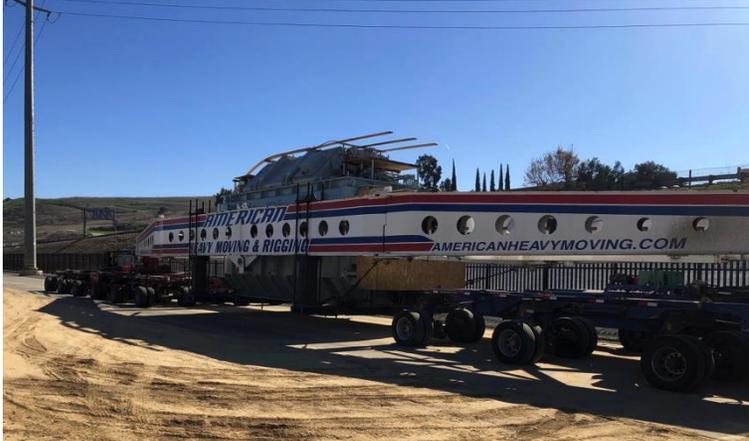
Photo 9 – Equipment being delivered onsite. Photo facing south.

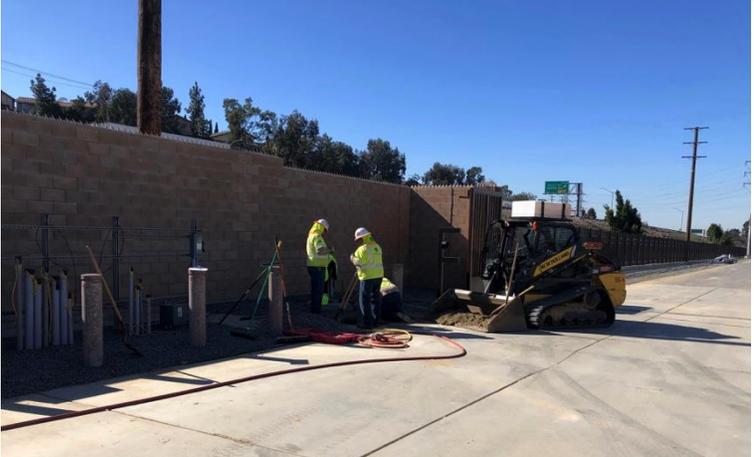
Crews were noted working on equipment along the new access road within the rack areas (Photo 10).

Photo 10 – A crew working on equipment along the new project road. Photo facing west.
1/29/20	Mesa Substation

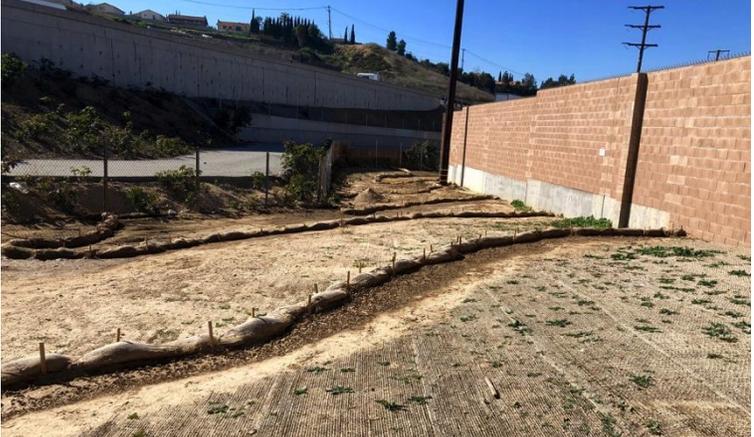
BMPs appeared to be in the same condition along the outside of the southern boundary wall (Photo 11). No upgrades have been made, but some maintenance appears to be ongoing; a pile of sediment was noted near the wattles.

Photo 11 – BMPs along the outside of the southern boundary wall. Photo facing southwest.
1/29/20	Mesa Substation

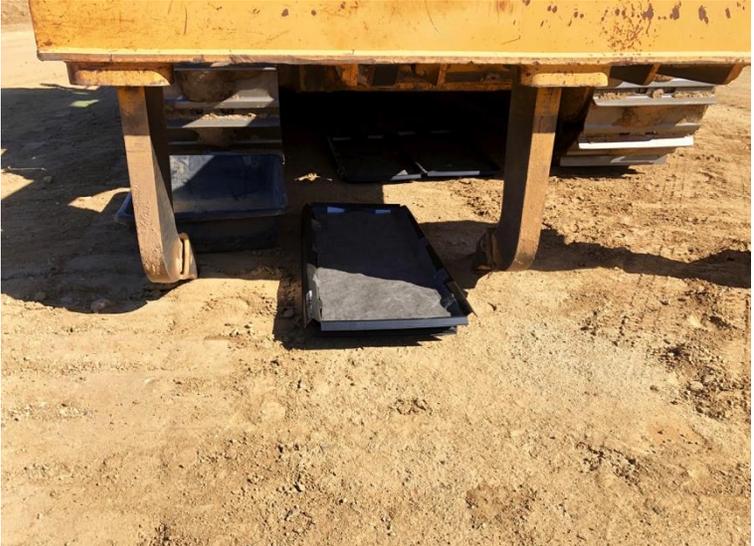
The new secondary containment drip pans now appear to be utilized for most of the parked equipment (Photo 12).

Photo 12 – New drip pans under parked equipment.

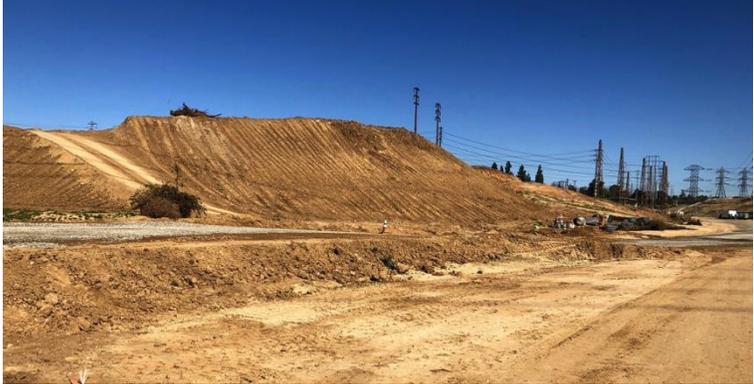
With Phase 3 grading underway, large quantities of open soil are throughout the project site, including the south-facing slope that drains toward the southern boundary wall (Photo 13). Also, extensive stockpiling of soil, rock, concrete, and asphalt is occurring in the southeastern portion of the project; all within the area draining toward the southern boundary wall (Photo 14).

Photo 13 – Cleared slope within the southeastern portion of the project site. Photo facing east.
1/29/20	Mesa Substation

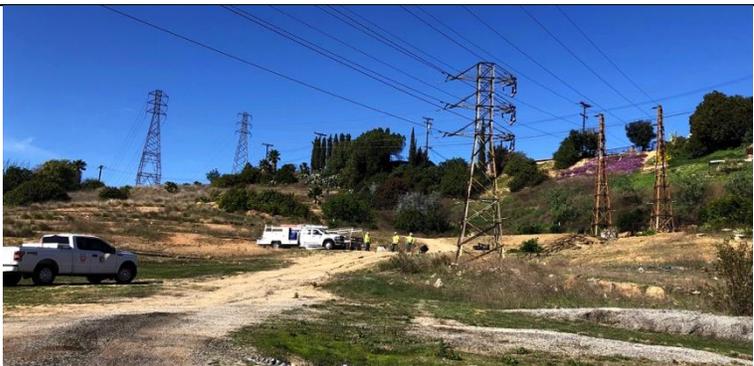
A weed removal crew was working around some of the existing towers within the telecommunications corridor north of Potrero Grande Drive (Photo 15).

Photo 15 – Weed removal crew working north of Potrero Grande Drive. Photo facing north.
