March 3, 2021

**Re: Monthly Report Summary #33 for the Mesa 500-kV Substation Project**

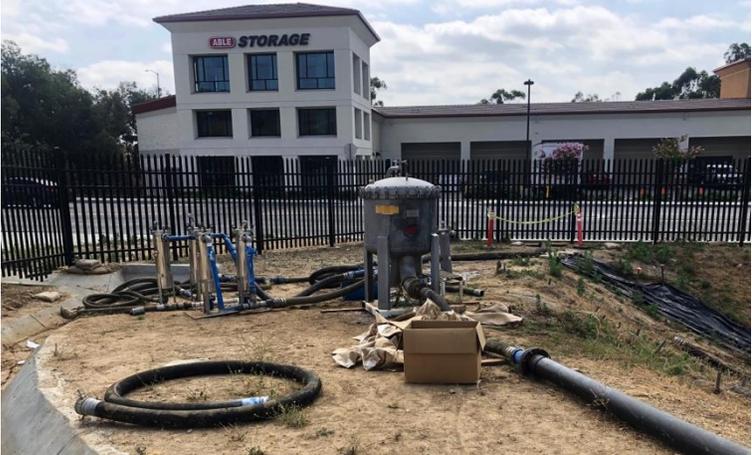
<p>A photograph showing water filtering equipment at the Mesa Substation. In the foreground, there is a large grey cylindrical tank and various pipes and hoses on a dirt area. In the background, a black metal fence separates the site from a white building with 'ABLE STORAGE' signage. The sky is blue with some clouds.</p>	Photo 10 – Water filtering equipment. Photo facing west.
6/17/20	Mesa Substation

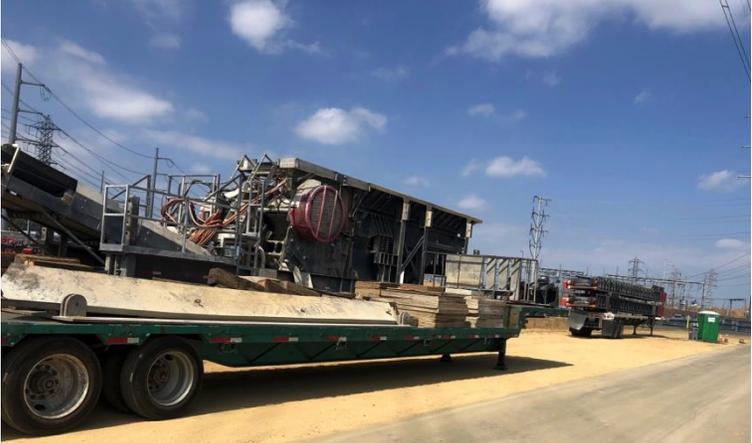
<p>A photograph of a green flatbed trailer loaded with conveyor belt equipment at the Mesa Substation. The equipment includes a large metal structure with a red cylindrical component. The trailer is parked on a dirt area with power lines and towers visible in the background under a blue sky.</p>	Photo 11 – Conveyor belt equipment onsite. Photo facing east.
6/17/20	Mesa Substation

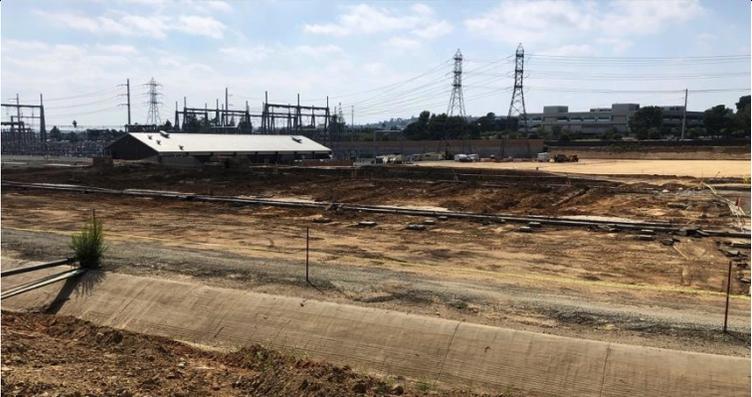
<p>A wide-angle photograph showing the removal of existing foundations and conduit at the Mesa Substation. The ground is mostly dirt and sand, with some concrete slabs and rebar visible. In the background, there are power lines, towers, and a building under a clear blue sky.</p>	Photo 12 - Removal of the existing foundations and conduit. Photo facing north.
