## ecology and environment, inc.

### **Re: Monthly Report Summary #3 for the Mesa 500-kV Substation Project**

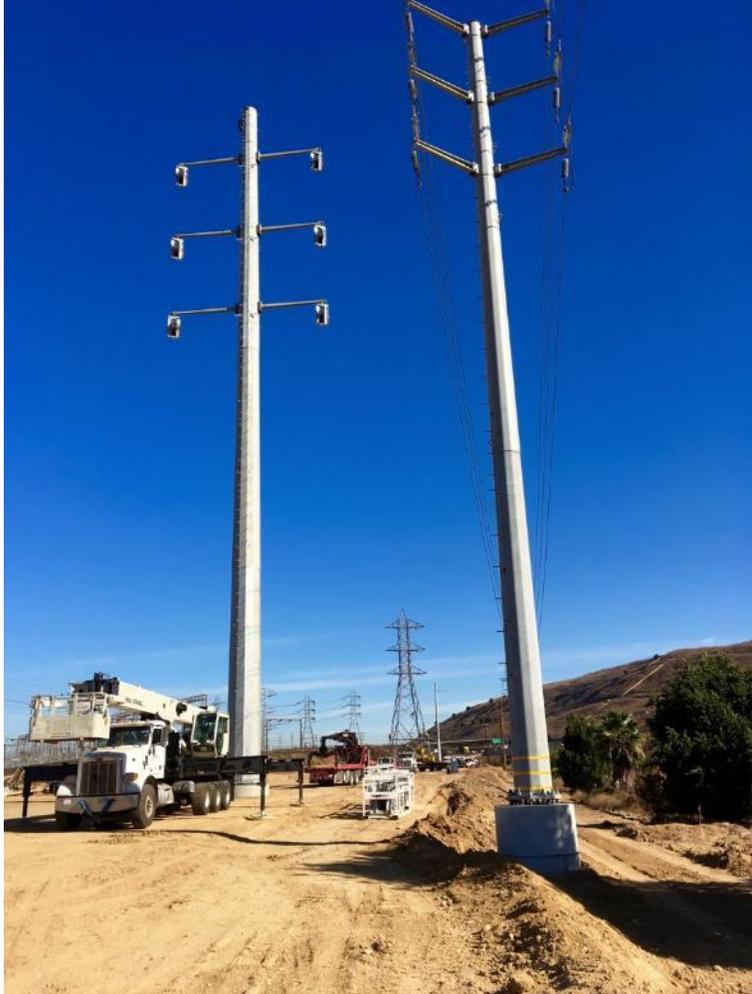
Towers were being constructed along the southern border of the Mesa Substation site (Photos 9 and 11).

A photograph showing two tall, silver tubular steel poles (TSPs) under construction at a substation site. The poles are positioned on a dirt area. In the background, a white truck with a crane attachment is visible, along with other utility structures and a clear blue sky.	Photo 9 – Work continues on the new tubular steel poles (TSPs). Photo facing east.
12/15/17	Mesa Substation
