Re: Monthly Report Summary #1 for the Santa Barbara County Reliability Project

CPUC Site Inspection Report
October 5, 13, 19, and 26, 2017

Santa Barbara County Reliability Project CPUC Site Inspection Form

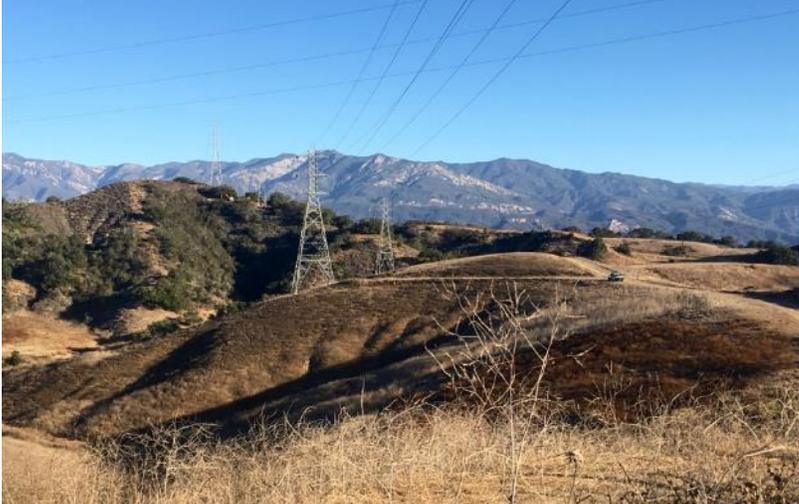
<p>Photo 2 – Access roads at the “Y.” Photo facing north.</p>
10/5/17	Construct 56 on Segment 3B

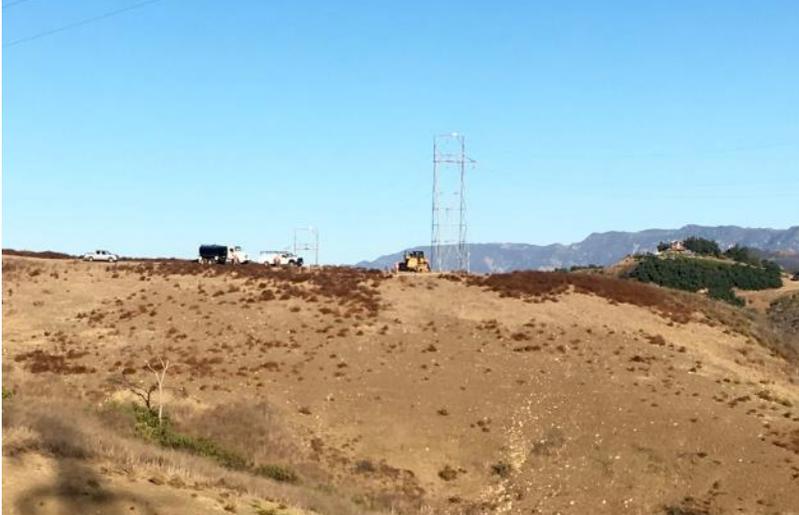
<p>Photo 3 – Equipment used during the noise evaluation at Construct 56. Photo facing west.</p>

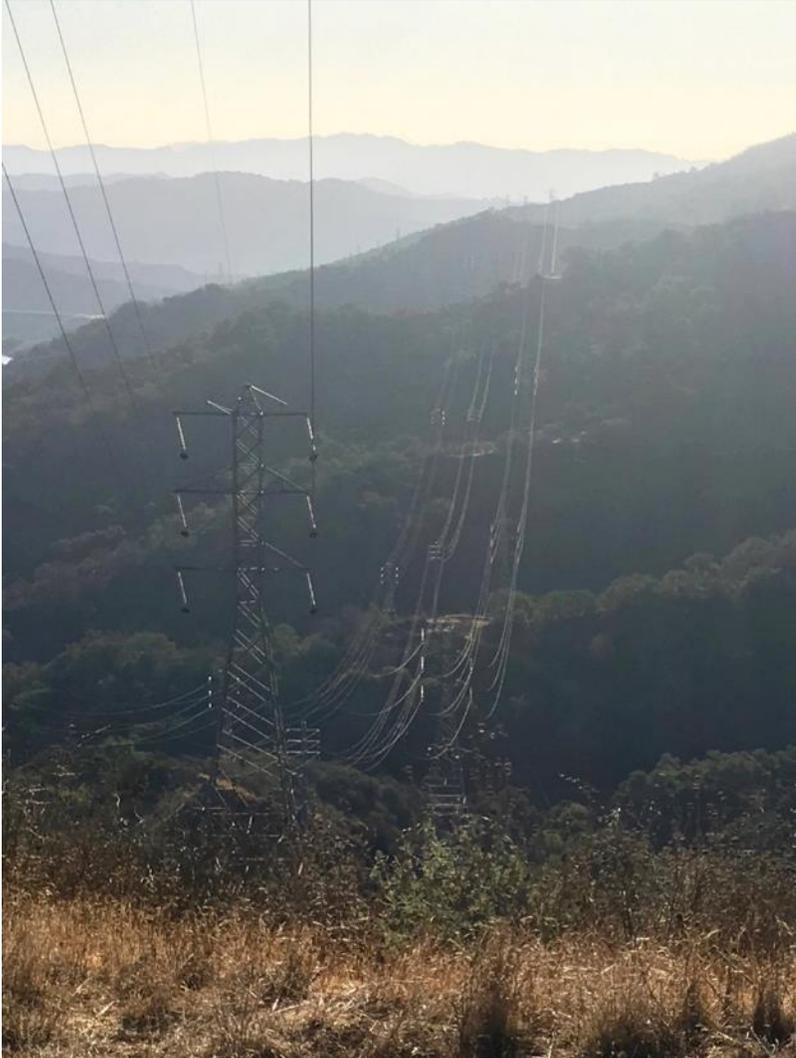
Photo 4 – Segment 2. Photo facing east
10/5/17	Construct 57

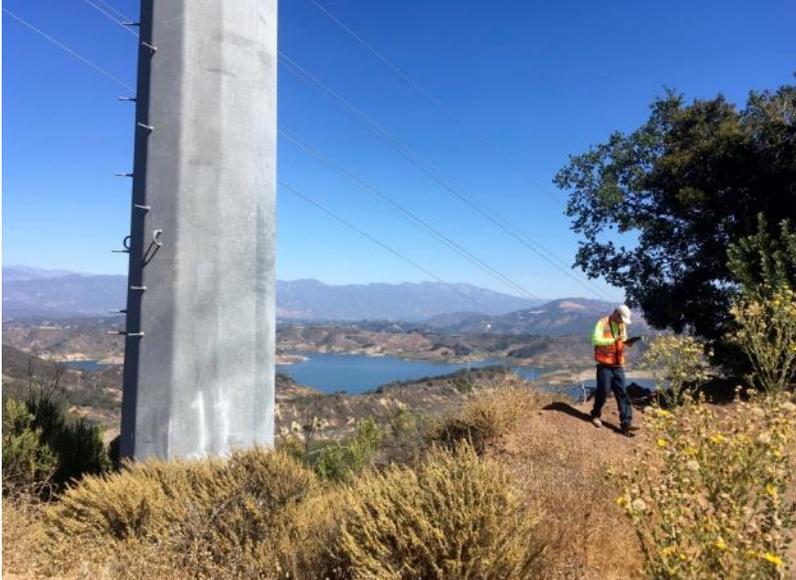
<p>Photo 7 – James Rasico (Rincon) checking the environmental constraints around one of the newer TSPs along Segment 2. Photo facing east, with Lake Casitas in the background.</p>

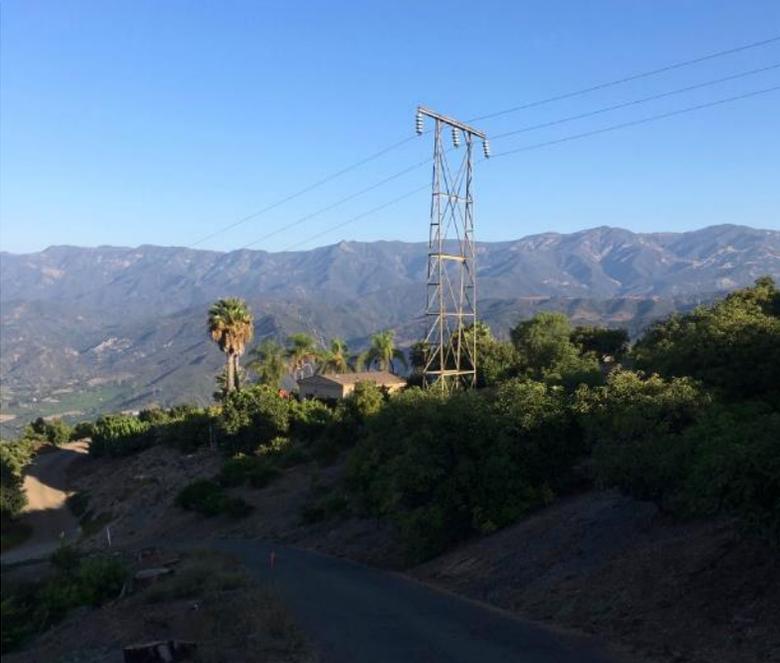
We stopped at Construct 69 where James Rasico (Rincon) "cleared" the area prior to BMP installation (Photo 2).

Photo 2 – Overview of Construct 69 within an avocado orchard. Photo facing north.

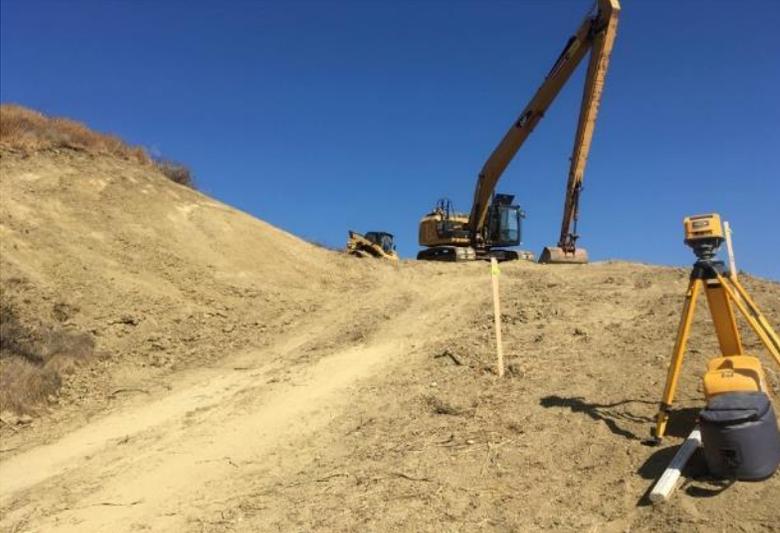
We drove past Construct 62 where excavation had begun for the welded wire wall (Photo 5).

Photo 5 – Excavation work at the pole site.
10/13/17	Segment 3B Construct 58

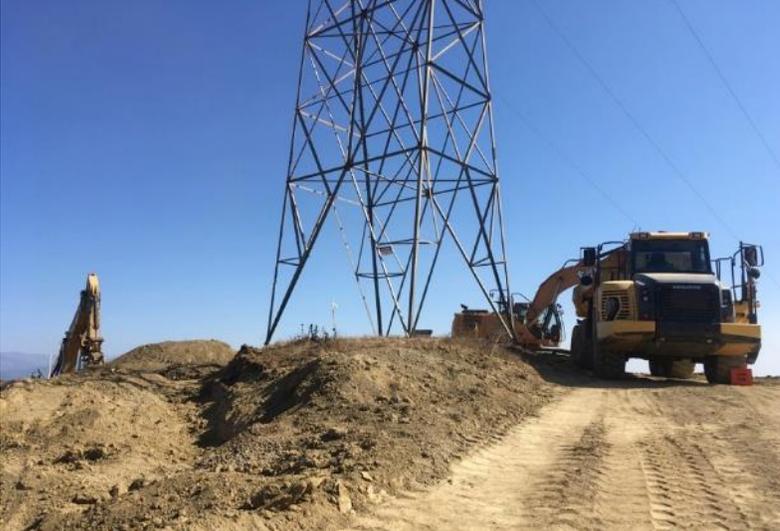
Photo 7 – Excavators working on digging down to “competent” soil. Photo facing east.

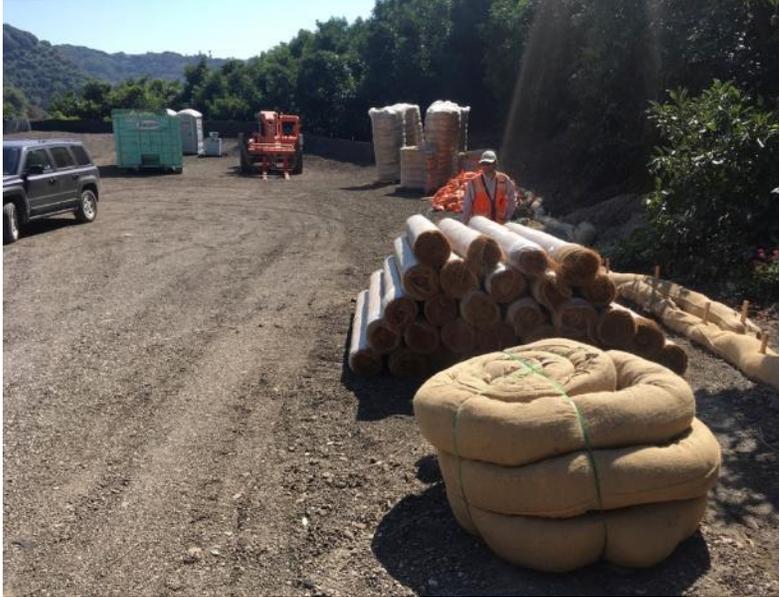
Photo 9 – Stockpiled BMP materials.

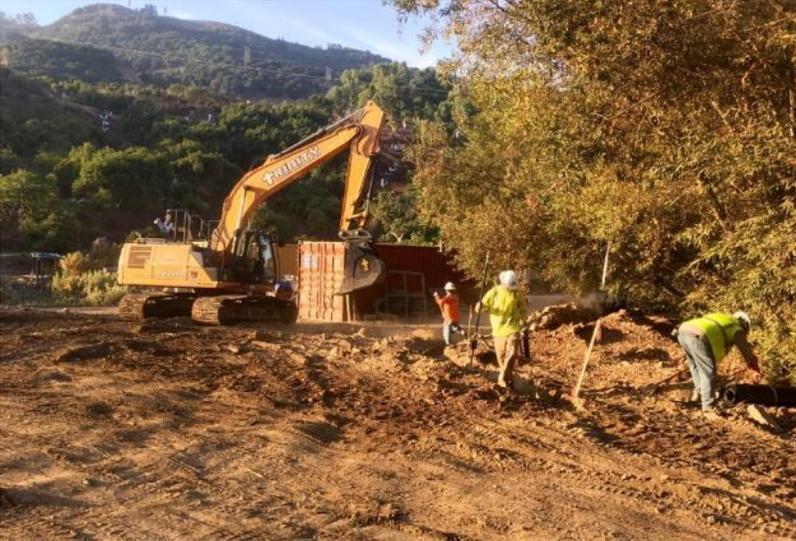
Our first stop was a new construction yard (Highway 150 Yard C) located immediately upstream from the Highway 150 Yard A. A Henkels & McCoy (H&M) crew was prepping the site using an excavator to clear rock and debris around the perimeter of the yard where the silt fencing will be installed (Photo 1). The exclusion fencing was being placed at the edge of the riparian vegetation dripline (APM BIO-1, APM BIO-2, APM BIO-3, MM BIO-1). A water truck was onsite for dust control (APM AQ-1).

Photo 1 – An additional area near the Highway 150 Yard A is being prepared as a storage yard. Photo facing southwest
10/19/17	Segment 3B Construct 58

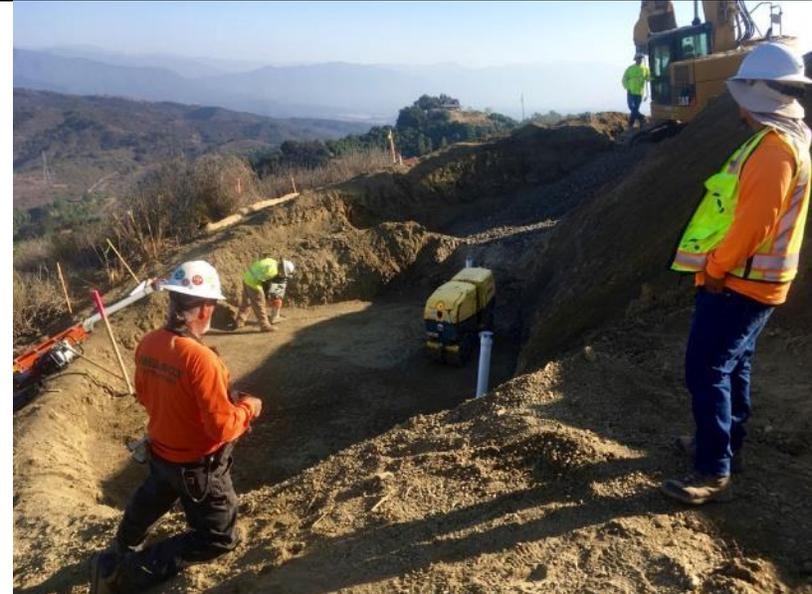
<p>A photograph showing a construction site on a hillside. In the foreground, a worker in an orange shirt and white hard hat stands with his back to the camera. To his right, another worker in a yellow safety vest and white hard hat stands facing him. In the background, a yellow excavator is visible, and a small yellow roller is compacting the ground. The terrain is a mix of dirt and sparse vegetation, with hills in the distance under a clear sky.</p>	Photo 3 – Construction crew is backfilling and compacting the area where the wire wall is being built. Photo facing east.
10/19/17	Segment 3B Construct 58

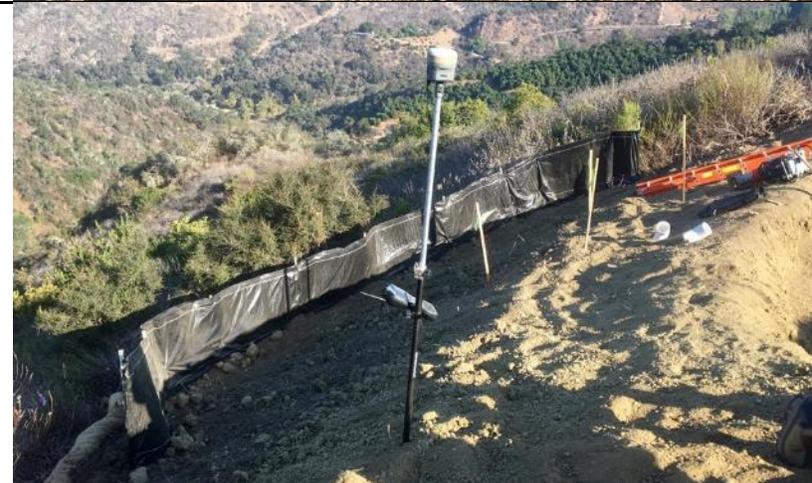
Construction activities included installing drain pipes, soil compaction (Photo 3), and installation of wire-backed silt fencing below the steep portion of the pad construction (Photo 4). Paulette Loubet (Rincon) was the onsite biological monitor. Numerous pieces of equipment were onsite, including two excavators, a bulldozer, a backhoe, a dump truck, and a water truck.

<p>A photograph of a steep, eroded hillside. A black wire-backed silt fence is stretched across the slope, supported by wooden stakes. A tall, silver light pole stands in the foreground. The background shows a valley with green trees and hills under a clear sky.</p>	Photo 4 – Wire-backed silt fence has been installed below the steep portion of the earth work. Photo facing north.

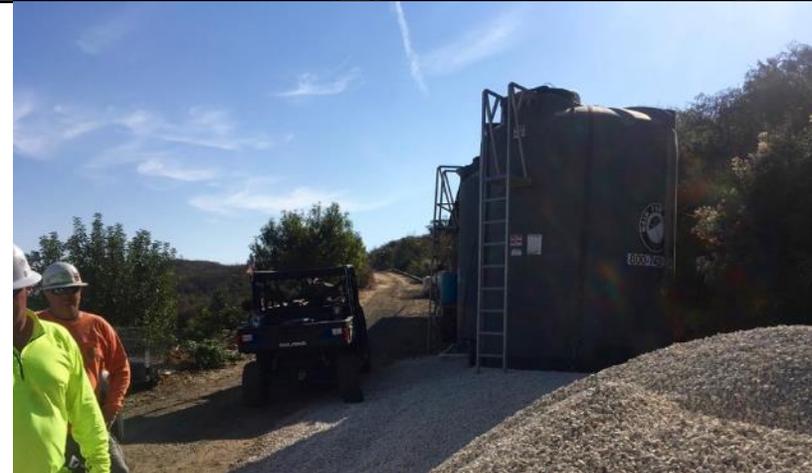
We drove to the H&M water tank/water pump area; everything had been installed and connected, so water could be delivered to the construction areas (Photo 5). The water pump was sitting in a plastic secondary containment structure, but was filling with water from a leaking hose (Photo 6). James Rasico (Rincon) pointed this out to the H&M crew and they stopped the leak. The crew was burying the water line where it crossed the road (Photo 7). While we were there, biological monitor Sarah Termondt (BRC) arrived to check in with the H&M crew.

<p>A photograph showing two large, dark-colored water tanks installed on a gravel access road. A black utility vehicle is parked nearby. Two workers in safety gear are visible in the foreground. The background features a clear blue sky and some trees.</p>	Photo 5 – Water tanks have been installed along the access road. Photo facing east.

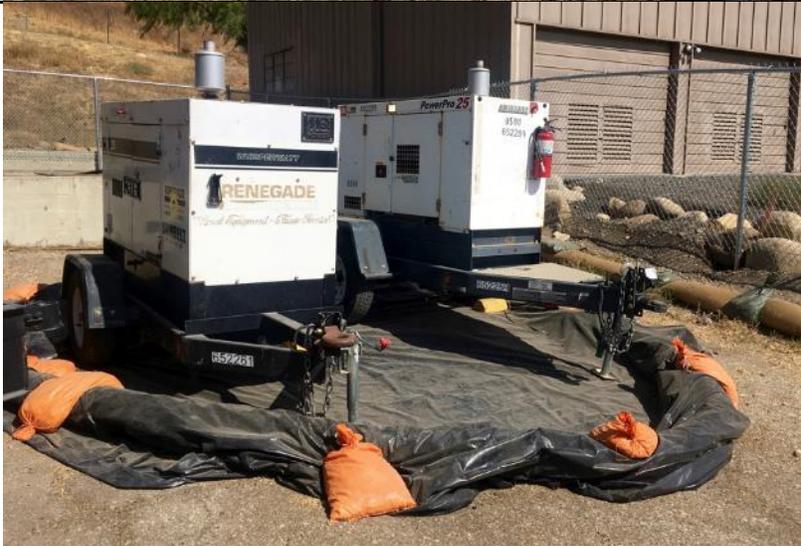
Our last stop was the Teen Challenge Yard, where fencing had been installed (MM BIO-1), trailers had been set up, and generators were connected with secondary containment underneath (Photos 8 & 9).

Photo 8 – Generators at the Teen Challenge Yard

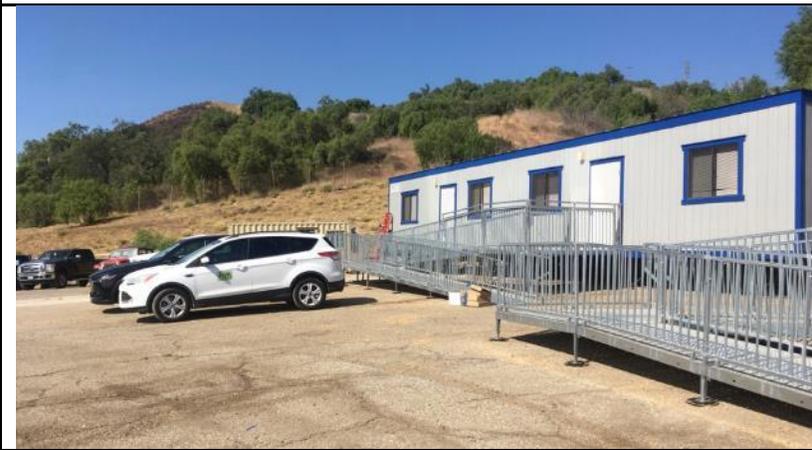
Photo 9 – Trailers at the Teen Challenge Yard. Photo facing north.

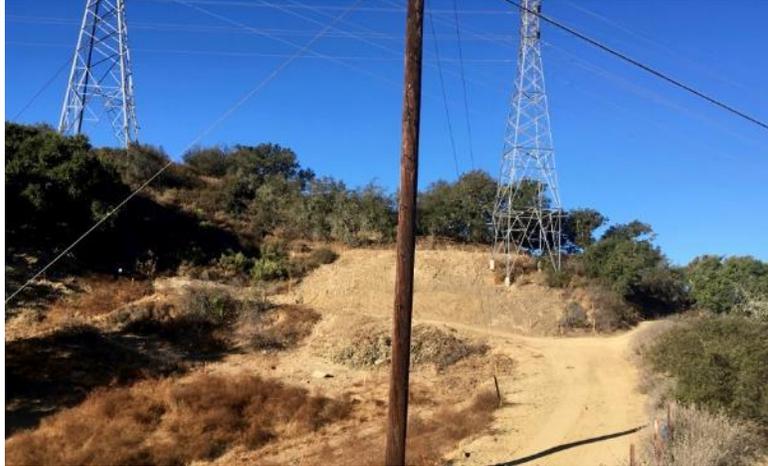
Our first stop was near the intersection of Segments 2 and 3B (the "Y") where crews had been working on a large pad; however, no crew members were onsite when we passed through (Photo 1).

<p>Photo 1 – Pad work near Construct 80. This will be a large pad because it is at the intersection of Segments 2 and 3B. Photo facing northwest.</p>
10/26/17	Segment 3B, Construct 61

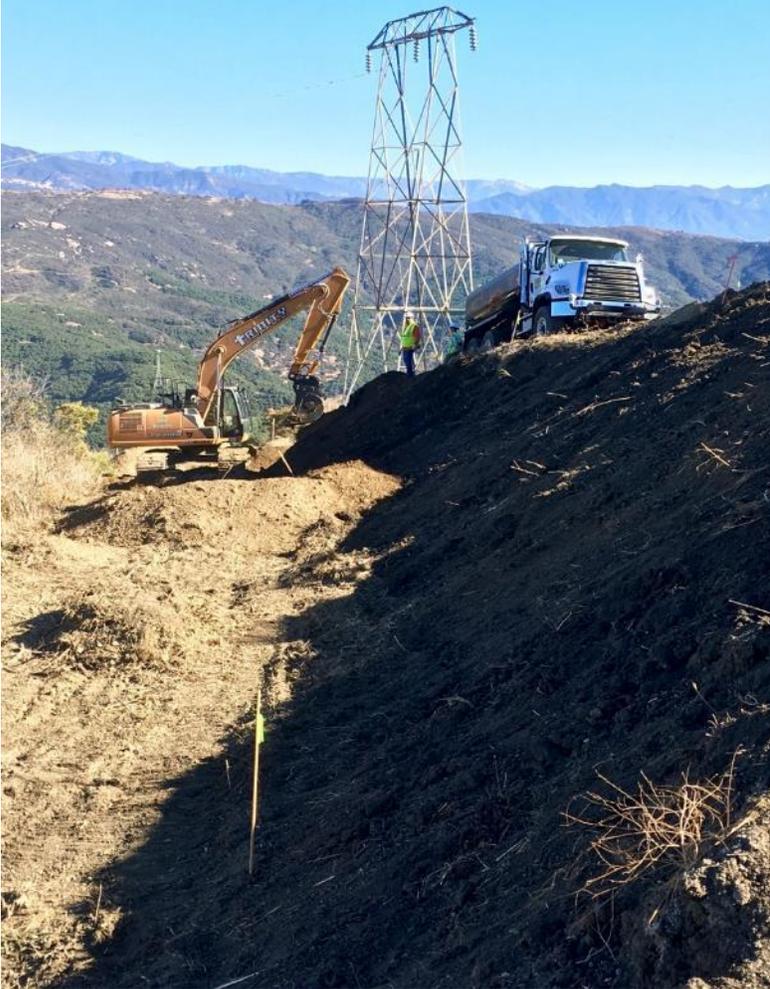
At Construct 58, a crew was completing the final grading of the access road and the construction pad (Photos 5 & 6).

Photo 5 – Finish work being conducted on the access road. Photo facing northeast.

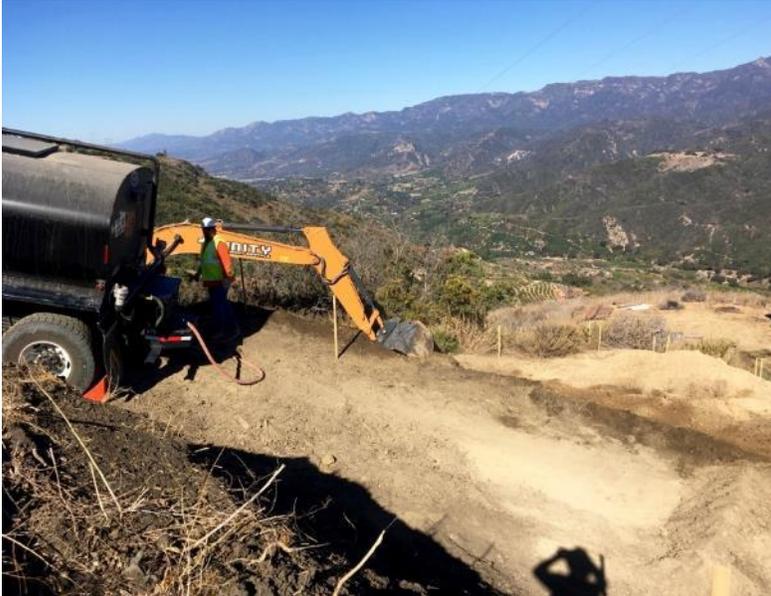
Photo 6 – Finish work being conducted on the construction pad. Photo facing west.
10/26/17	Segment 1

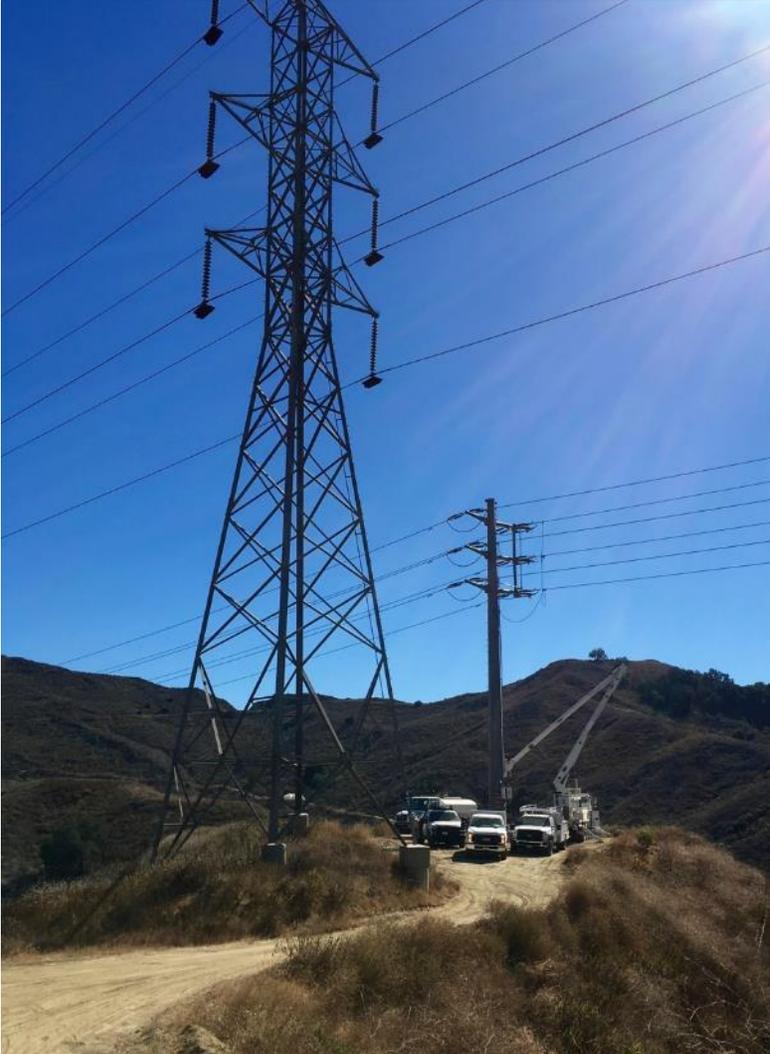
We drove to the southern end of Segment 1 and entered the access road at the Santa Clara Substation. We drove the entire Segment (Photo 7) and checked on Environmentally Sensitive Area (ESA) signs, a number which had been knocked down (APM BIO-1). We found biological monitor Asher Deitch (BRC) near the Getty Tap area where crews were conducting overhead welding on the existing poles in preparation for wire stringing (Photo 8). Fire trucks were with this crew (MM HZ-2).

Photo 8 – Crews working on the towers at the Getty Tap. Photo facing south.
