# El Casco System Project

## Mitigation Monitoring, Compliance and Reporting Program

# FINAL REPORT

*Prepared for*  
**California Public  
Utilities Commission**

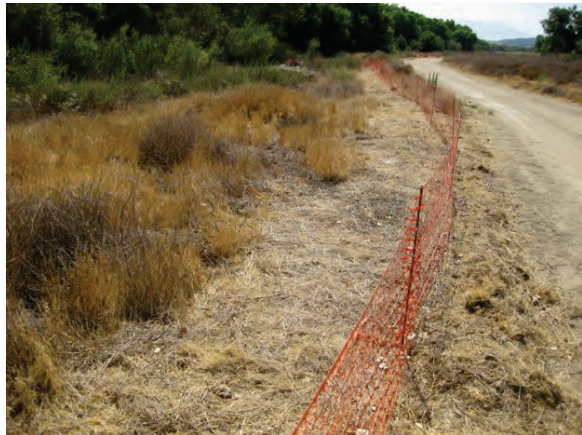
Figure 2 — Exclusion fencing placed around smooth tarplant populations adjacent to planned culvert installation on the El Casco Substation access Route. The photograph faces east toward the substation site.

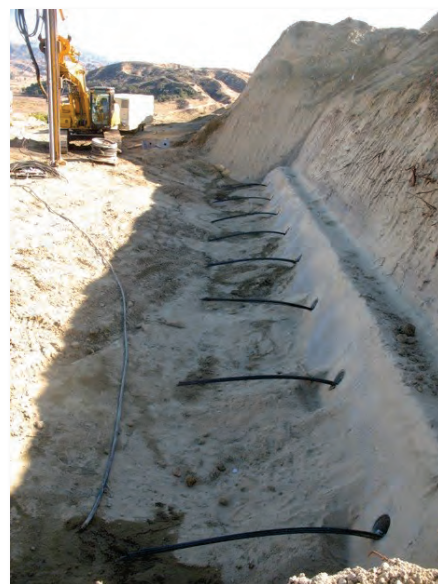
During the first week of October 2009, terracing of the hillside behind the substation site began. Fourteen terraces were constructed in stair step fashion on two prominent ridges of the hillside. Ten terraces were placed on one ridge, and four on the other. The construction of the terraces proceeded as follows. The face of each terrace was fitted with a tie-back wall structure that provided an anchor for an approximately 120-foot-long cable placed in an oblique bore dug into the hill. Each bore contained a concrete caisson at the bottom for the lower cable anchor. The cable was tightened to create tension between the upper wall and the lower caisson. The terracing was required because the substation placement involved cutting into the toe of the slopes. The sedimentary layers of the slopes were considered to be potentially unstable without tie-back terracing.

Figure 4 — A tie-back wailer under construction on the face of one of the terraces. After completion of the wailer, the 120-foot cable anchors were placed under tension.

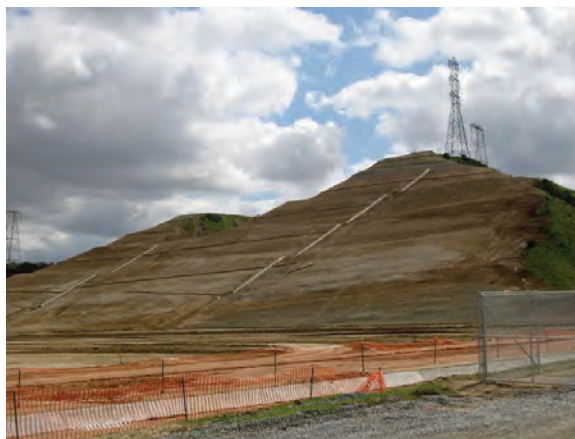
Figure 6 — View of the completed terraced slope at El Casco Substation. Note the newly installed V-ditches. The photograph faces southeast.

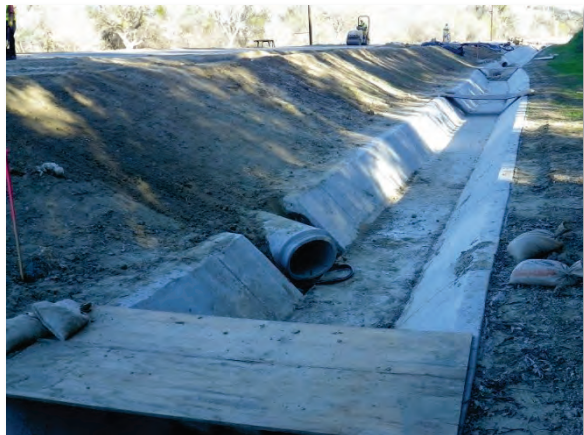
Figure 11 — View of installed wildlife culverts under the main El Casco Substation access road. The photograph faces east.

Southern Pacific rattlesnakes. These V-ditches were checked on a daily basis. Trapped animals were relocated. The design of the permanent V-ditches was altered to prevent entrapment. In addition, wildlife culverts under the El Casco Substation access road were added. Nesting attempts by some bird species, especially house finch, in construction structures was discouraged. Partially completed and non-active nests were removed.

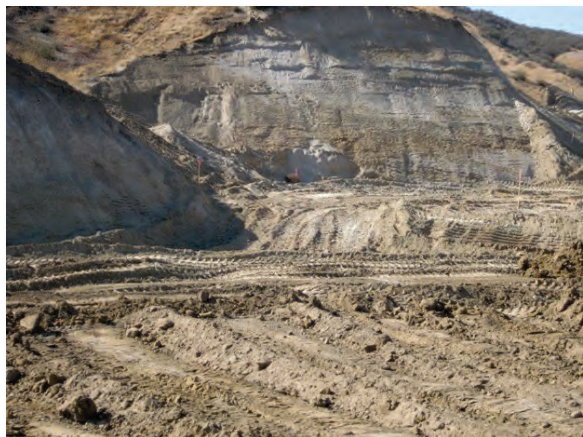
Major paleontological discoveries were made during excavation between November 2010 and April 2011. A wide variety of plant, mammal, bird and invertebrate material was recovered and processed by SCE Paleontologists. The fossils were found during excavation in the eastern over-excavation pit, within excavation at the toe of the eastern ridge, and in some of the hillside terraces. The fossils were in the San Timoteo Formation and thought to be between 0.9 and 6.1 million years old. This formation is known to be rich in significant fossil resources from the medial Pleistocene and Pliocene epochs. A field laboratory was set up on site to process the discoveries and dirt samples from the sites as required by Paleontology Treatment Plan protocol. Paleontological Monitors were present during all ground disturbances. The contractor cooperated by shifting excavation activity to other areas while Paleontologists recovered material.

Figure 12 — Most fossils were found in the easternmost over-excavation pit at the toe of the eastern ridge terrace. The photograph faces south.

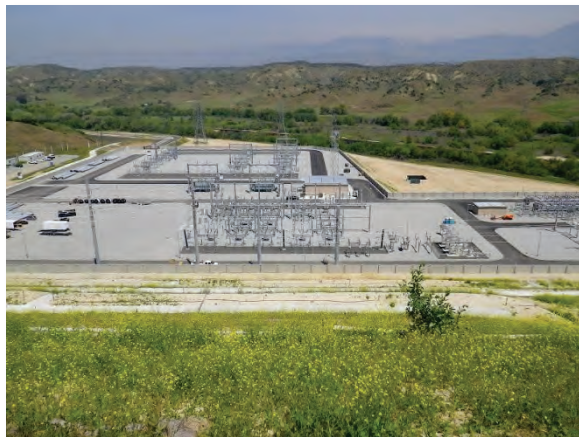
The CPUC EM conducted the final inspection of El Casco Substation construction and compliance activities on April 23, 2013, at which time all construction and crew demobilization had been completed. No outstanding construction related compliance issues were identified. Work on the habitat restoration of temporarily disturbed areas continues. Sheep grazing around the substation which had been problematic appeared to be under control at that time. Exclusion fencing was in place to prevent sheep access to the restoration areas. Please see Section 7.0 for a summary of restoration activities.

*Figure 17 — View of El Casco Substation. The photograph faces north.*

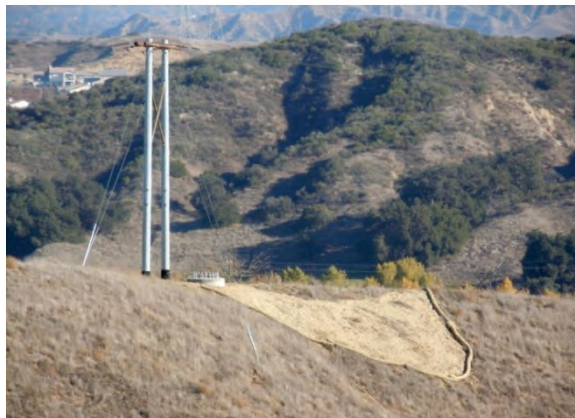
Erosion controls were established at several hillside locations, particularly on Segment 8.

Figure 22 — Newly installed fiber rolls at a foundation site.

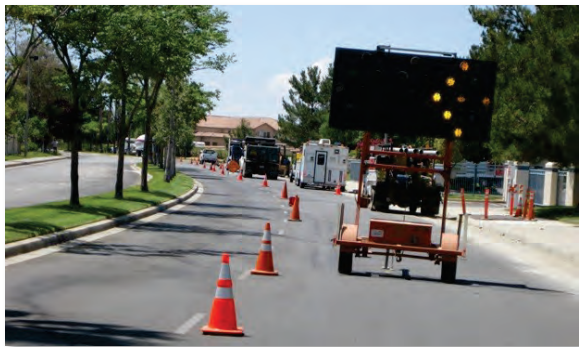
Figure 27 — Proper signage, demarcation of the work limits, and traffic control at the Sun Lakes Blvd FOC installation. Steel plates protect the road surface and cover open trench.

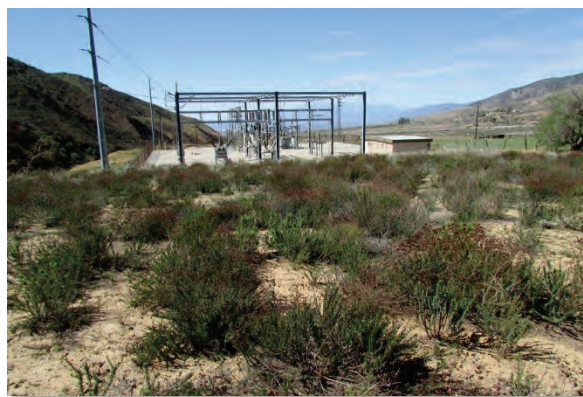
Figure 30 — View of the temporary impact area just east of the Zanja Substation. Note the dense growth of native vegetation. March 12, 2014.

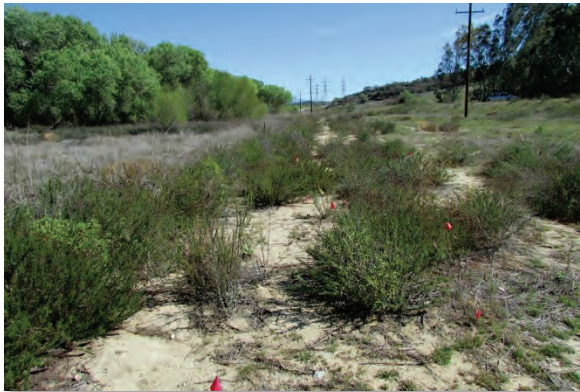
Figure 32 — View of a portion of the secondary smooth tarplant HMMP area. March 12, 2014.

**Secondary Site:** The secondary 2.4-acre site is located on the old dirt access road and adjacent vegetation parallel to San Timoteo Creek that was abandoned for the new paved El Casco Substation access road. A large portion of the area was hydroseeded in 2011 as part of the El Casco Substation access road restoration. The seed mix did not contain smooth tarplant, yet smooth tarplant sprouted up voluntarily at the location and were surviving well. Undisturbed areas consisted of ruderal areas dominated by Russian thistle and non-native grassland. SCE proposed the site for mitigation use to the RCA and the County Parks Department in late 2011 and met no objection. Information regarding the second

**December 2013 Status:** As reported by SCE in their 2013 El Casco System Project Annual Restoration Report (and accompany appendixes), smooth tarplant was inventoried at both the primary and secondary mitigation areas in 2013 and a total of 404 plants were observed occupying an area 1.24 acres in size. If accurate, the number of plants observed and the size of occupied area would exceed the performance criteria established in the HMMP (400 plants in 1.22 acres). Additional weeding, seeding, and monitoring are recommended to maintain the success criteria.
