Re: Monthly Report Summary #19 for Aliso Canyon Turbine Replacement Project

Aliso Canyon Turbine Replacement Project CPUC Site Inspection Form

Project:	Aliso Canyon Turbine Replacement	Date:	October 8, 2015
Project Proponent:	Southern California Gas Company and Southern California Edison	Report #:	VS074
Lead Agency:	California Public Utilities Commission	Monitor(s):	Vince Semonsen
CPUC PM:	Andrew Barnsdale, Energy Division	AM/PM Weather:	Partly cloudy, mild temperatures, and calm. Becoming clear and hot with a slight breeze.
E & E CM:	Lara Rachowicz	Start/End time:	0800 to 0945 at TSPs 6 through 32. 1015 to 1330 at the Aliso Storage Field.
Project NTP(s):	Guard House and Road Widening (NTP-1). The new Admin/IM Building (NTP-2) and Central Compressor Station (CCS) (NTP-3). P-41 Fill Site (NTP-2), PS-42 Fill Site, P-32 Fill Site (NTP-3), and the Natural Substation (NTP-A, NTP-D). TSPs 2 through 42 (NTPs A, C, and D) and the SCE 210 Freeway Yard.

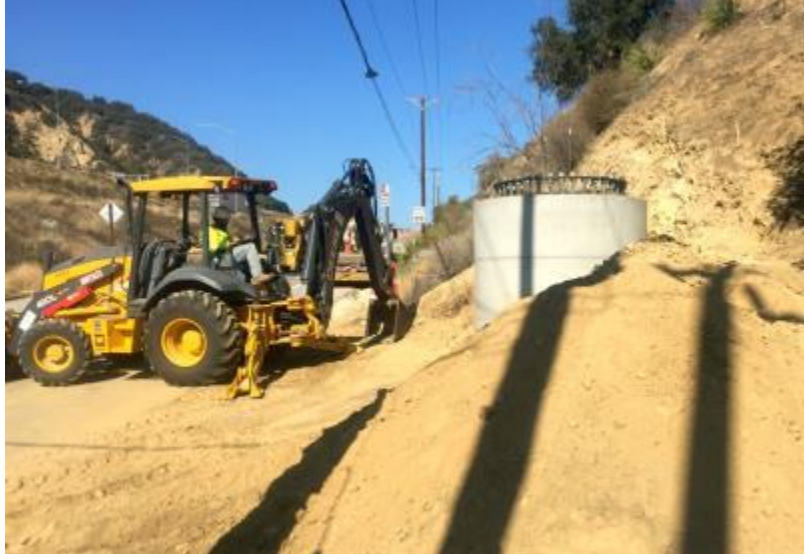
Date	Location	Photo	Description
10/13/15	TSP 34

A yellow backhoe loader is positioned on a dirt path, working on a concrete structure. The structure is cylindrical and appears to be a foundation or part of a utility installation. The background shows a dirt embankment and some vegetation.	Foundation work for TSP 34.
10/13/15	TSP 30

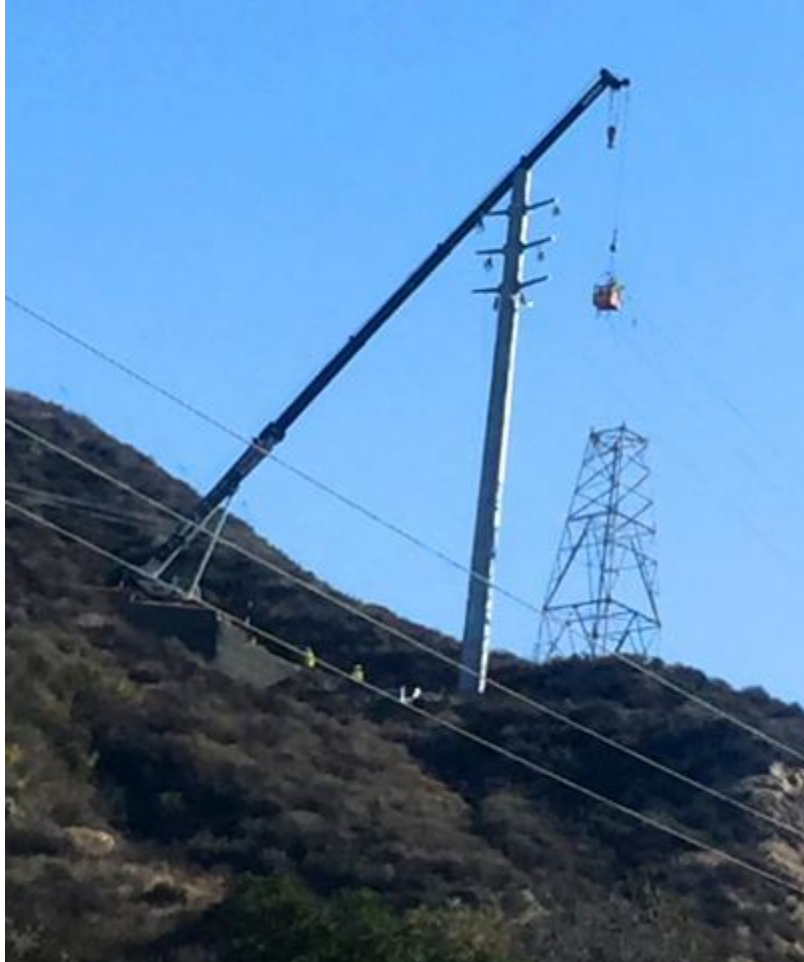
A crane is lifting a tall, dark metal pole on a hillside. The pole is being hoisted by a cable. In the background, there is a large metal tower structure and a clear blue sky. The terrain is hilly and covered with sparse vegetation.	Pole installation and line work.

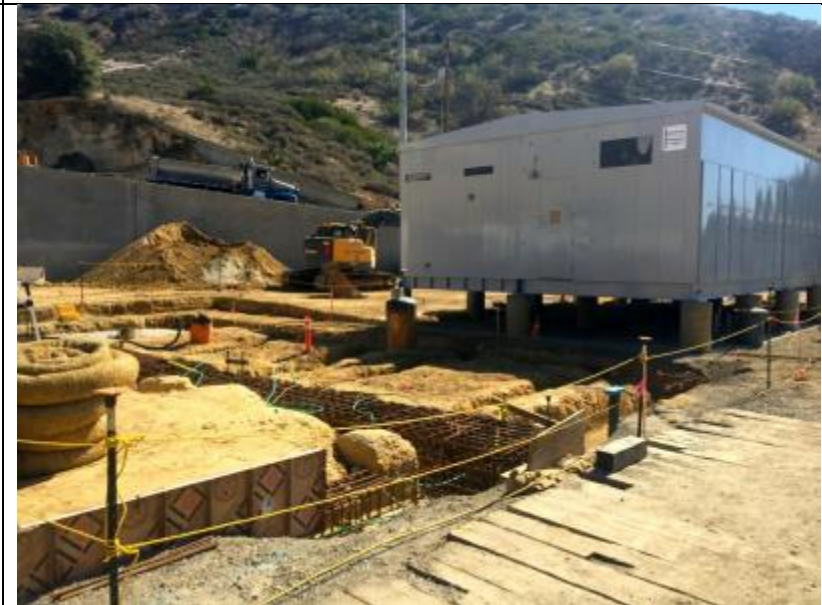
Date	Location	Photo	Description
10/22/15	CCS

Ongoing construction activities.
10/22/15	CCS

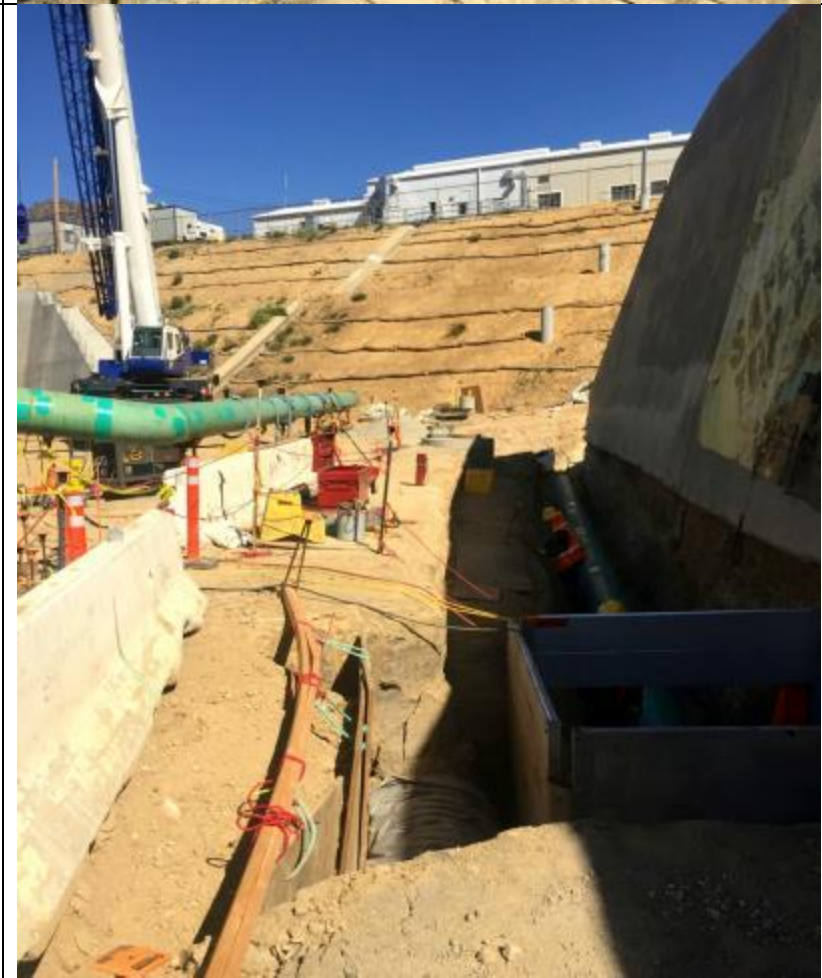
Ongoing construction activities.

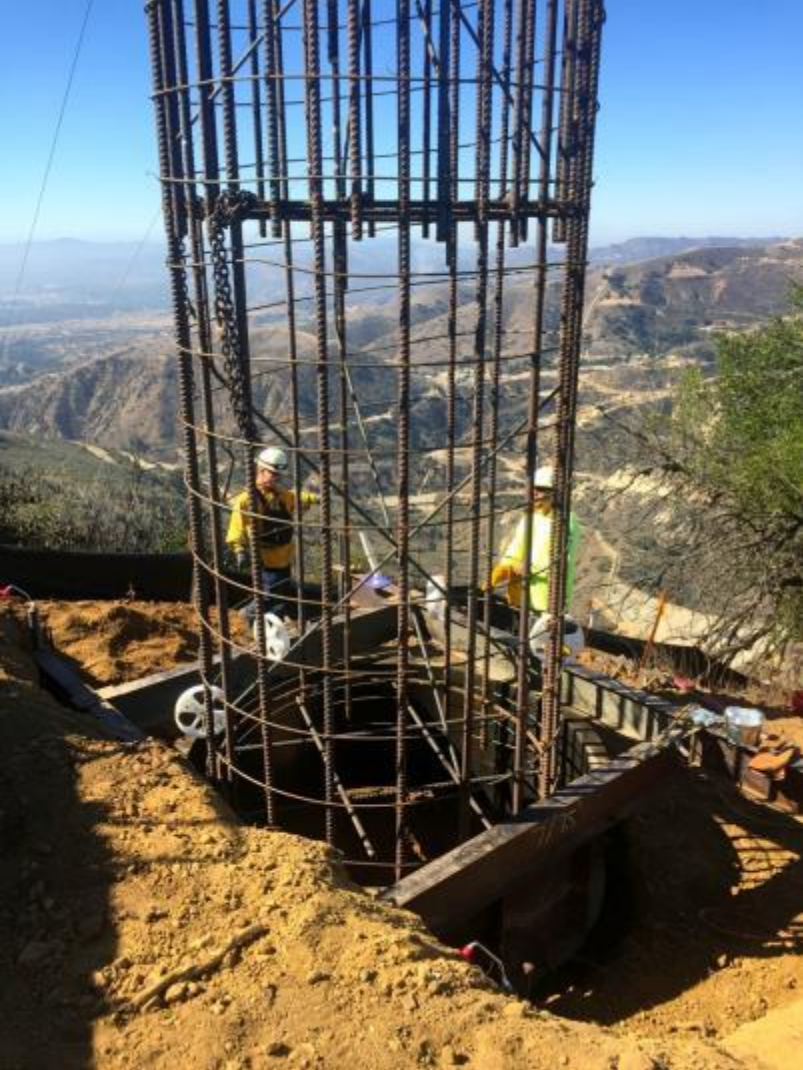
REPRESENTATIVE SITE PHOTOGRAPHS			
Date	Location	Photo	Description
10/22/15	TSP 42

I drove with Lucy Cortez to SCE's TSPs 40, 41, and 42 sites. At TSP 42, the crew was in the process of lowering the cage into the foundation hole – see photo. The fire crew was onsite and watering the surrounding vegetation because the crew was using cutting torches to remove rebar as they lowered the cage. According to the SCE inspector, the cage was 41 feet long and weighed 10,000 pounds; the crew was planning to pour the foundation the next day. We looked at TSPs 40 and 41– see photos; TSP 40 had just been poured and a crew was onsite pulling the forms and cleaning up the area. Below TSP 40, SCE had stockpiled the topsoil for TSP 42, which was covered with jute netting. Lucy stated that the topsoil may need additional protection – see photo.

Cage installation.
10/22/15	TSP 41	 	Newly poured foundation for TSP 41 – clean-up is ongoing.

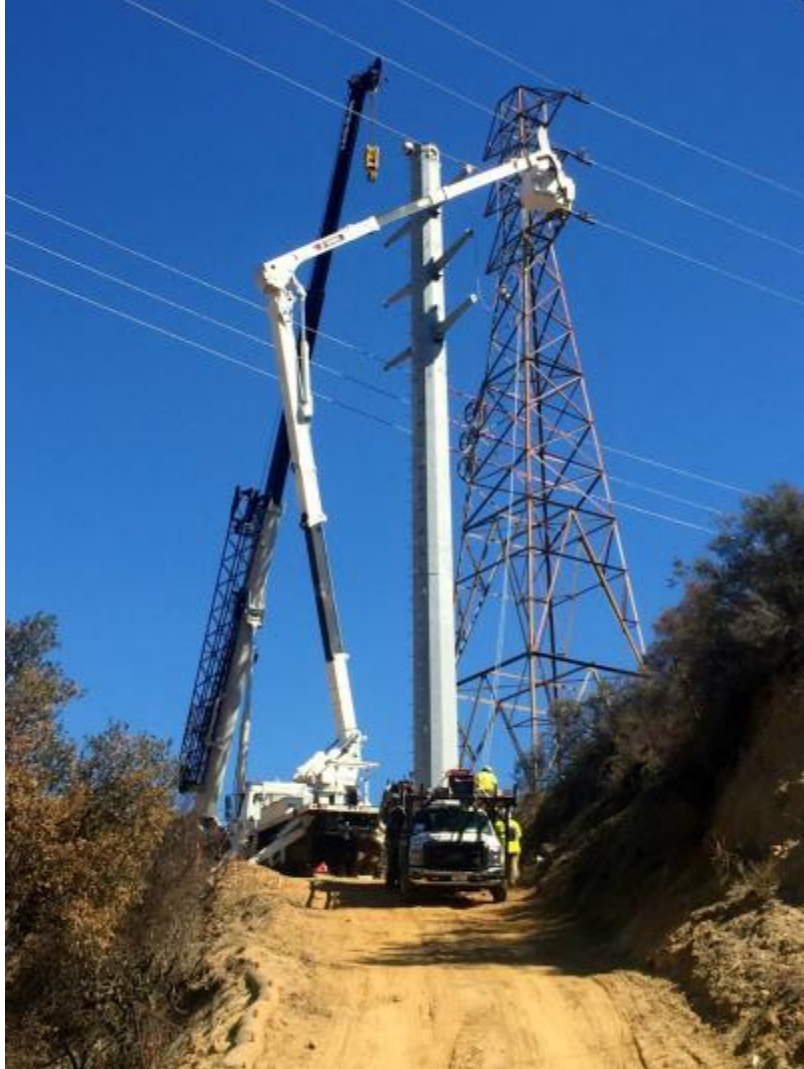
Date	Location	Photo	Description
10/22/15	TSP 26

I drove to TSPs 26 through 34 along Highway 5 where crews were continuing their work on the poles and pulling wire – see photos. I also drove past TSPs 8 and 9 and noted that the old foundations had been pulled and the areas were restored.

A photograph showing a utility truck with a crane arm lifting a tall metal pole on a dirt road. A lattice tower is visible in the background.	Pole installation and wire pulling.

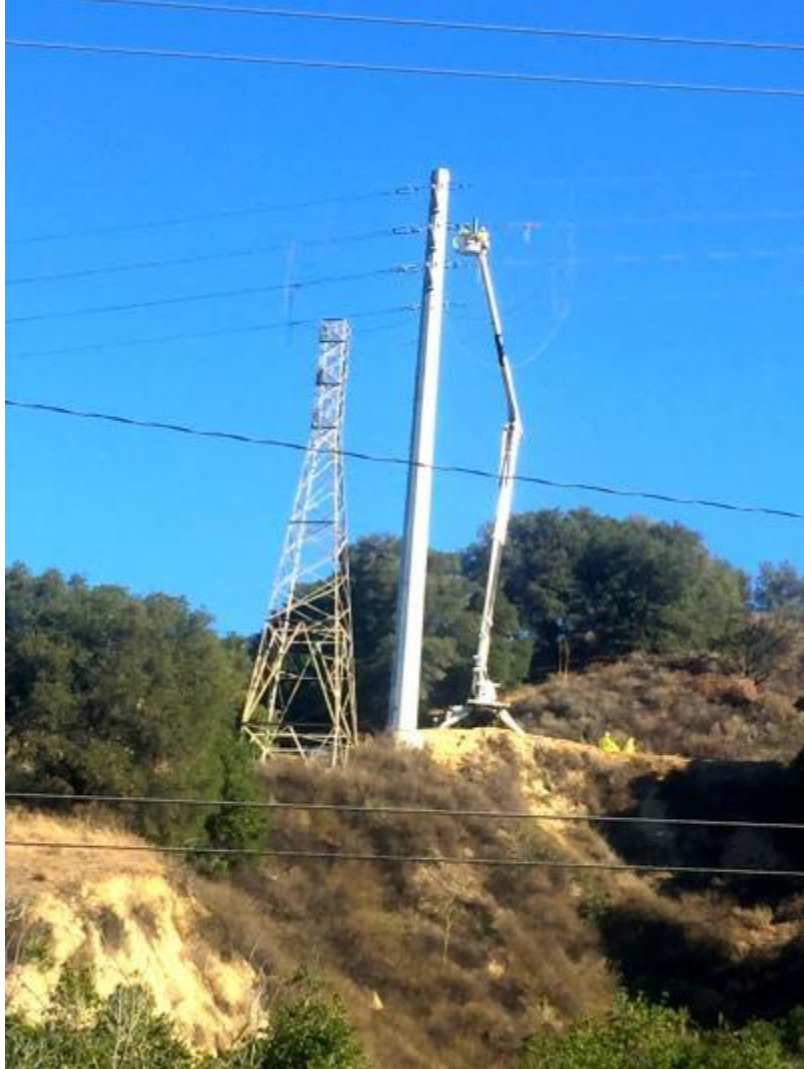
Date	Location	Photo	Description
10/29/15	TSP 29

A photograph showing a tall utility pole being worked on by a crane on a hillside. A lattice tower is visible in the background.	Pulling wire.

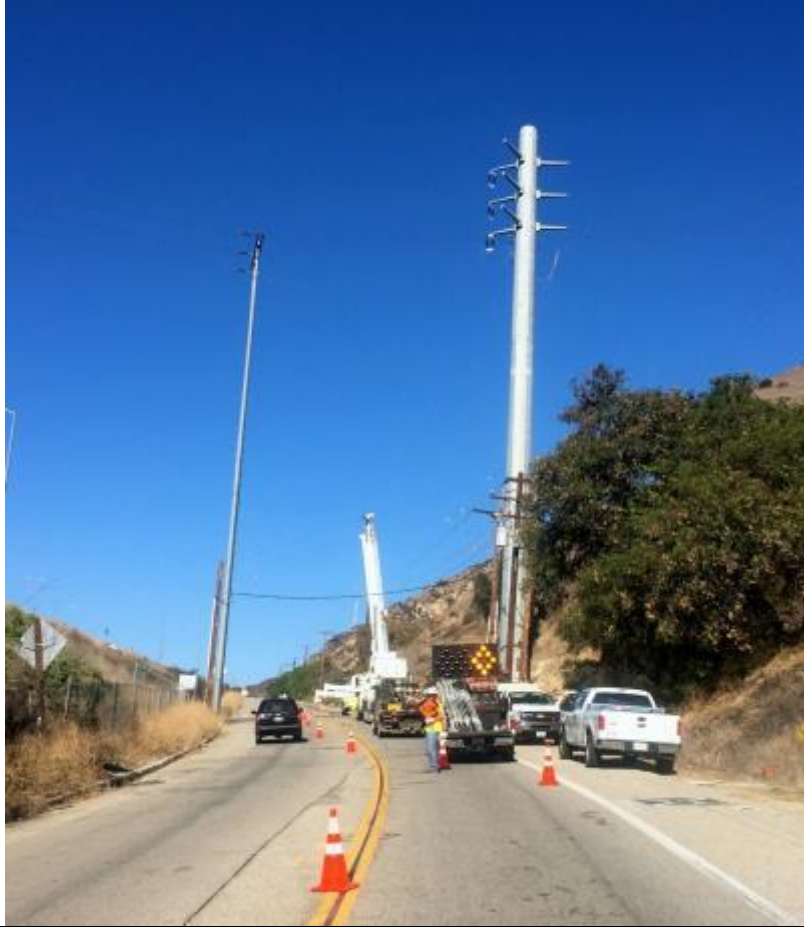
Date	Location	Photo	Description
10/29/15	TSP 34

Pole work and wire pulling.
