January 13, 2020

Re: Monthly Report Summary #16 for the Mesa 500-kV Substation Project

This report provides a summary of the compliance monitoring activities that occurred during the period from **January 1 to 31, 2019**, for the Mesa 500-kilovolt (kV) Substation (Mesa Substation) Project in Los Angeles County, California. Compliance monitoring was performed to ensure that all project-related activities conducted by Southern California Edison (SCE) and their contractors comply with the requirements of the Final Environmental Impact Report (Final EIR) for the Mesa Substation Project, as adopted by the California Public Utilities Commission (CPUC) on February 9, 2017.

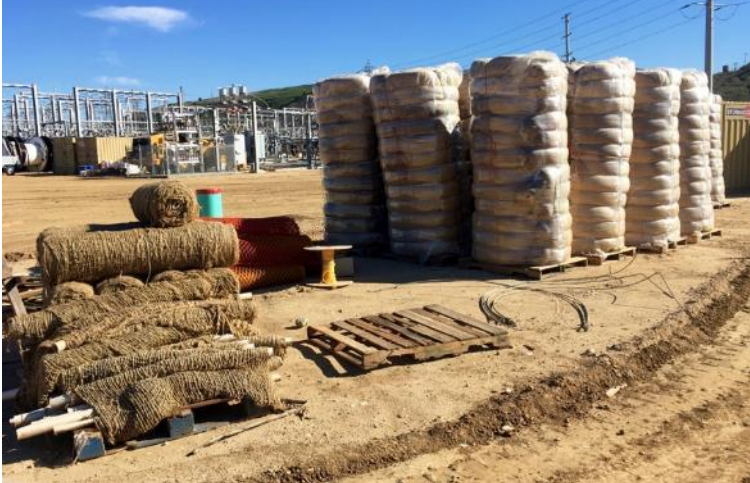
Photo 3 – Stockpiled sediment control materials. Photo facing south.
1/3/19	Mesa Substation

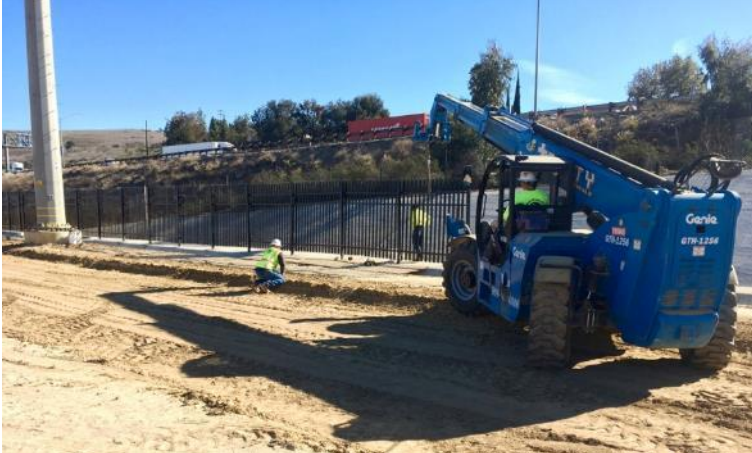
Photo 7 – Fence installation along the southern boundary of the project. Photo facing southeast.
1/3/19	Mesa Substation

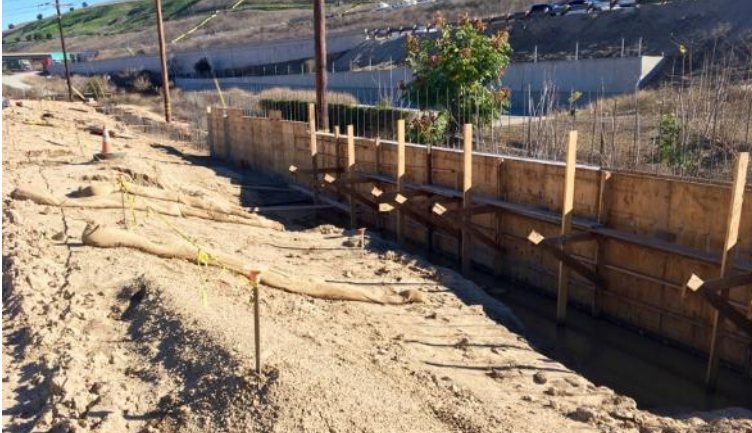
Photo 8 – Wall foundation installation along the southern project boundary. Photo facing southeast.

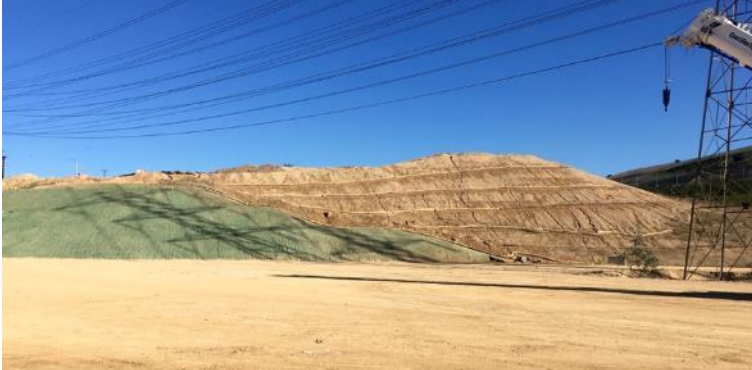
Photo 13 – Hydroseeding along slopes at the southeastern corner of the Mesa Substation Site. Photo facing southeast.

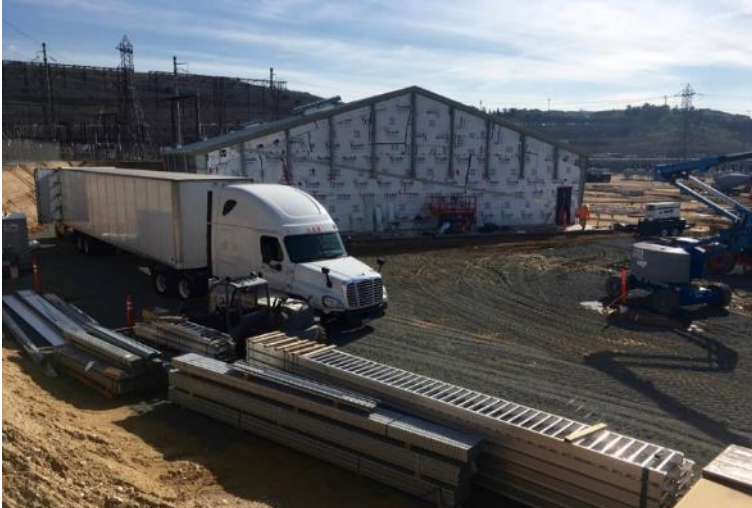
Work at the Senior Mechanical Electrical Equipment Room (MEER) building continued – Photo 1. The area surrounding the building was stabilized with gravel to allow easier truck access and minimize mud.

<p>Photo 1 – Gravel was laid around the Senior MEER, preventing mud accumulation. Photo facing south.</p>
1/9/19	Mesa Substation

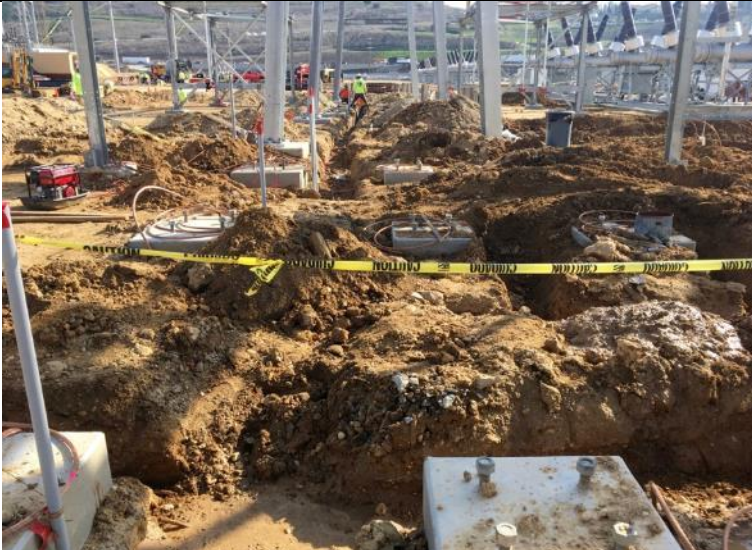
Work within the 220-kilovolt (kV) switchrack area continued, with ongoing trenching for the installation of the copper grounding wire – Photo 3 – as well as the aboveground wire stringing – Photo 10.

<p>Photo 3 – Excavations for copper grounding work within the 220-kV switchrack area. Photo facing south.</p>

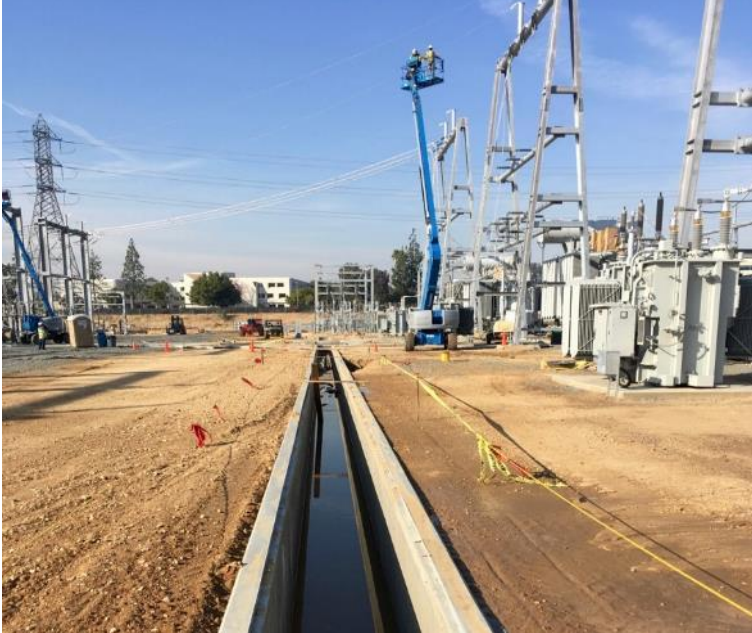
<p>Photo 10 – Aboveground installation work in the 220-kV switchrack area. Photo facing north.</p>

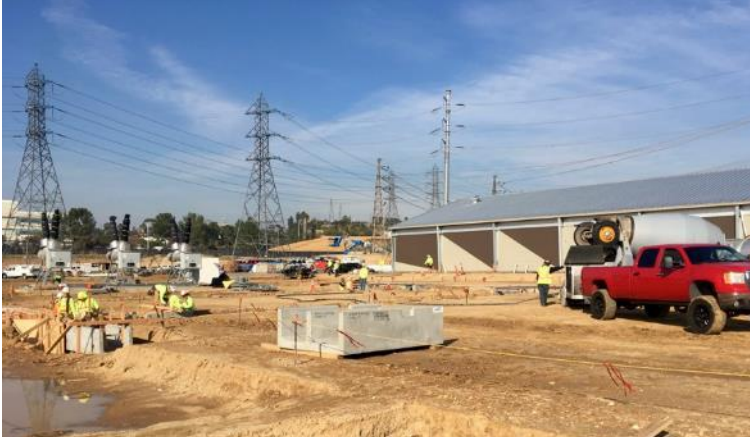
A crew was pouring concrete slurry in the trenches immediately west of the Senior MEER building – Photo 11. The concrete washout work area near the southeastern corner of the Mesa Substation site needed to be cleaned – Photo 15.

<p>Photo 11 – Crews pouring concrete slurry immediately west of the Senior MEER. Photo facing northeast.</p>
1/9/19	Mesa Substation	 	<p>Photo 12 – Some uncovered excavations are filled with water. Photo facing south.</p>
1/9/19	Mesa Substation

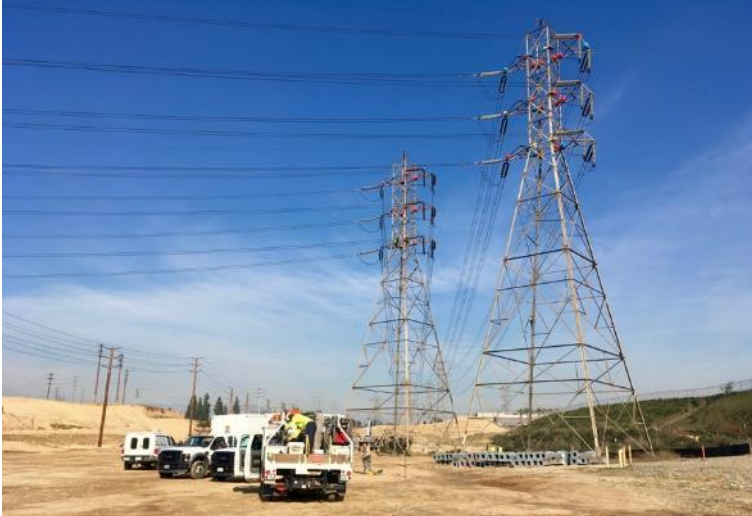
An SCE crew near the Coastal California Gnatcatcher habitat was installing nest deterrent devices (large plastic balls) at potential nest locations within the latticework steel towers (LSTs) – Photo 14. Coastal California Gnatcatcher biologist Ben Smith (ICF) was overseeing this work. I spoke with lead biologist Matt Daniele (ICF) about SCE's recent self-issued Level 2 Non-Compliance (NCR-003) in which this crew had removed old nesting material prior to installing the nest deterrent devices. He explained that crews received additional training to ensure that similar compliance incidents do not reoccur.

<p>Photo 14 – SCE crews installing nest deterrents (plastic balls) on latticework steel towers. Photo facing east.</p>
1/9/19	Mesa Substation

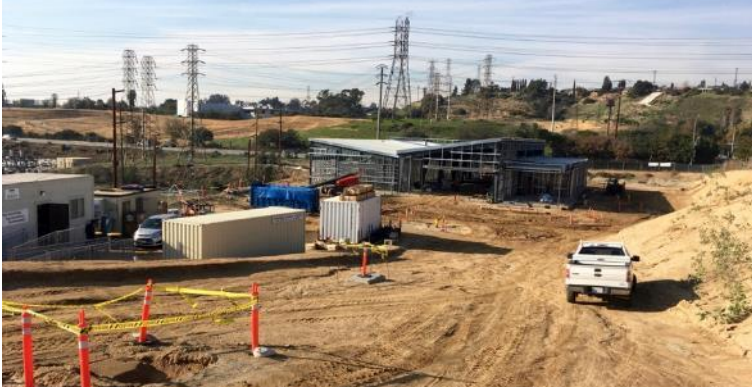
Operations Building construction continued in the northeast corner of the project site and I did not observe any compliance issues – Photo 16.

<p>Photo 16 – Construction continues at the Operations Building. Photo facing north.</p>

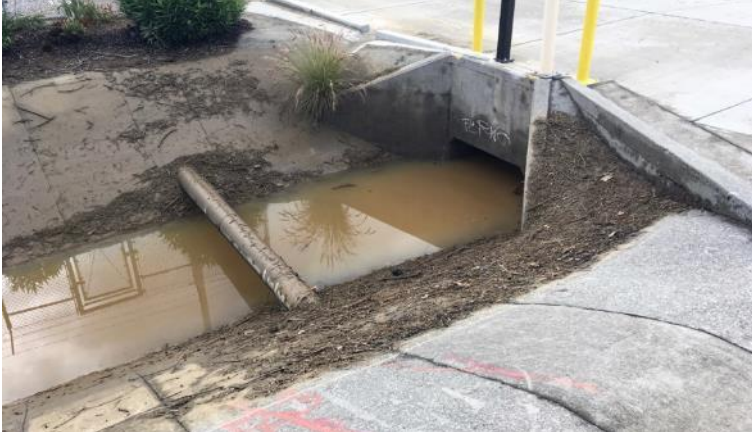
Crews continued to pump out water that filled drainage ditches and excavated areas. The pumped water flowed across the project site and into the large detention basin. The concrete drainage ditch surrounding the old Mesa Substation Site was also filled with water and was being pumped from the ditch into the project site – Photo 1. The pump and gas canister were staged near ponded water without containment – Photo 2. I asked Willie Clark (Power Grade foreman) to remove the equipment from the drainage channel and install containment. A crew was pumping water from a few foundation excavations. These pumps were in containment bins – Photo 12.

<p>Photo 1 – Stormwater runoff within the concrete-lined channel surrounding the old Mesa Substation.</p>
1/18/19	Mesa Substation

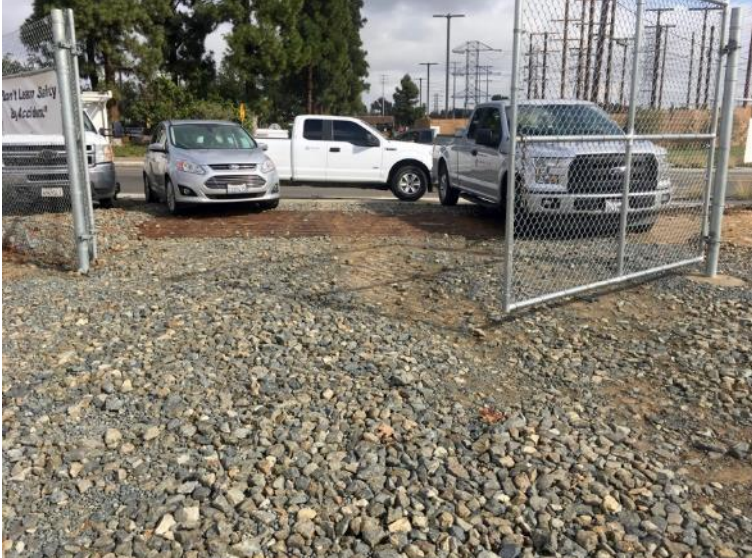
There was substantial mud accumulated in the rock and rumble plates at the project entry/exit points – Photos 3 & 4. Pete Lubich (ULM Services, Inc.) explained they had cleaned both entry/exit locations before the rainstorms and would clean them again, as needed, after the weekend.

Photo 4 – The eastern entry/exit area. Photo facing east.
1/18/19	Mesa Substation

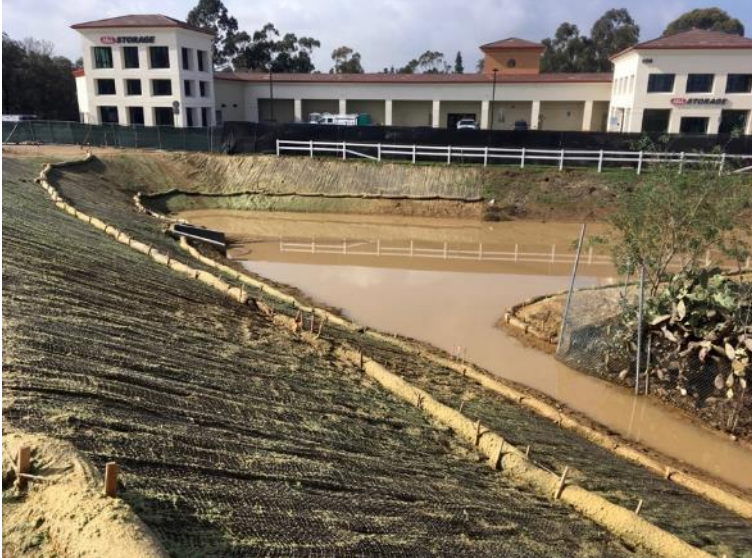
The small “triangular” detention basin was full of water that was exiting this basin via the standpipe – Photo 9.

Photo 9 – Small “triangular” detention basin. Photo facing west.
1/18/19	Mesa Substation	 	Photo 10 – Standpipe in the large detention basin. Photo facing north.
1/18/19	Mesa Substation

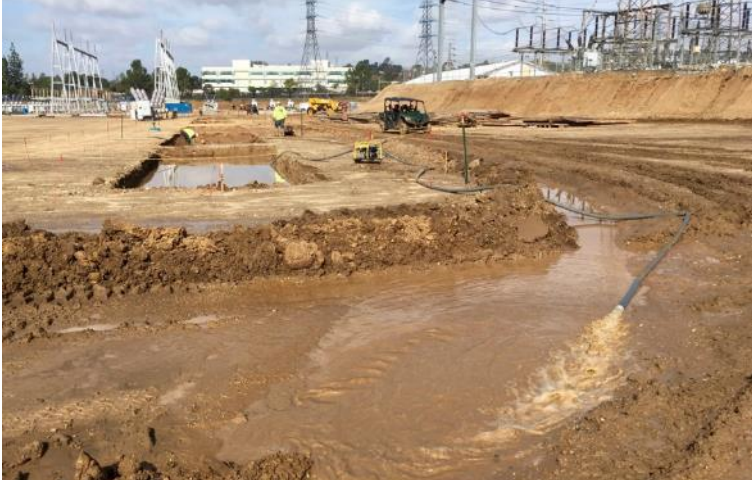
Photo 12 – Water being pumped from inundated excavations. Photo facing north.
1/18/19	Mesa Substation

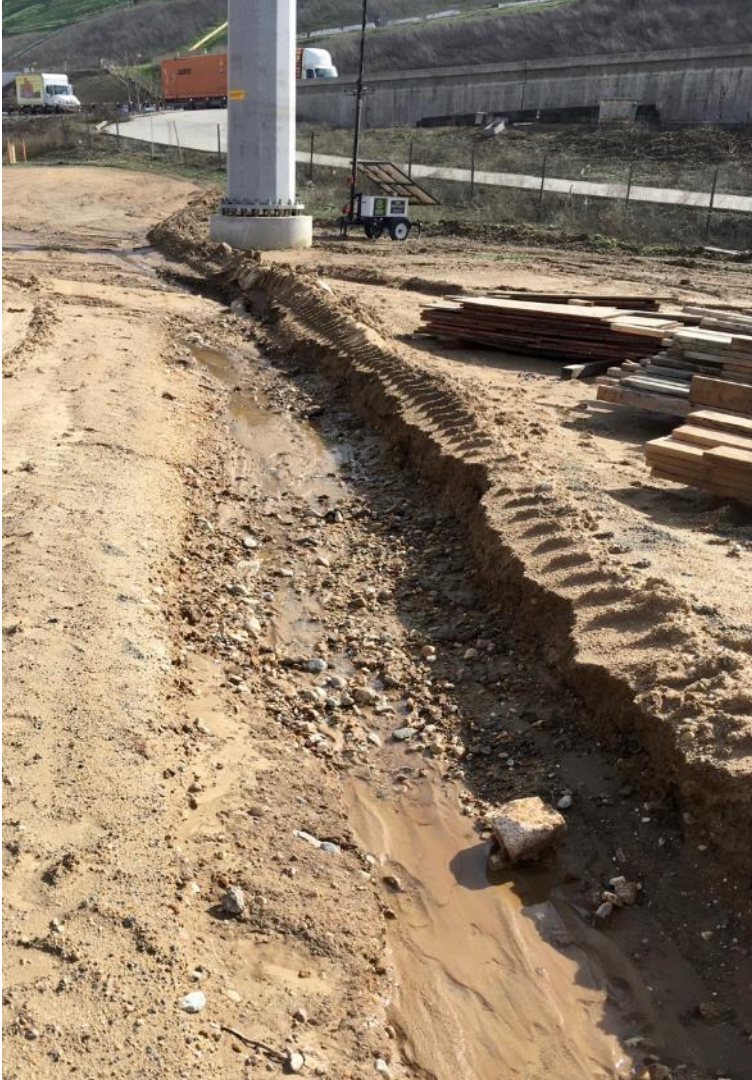
Photo 13 – Stormwater runoff diversion berm just east of the southern boundary wall. Photo facing southeast.

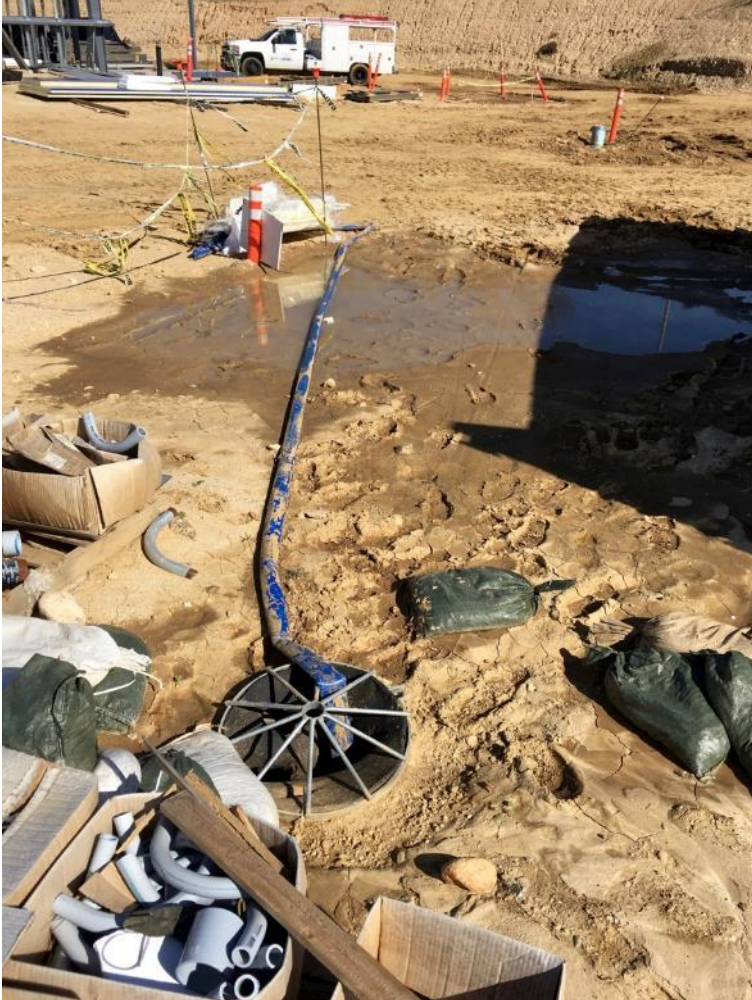
Photo 12 – Stormwater runoff being pumped into a standpipe.

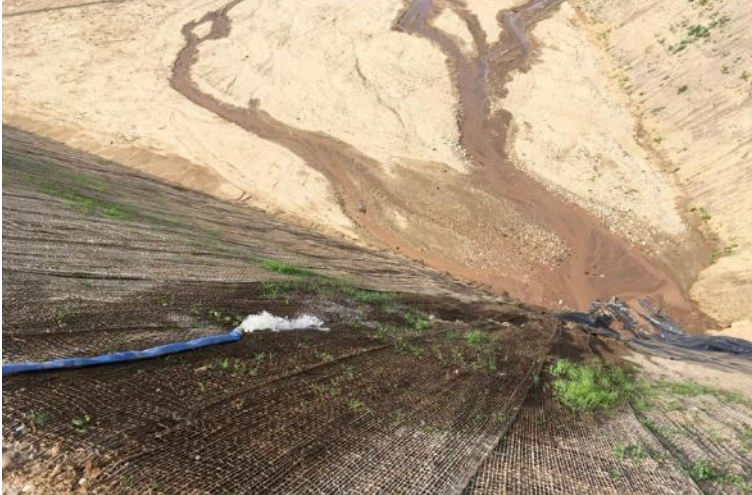
Photo 7 – Water being pumped into the detention basin from trenches.
1/28/19	Mesa Substation

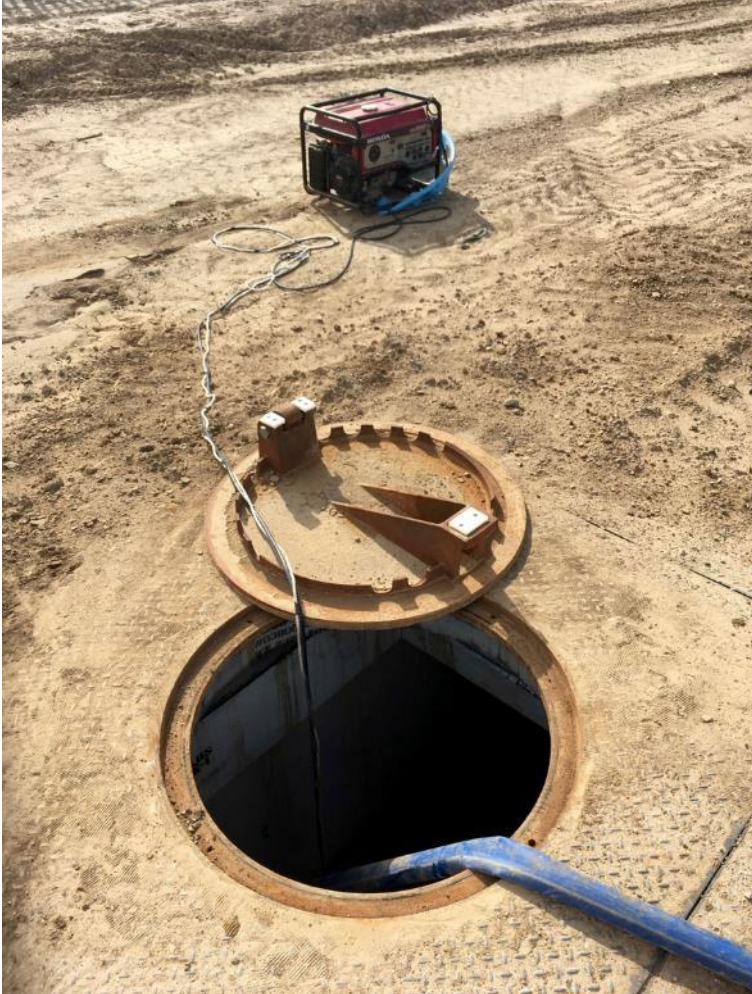
Photo 8 – Water being pumped out of the conduit vault.
