February 23, 2021

Re: Monthly Report Summary #29 for the Mesa 500-kV Substation Project

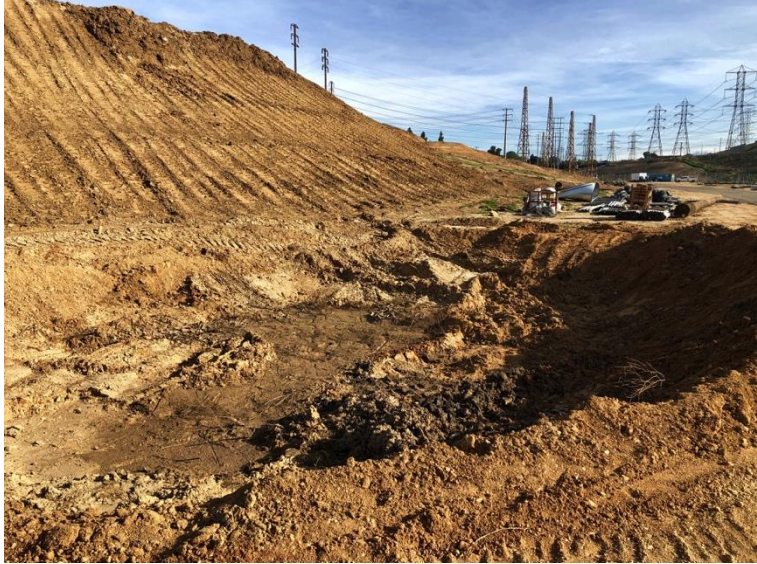
Photo 4 – Open ground within the southeastern portion of the project site. Photo facing east.
2/05/20	Mesa Substation

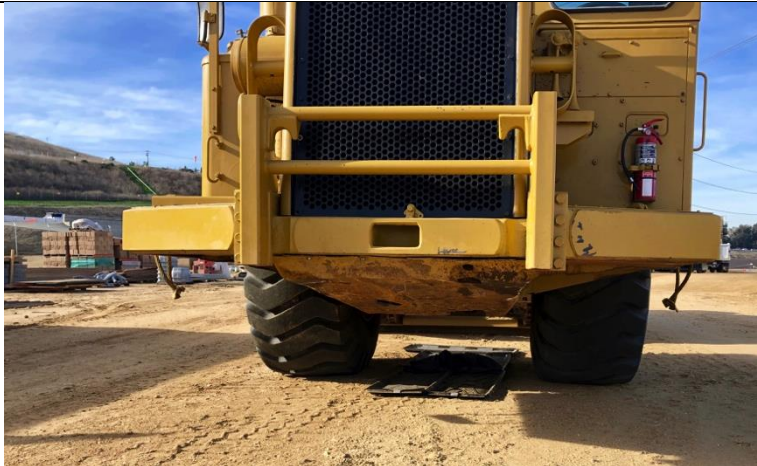
Photo 5 – Drip pans under the parked equipment.
2/05/20	Mesa Substation

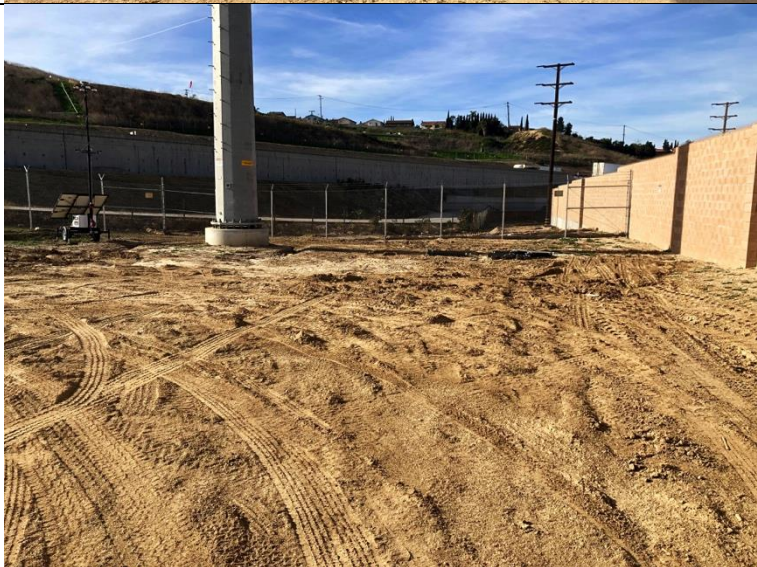
Photo 6 – The area just east of the southern boundary wall. Photo facing southwest.

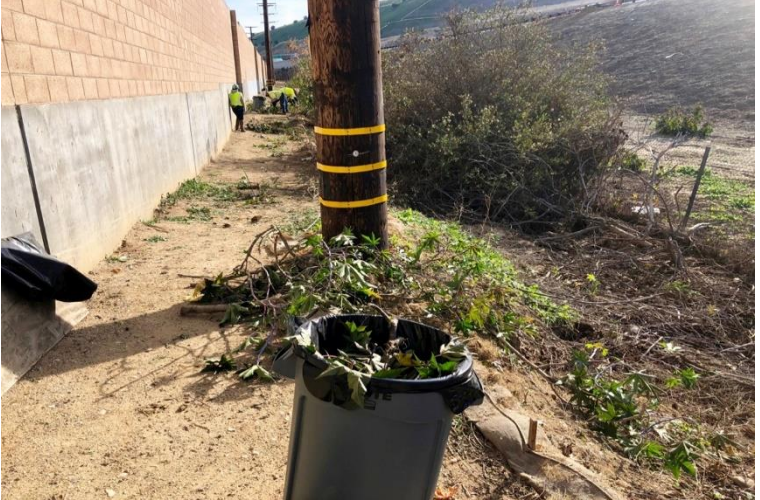
Photo 8 – Castor bean removal outside of the southern boundary wall. Photo facing east.
2/05/20	Mesa Substation

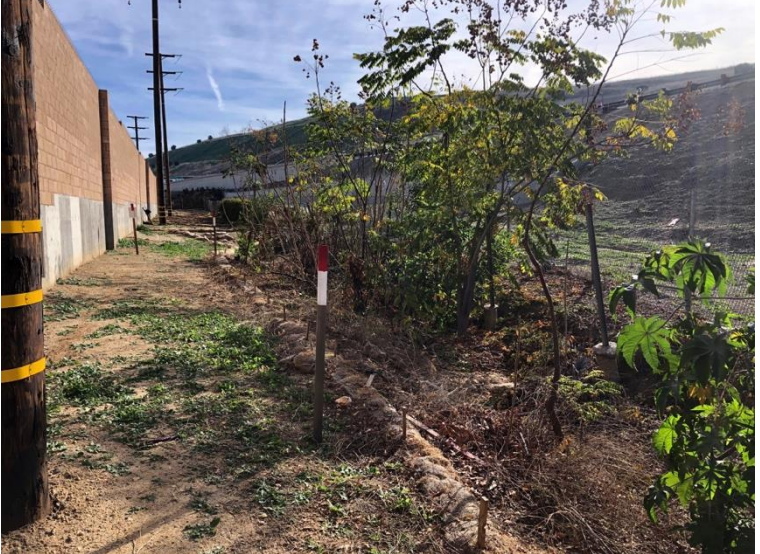
Photo 9 – Bird buffer stakes around a hummingbird nest outside of the southern boundary wall. Photo facing southeast.

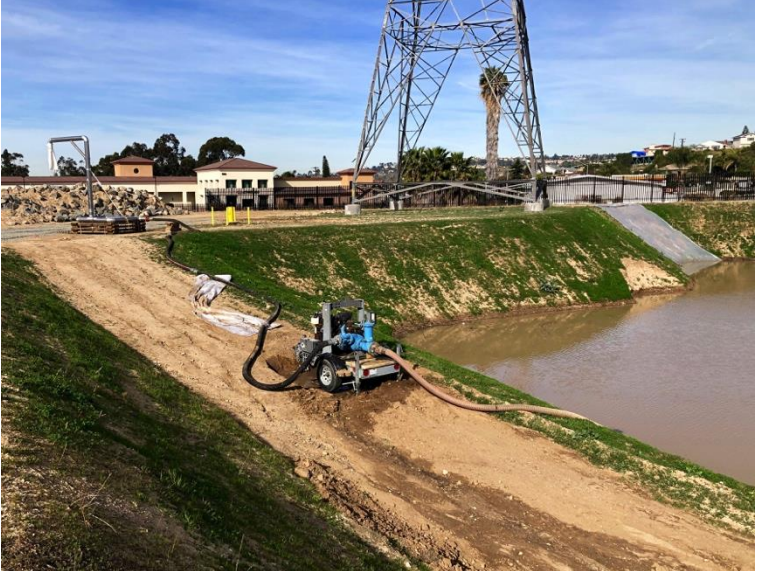
Photo 10 – A pumping setup has been installed near the large catch basin. Photo facing northwest.
2/05/20	Mesa Substation

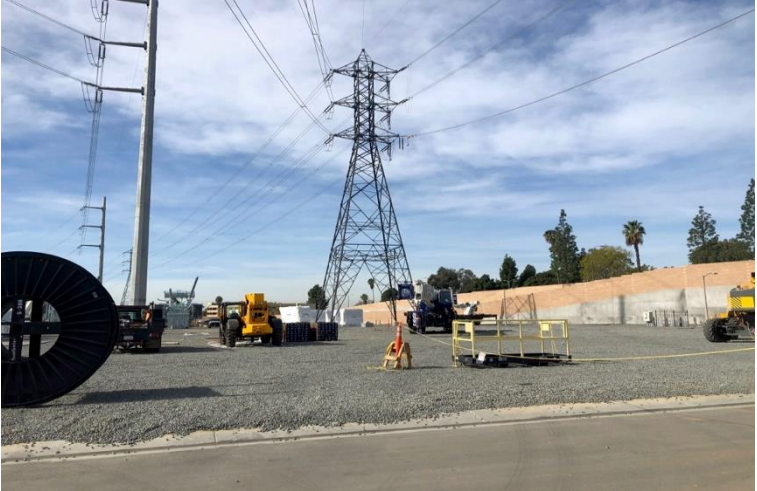
Photo 11 – Crews working within the 66-kV rack area on equipment installation and wire pulling. Photo facing west.
2/05/20	Mesa Substation

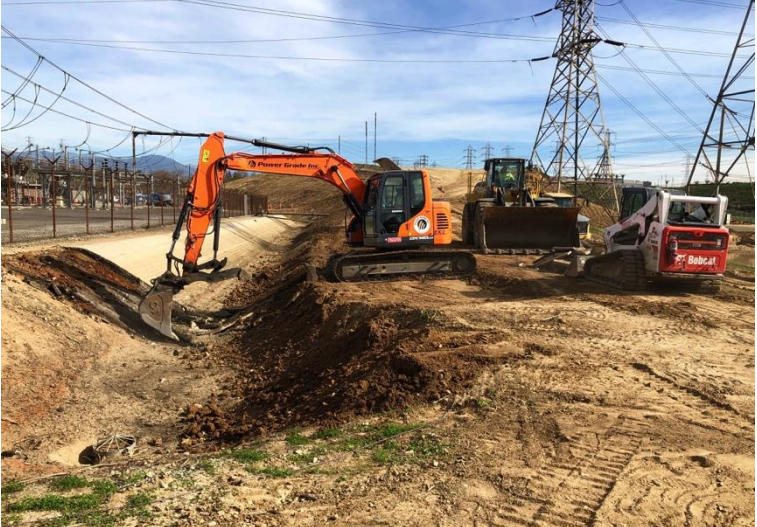
Photo 12 – Equipment working on removing the concrete-lined channel along the southern side of the old substation. Photo facing east.

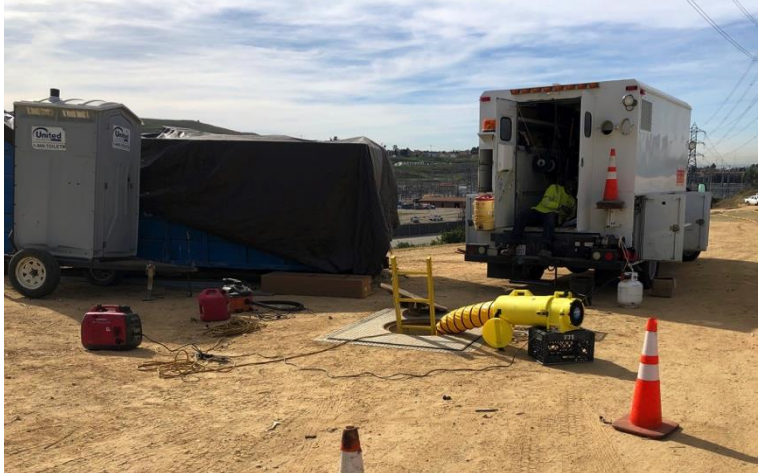
Photo 13 – Vault work within the telecommunications corridor north of Potrero Grande Drive. Photo facing southwest.
2/05/20	Mesa Substation

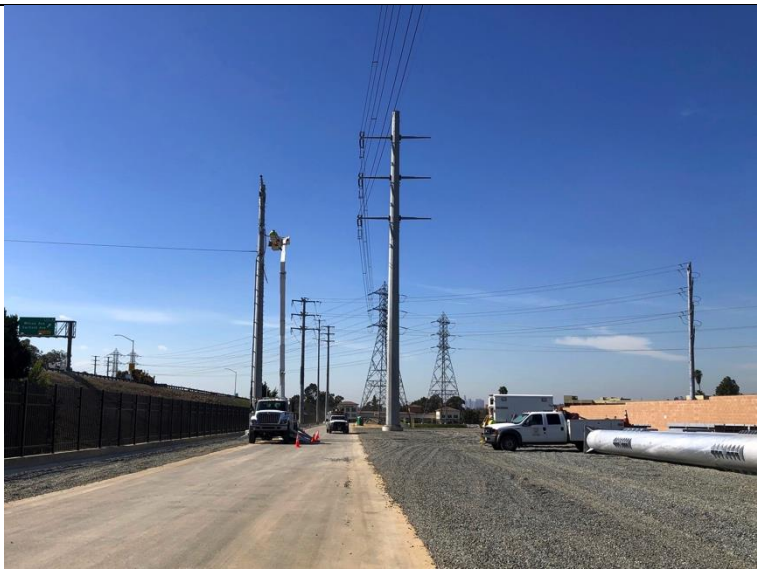
Wire stringing was being performed at several locations within the new rack areas (Photos 4 and 9).

Photo 4 – Crews pulling wire near the southern boundary fence. Photo facing west.
2/12/20	Mesa Substation

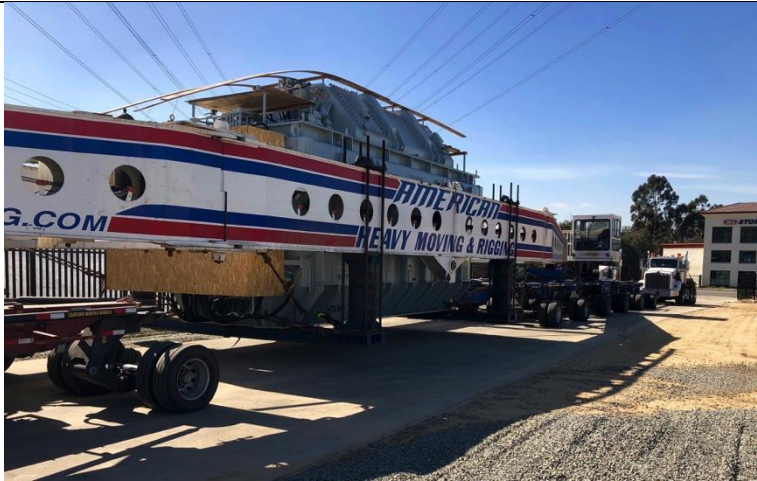
Another large transformer has been delivered to the site through the western entrance (Photo 5).

Photo 5 – A large transformer was recently delivered to the site. Photo facing west.
2/12/20	Mesa Substation	 	Photo 6 – Other transformers being worked on near the 66-kV rack area. Photo facing northeast.

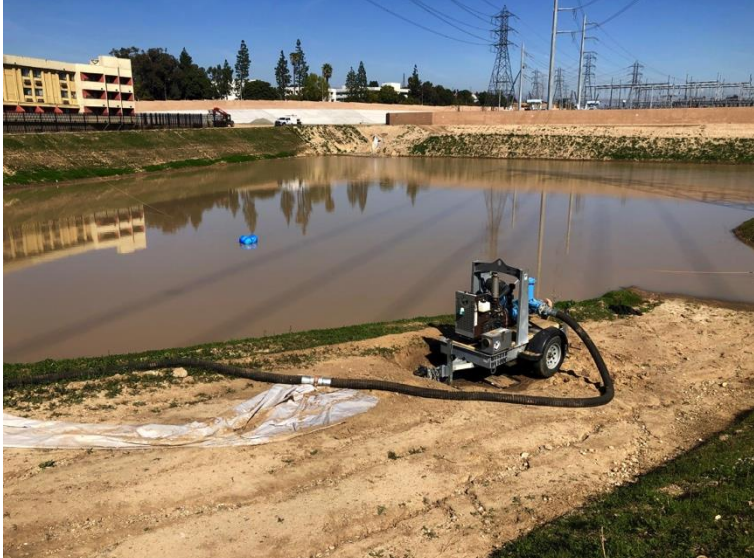
The large retention basin continued to hold water and the pumping system remained in place to fill water trucks (Photo 6). Water was being used to minimize dust on the access roads and within the Phase 3 grading area.

Photo 7 – The pumping setup remains near the large catch basin. Photo facing northeast.
2/12/20	Mesa Substation

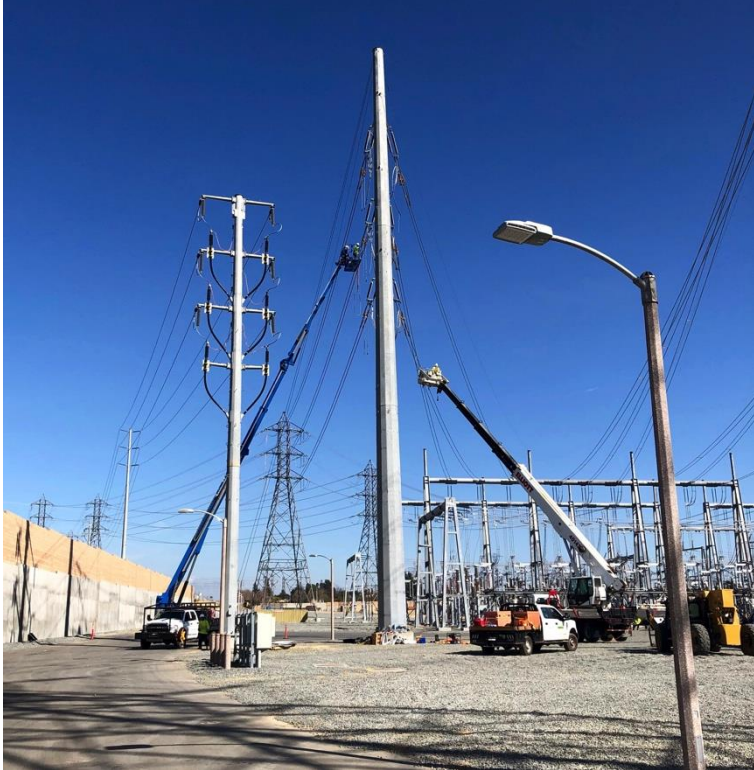
Photo 9 – More wire work near the northern portion of the project site. Photo facing east.
2/12/20	Mesa Substation

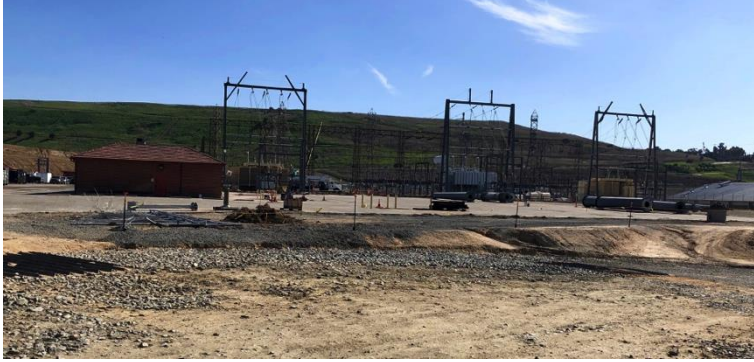
Equipment and buildings were being taken down within the old substation (Photo 10). This work was being performed within Areas A and F on the Phase 3 grading map (Photo 12).

Photo 10 – Equipment removal within the old substation. Photo facing south.

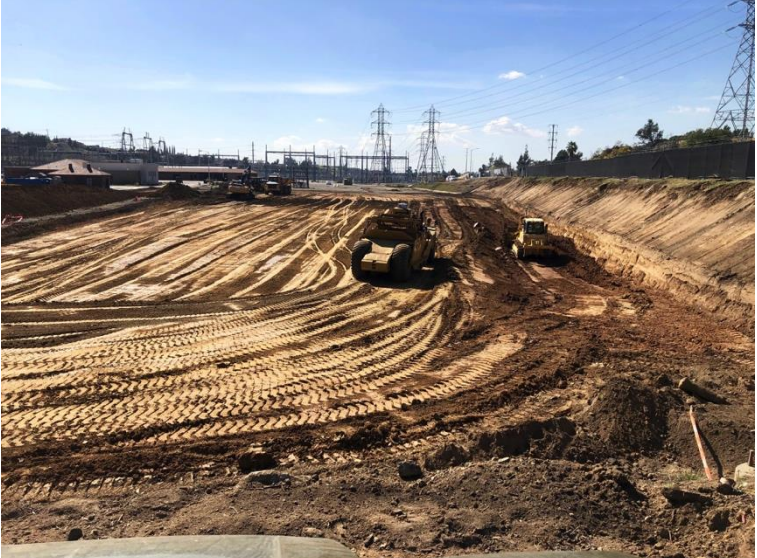
Grading operations continued with bulldozers and belly scrapers moving soil within Phase 3 Area B (Photo 11). Mr. Lubich indicated that they were currently over-excavating the area, searching for the "bottom." Some areas had contaminated soil; they were removing the asphalt and then digging out and segregating the next 18 inches of soil.

Photo 11 – Soil work within Areas A and B. Photo facing west.
2/12/20	Mesa Substation

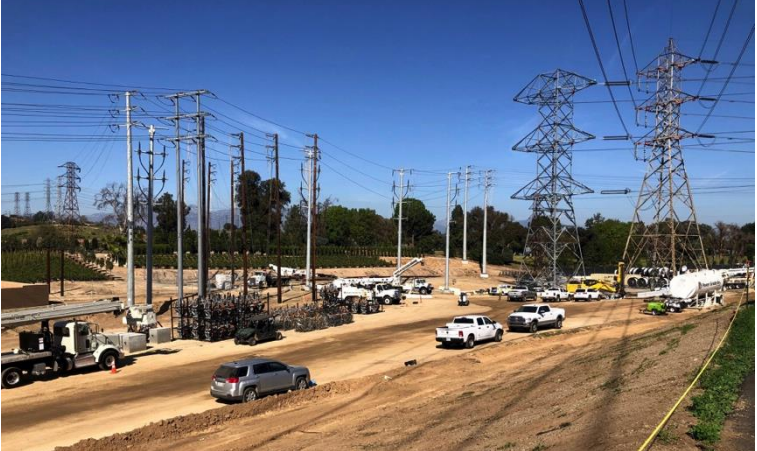
Large quantities of SCE equipment and materials were staged in the telecommunication corridor east of Market Place Drive (Photo 13).

Photo 13 – Parking and staging area within the telecommunications corridor east of Market Place Drive. Photo facing northeast.

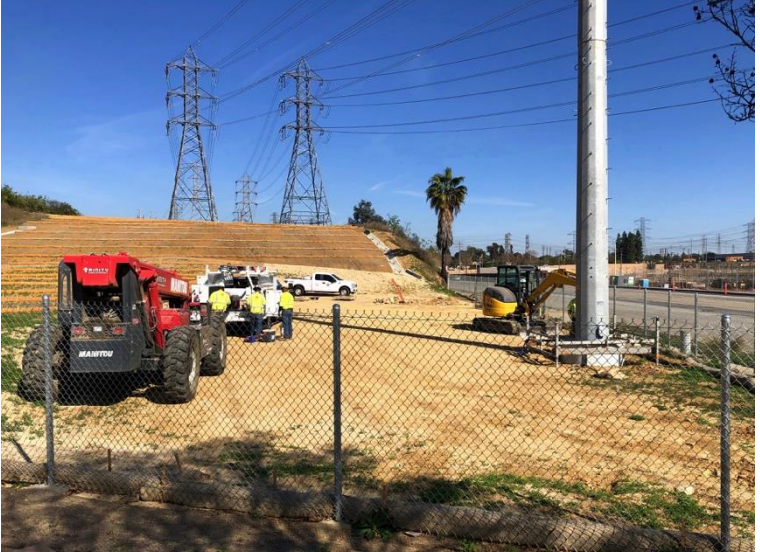
Some additional work was being completed around the tubular steel pole (TSP) and underground vault within the telecommunication corridor north of Potrero Grande Drive (Photo 14).

Photo 14 – Work on a vault and around the bottom of a TSP in the telecommunications corridor north of Potrero Grande Drive. Photo facing east.

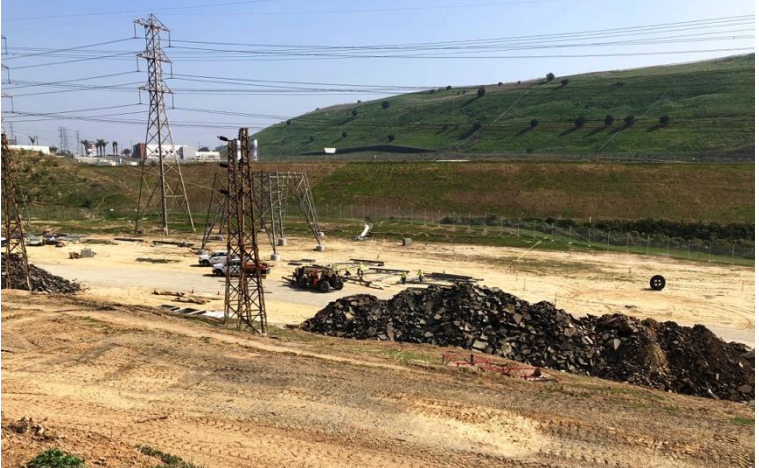
Photo 4 – Some tower construction being completed near the nest buffer boundary. Photo facing southeast.
2/19/20	Mesa Substation

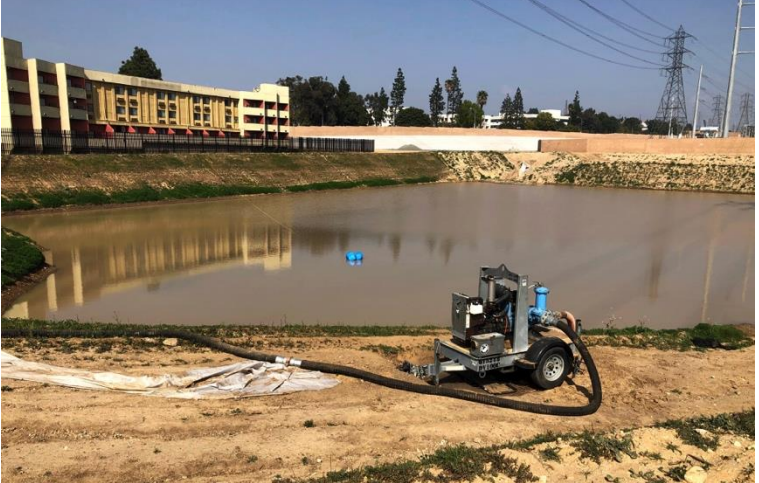
We drove to the western end of the site to observe the two catch basins. The small triangular basin was dry and remains full of captured sediment (Photo 5). The large retention basin continued to hold water, which was being used for dust control and compaction work (Photo 6).

Photo 6 – The large retention basin with pumping equipment. Photo facing northeast.

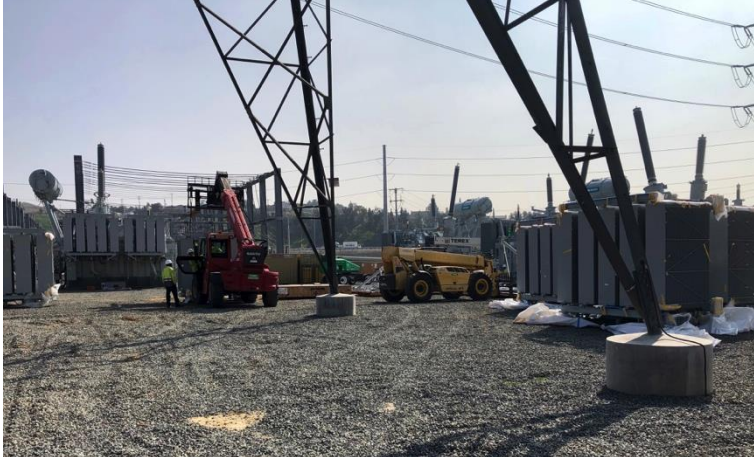
Crews continued to work on a variety of tasks within the new rack areas including transformer installation and wire pulling in the vaults (Photo 7).

<p>Photo 7 – Work continues on building the transformers. Photo facing south.</p>
2/19/20	Mesa Substation

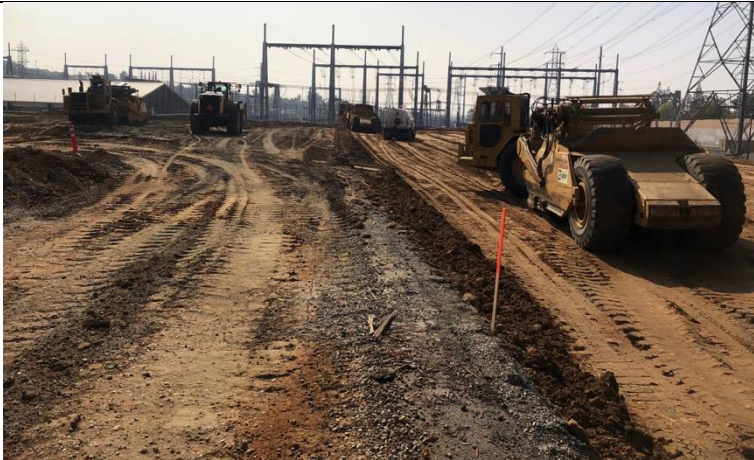
<p>Photo 9 – Soil work within the old substation. Photo facing west.</p>

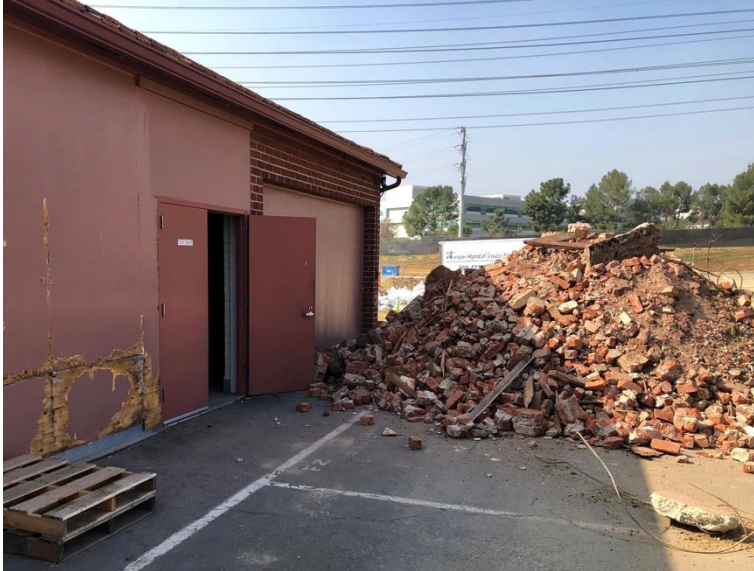
<p>A photograph showing the demolition of a brick building. A large pile of red bricks and rubble is in the foreground. To the left, a portion of a red brick building remains, with a doorway and some peeling paint. A wooden pallet is on the ground in the lower-left corner. The background shows a clear sky and some distant trees.</p>	Photo 11 – Demolition of the old brick substation buildings. Photo facing north.

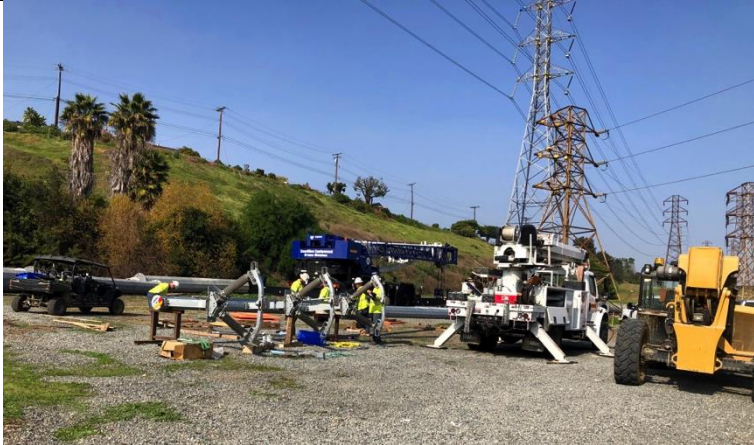
A crew was working in the telecommunication corridor north of Potrero Grande Drive and east of Market Place Drive, installing the new towers (Photo 12).

<p>A photograph of a telecommunications tower installation site. Several workers in high-visibility vests are working on a large metal tower structure. A yellow excavator and other heavy machinery are present. The site is a gravel area with a grassy hillside in the background. Power lines and other towers are visible in the distance under a clear blue sky.</p>	Photo 12 – Tower installation work within the telecommunications corridor. Photo facing east.

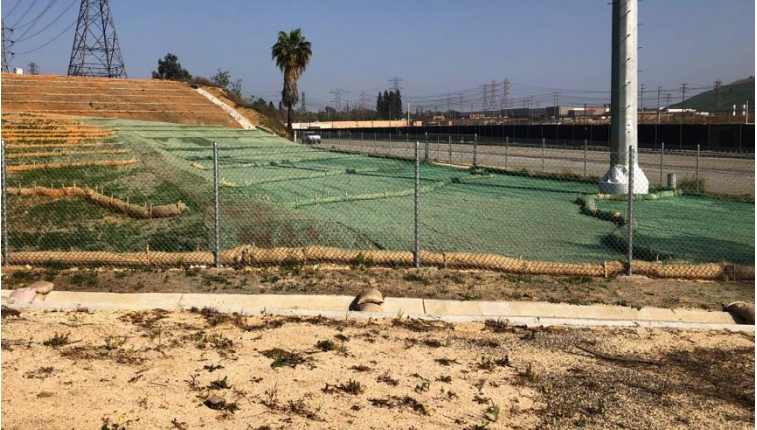
Photo 13 – Hydromulch has been sprayed over the disturbed soil area within the telecommunications corridor north of Potrero Grande Drive. Photo facing east.

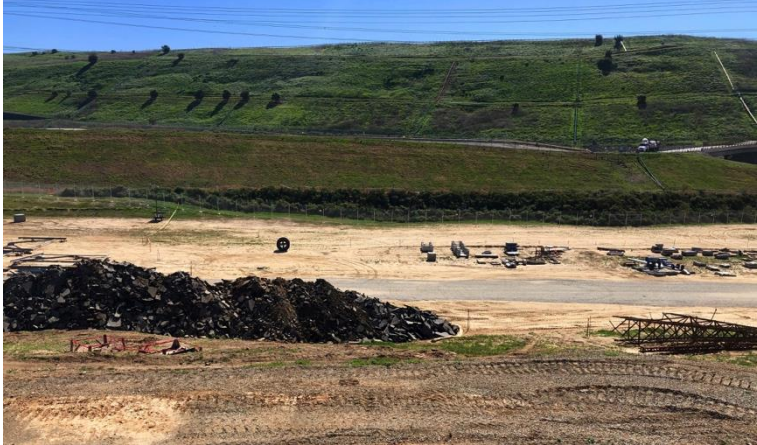
Photo 2 – Coastal California gnatcatcher nest buffer area. Photo facing south.
2/26/20	Mesa Substation

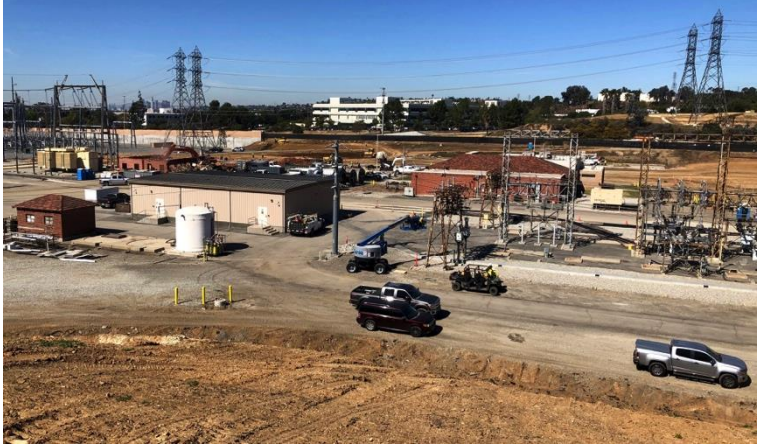
Photo 3 – Equipment removal from the old substation. Photo facing north.

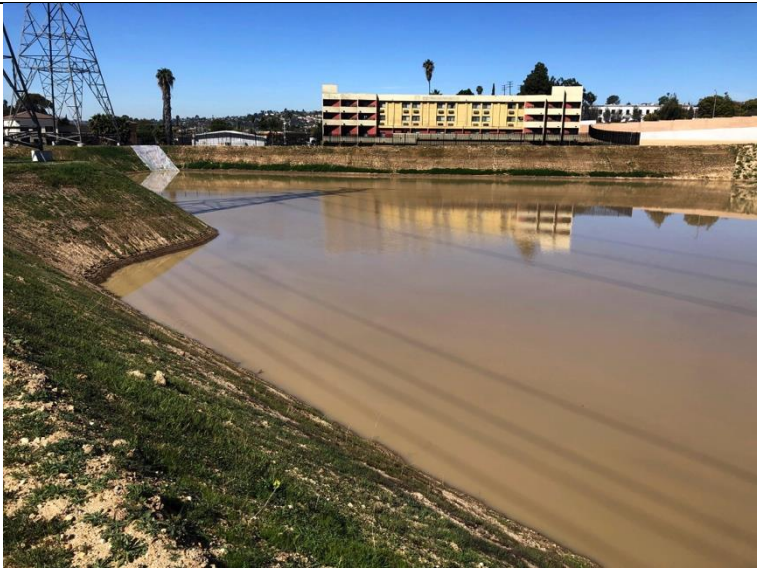
Photo 4 – The large retention basin with pumping equipment. Photo facing northwest.
2/26/20	Mesa Substation

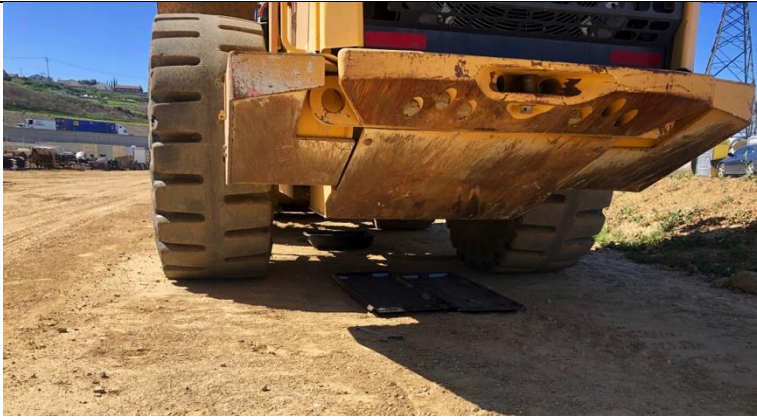
Photo 5 – Drip pans under parked construction vehicles. Photo facing west.
2/26/20	Mesa Substation

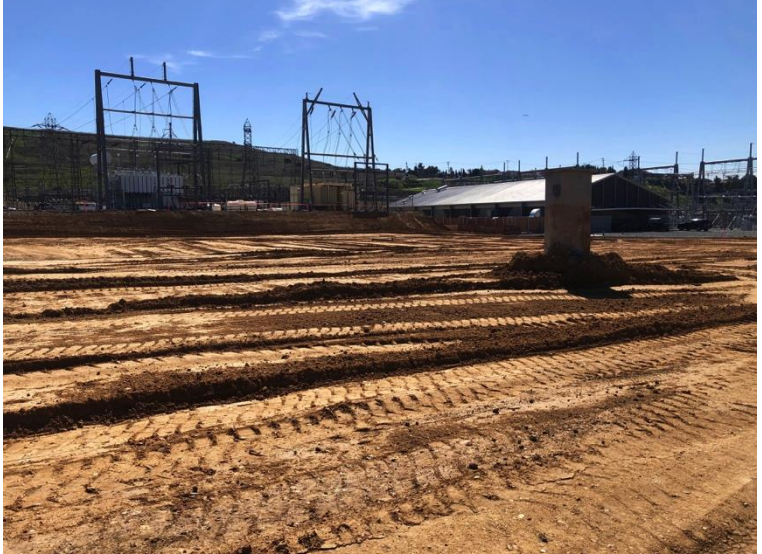
Photo 7 – Soil work within the old substation. Photo facing south.
2/26/20	Mesa Substation

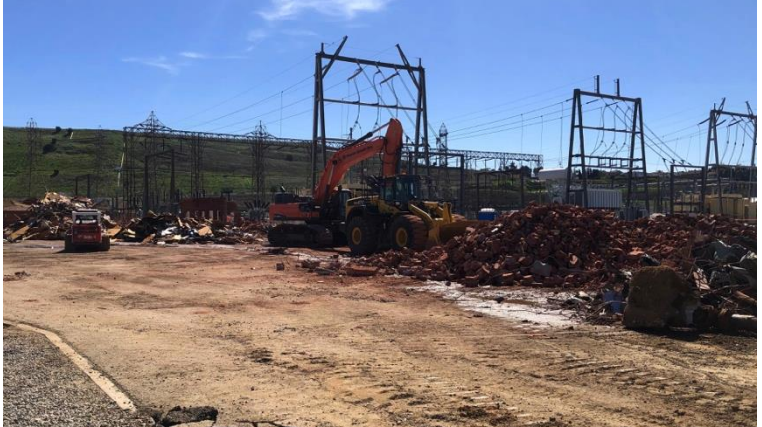
Photo 8 – Removal of the old substation buildings. Photo facing south.
2/26/20	Mesa Substation

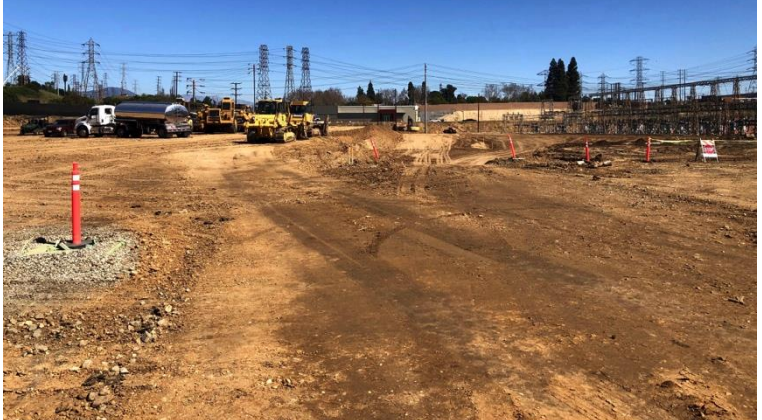
Photo 9 – Soil work within the old substation. Photo facing east.
