February 23, 2021

Connie Chen
Project Manager
California Public Utilities Commission
505 Van Ness Avenue
San Francisco, CA 94102

Re: Monthly Report Summary #30 for the Mesa 500-kV Substation Project

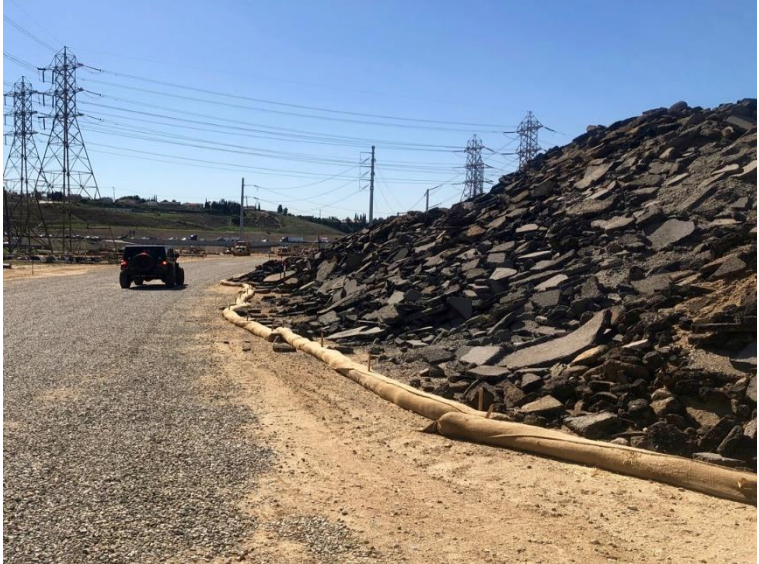
Photo 2 – Piles of asphalt along the project access road. Photo facing southwest.
3/03/20	Mesa Substation

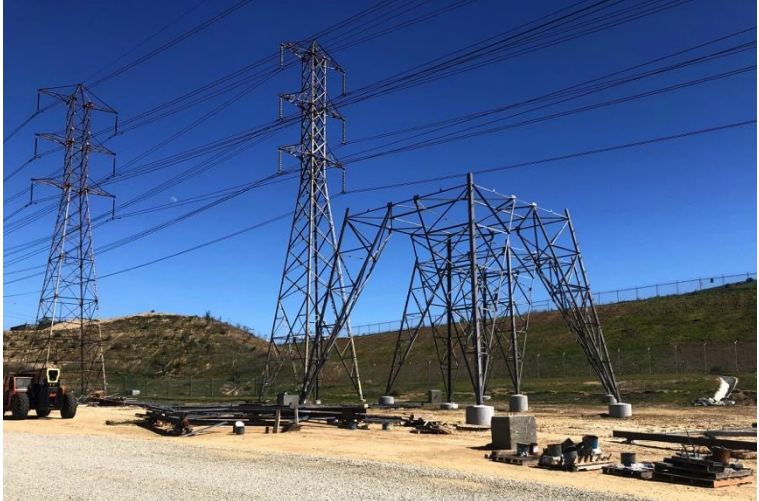
Photo 3 – Lattice steel tower under construction. Photo facing southeast.

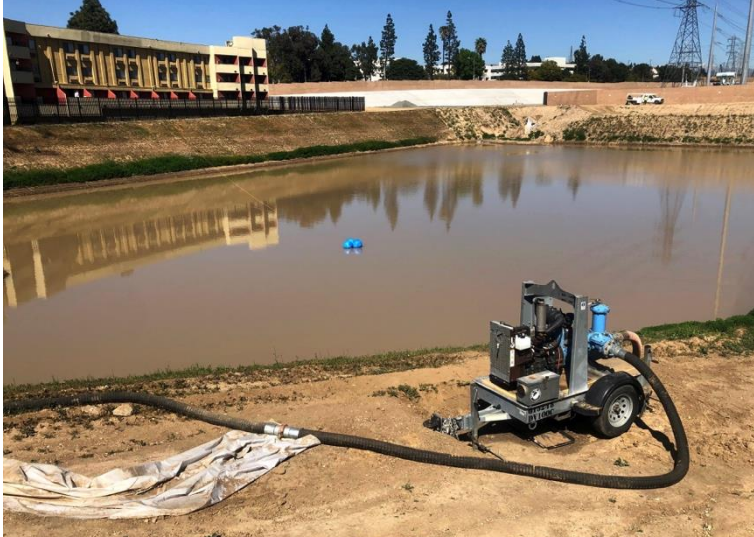
Photo 4 – The large retention basin with pumping equipment. Photo facing northeast.
3/03/20	Mesa Substation

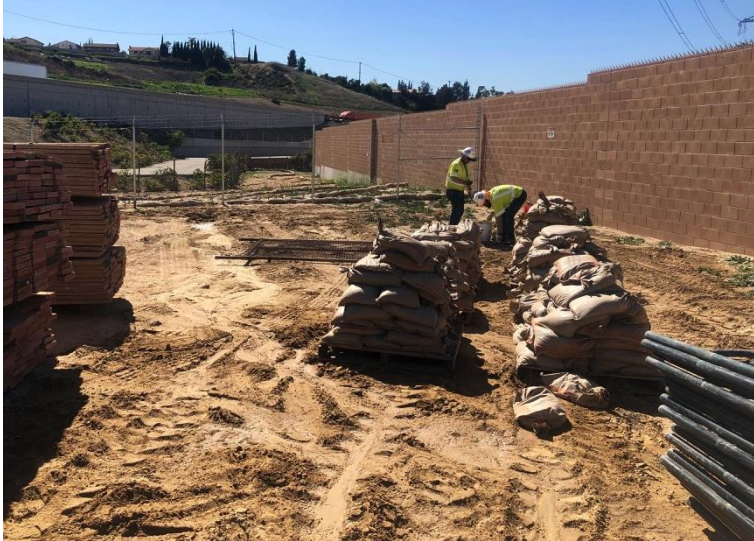
Photo 5 – Weed removal crew working around the material staging area. Photo facing west.
3/03/20	Mesa Substation

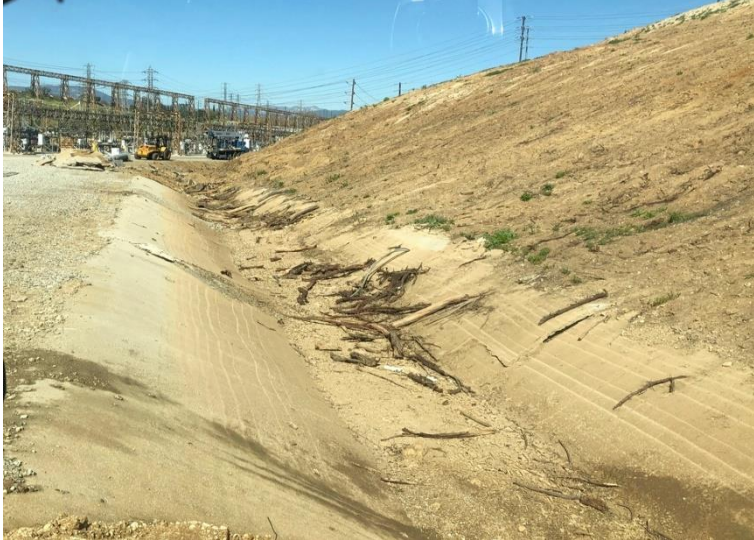
Photo 9 – Portion of the concrete-lined channel remains south of the old substation. Photo facing east.

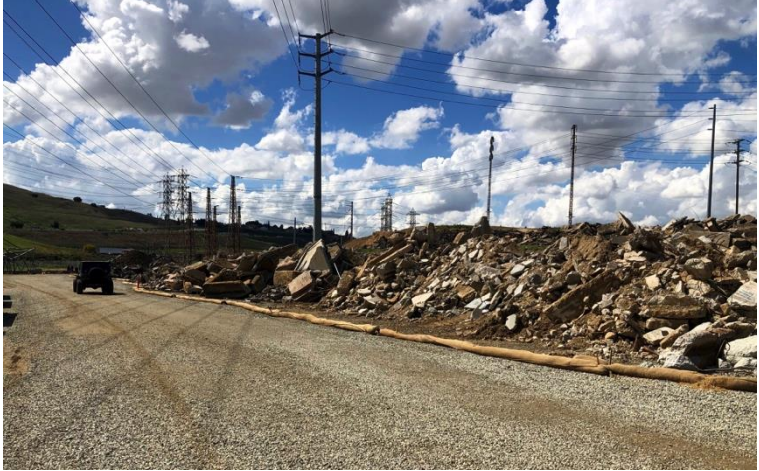
The amount of stockpiled material continued to grow in the area south of the old substation; straw wattles had been placed around the piles (Photo 1). Contaminated soil excavated during the Phase 3 grading operation are being kept in sealed containers in this same area (Photo 2).

Photo 1 – Stockpiled materials with straw wattle around them. Photo facing southwest.
3/11/20	Mesa Substation

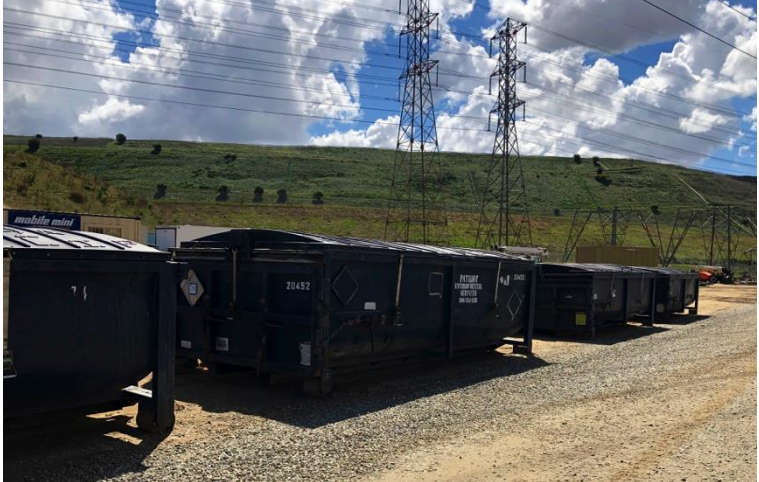
Photo 2 – Containers for contaminated soil. Photo facing south.
3/11/20	Mesa Substation

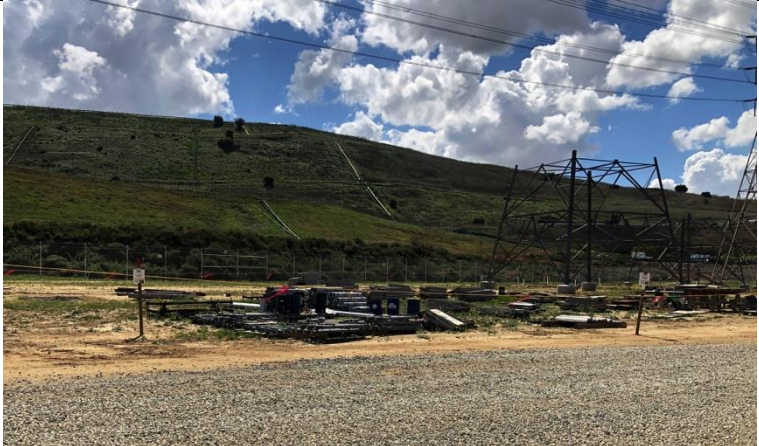
The costal California gnatcatcher nest remained active, so the buffer fencing and signage remained in place (Photo 3). From a certain vantage point, the avian biologist can see the nest and reported that the nest had been completed but no eggs were noted yet. Mr. Daniele had two additional avian biologists onsite acting as biological monitors.

Photo 3 – Nest buffer signage and roped off buffer limit. Photo facing south.

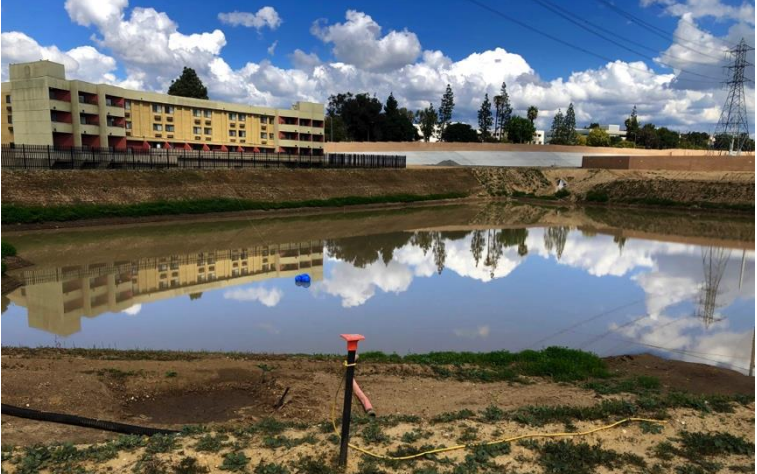
The pumping equipment has been removed from the large retention basin access road and, according to Mr. Daniele, they are checking into ways to dewater the basin (Photo 4).

Photo 4 – The large retention basin; the pumping equipment has been pulled out of the area. Photo facing northeast.
3/11/20	Mesa Substation

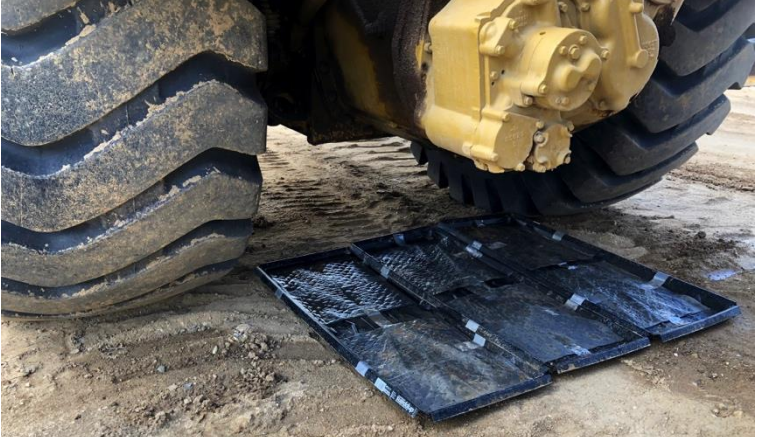
Major grading work was on hold because of the rainy weather, so there were numerous large pieces of equipment parked onsite. I checked the secondary containment and felt additional drip pans under the larger pieces were needed (Photo 7). I passed my concerns on to Mr. Daniele.

Photo 7 – Secondary containment under some parked equipment.
3/11/20	Mesa Substation

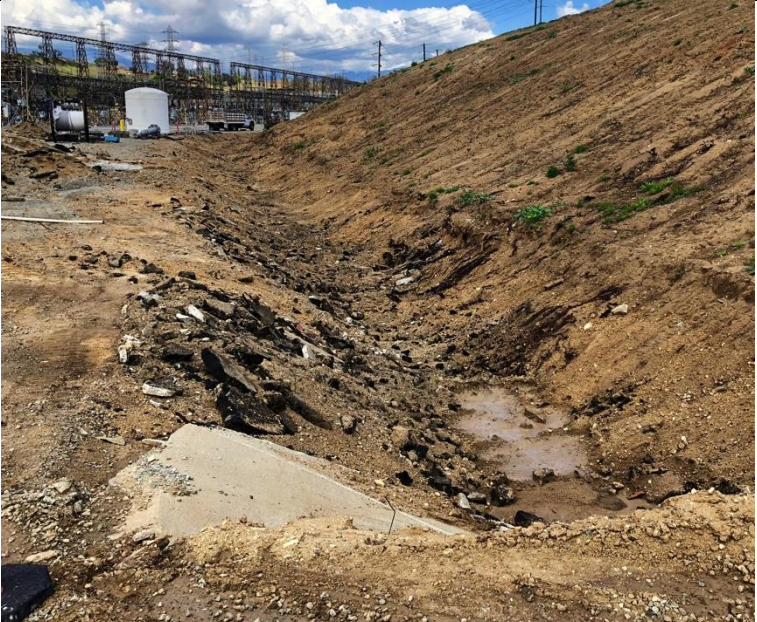
The concrete-lined channel running along the south side of the old substation had been partially removed. This area was of concern, since rainwater runoff will collect in this channel and run down into the project site (Photos 8 and 9).

Photo 8 – Old drainage channel along the south side of the existing substation. Photo facing east.
3/11/20	Mesa Substation

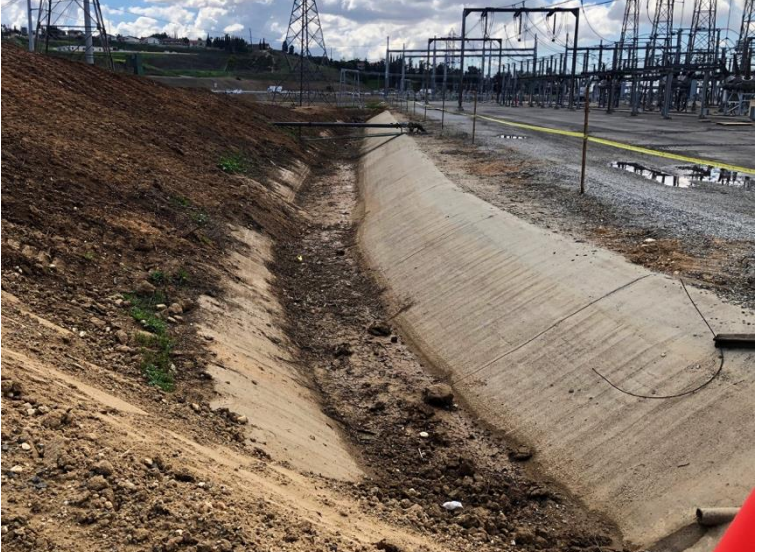
Photo 9 – Old drainage channel along the south side of the existing substation. Photo facing southwest.

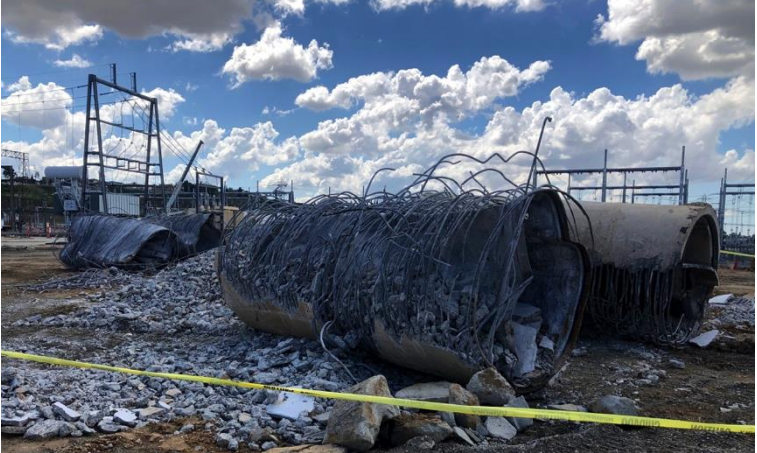
What appeared to be an old storm drainpipe has been removed during the Phase 3 grading and is now being broken up for recycling (Photo 10). Additional portions of this pipe are being excavated (Photo 11).

Photo 10 – Old drainpipe removed during the Phase 3 grading operation. Photo facing southwest.
3/11/20	Mesa Substation

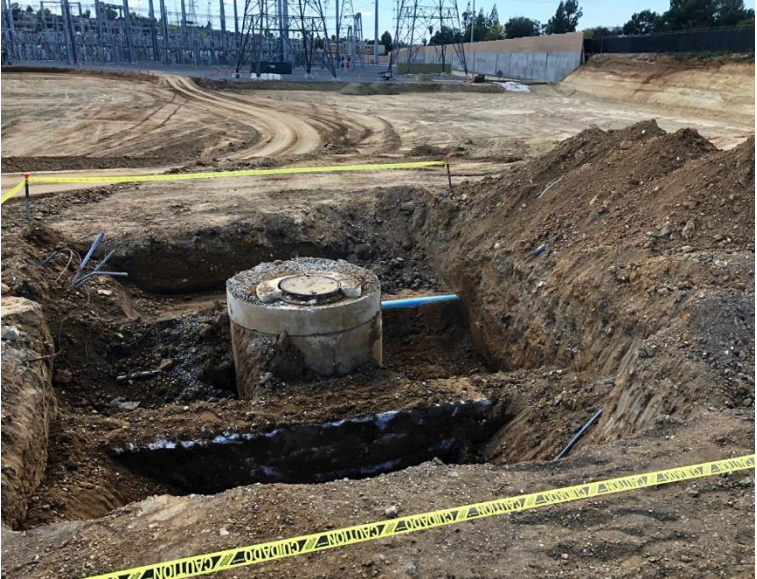
Photo 11 – Old pipe being excavated. Photo facing west
3/11/20	Mesa Substation

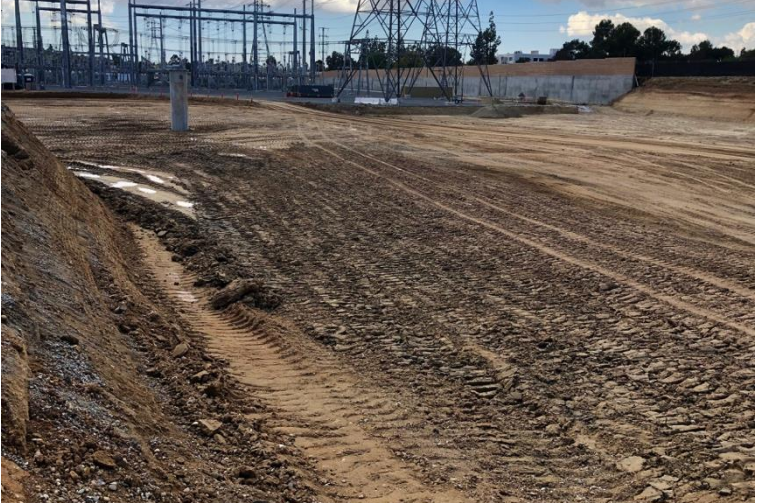
A large quantity of soil work has been performed in the area just northeast of the Senior MEER building (Photo 12). Some equipment was parked within the newly graded area (Photo 13).

Photo 12 – Phase 3 grading area near the Senior MEER building. Photo facing west.

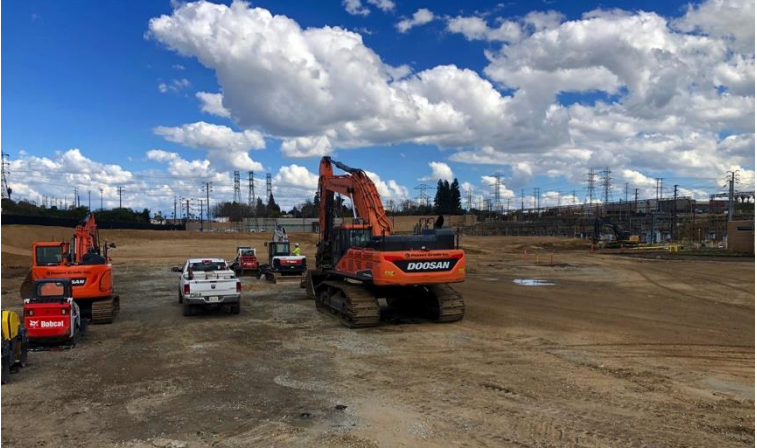
Photo 13 – Parked equipment with the Phase 3 grading area. Photo facing east.
3/11/20	Mesa Substation

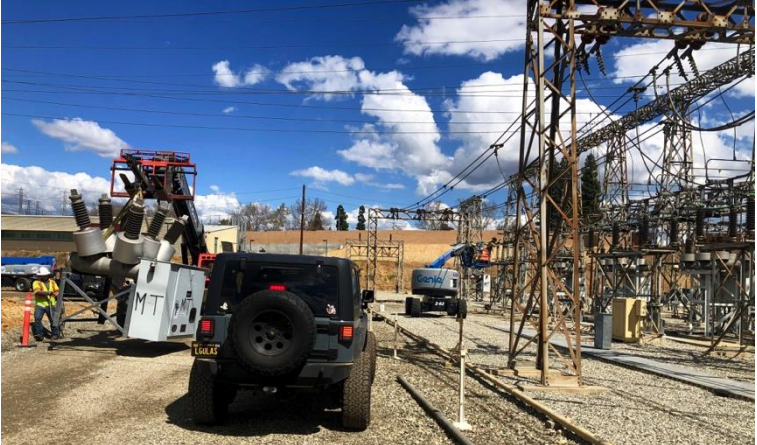
Crews were working within the old substation removing equipment (Photo 14).

Photo 14 – Crews removing equipment from the old substation. Photo facing east.

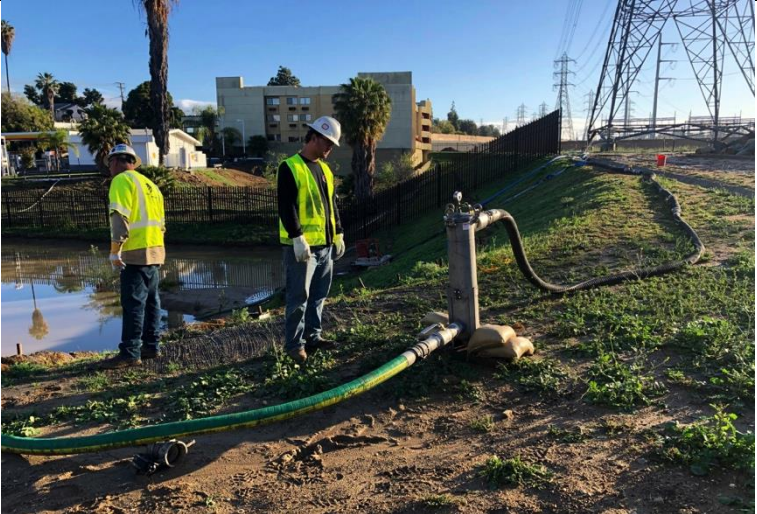
We drove down to the western end of the project where the retention basins are located. A crew was setting up a dewatering system between the large retention basin and the smaller triangular detention basin (Photo 1). They were currently testing the system, pumping a small amount of water through the filtering system and into the small basin (Photo 2). This water was sampled and measured by Inspector Morales, who indicated his equipment measured the turbidity at 125 Nephelometric Turbidity Units (NTUs). Inspector Morales was to be onsite while the dewatering work was being conducted, measuring the turbidity (maximum approved levels call for no more than 250 NTUs) and the volume (maximum pumping rate is 90 cubic feet per second (CFS)).

Photo 1 – Crews installing the dewatering system. Photo facing east.
3/23/20	Mesa Substation

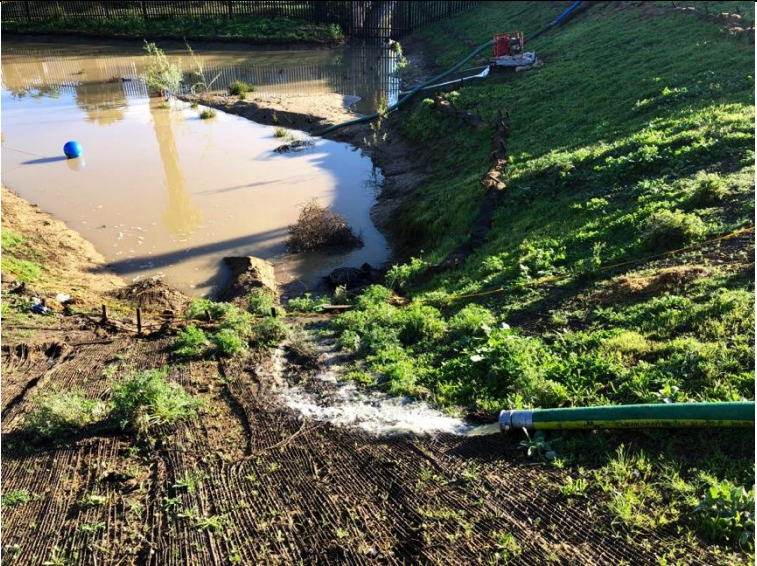
Photo 2 – A small amount of filtered water from the large retention basin is pumped back into the small triangular detention basin. Photo facing north.

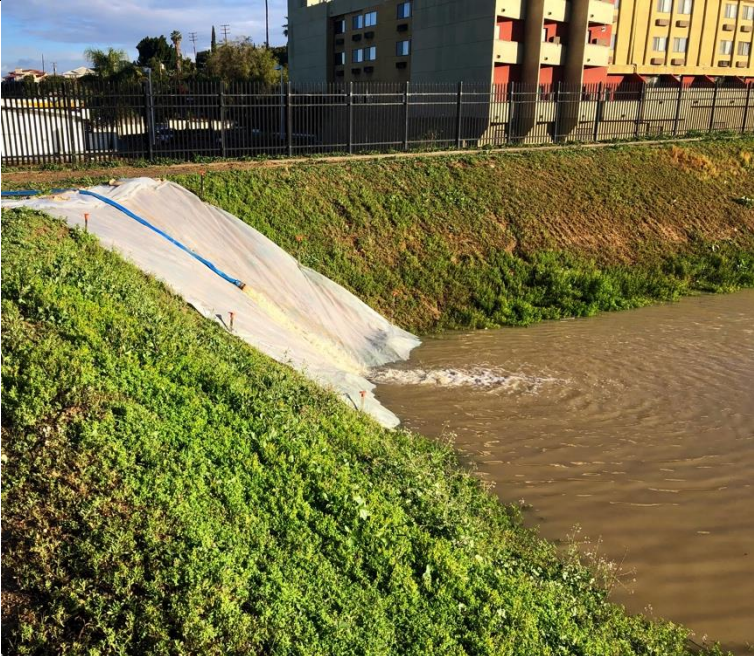
A crew was also pumping out the small triangular detention basin using a large water pump located just over the intake culvert (Photo 3). The drip pan under this pump was in poor condition and needed to be fixed or replaced; I passed this information on to Inspector Morales and Mr. Daniele. Water continued to enter this basin via several drainage ditches; the water was being pumped into the large retention basin with BMPs in place to reduce erosion (Photo 4).

<p>Photo 4 – Water being pumped from the small detention basin into the large retention basin; plastic prevents bank erosion. Photo facing northeast.</p>

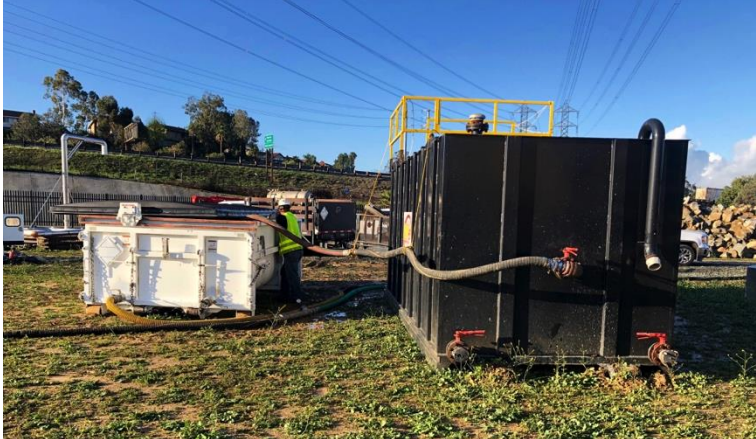
The filtering system consisted of two holding tanks and a generator powering electric water pumps (Photo 5). Water pumps into the larger tank, and then gravity feeds into the smaller tank, which is lined with a filter fabric. Water exiting the smaller tank will then flow into the public drainage system via the standpipe located in the small triangular basin. Crews were installing a flow meter on the pipe coming from the small tank, along with a spigot from which Inspector Morales can take samples. I noticed that the electric water pump appears to have been just dropped into the basin without being attached to a floating device (Photo 6). This seemed like it would compromise the filtering effort, as it would be drawing mud from the bottom of the basin. I mentioned this to Inspector Morales.

Photo 5 – The two-tank filtering systems for dewatering the large detention basin. Photo facing west.
3/23/20	Mesa Substation

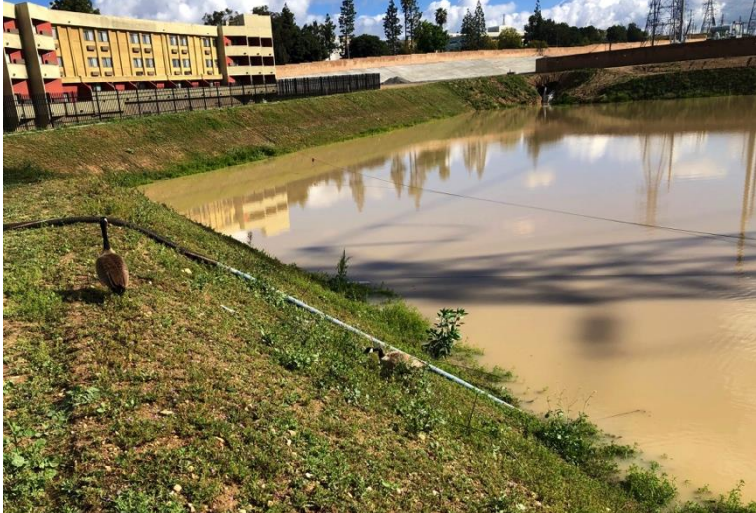
Photo 6 – Electric water pumps for the dewatering system have been laid down the banks of the detention basin. Photo facing northeast.
3/23/20	Mesa Substation

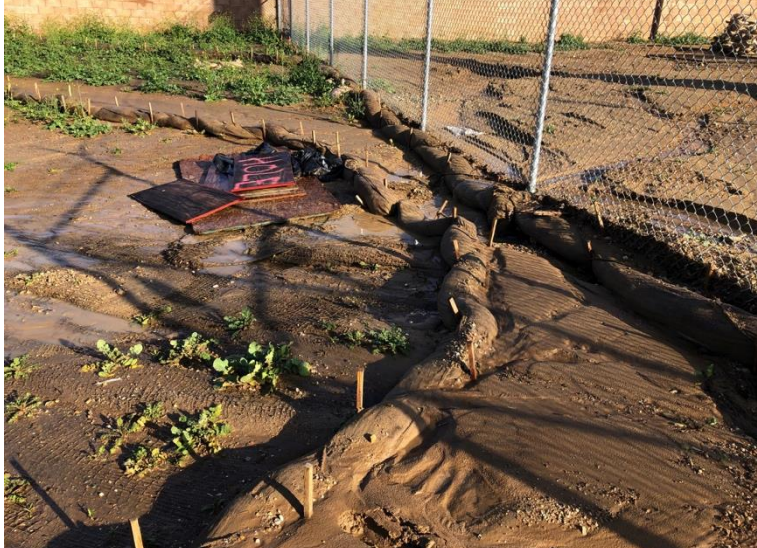
<p>Photo 9 – Initial portion of the BMP area outside of the wall. Photo facing north.</p>

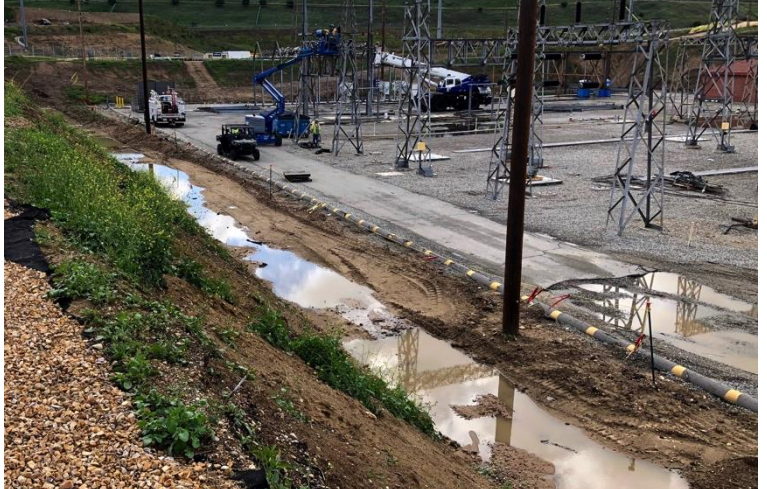
Crews are working within the old substation, removing equipment (Photo 16).

Photo 16 – Rainwater runoff flowing south in the old drainage channel. Crews are working within the old substation. Photo facing south.

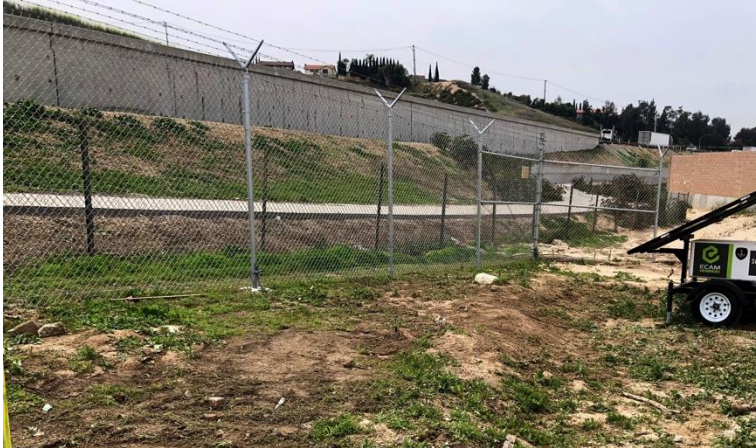
Photo 14 – Weeding work completed by hand. Photo facing west.

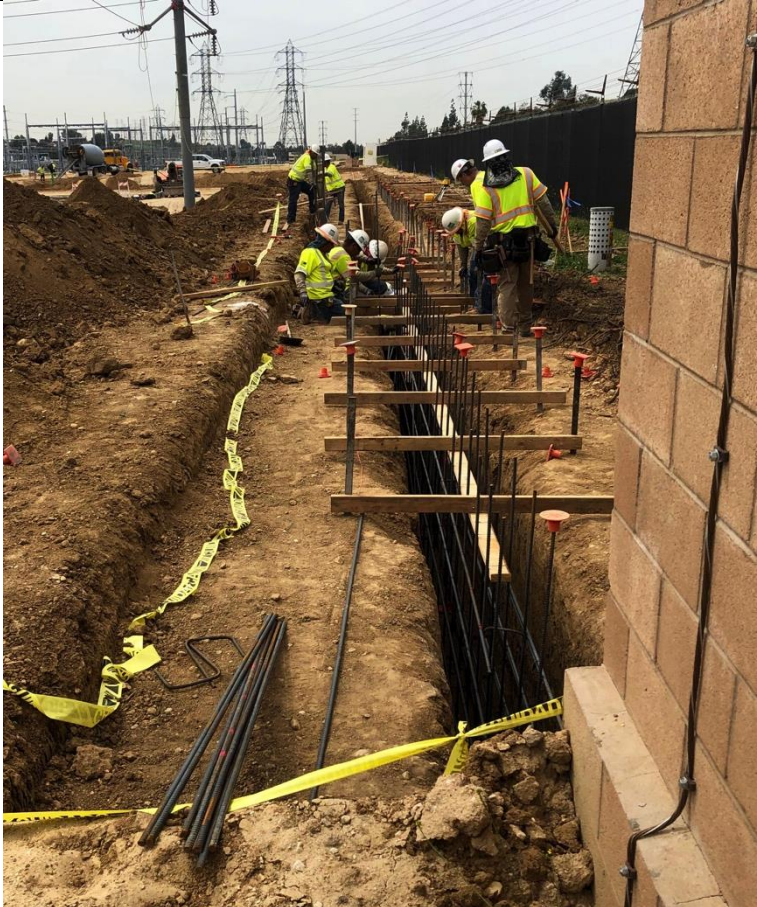
A crew had begun work on the northern boundary wall connecting into the wall around the Mesa Operations Building (Photo 16). The trench has climbing structures in place and the biologists onsite continue to check the trenches first thing in the morning for wildlife. I observed Biological Monitor Wayne Woodroof onsite and we drive over to the work north of Portrero Grande Drive. Crews in this area are restringing wire onto the new poles and are wrecking out the old lattice steel towers (Photos 17 and 18). Mr. Woodroof was hopeful that they would complete this work soon since the vegetation in the area had previously supported nesting birds.

Photo 16 – Trenching and rebar installation being performed for the northern boundary wall. Photo facing west.

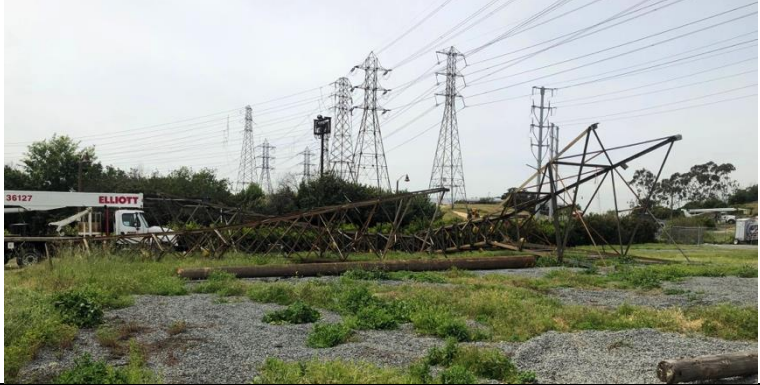
Photo 17 – Wrecking out old lattice steel towers north of Potrero Grande Drive. Photo facing west.
3/31/20	Mesa Substation

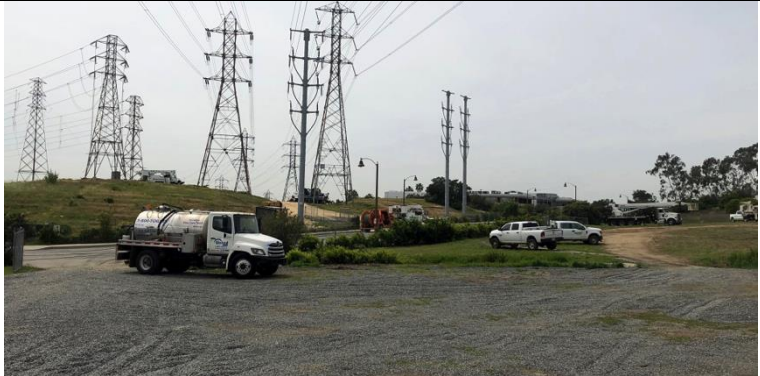
Photo 18 – Wire stringing in the telecommunications area north of Potrero Grande Drive. Photo facing west.
