February 23, 2021

Re: Monthly Report Summary #31 for the Mesa 500-kV Substation Project

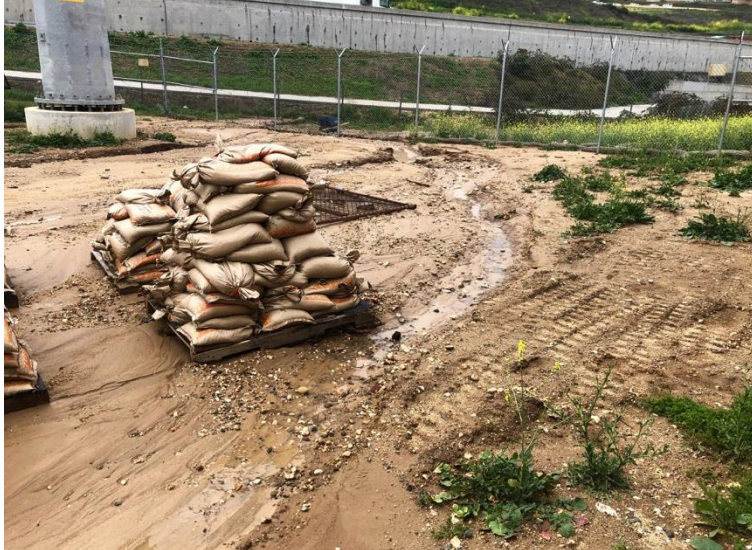
A photograph showing a dirt staging area at a substation. In the foreground, there is a stack of several sandbags on a pallet. A muddy stream of water is flowing through the dirt, indicating rainwater runoff. In the background, there is a chain-link fence and a concrete wall. The sky is overcast.	Photo 7 – Rainwater runoff exiting the site through the equipment staging area. Photo facing southwest.

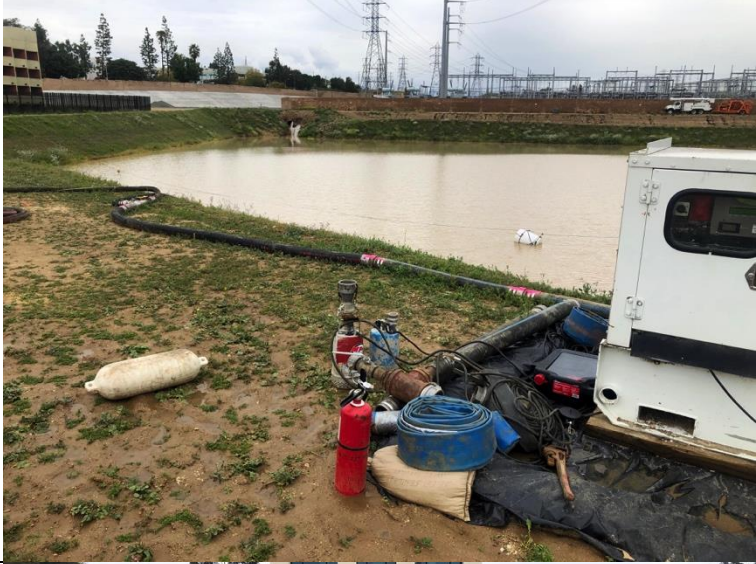
Photo 10 – Dewatering and desilting operation near the large retention basin. Photo facing northeast.
4/07/20	Mesa Substation

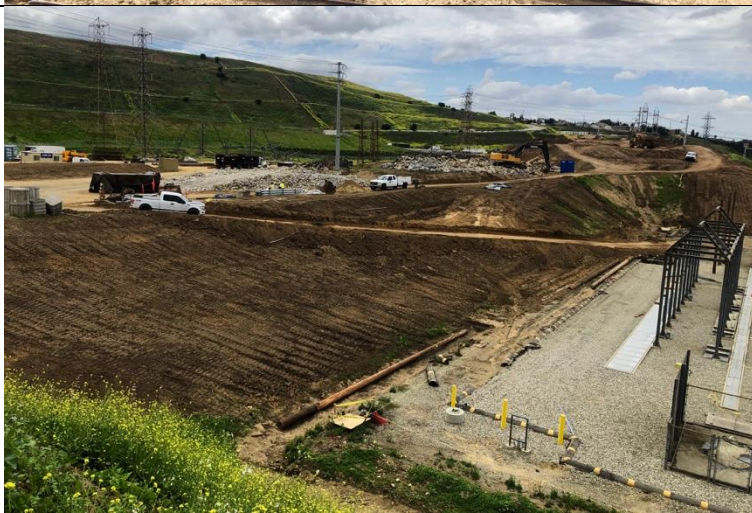
The piles of construction debris continued to be stockpiled within the southeastern portion of the site, with equipment working to break it up for offsite transport (Photo 2). A crew was working on one of the lattice steel towers (Photo 3).

Photo 2 – Demolished construction materials in the southeastern portion of the project site. Photo facing southwest.

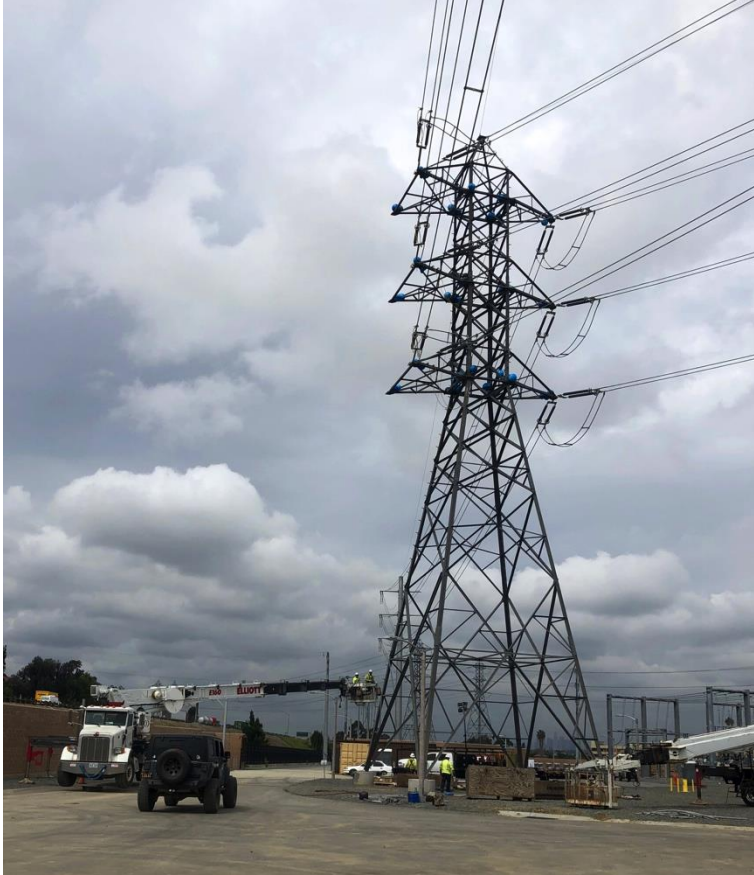
A tall, lattice steel tower is under construction at a substation. The tower is the central focus, with several power lines extending from it. In the background, there are other structures, including a white truck and a dark SUV. The sky is overcast with grey clouds.	Photo 3 – Crew working on a lattice steel tower. Photo facing west.
4/17/20	Mesa Substation

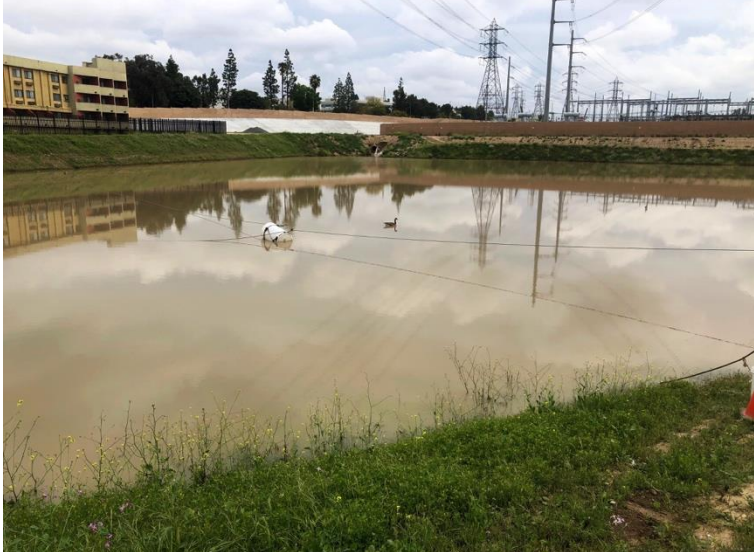
The large retention basin was filling up, but the rainy season was nearly at an end (Photo 4). A pair of Canada geese (*Branta canadensis*) had begun nesting under one of the towers near the basin; nest buffer signs were installed (Photo 5). One of the birds was seen in Photo 4. Lead Biologist Matt Daniele sent me a photo of the nest (Photo 6). We discussed nesting birds and Mr. Daniele said the coastal California gnatcatcher (*Polioptila californica*) nest failed, possibly because of the heavy rains, but they started a new nest. Paperwork was submitted for a new nest buffer reduction.

A large retention basin filled with muddy water is the main subject. The water reflects the sky and the power lines in the background. In the distance, there is a yellow building and several high-voltage power towers. The foreground is a grassy area.	Photo 4 – Large retention basin. Photo facing northeast.

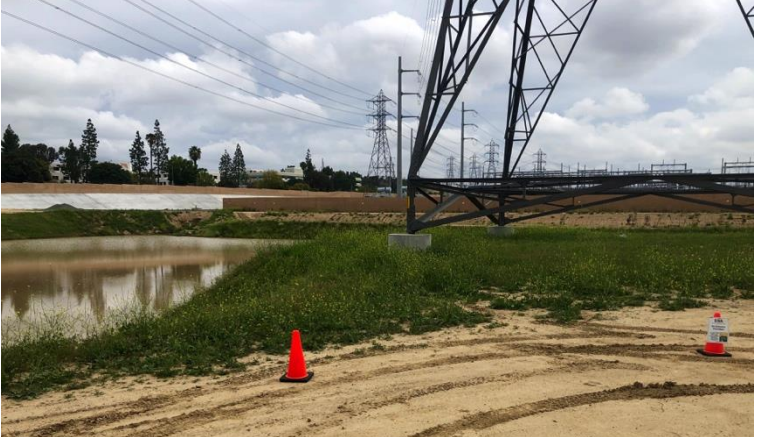
Photo 5 – A pair of Canada geese nesting under the tower; nest buffer signs were installed. Photo facing east.
4/17/20	Mesa Substation

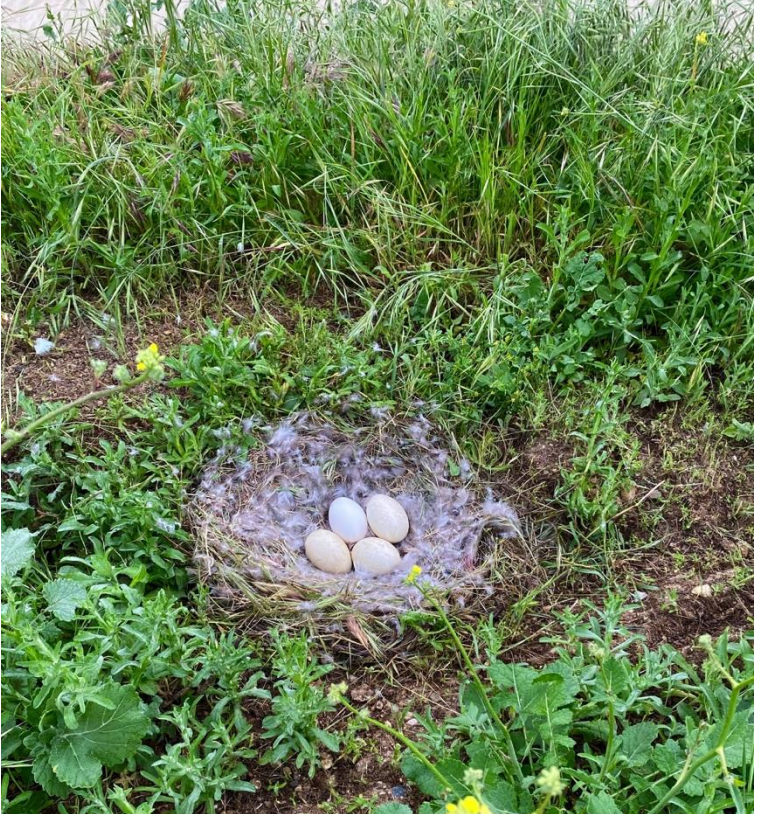
Photo 6 – Canada goose nest under the tower. Photo taken by Matt Daniele.

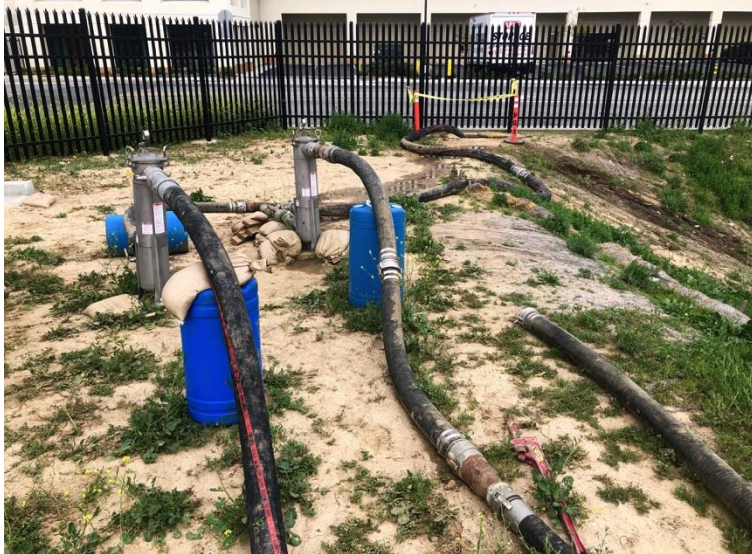
The dewatering operation was up and running, with a full-time SWPPP inspector monitoring the Nephelometric Turbidity Units (NTUs) and flow levels. The SWPPP inspector said all the NTU readings and flow rates were within the approved parameters (Photo 7). The water hose was moved from the standpipe in the small triangular detention basin into the manhole near East Markland Drive (Photo 8). The technician operating the dewatering system said pumping occurred from 0700 to 1900 hours.

A photograph showing several blue cylindrical filtration cannisters connected to a network of black hoses on a sandy, grassy area. In the background, there is a black metal fence and a building.	Photo 7 – Dewatering filtration cannisters. Photo facing west.
4/17/20	Mesa Substation

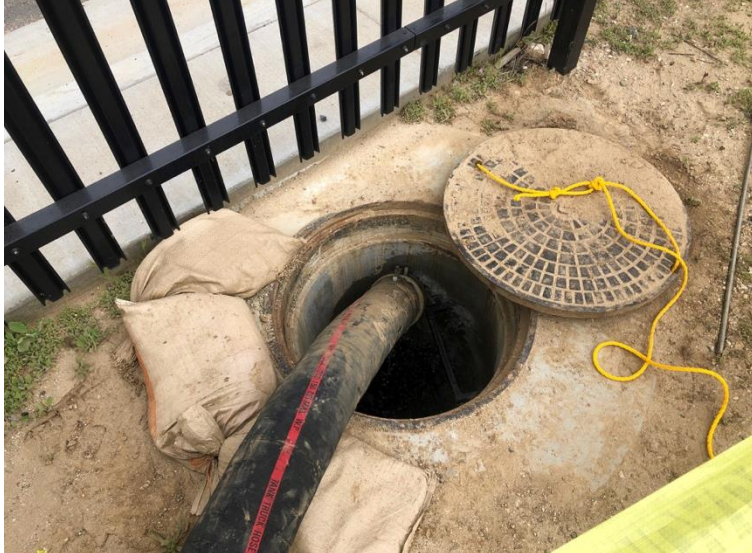
A photograph showing a large black hose leading into a circular manhole opening. A concrete manhole cover is nearby, and a yellow rope is tied to it. The area is sandy and partially enclosed by a black metal fence.	Photo 8 – Filtered water going into the offsite drainage system.

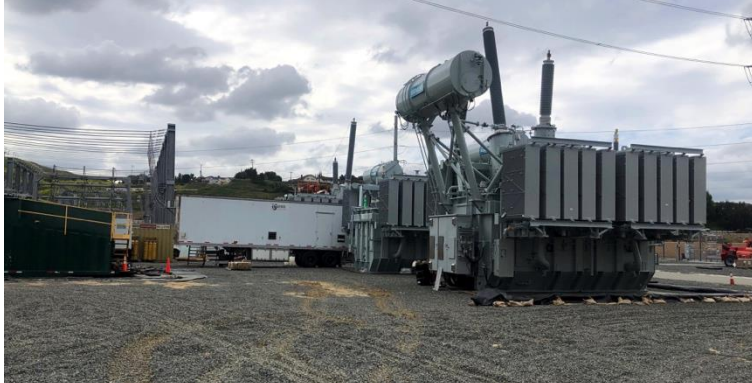
Transformers continued to be worked on within the new rack areas (Photo 11). I checked the fuel tanks within the construction fueling station and their secondary containment appeared in good condition.

Photo 11 – Transformers within the new rack areas. Photo facing south.
4/17/20	Mesa Substation

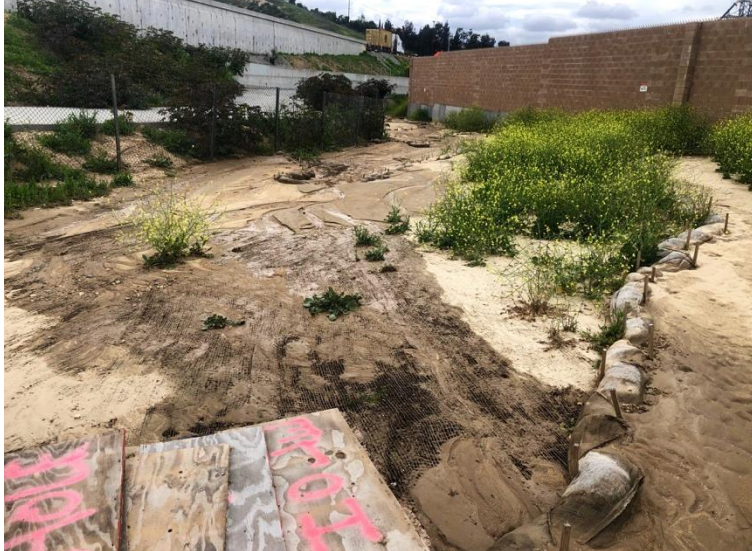
No maintenance or upgrades to the BMPs were completed along the outside of the southern boundary wall (Photo 12). These BMPs were not functioning so sediment-laden water was flowing through the southeastern portion of the project site. Channels cut by the rainwater runoff showed that a large quantity of water was coming through the area (Photo 13).

Photo 12 – BMPs outside of the southern boundary wall. Photo facing west.
4/17/20	Mesa Substation

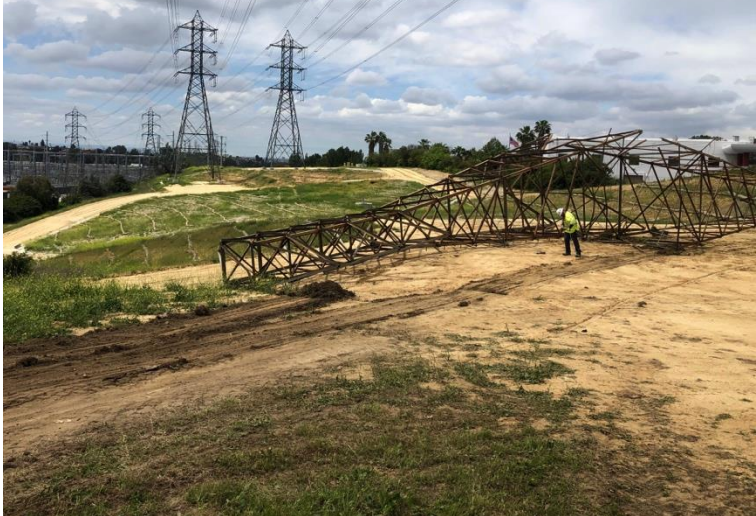
A crew was working north of Potrero Grande Drive, removing some of the existing lattice steel towers (Photo 21). The exit and entry BMPs into the area were not functioning and mud was being tracked out onto the public roadway (Photo 22). I spoke to

Photo 21 – Lattice steel tower removal within the telecommunications corridor north of Potrero Grande Drive. Photo facing west.

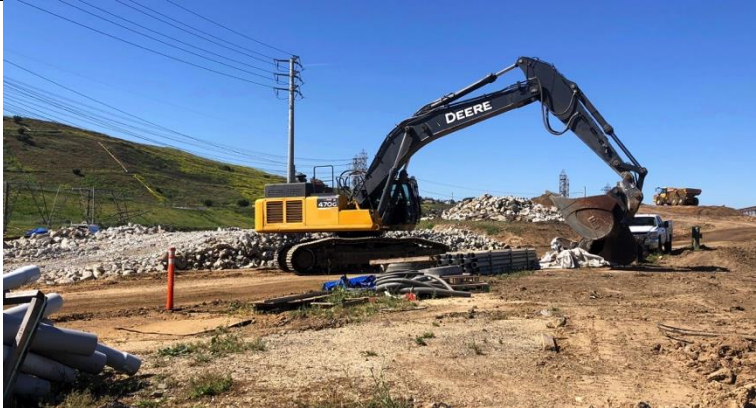
Photo 1 – Demolished construction materials in the southeastern portion of the project site. Photo facing southwest.
4/24/20	Mesa Substation

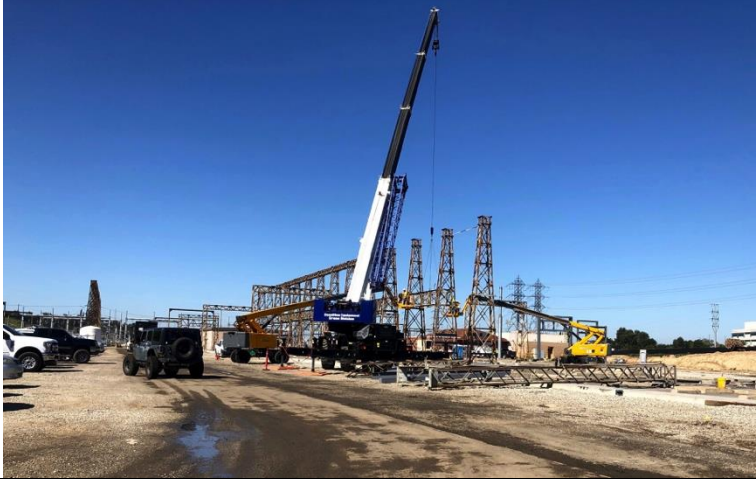
Photo 2 – Removal of the existing substation infrastructure. Photo facing west.
4/24/20	Mesa Substation

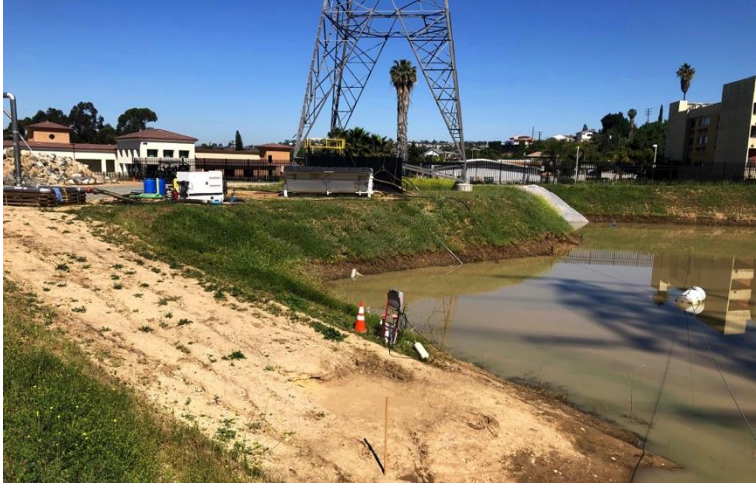
Photo 3 – Large retention basin and dewatering system. Photo facing north.

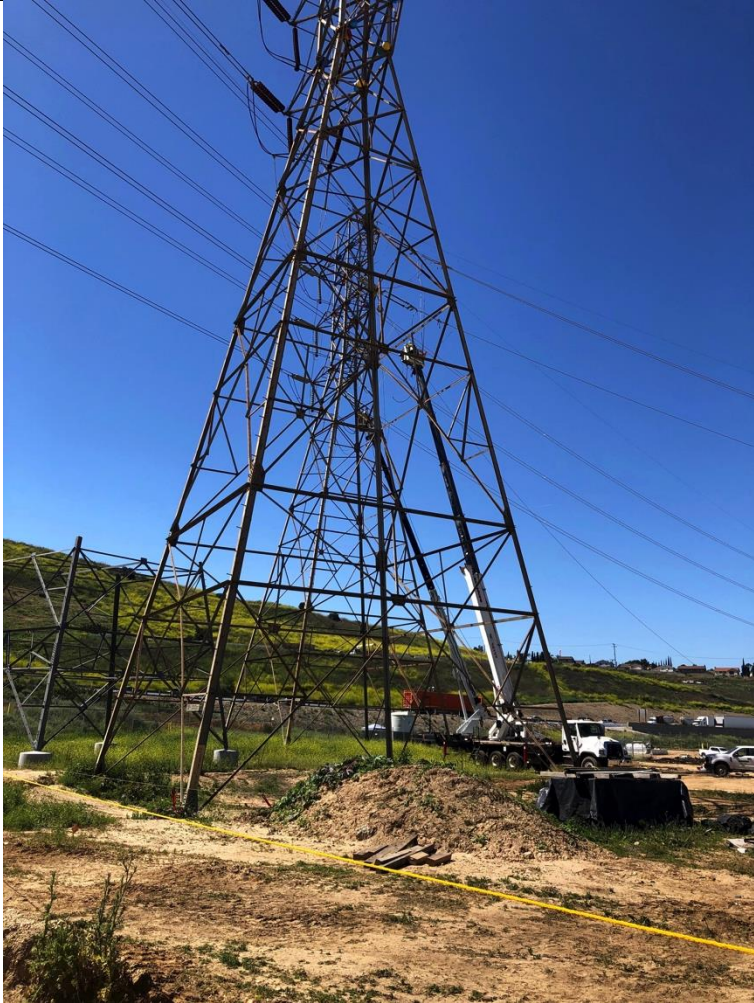
Photo 9 – Line crew pulling wire to the lattice steel towers. Photo facing southwest.

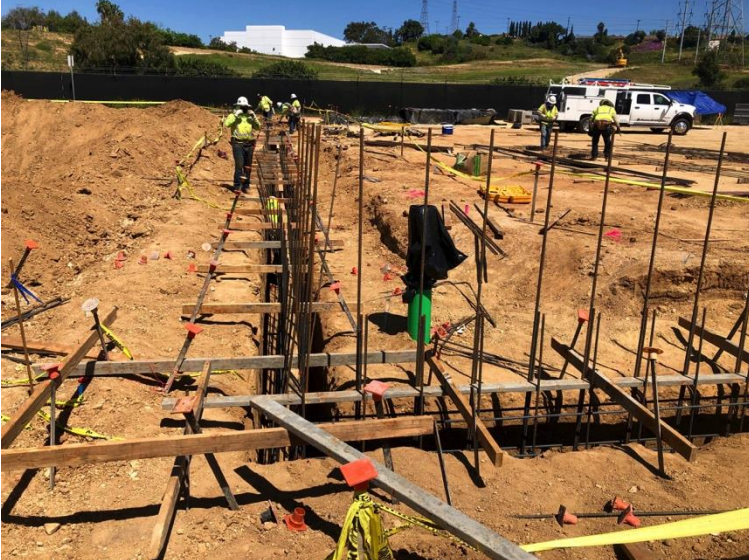
Photo 13 – Northern boundary wall construction. Photo facing north.
4/24/20	Mesa Substation

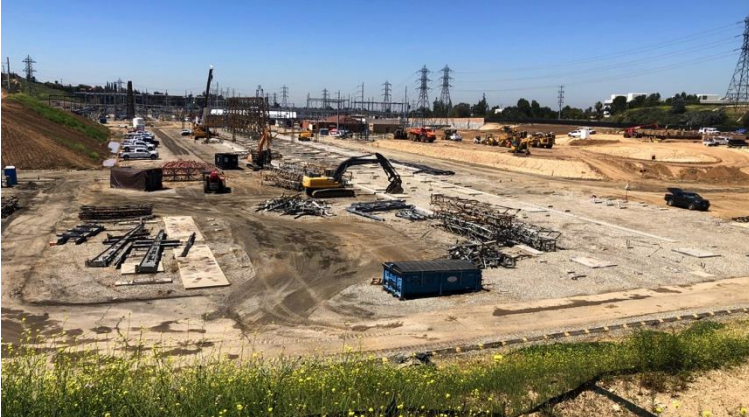
Photo 15 – Overview of the Phase 3 grading and substation demolition. Photo facing west.

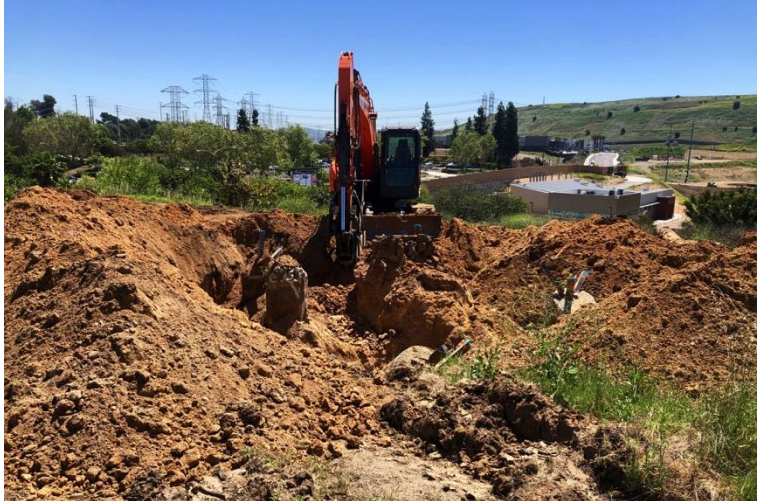
Photo 16 – Removal of the existing tower foundations within the Transmission Corridor north of Potrero Grande Drive. Photo facing south.

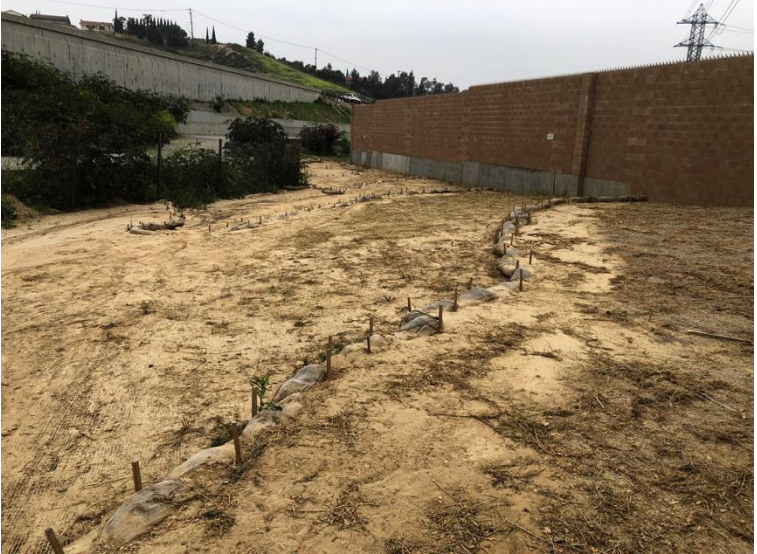
Photo 3 – Area outside of the southern boundary wall had been weeded. Photo facing southwest.

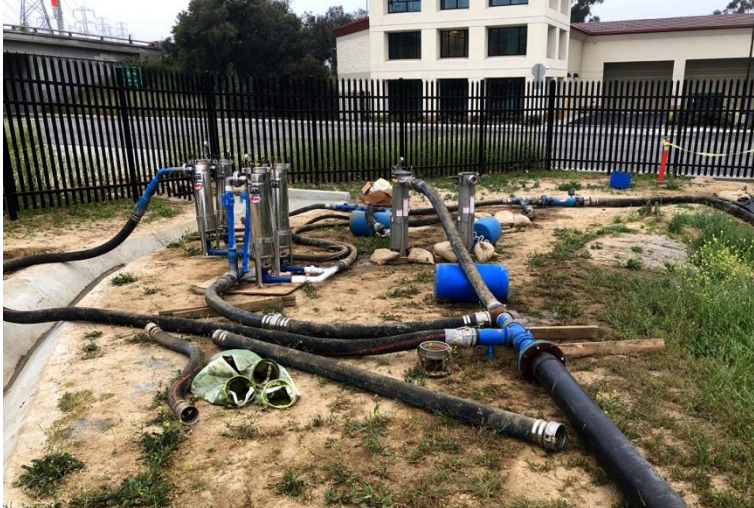
Photo 8 – Filter canisters had been doubled. Photo facing west.
4/30/20	Mesa Substation

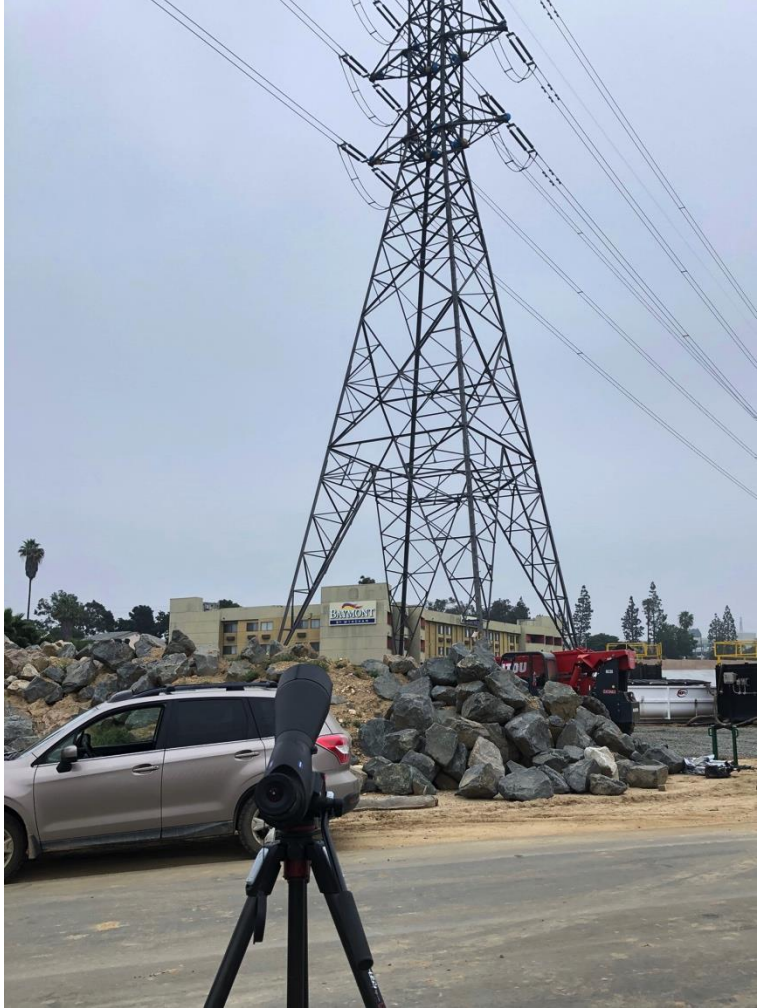
Photo 10 – A raven nest in a lattice steel tower. Photo facing northeast.
4/30/20	Mesa Substation
