**Re: Monthly Report Summary #38 for the Mesa 500-kV Substation Project**

CPUC Site Inspection Reports  
November 4, 11, and 19, 2020

## Mesa 500–kV Substation Project CPUC Site Inspection Form

<b>Project:</b>	Mesa 500-kV Substation Project	<b>Date:</b>	November 4, 2020
<b>Project Proponent:</b>	Southern California Edison (SCE)	<b>Report #:</b>	VS142
<b>Lead Agency:</b>	California Public Utilities Commission (CPUC)	<b>Monitor(s):</b>	Vince Semonsen
<b>CPUC PM:</b>	Connie Chen, Energy Division	<b>AM/PM Weather:</b>	Warm and calm with hazy sunshine
<b>WSP CM:</b>	Silvia Yanez	<b>Start/End time:</b>	1100 to 1245 hours
<b>Project NTP(s):</b>	Notice to Proceed (NTP)-1, NTP-2

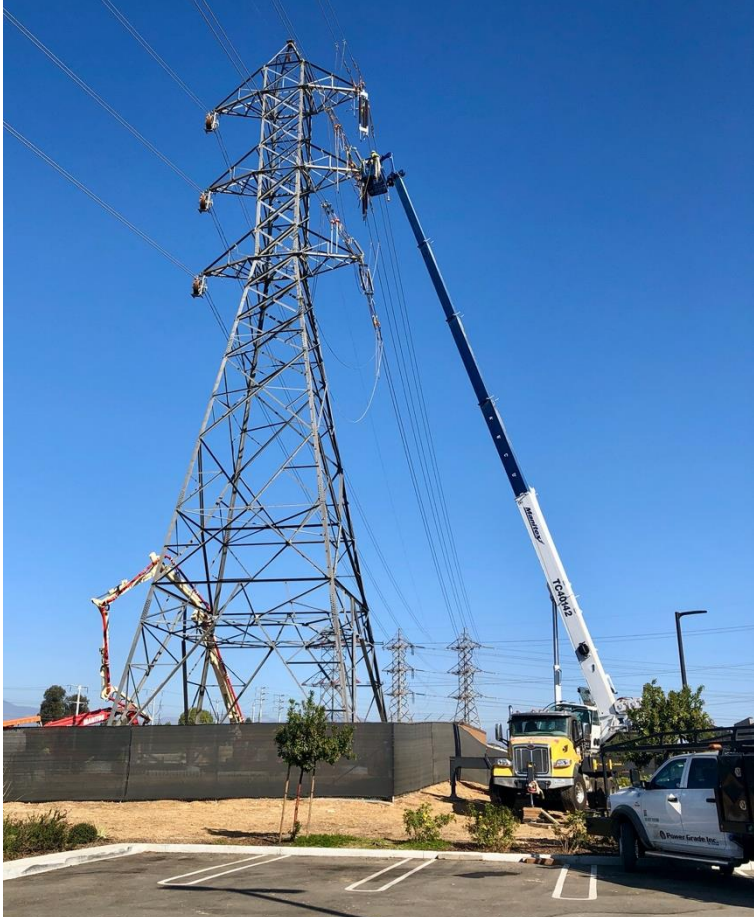
I arrived onsite at 1130 hours and noted installation work on the new lattice steel tower installed within the telecommunications corridor near the construction trailers (Photo 1). Portions of the existing tower was being staged north of the trailers (Photo 2). Some additional footings were being poured for another lattice steel tower adjacent to the newly installed tower (Photo 3).

<p>A tall, lattice steel tower is under construction. A large blue and white crane is positioned to the right, with its boom extended towards the tower. The tower is situated in an open area with a parking lot in the foreground and other utility structures in the background under a clear blue sky.</p>	Photo 1 – Wire work on a new lattice steel tower. Photo facing east.
11/19/20	Mesa Substation

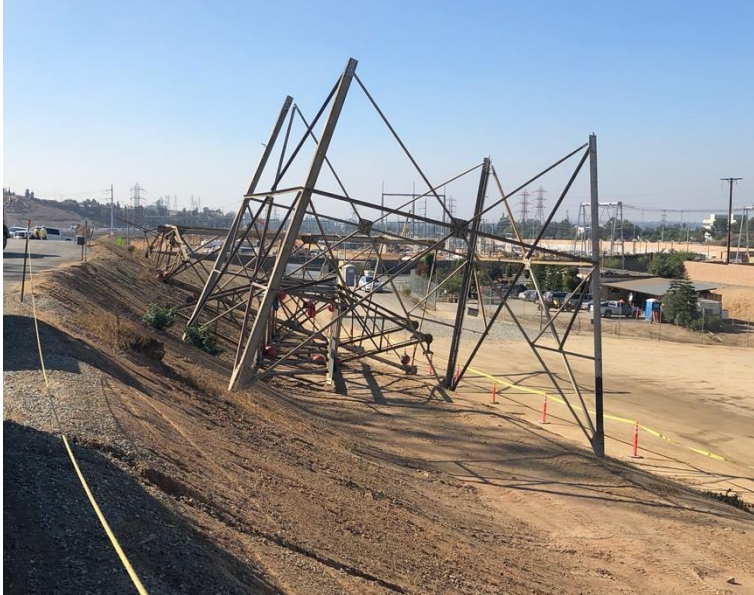
<p>A large lattice steel tower structure is shown in a collapsed or partially dismantled state. It is situated on a dirt embankment. In the background, there are construction trailers and other utility structures under a clear sky.</p>	Photo 2 – Portions of the existing lattice steel tower near the construction trailers. Photo facing west.

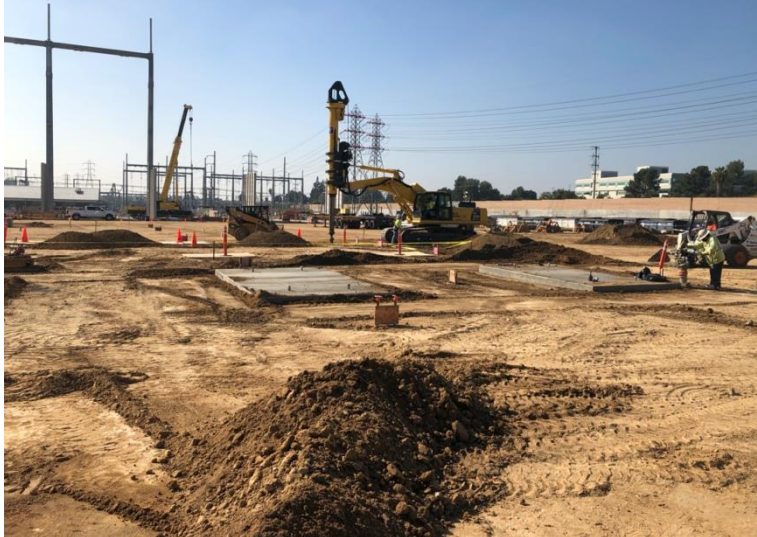
Mr. Lubich introduced me to John Lino, the Professional Electrical Construction Services superintendent. I also meet Adrian Vasquez from Professional Electrical Construction Services, who described the work they were performing. Professional Electrical Construction Services was working on foundation installation (Photo 14) and the installation of the infrastructure around the transformer foundations (Photos 15 and 16).

A wide-angle photograph of a construction site at the Mesa Substation. The ground is mostly dirt with some concrete foundations laid out. In the background, several tall metal structures are under construction, and a yellow crane is visible. The sky is clear and blue.	Photo 14 – Phase 4 foundation work. Photo facing west.
11/19/20	Mesa Substation

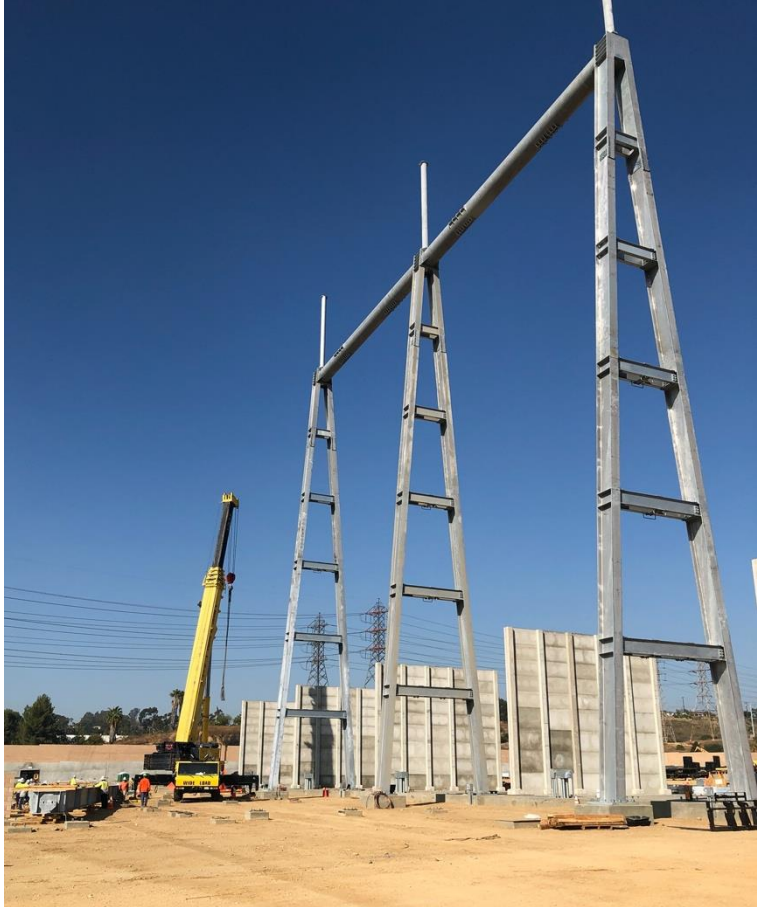
A close-up photograph of large, silver metal infrastructure structures being installed at the Mesa Substation. The structures are tall and have a lattice-like design. A yellow crane is positioned to the left, and a concrete wall is visible in the background. The sky is clear and blue.	Photo 15 – Ongoing infrastructure installation within the Phase 4 area by Professional Electrical Construction Services. Photo facing north.
