March 12, 2021

Re: Monthly Report Summary #39 for the Mesa 500-kV Substation Project

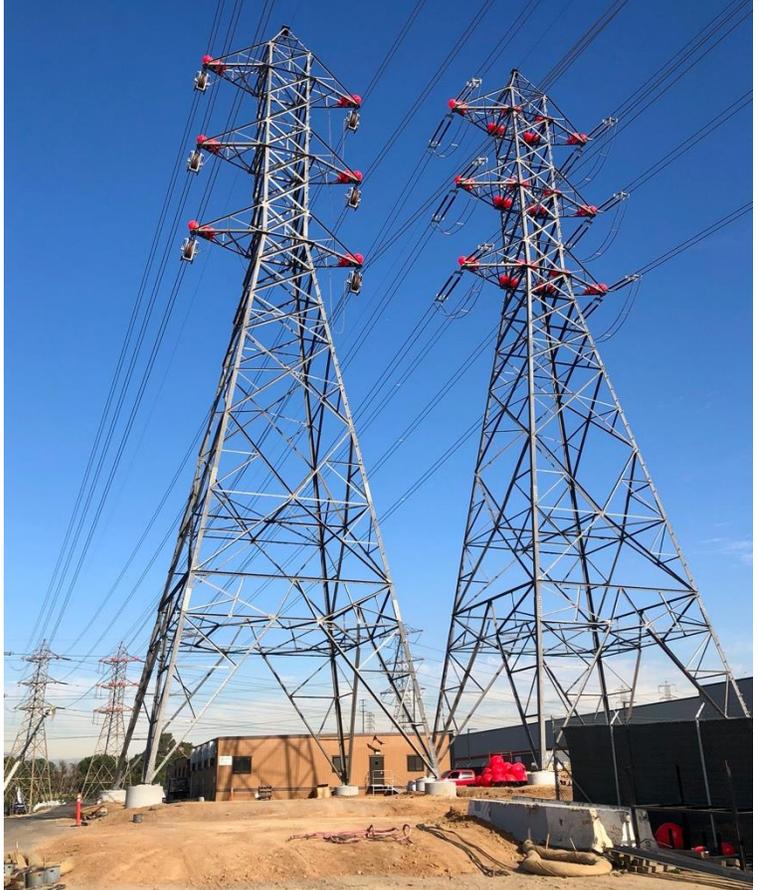
The new lattice steel towers near the trailers had been installed and appeared to have most of the raptor nest exclusion balls installed (Photo 1). Wire work continued along the transmission corridor with equipment in place on either side of Market Place Drive (Photo 2). Photo 3 provided an overview of the Phase 4 portion of the site taken near the construction trailers (Photo 3).

<p>Photo 1 – Lattice steel towers near the construction trailers with raptor nest exclusion balls installed. Photo facing east.</p>
12/09/20	Mesa Substation

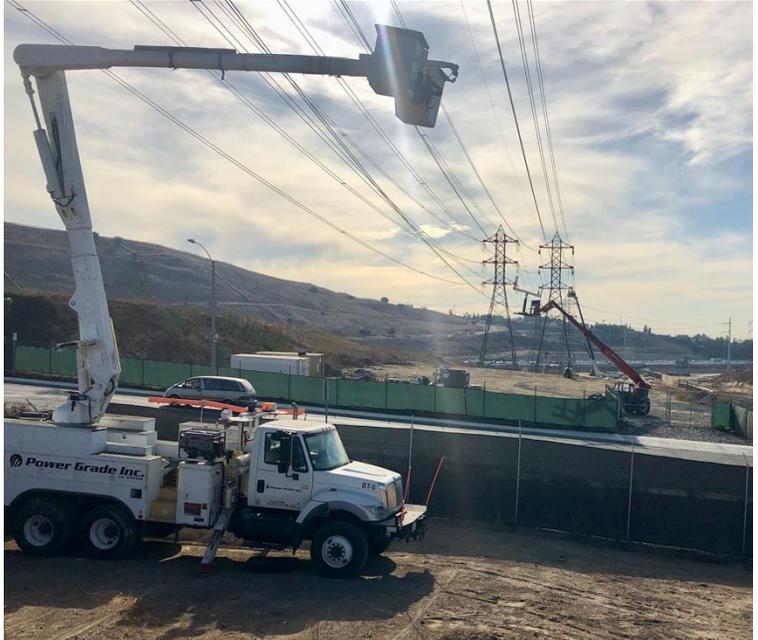
<p>Photo 2 – Wire stringing equipment parked on either side of Market Place Drive, west of the construction trailers. Photo facing west.</p>

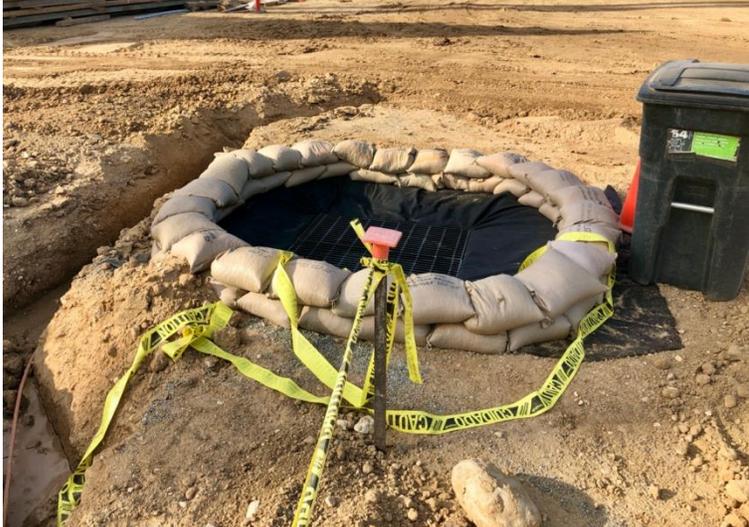
Most of the storm drain inlets were sealed off with sediment control BMPs (Photo 6). No rainwater runoff was expected to enter the drainage system.

Photo 6 – BMPs around the storm drain inlets.
12/09/20	Mesa Substation

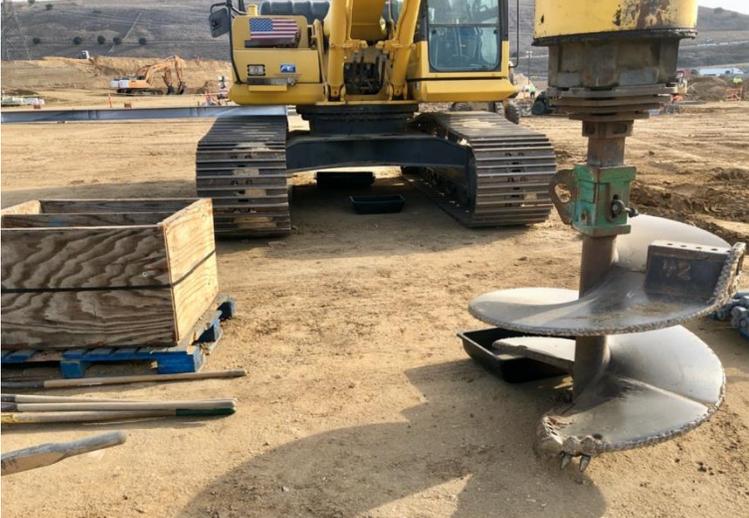
Power Grade continued to work on the storm drain system (Photo 11). Equipment parked onsite appeared to have adequate secondary containment (Photo 12).

Photo 12 – Secondary containment appeared adequate under the parked equipment. Photo facing south.
12/09/20	Mesa Substation

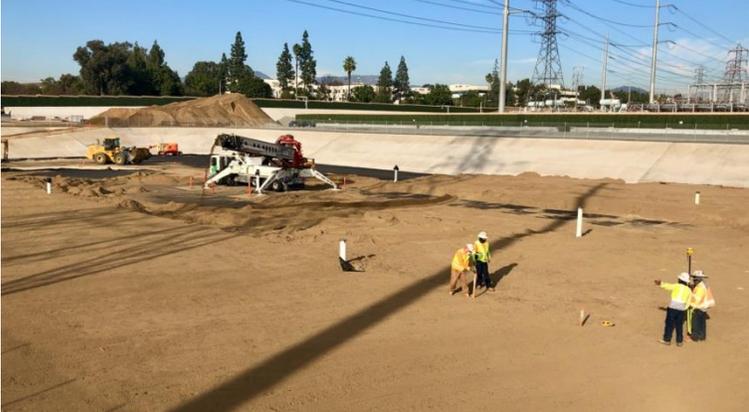
We drove to the detention basins where crews were adding an additional layer of material over the pea gravel and piping (Photo 13). The sediment remained in the small triangular catch basin and in the V ditch leading into the basin.

Photo 13 – Additional layers added to the eastern portion of the detention basin. Photo facing north.
12/09/20	Mesa Substation

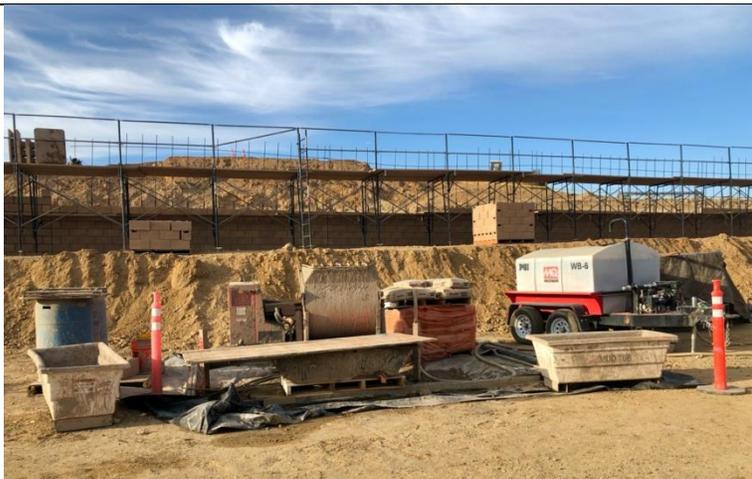
The brick work continued on the southern boundary wall; the mortar mixing station appeared clear of trash and was well contained (Photo 15).

Photo 15 – Brick laying continued on the southern boundary wall. Photo facing north.

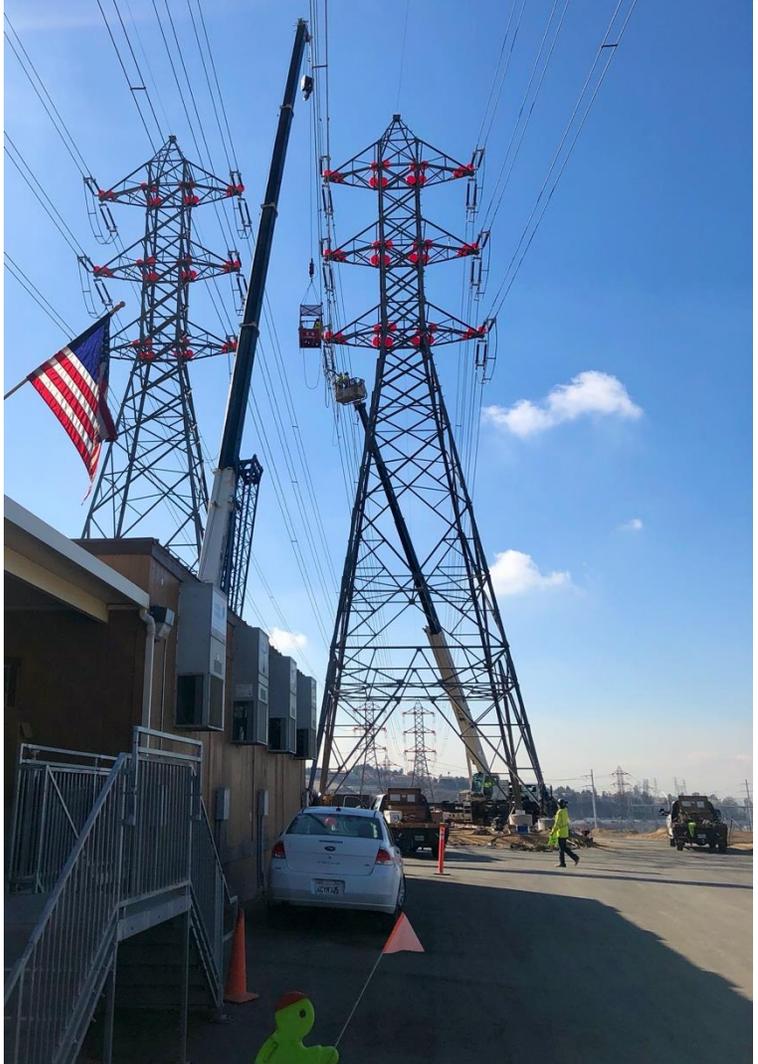
Crews were working in the lattice steel towers adjacent to the trailers (Photo 1) and in the towers east of the trailers (Photo 2). It appeared they were installing the raptor nest exclusion balls. According to Mr. Daniele, seven additional towers were awaiting installation of the exclusion balls. The work was timely as Mr. Daniele had observed a pair of red-tailed hawks (*Buteo jamaicensis*) exhibiting nesting behavior.

Photo 1 – Work continued on the towers near the construction trailers. Photo facing west.

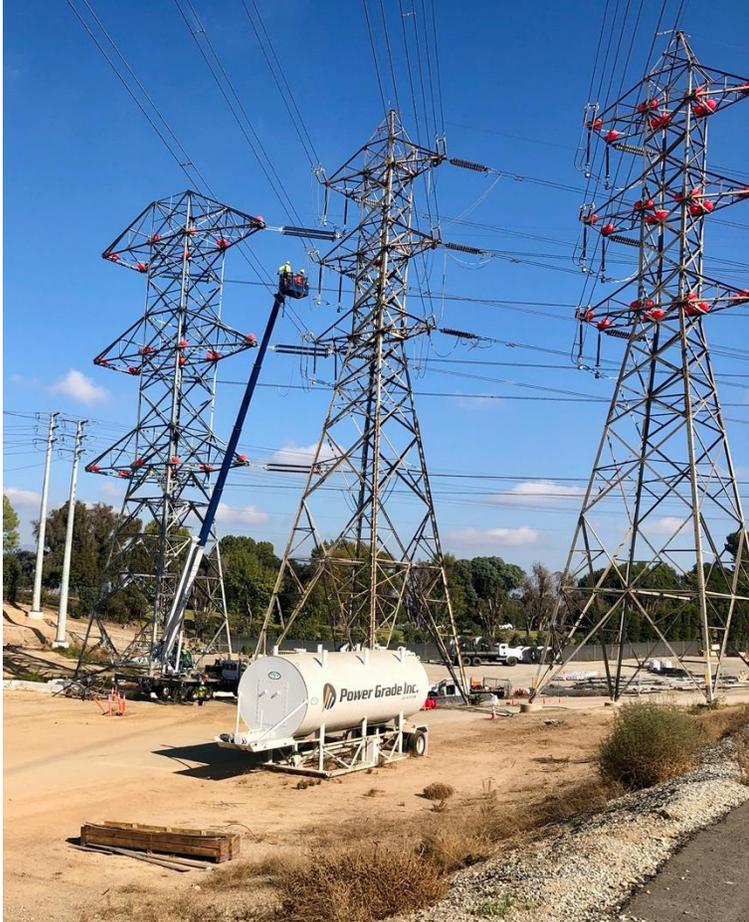
Photo 2 – Work continued on the towers located east of the construction trailers. Photo facing east.
12/17/20	Mesa Substation

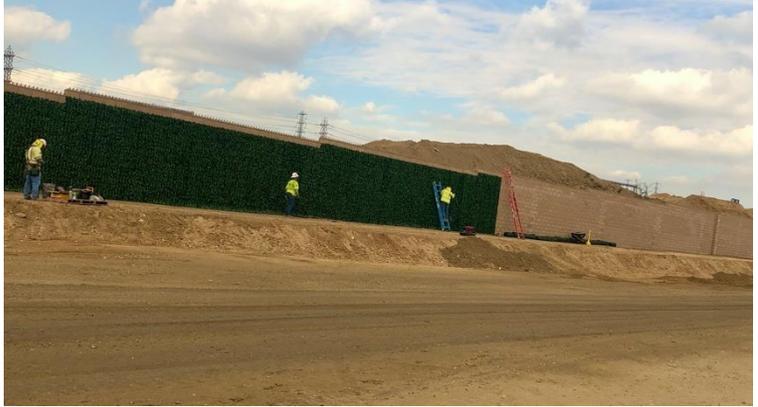
No BMP upgrades had been implemented along the southern portion of the project site. A crew was working on installing green plastic ivy on the southern boundary wall (Photo 12).

Photo 12 – A crew adding plastic ivy to the southern boundary wall. Photo facing northeast.

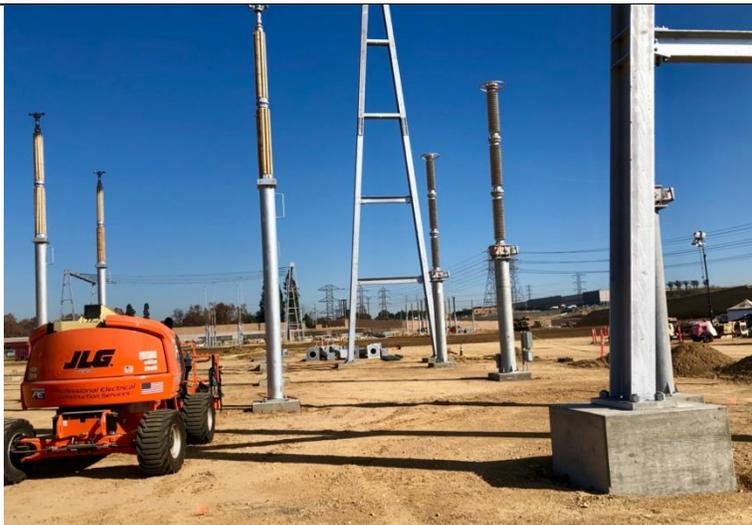
Photo 2 – The 500-kV substation infrastructure. Photo facing northeast.
12/22/20	Mesa Substation

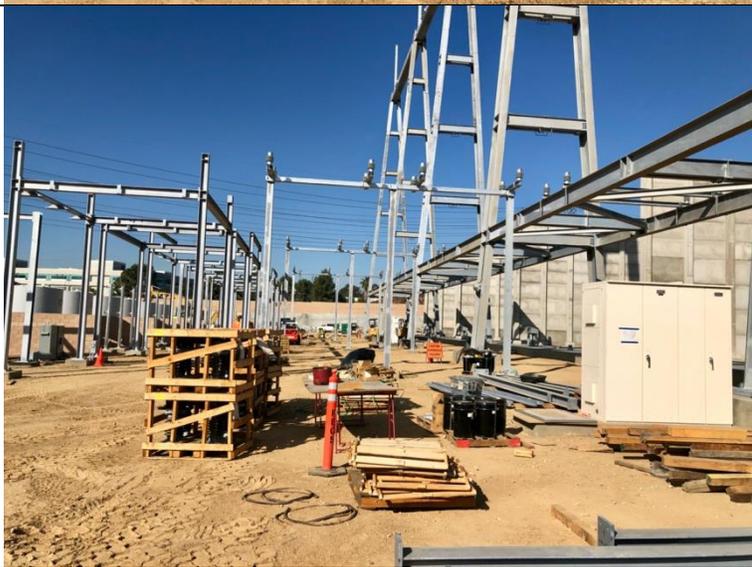
Photo 3 – The 500-kV substation infrastructure installation. Photo facing north.
12/22/20	Mesa Substation

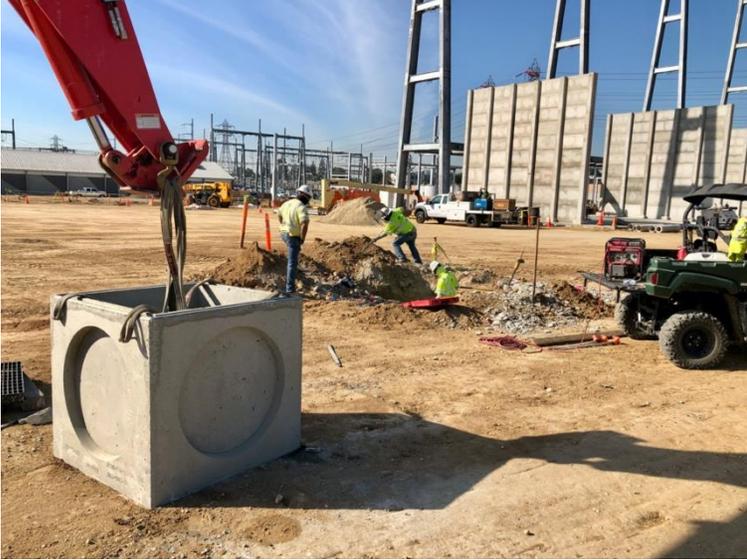
Photo 5 – Upgrades to the stormwater drainage system. Photo facing west.
12/22/20	Mesa Substation

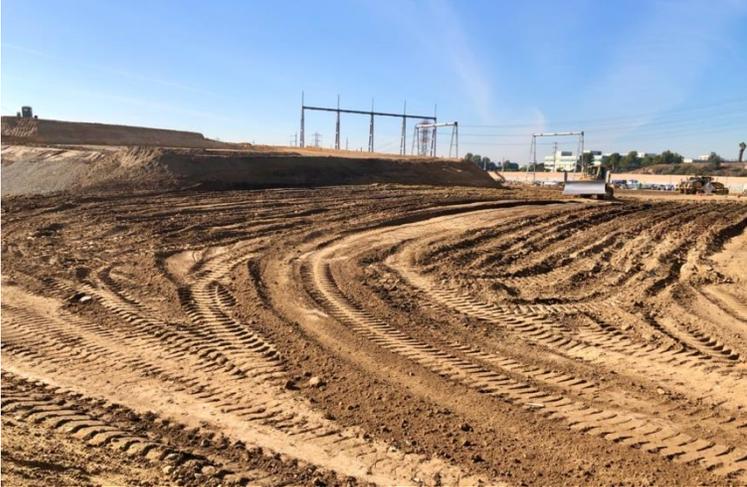
Photo 6 – Earthwork activities conducted by Power Grade crews. Photo facing northwest.
12/22/20	Mesa Substation

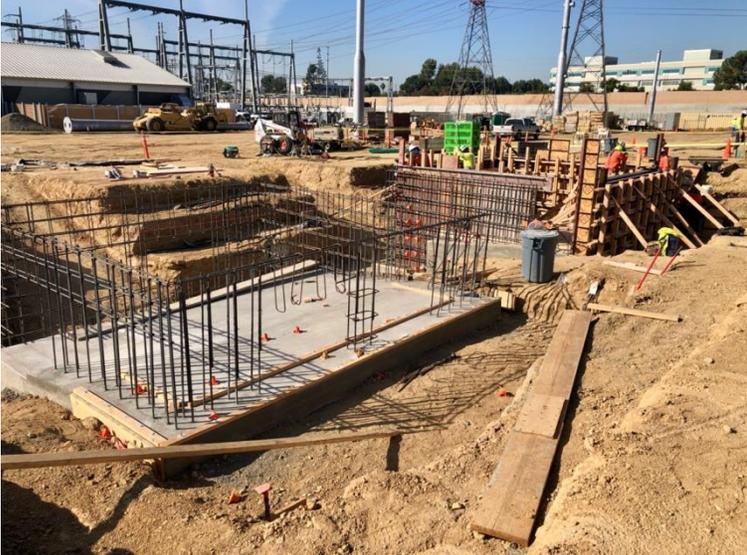
Photo 7 – The cable tray pulling station being formed and poured. Photo facing northwest.

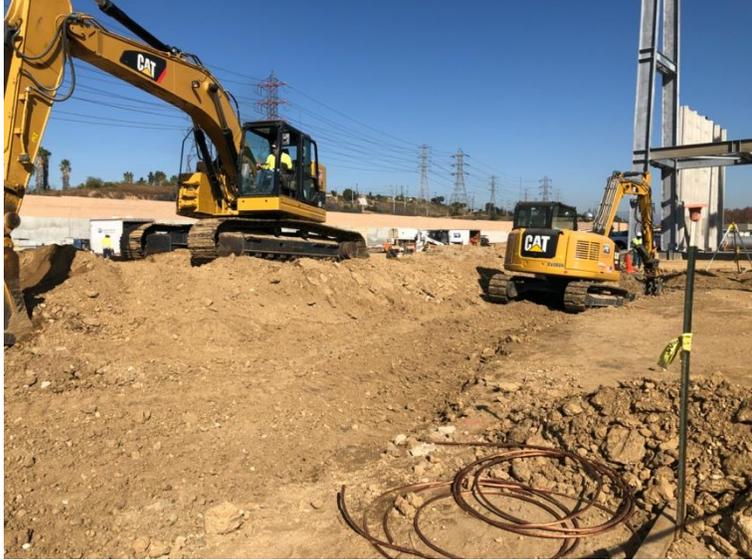
<p>Photo 8 – Backfilling the conduit trench by the Professional Electrical Construction Services crews. Photo facing northeast.</p>
12/22/20	Mesa Substation

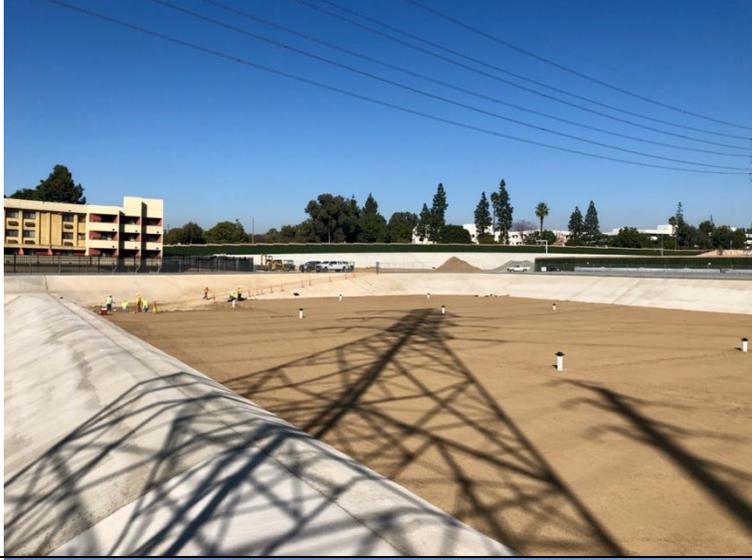
<p>Photo 9 – The final layer of material added to the eastern portion of the detention basin. Photo facing north.</p>
12/22/20	Mesa Substation

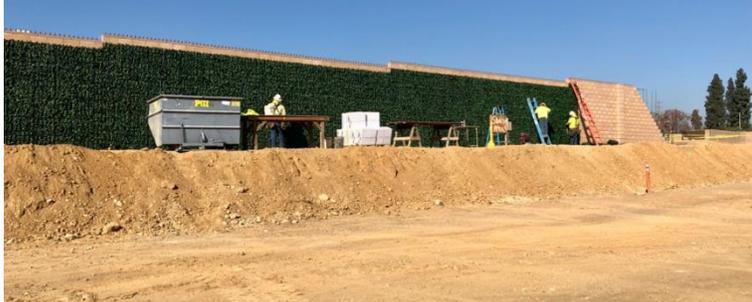
<p>Photo 10 – A crew adding the final plastic ivy to the southern boundary wall. Photo facing northeast.</p>

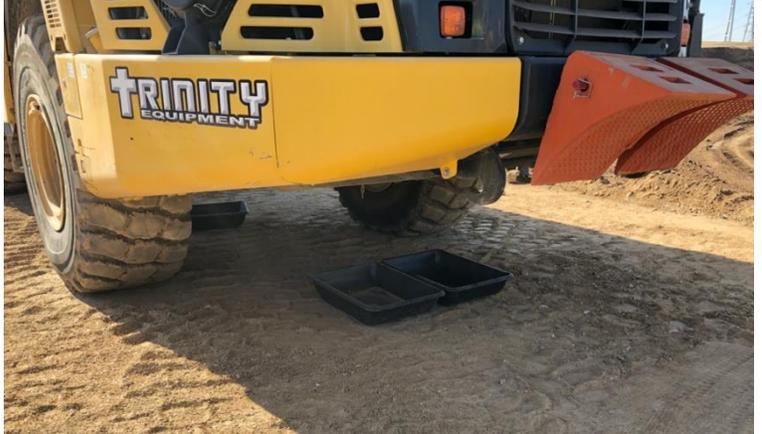
Power Grade crews were onsite working on the storm drain system (Photo 5) and were conducting earth moving activities (Photo 6). The two detention basins were nearly complete (Photo 9) and installation of the plastic ivy on the southern boundary wall was almost completed (Photo 10). I inspected the secondary containment under the parked equipment and they all had drip pans present (Photo 11).

Photo 12 – Secondary containment present under the parked equipment.

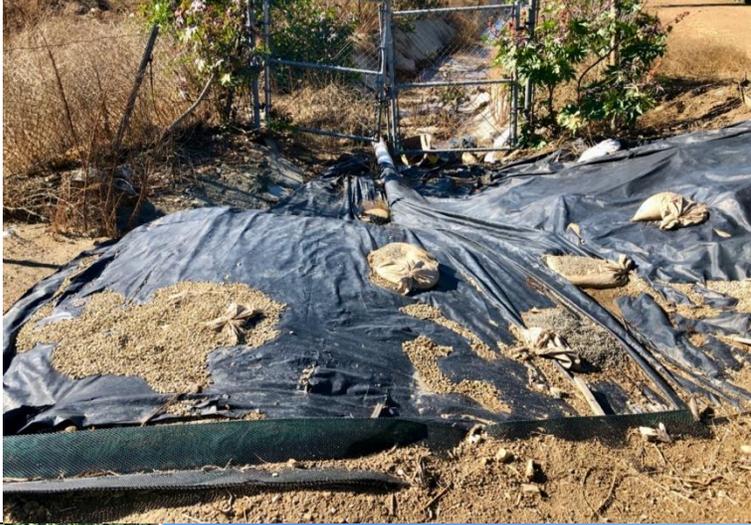
Previous BMP work, including some plastic sheeting, installed at the top of the Caltrans channel needed to be cleaned up and removed (Photo 10).

Photo 10 – Existing BMPs remained at the entrance to the CalTrans concrete channel. Photo facing west.
12/29/20	Mesa Substation
