Re: Monthly Report Summary #43 for the Mesa 500-kV Substation Project

Mesa 500-kV Substation Project CPUC Site Inspection Form

Project:	Mesa 500-kV Substation Project	Date:	April 7, 2021
Project Proponent:	Southern California Edison (SCE)	Report #:	VS163
Lead Agency:	California Public Utilities Commission (CPUC)	Monitor(s):	Vince Semonsen
CPUC PM:	Connie Chen, Energy Division	AM/PM Weather:	Sunny and mild with a slight breeze
WSP CM:	Silvia Yanez	Start/End time:	1100 to 1300
Project NTP(s):	Notice to Proceed (NTP)-1, NTP-2

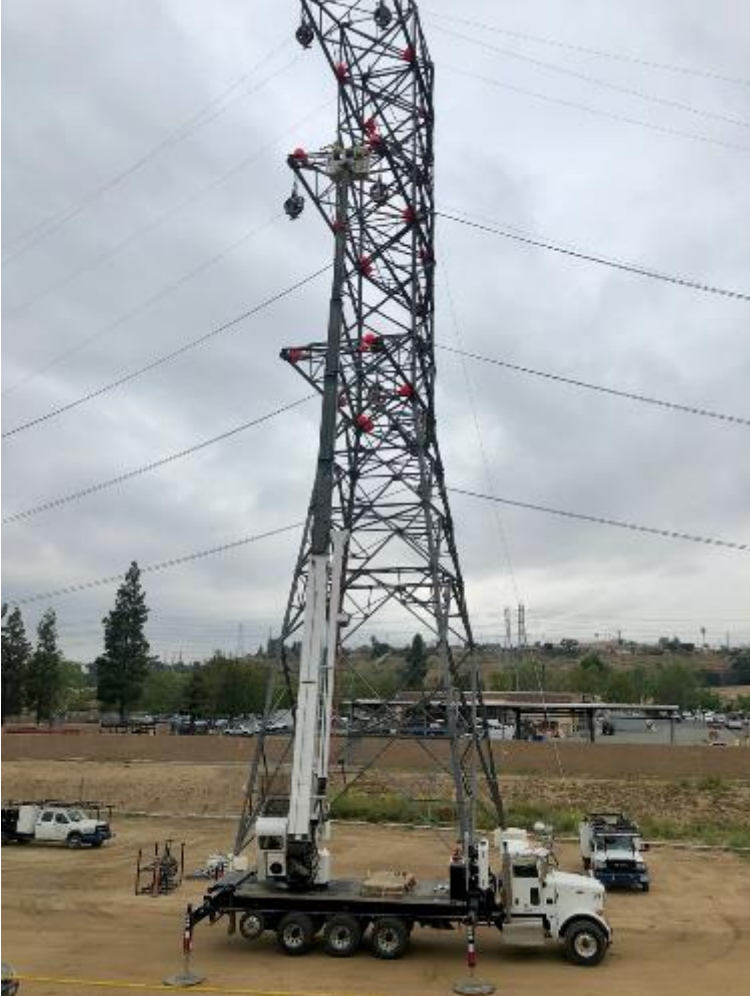
Crews strung wire from the newly erected latticework towers located near the construction trailers (Photo 1) and at the east end of the Phase 4 construction area (Photo 2). A house finch (*Haemorhous mexicanus*) built a nest in one of the arms of the towers near the construction trailers, causing a delay in wire-stringing activities.

A tall, silver lattice tower is being erected by a white crane mounted on a truck. The crane is positioned on a dirt area. In the background, there are other utility vehicles, trees, and a cloudy sky. The tower is the central focus, extending from the ground to the top of the frame.	Photo 1 – Wire stringing within the newly erected latticework towers. Photo facing north.
04/22/21	Mesa Substation

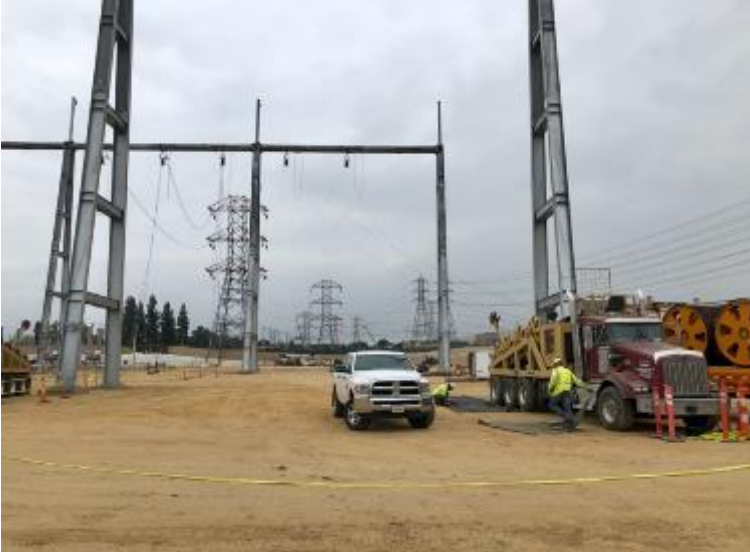
A view of a 500-kV substation area. Several tall, silver lattice towers are visible. A white pickup truck is parked in the foreground. A large red truck with yellow equipment is also present. The ground is dirt, and there are yellow caution tapes. The sky is overcast.	Photo 2 – Wire pulling equipment within the 500-kV substation area. Photo facing east.
