December 12, 2019

Re: Monthly Report Summary #24 for the South Orange County Reliability Enhancement (SOCRE) Project

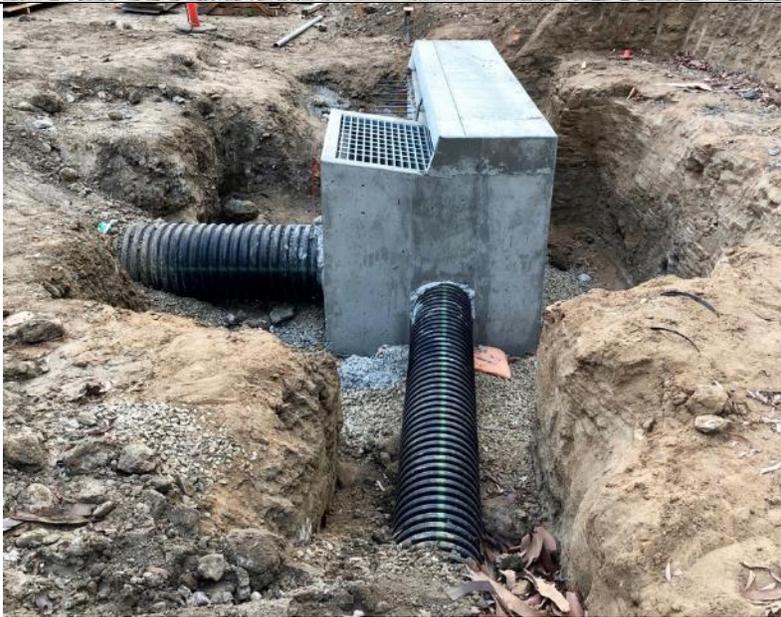
Work continued for the storm drain inlets throughout the project site (Photos 2, 4, and 6).

A photograph of a concrete storm drain inlet box installed in a trench. The box is rectangular and has a metal grate on top. Two black corrugated pipes are connected to the box: one on the left and one on the right, both leading into the ground.	Photo 2 – Storm drain inlet located near the southwestern portion of the substation.

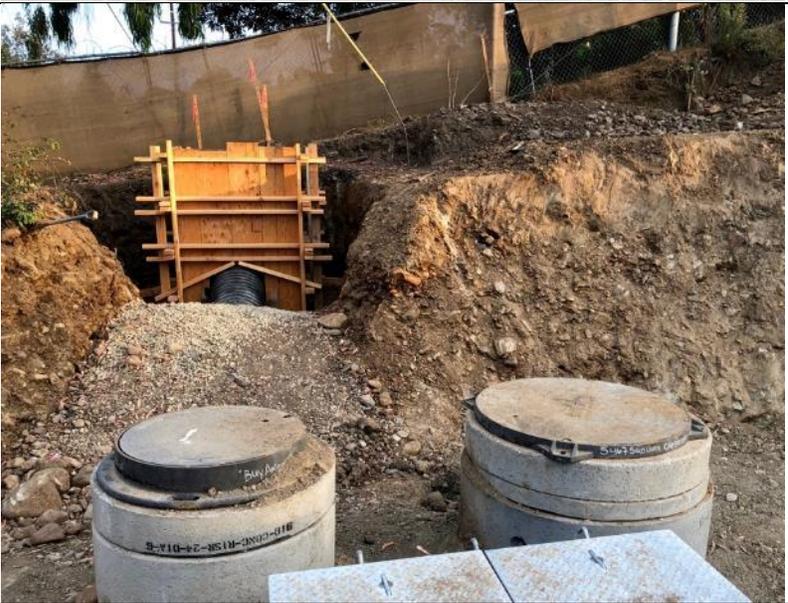
Photo 4 – Forms installed for the storm drain inlet located in the northwestern portion of the substation. Photo facing north.

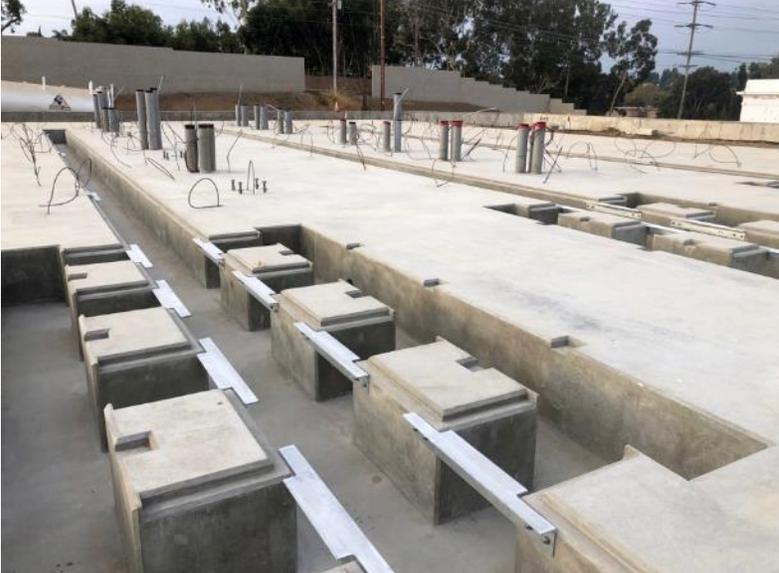
At the 138-kilovolt (kV) gas insulated substation (GIS) building pad, no work was underway, and it appeared that the pad had been finished (Photo 5). Work on the storm drain inlets continued inside the 138-kV GIS building retaining wall (Photo 6).

Photo 5 – 138-kV GIS building pad. Photo facing southwest.
10/09/19	San Juan Capistrano Substation

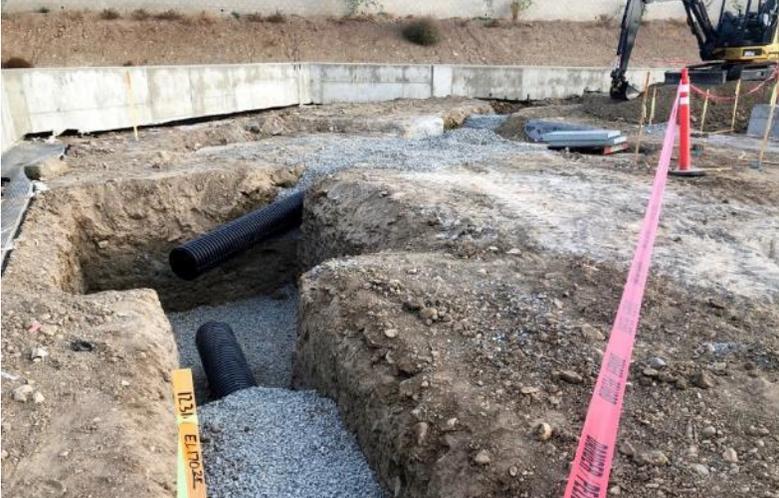
Photo 6 – Storm drain work inside the 138-kV GIS building retaining wall.
10/09/19	San Juan Capistrano Substation

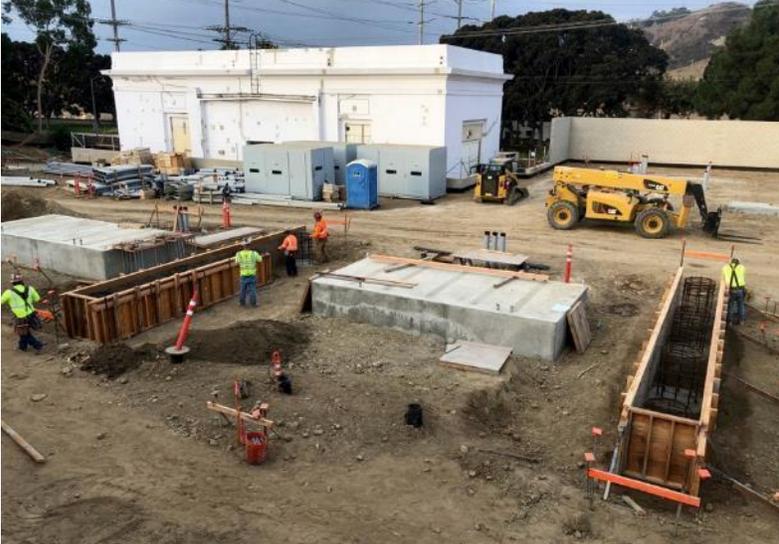
Foundation work continued around the transformer pads (Photo 7). The remaining excess soil was being loaded into dump trucks by a front loader for transport offsite (Photo 8).

Photo 7 – Foundation work around the transformer pads. Photo facing west.

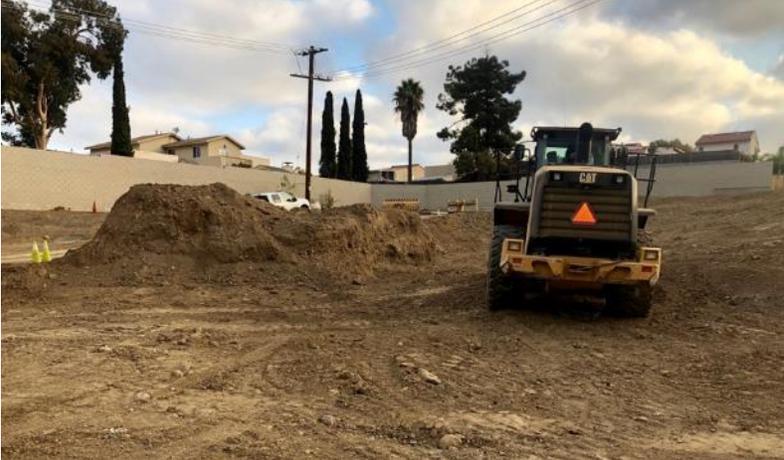
Photo 8 – A crew loading the remaining excess soil for transport offsite. Photo facing east.
10/09/19	San Juan Capistrano Substation

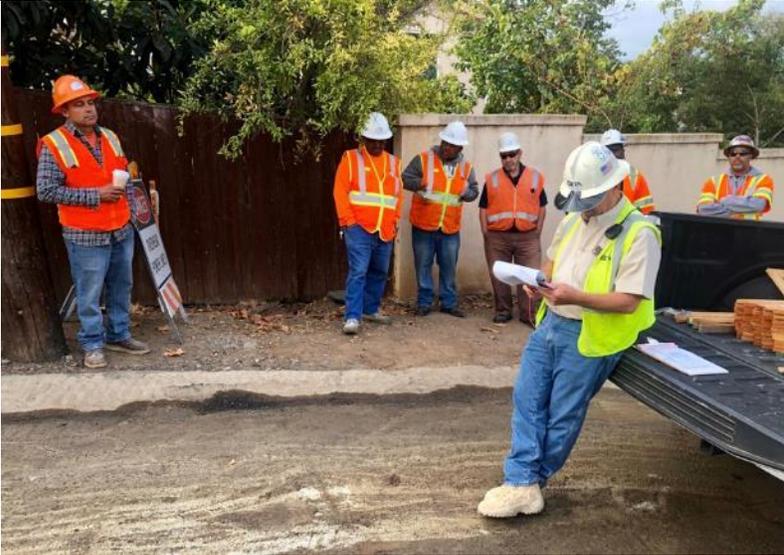
I attended the tailboard meeting for the underground conduit work being installed on Calle Bonita (Photo 10). Work was scheduled to start later in the morning due to traffic concerns. The laydown yard for the underground work had been experiencing an issue with water leaking from irrigation piping (Photo 11). Water also was filtering down the access road and creating mud (Photo 12), which could present an issue when bringing in the drilling rig for the tubular steel pole (TSP) foundation. The SDG&E LEI planned to investigate the watering schedule and affected locations.

Photo 10 – Morning tailboard meeting for the underground work crews.

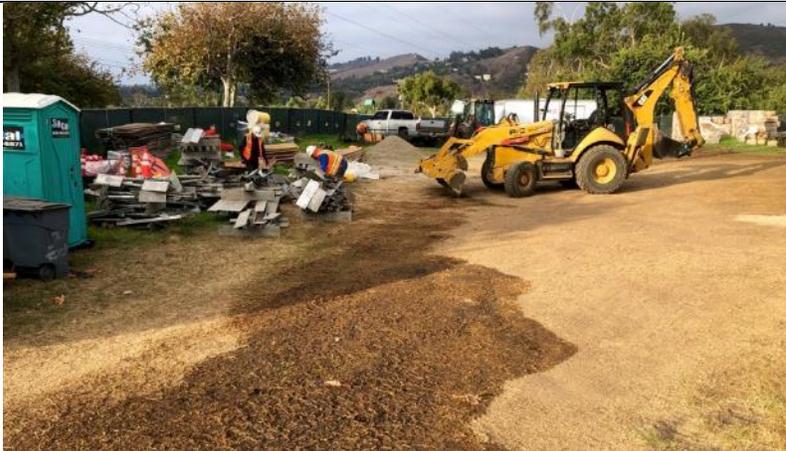
Photo 11 – Laydown yard for the underground work. Photo facing west.
10/09/19	Serra Park, near San Juan Capistrano Substation

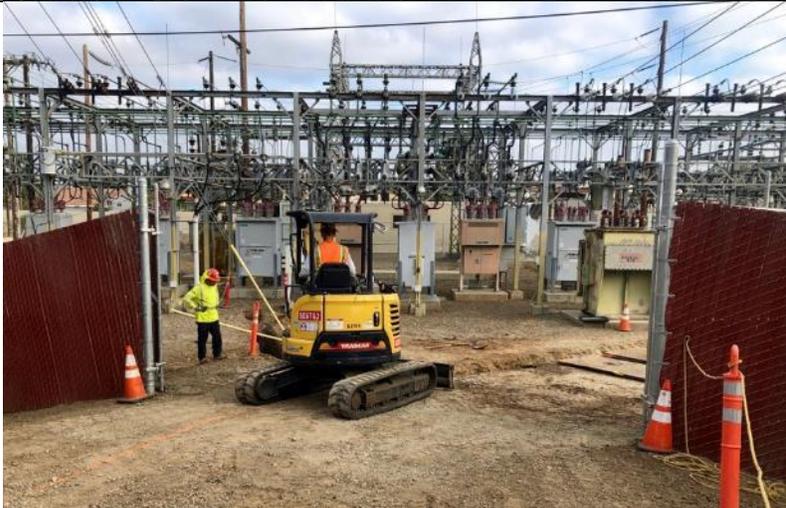
Since trenching was scheduled to begin, paleontological and cultural resource monitors were onsite. Trenching was expected to be completed by the end of the day. A crew with a small excavator was working within the old substation to dig a trench to the new access road (Photo 13).

Photo 13 – Trenching work near the existing substation and the new access roadway. Photo facing north.

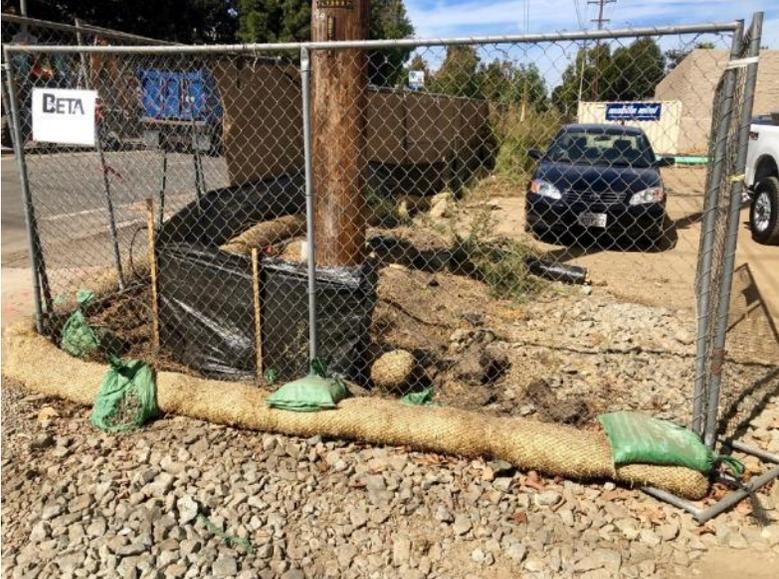
New silt fencing and straw wattles had been placed around the project site (Photo 5). Crews had also sprayed most of the exposed slopes with a hydro mulch (Photo 6). Additional wattles and bales of mulch material had been stockpiled onsite (Photo 8). The best management practices (BMPs) at the main entry/exit still needed additional, larger rock (Photo 7).

Photo 5 – New silt fencing and straw wattles installed around the substation site. Photo facing north.
10/16/19	San Juan Capistrano Substation

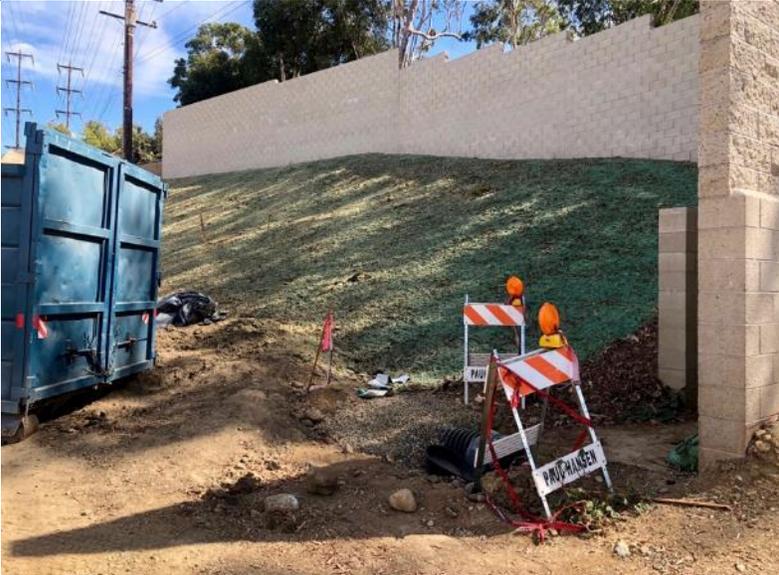
Photo 6 – Bare earth slopes recently sprayed with hydro mulch. Photo facing southeast.
10/16/19	San Juan Capistrano Substation

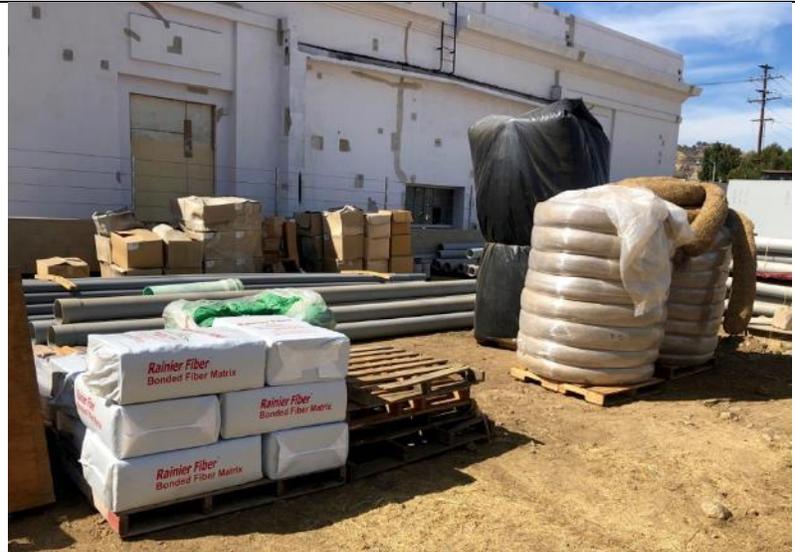
Photo 8 – Stockpiled erosion control materials. Photo facing northwest.
10/16/19	San Juan Capistrano Substation

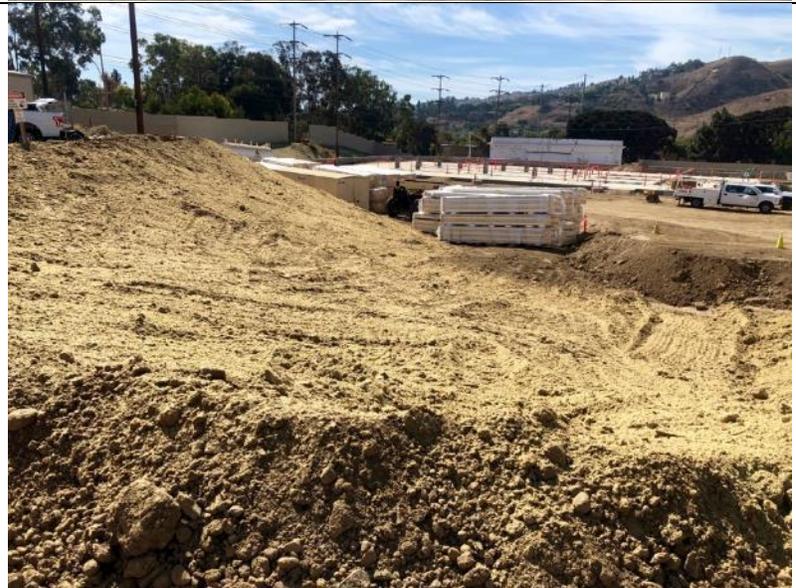
The remaining excess soil noted during my previous site visit had been hauled offsite. The stockpile area had been recontoured sprayed with hydro mulch (Photo 12).

Photo 12 – Soil stockpile area recontoured and sprayed with hydro mulch. Photo facing west.
10/16/19	San Juan Capistrano Substation

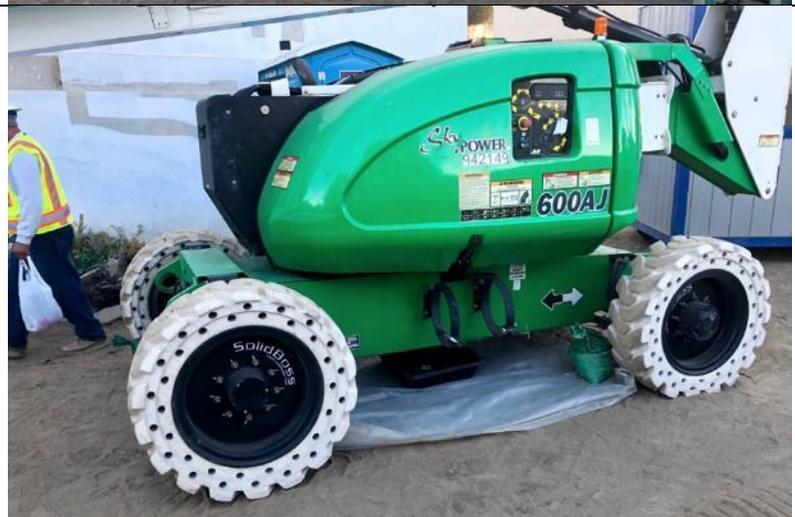
Photo 2 – Manlifts well contained with plastic and drip pans.
10/24/19	San Juan Capistrano Substation

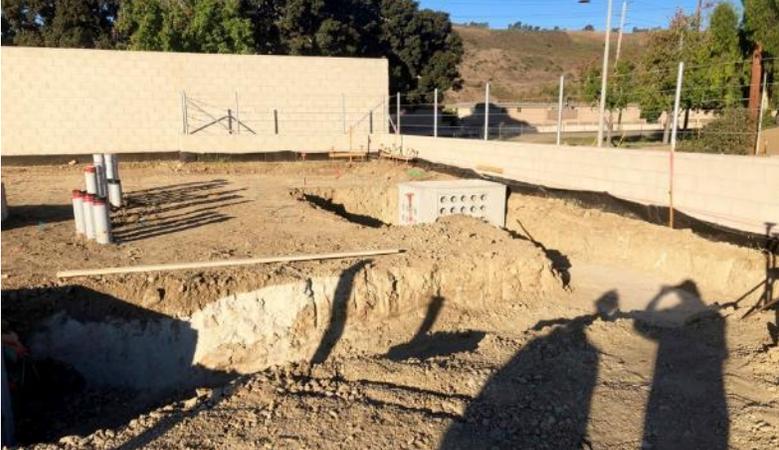
Photo 5 – Open conduit trenches in the switch rack area. Photo facing northwest.
10/24/19	San Juan Capistrano Substation

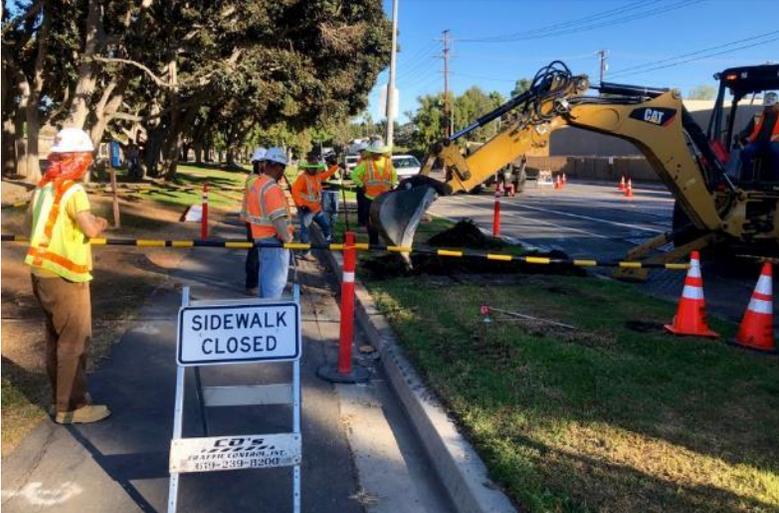
An EI was overseeing the underground work. Excavation work was beginning west of Camino Capistrano in Long Park next to the jack and bore site (Photo 10). All trees within the jack and bore site had been cut down and the stumps were to be removed. The excavation work was being monitored by paleontological and archeological resource monitors. The work will be performed by hand as crews approach several existing utility lines. Traffic control was in place and working well.

Photo 10 – Excavation within Long Park west of Camino Capistrano. Photo facing north.
10/24/19	Galano Way, east of the San Juan Capistrano Substation

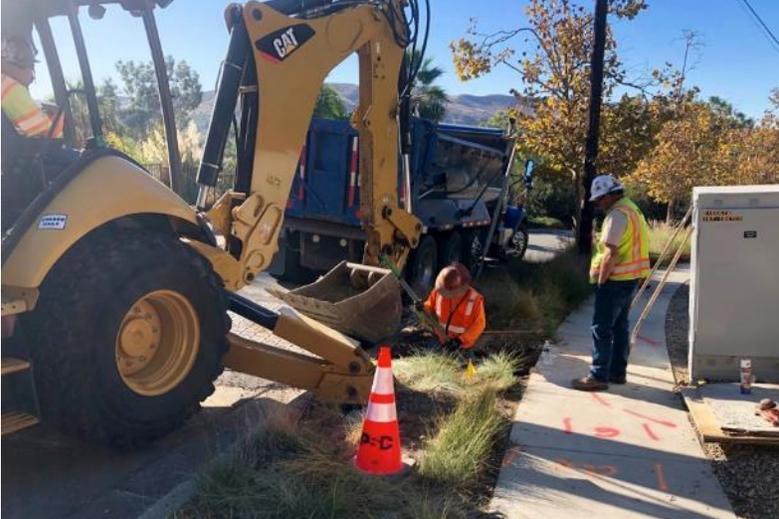
I drove to Galano Way on the east side of Interstate 5 where a crew was potholing along the conduit trench. The crew was tying into existing equipment. Most of this work was being completed by hand due to the presence of existing pipes (Photo 11). Traffic control was also in place at this location.

Photo 11 – Potholing work within Galano Way east of Interstate 5. Photo facing south.

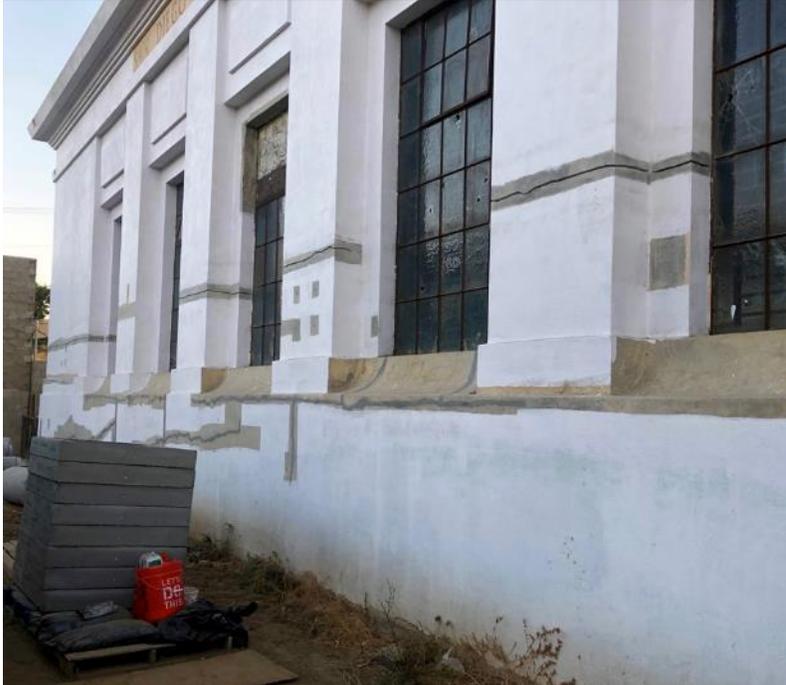
Construction crews continued to repair and patch walls of the former utility structure (Photo 1).

Photo 1 – Cleaning and patching the walls of the former utility structure. Photo facing north.
10/31/19	San Juan Capistrano Substation

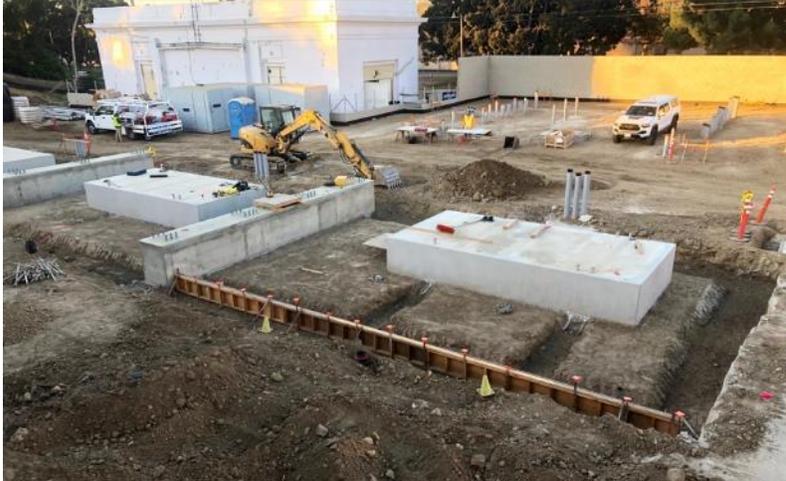
Work continued in the transformer area, with excavation around the foundations and new forms being installed (Photo 2). A conduit vault remained open within the switch rack area (Photo 3).

Photo 2 – Work around the transformer foundations. Photo facing west.

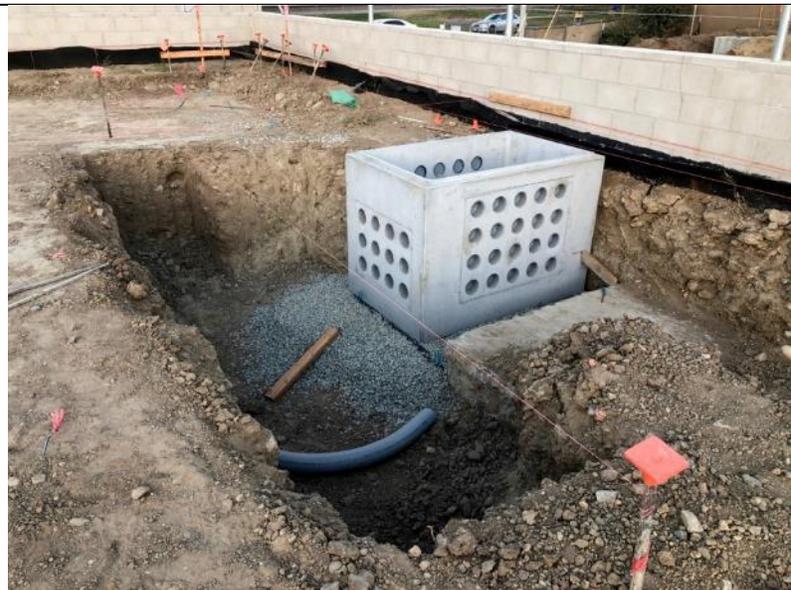
Photo 3 – Conduit vault in the switch rack area.
10/31/19	San Juan Capistrano Substation

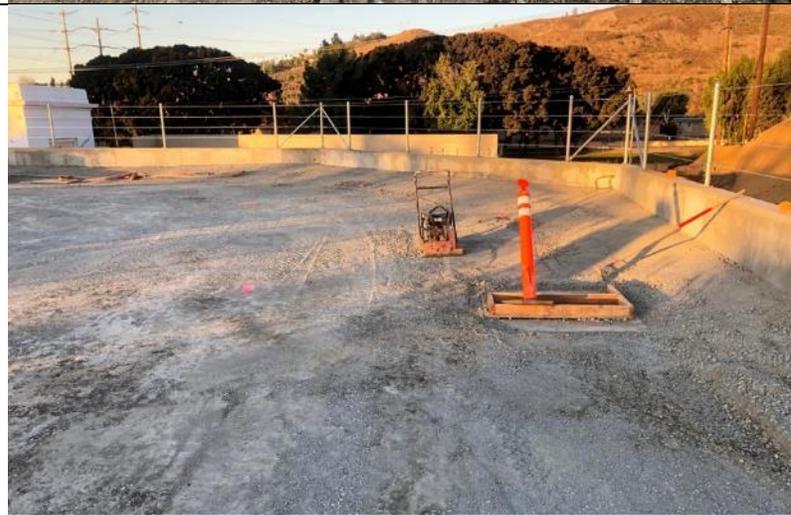
The waterproofing for the 138-kilovolt (kV) gas insulated substation (GIS) building retaining wall was complete. Final backfilling between the wall and the building and compaction of the road base was underway (Photo 4). This allowed the building materials to be moved onto and around the building pad (Photos 5 and 6). New building materials were onsite and stockpiled east of the building pad (Photo 7). Excess soil was being brought to the stockpile area (Photo 8). An overview of the 138-kV GIS building pad is presented as Photo 10.

Photo 4 – Final compaction of the road base around the 138-kV GIS building pad. Photo facing west.
10/31/19	San Juan Capistrano Substation

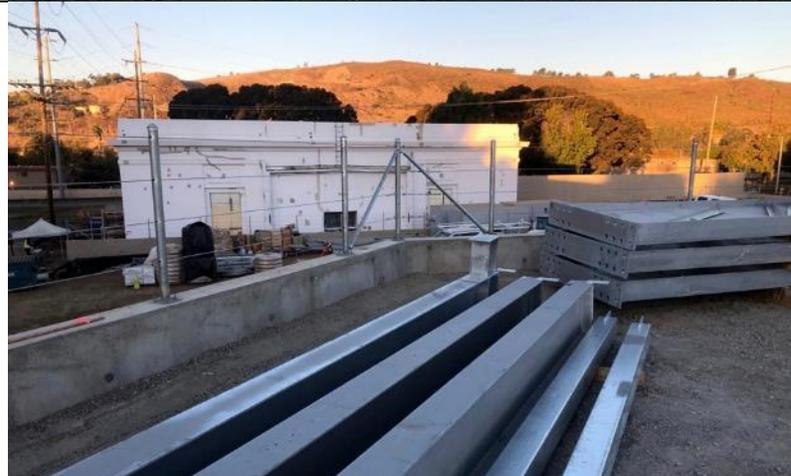
Photo 5 – Building materials stockpiled on the newly backfilled area. Photo facing west.

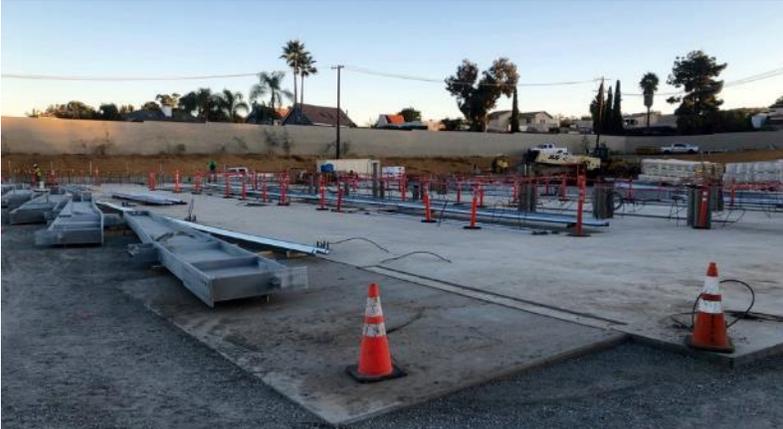
Photo 6 – Building materials being brought onto and placed around the 138-kV GIS building pad. Photo facing north.
10/31/19	San Juan Capistrano Substation

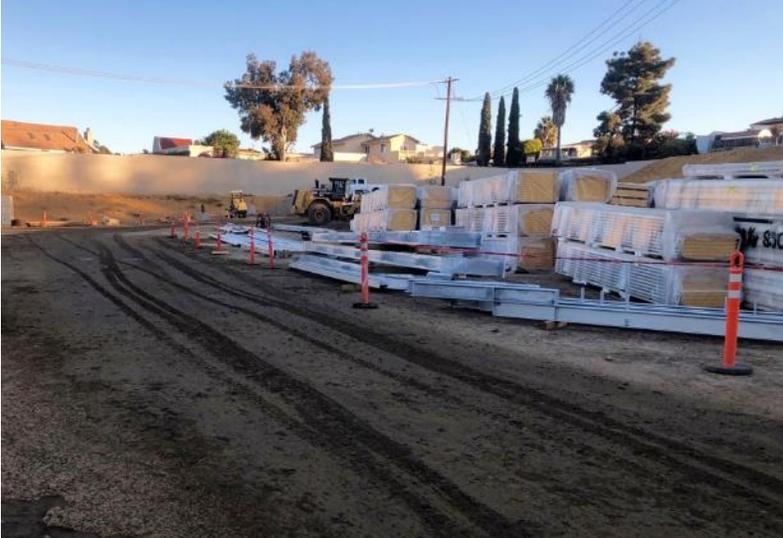
Photo 7 – Building materials stockpiled just east of the 138-kV GIS building pad. Photo facing north.
10/31/19	San Juan Capistrano Substation

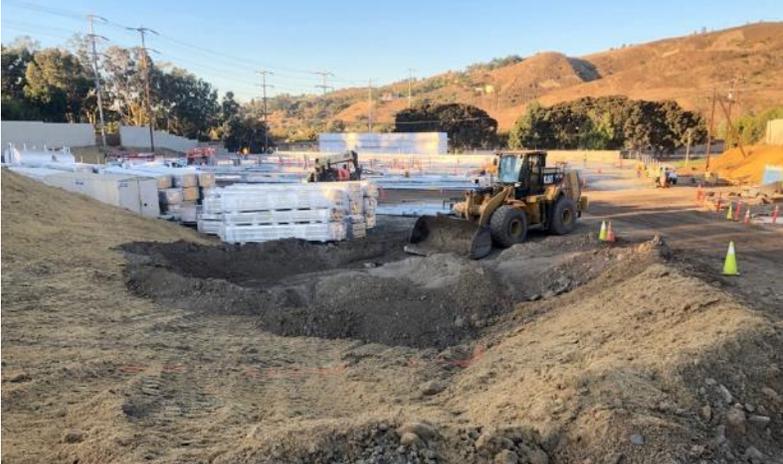
Photo 8 – Soil stockpile area. Photo facing west.
