Re: Monthly Report Summary #27 for the South Orange County Reliability Enhancement (SOCRE) Project

CPUC Site Inspection Reports
January 10, 17, 23, and 29, 2020

South Orange County Reliability Enhancement Project CPUC Site Inspection Form

Project:	South Orange County Reliability Enhancement (SOCRE) Project	Date:	January 10, 2020
Project Proponent:	San Diego Gas & Electric (SDG&E)	Report #:	VS063
Lead Agency:	California Public Utilities Commission (CPUC)	Monitor(s):	CPUC/Ecology and Environment, Inc., member of WSP (E & E) Compliance Monitor (CM)
CPUC PM:	Andrew Barnsdale, Energy Division	AM/PM Weather:	Clear and calm with cold temperatures
CPUC CM (E & E):	Joe Donaldson	Start/End Time:	0730 to 0945
Project NTP(s):	Notice to Proceed (NTP)-3, NTP-4, NTP-5, and NTP-6

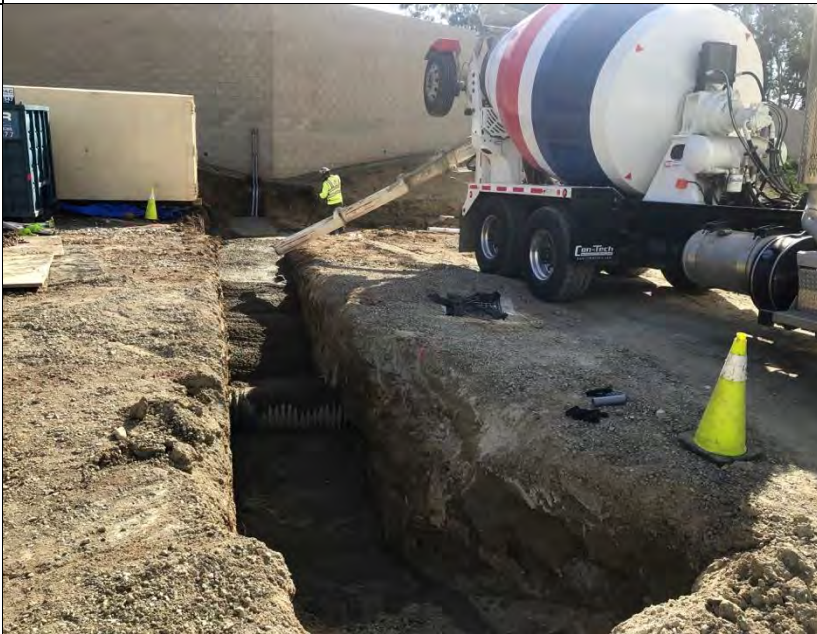
Trenching and installation of conduit continued along the southern portion of the substation site (Photo 6). A conduit trench was being filled with slurry near the 138-kilovolt (kV) gas-insulated substation (GIS) building (Photo 7). After the slurry is poured, the crews will wash out the equipment in the trench.

A concrete mixer truck with a red, white, and blue drum is parked on a dirt surface. A large, deep trench has been excavated in the ground, with a worker in a yellow safety vest visible in the background. A yellow traffic cone is in the foreground.	Photo 7 – Conduit work within the northern portion of the substation. Photo facing south.
01/29/20	San Juan Capistrano Substation
