June 8, 2020

Re: Monthly Report Summary #30 for the South Orange County Reliability Enhancement (SOCRE) Project

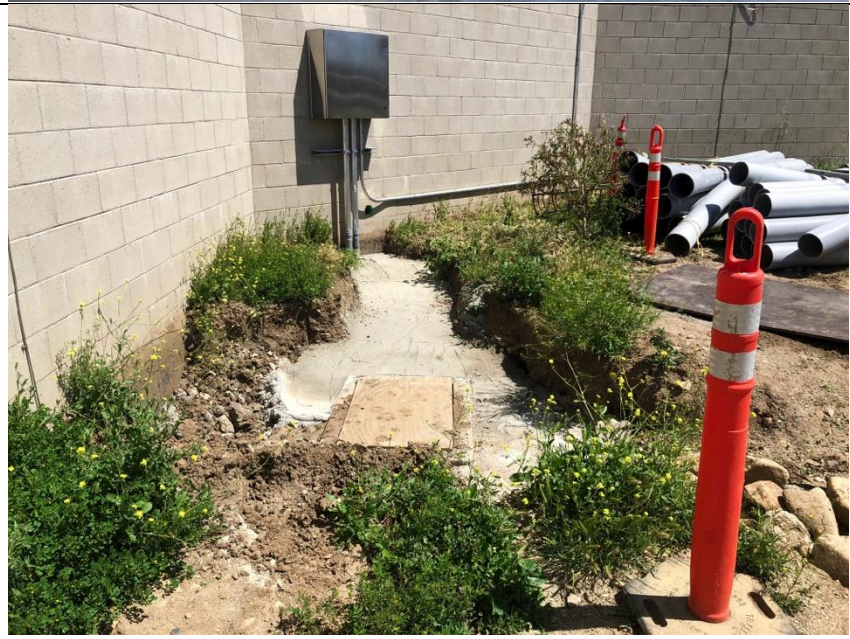
| Date | Location | Photo | Description |
|---|---|---|---|
| 04/03/20 | San Juan Capistrano Substation | An exterior view of a light-colored concrete block wall. A black electrical cabinet is mounted on the wall. A concrete path leads from the wall towards the foreground. To the right, there are several orange and white safety bollards and a stack of white pipes. The ground is dirt with some green weeds. | Photo 8 – Electrical equipment attached to the boundary wall in the northeast corner of the substation. Photo facing northeast. |

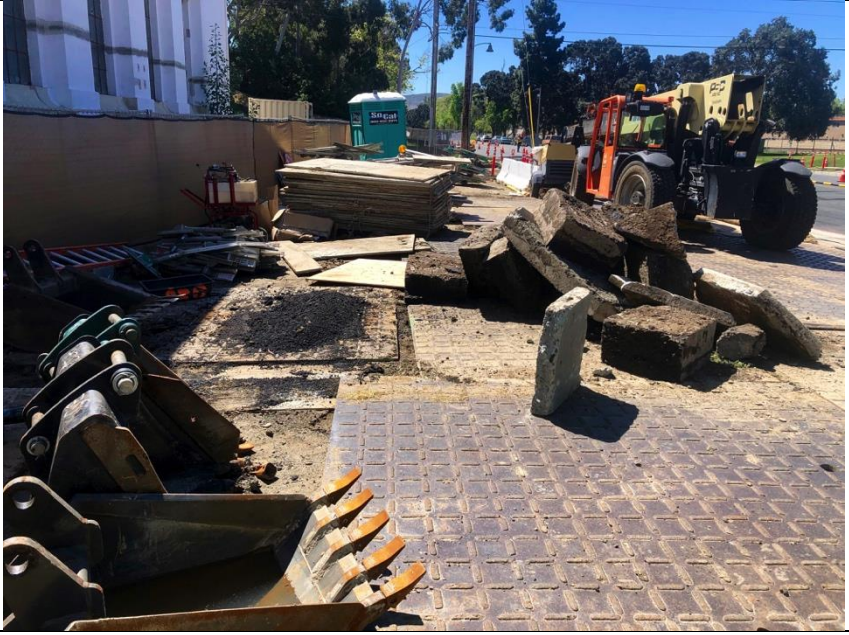
I observed that work continues within Camino Capistrano, with a large quantity of materials stockpiled in the area between the roadway and the existing utility structure (Photo 1) and trenching continuing in the street (Photo 2). The Lead Environmental Investigator (LEI) stated cultural resource and paleontology monitors were not needed because of the extensive underground work already completed in the area.

| Date | Location | Photo | Description |
|---|---|--|--|
| 04/15/20 | San Juan Capistrano Substation | | Photo 1 – Equipment staging area for work along Camino Capistrano. Photo facing south. |

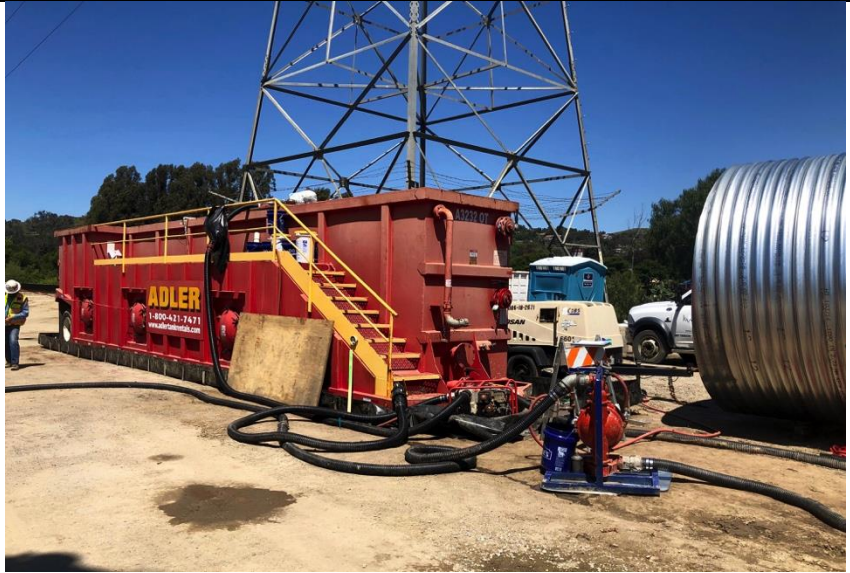
| Date | Location | Photo | Description |
|---|--|--|--|
| 04/15/20 | Transmission line route, tower location 10 | | Photo 9 – A baker tank at tower location 10. Photo facing north. |

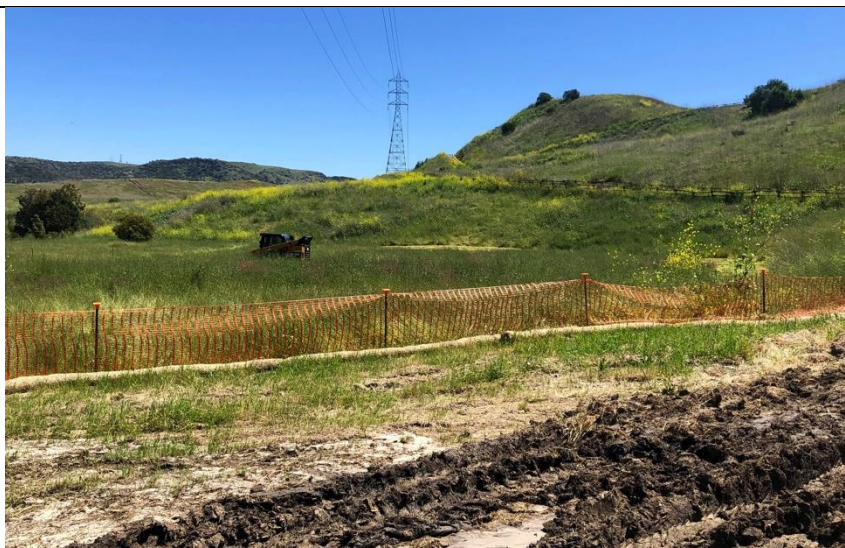
The LEI and I travelled to the access road and laydown area for tower locations 11 and 12. The access road runs through a gated community and then enters a dirt road, which has rumble plates, sandbags, and wattles installed (Photo 10). The laydown area was being mowed (Photo 11) and, according to the LEI, two biologists had inspected the area for wildlife earlier that day. I walked through a portion of the area to be mowed and found no wildlife or nesting birds.

| Date | Location | Photo | Description |
|---|---|--|--|
| 04/15/20 | SOCRE transmission corridor | | Photo 11 – Staging area located between tower locations 11 and 12 being mowed. Photo facing south. |

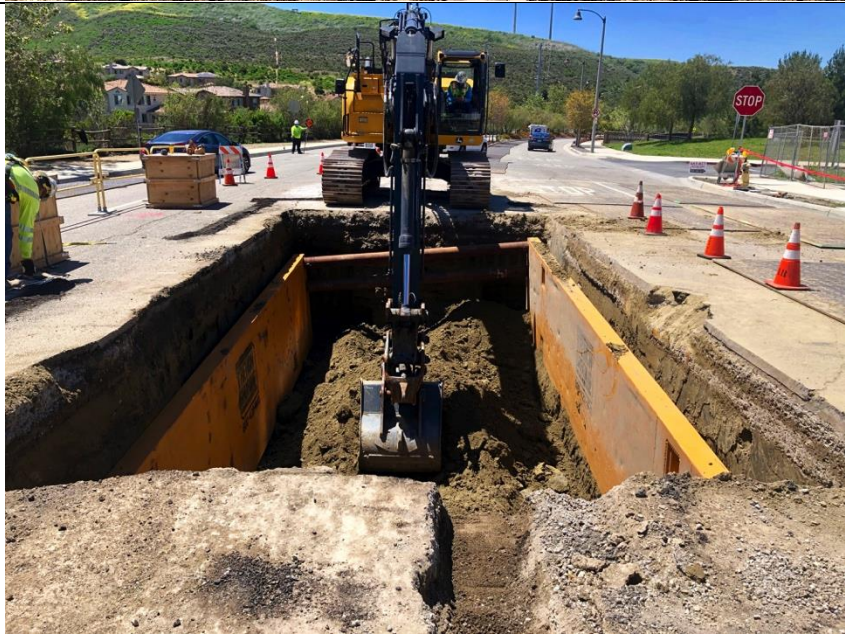
At Stallion Ridge, a road crew was installing a conduit vault within the roadway (Photo 12). A cultural resource monitor was onsite monitoring the trenching activity. Traffic control was in place to manage the traffic travelling to and from the high school.

| Date | Location | Photo | Description |
|---|---|--|--|
| 04/15/20 | SOCRE transmission corridor | | Photo 12 – Excavation for a vault within Stallion Ridge Road. Photo facing west. |

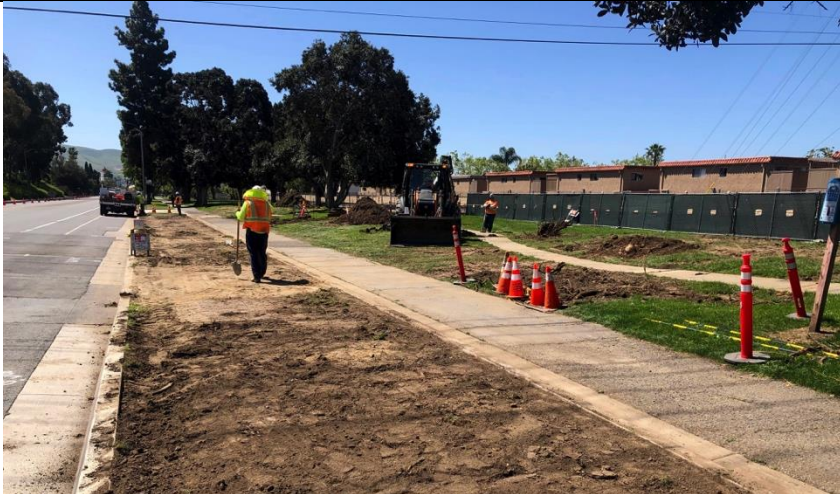
| Date | Location | Photo | Description |
|---|---|--|--|
| 04/22/20 | San Juan Capistrano Substation | | Photo 1 – Equipment clearing the jack and bore area between the railroad tracks and Camino Capistrano. Photo facing south. |

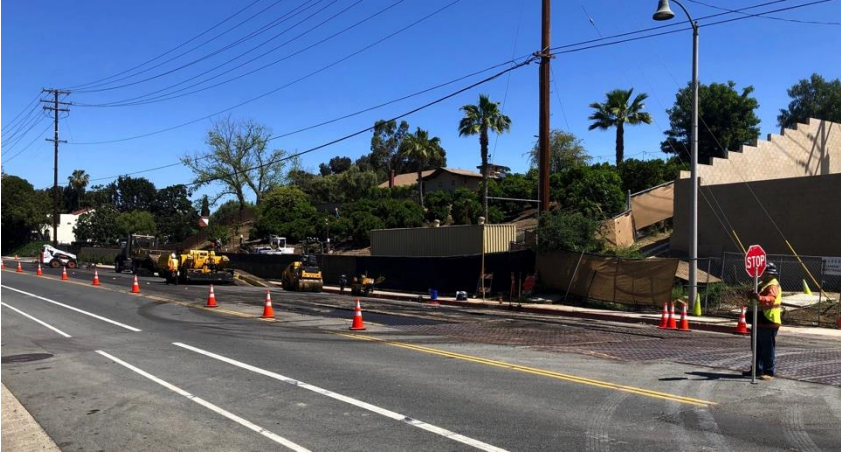
| REPRESENTATIVE SITE PHOTOGRAPHS | | | |
|---|---|--|--|
| 04/22/20 | San Juan Capistrano Substation | | Photo 2 – Paving being placed within Camino Capistrano. Photo facing north. |

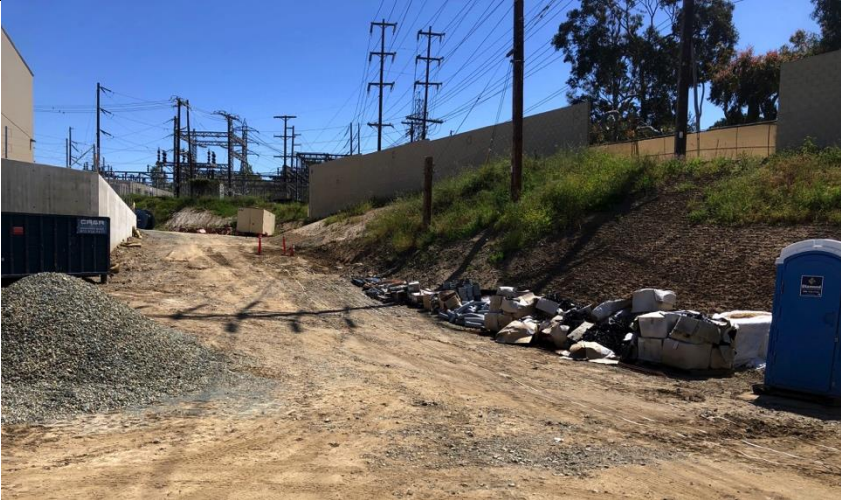
| REPRESENTATIVE SITE PHOTOGRAPHS | | | |
|---|---|--|--|
| 04/22/20 | San Juan Capistrano Substation | | Photo 4 – Staged materials along the southern substation access road. Photo facing east. |

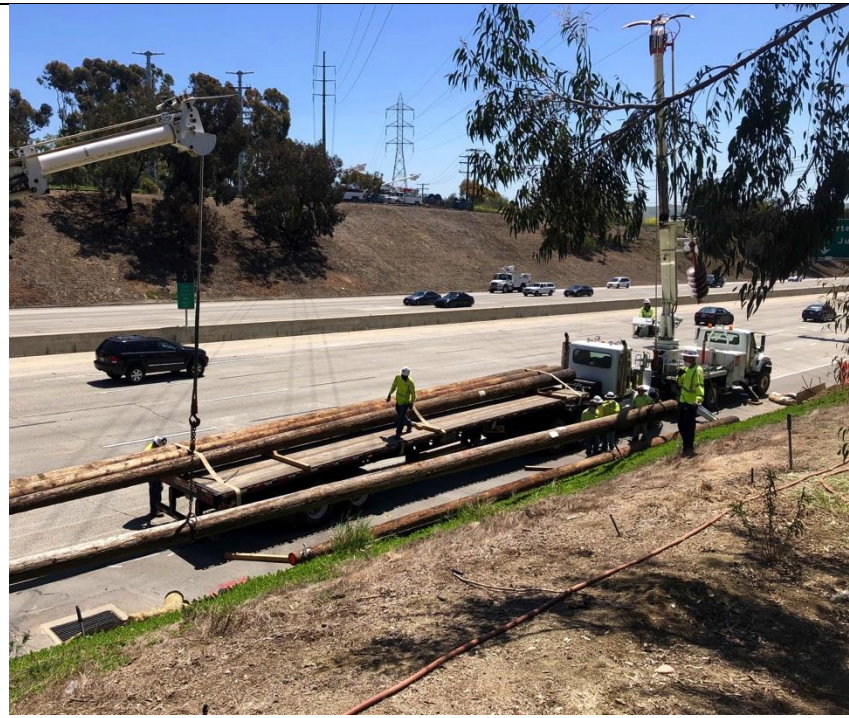
| Date | Location | Photo | Description |
|---|---|---|--|
| 04/22/20 | SOCRE transmission corridor | | Photo 7 – Line crews installing wooden poles for a guard structure over Interstate 5. Photo facing southeast. |

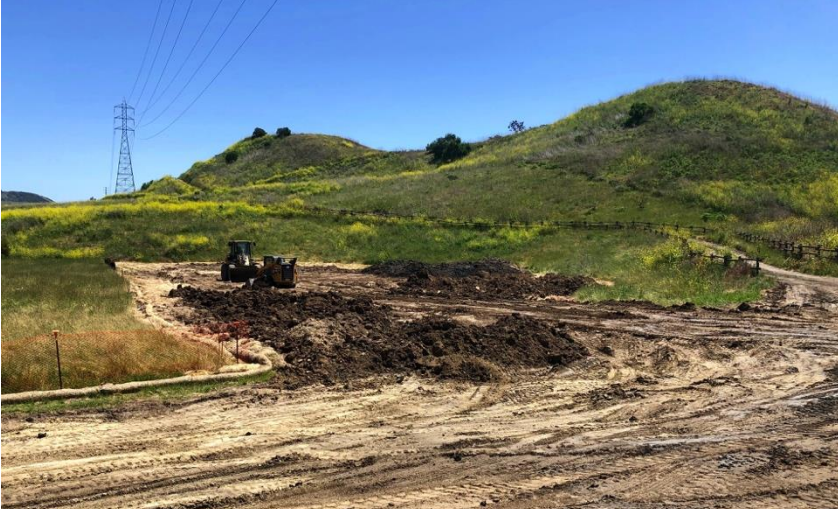
| Date | Location | Photo | Description |
|---|---|---|--|
| 04/22/20 | SOCRE transmission corridor | A wide-angle photograph showing a large, dark brown stockpile of excavated soil in a field. In the background, there are green hills under a clear blue sky, with a power line tower visible on the left. A small piece of construction equipment is parked near the soil pile. | Photo 12 – Stockpile of excavated soil from drilling at tower location 10. Photo facing south. |

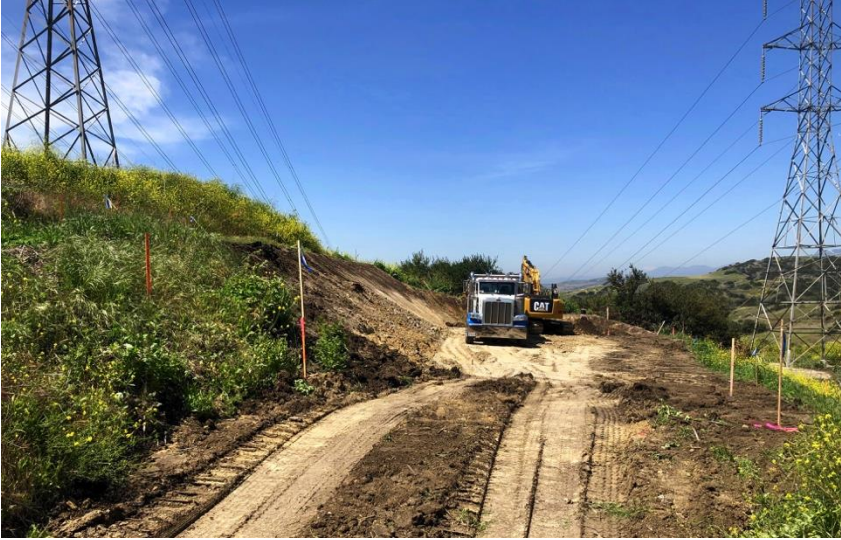
| REPRESENTATIVE SITE PHOTOGRAPHS | | | |
|---|---|---|---|
| 04/22/20 | SOCRE transmission corridor | | Photo 17 – Grading at tower location 21. Photo facing north. |

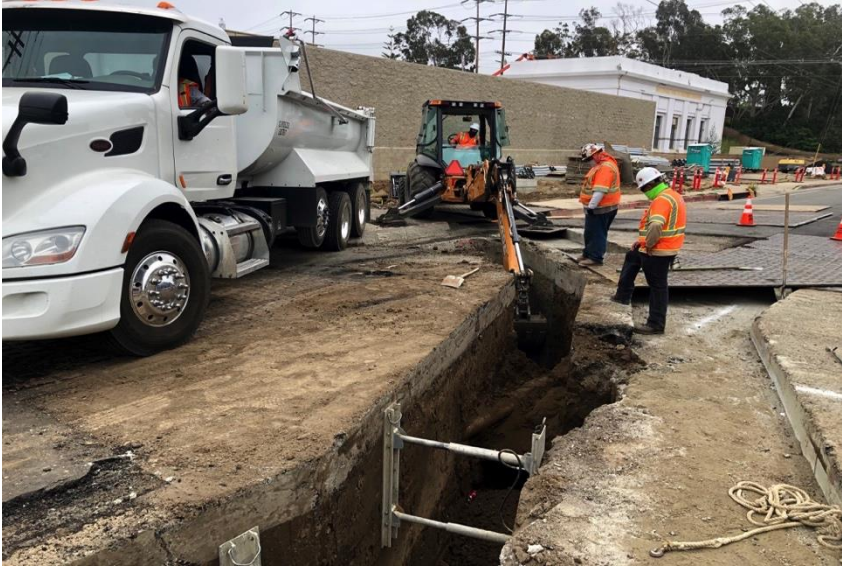
| REPRESENTATIVE SITE PHOTOGRAPHS | | | |
|---|---|--|---|
| 04/29/20 | San Juan Capistrano Substation | | Photo 2 – Trenching continuing within Camino Capistrano. Photo facing south. |

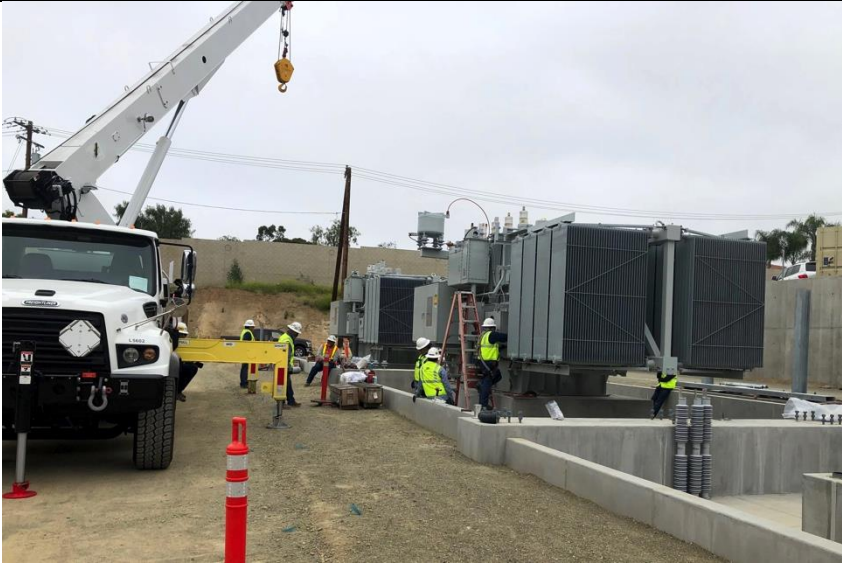
| REPRESENTATIVE SITE PHOTOGRAPHS | | | |
|---|---|--|---|
| 04/29/20 | San Juan Capistrano Substation | | Photo 3 – Continued installation of transformers. Photo facing north. |

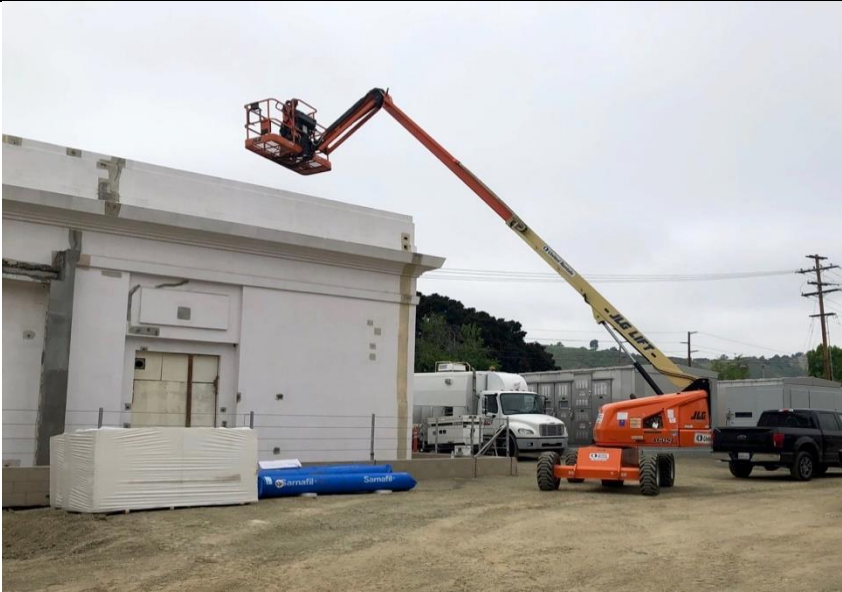
| REPRESENTATIVE SITE PHOTOGRAPHS | | | |
|---|---|--|---|
| 04/29/20 | San Juan Capistrano Substation | | Photo 4 – Work was conducted on the former utility structure. Photo facing northwest. |

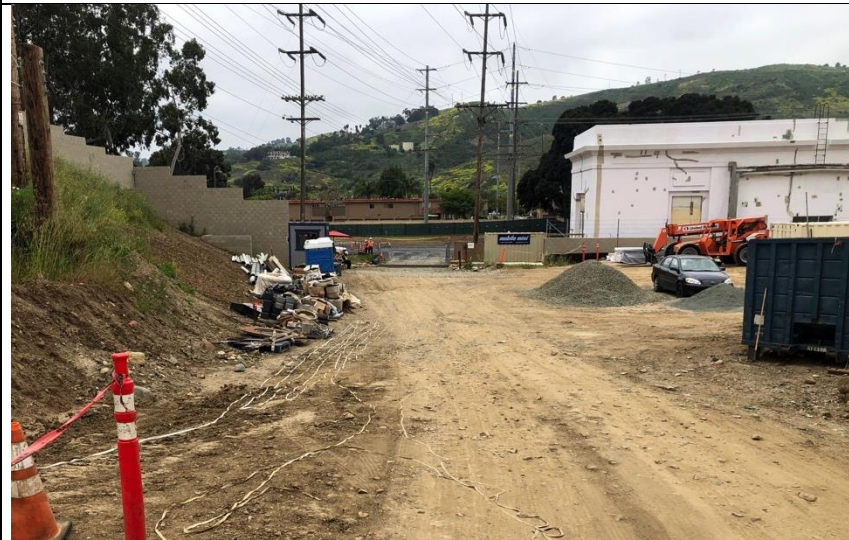
| Date | Location | Photo | Description |
|---|---|---|---|
| 04/29/20 | San Juan Capistrano Substation | | Photo 5 – The southern entry/access road for the substation is now being utilized. Photo facing west. |

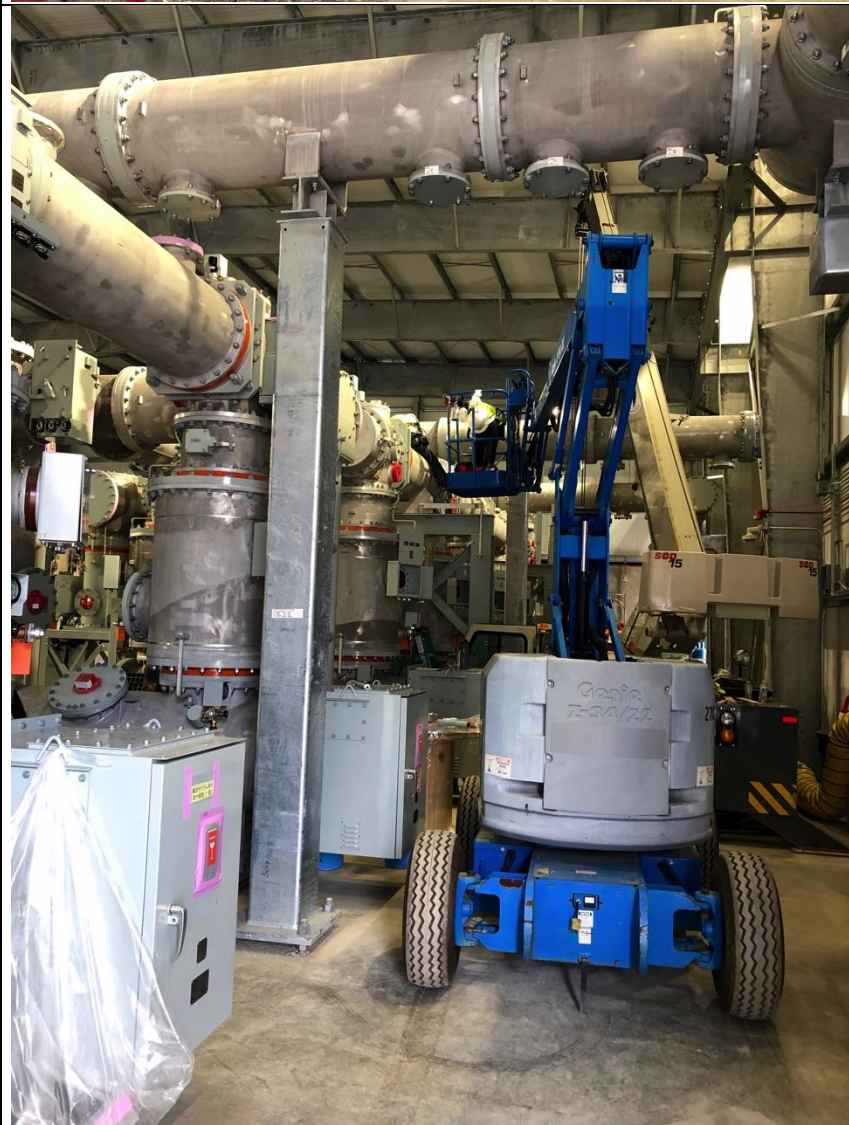
| Date | Location | Photo | Description |
|---|---|---|---|
| 04/29/20 | San Juan Capistrano Substation | | Photo 6 – Work continues within the 138-kV GIS building. |

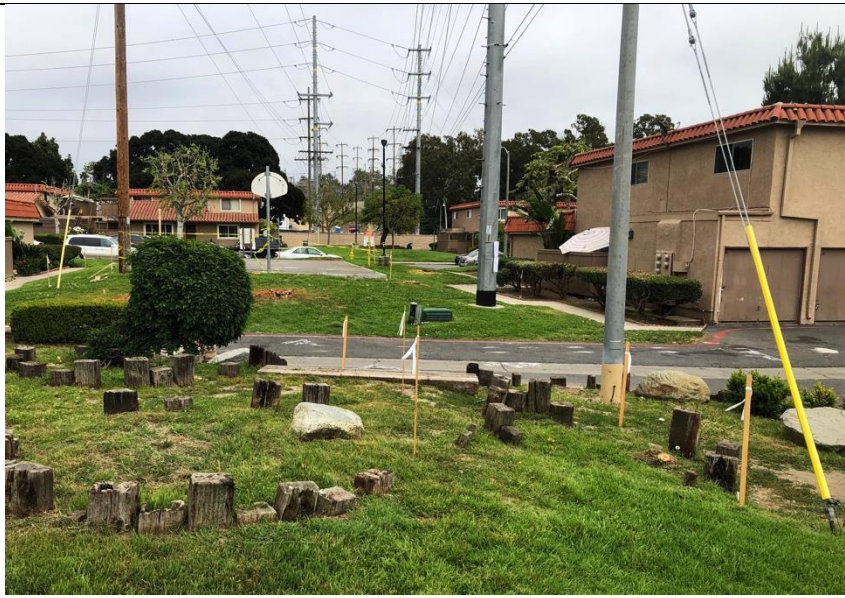
| Date | Location | Photo | Description |
|---|---|--|---|
| 04/29/20 | San Juan Capistrano Substation | | Photo 7 – Trees were removed in the work area west of the railroad tracks. Photo facing east. |

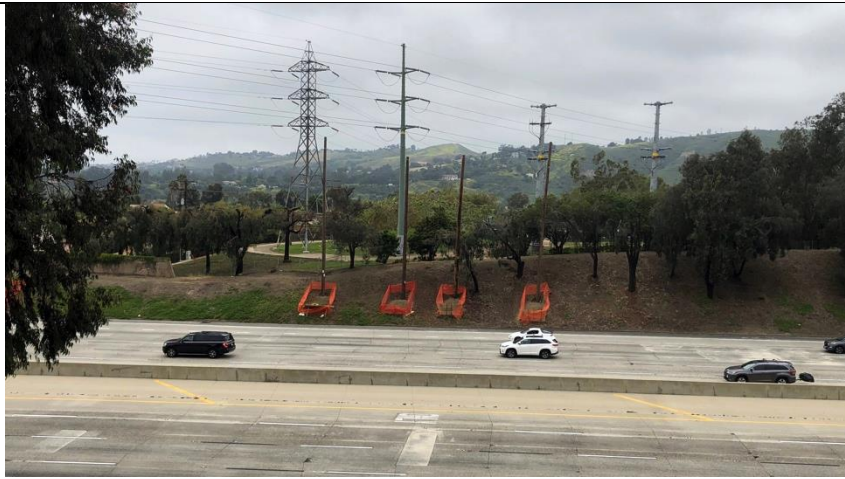
| Date | Location | Photo | Description |
|---|---|--|---|
| 04/29/20 | SOCRE transmission corridor | | Photo 8 – Temporary guard poles are in place along Interstate 5. Photo facing west. |

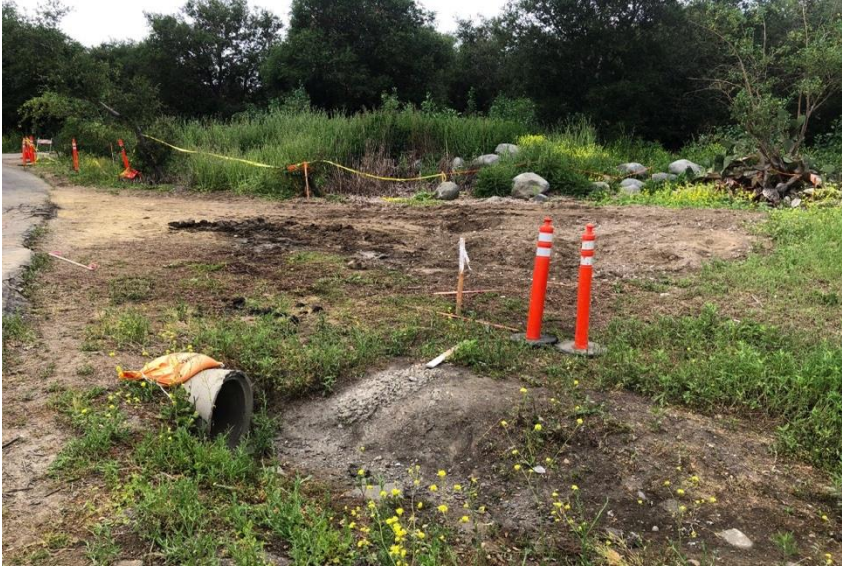
| REPRESENTATIVE SITE PHOTOGRAPHS | | | |
|---|--|--|--|
| 04/29/20 | Transmission line route, tower location 9 | | Photo 10 – Tower location 9 work area; the former tower and foundation were removed. Photo facing northwest. |

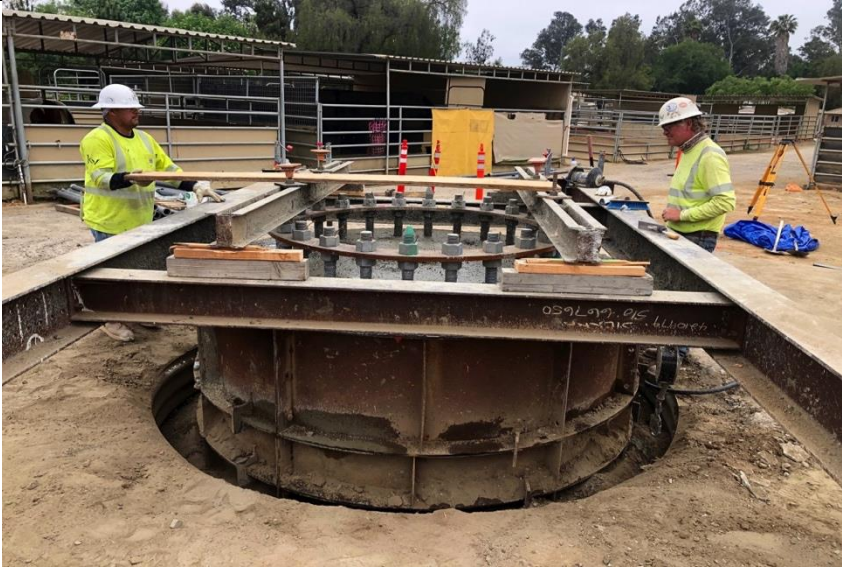
| REPRESENTATIVE SITE PHOTOGRAPHS | | | |
|---|--|--|--|
| 04/29/20 | Transmission line route, tower location 10 | | Photo 12 – Foundation for tower location 10 was poured. Photo facing south. |

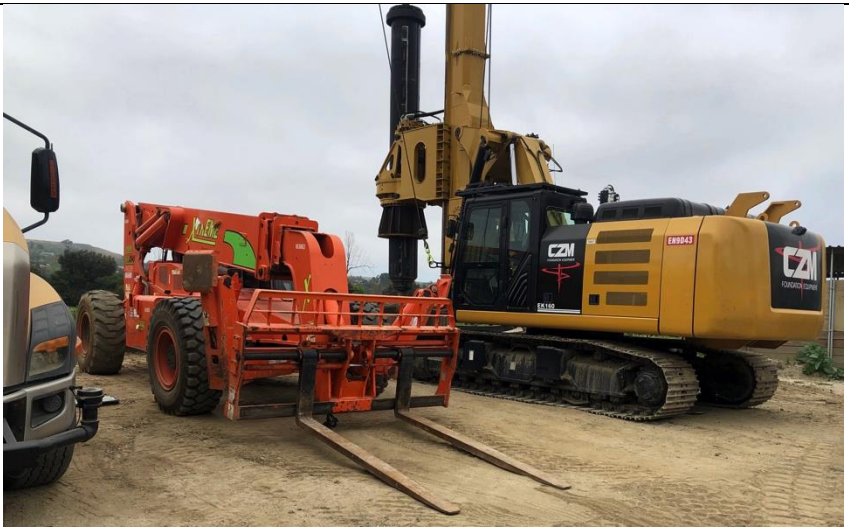
| Date | Location | Photo | Description |
|---|--|--|--|
| 04/29/20 | Transmission line route, tower location 10 | A yellow tracked excavator with 'CZM' branding and 'EM5043' on its side is parked on a dirt surface. To its left is an orange backhoe loader. The background shows a cloudy sky and some distant trees. | Photo 13 – Equipment parked near tower location 10. Photo facing north. |

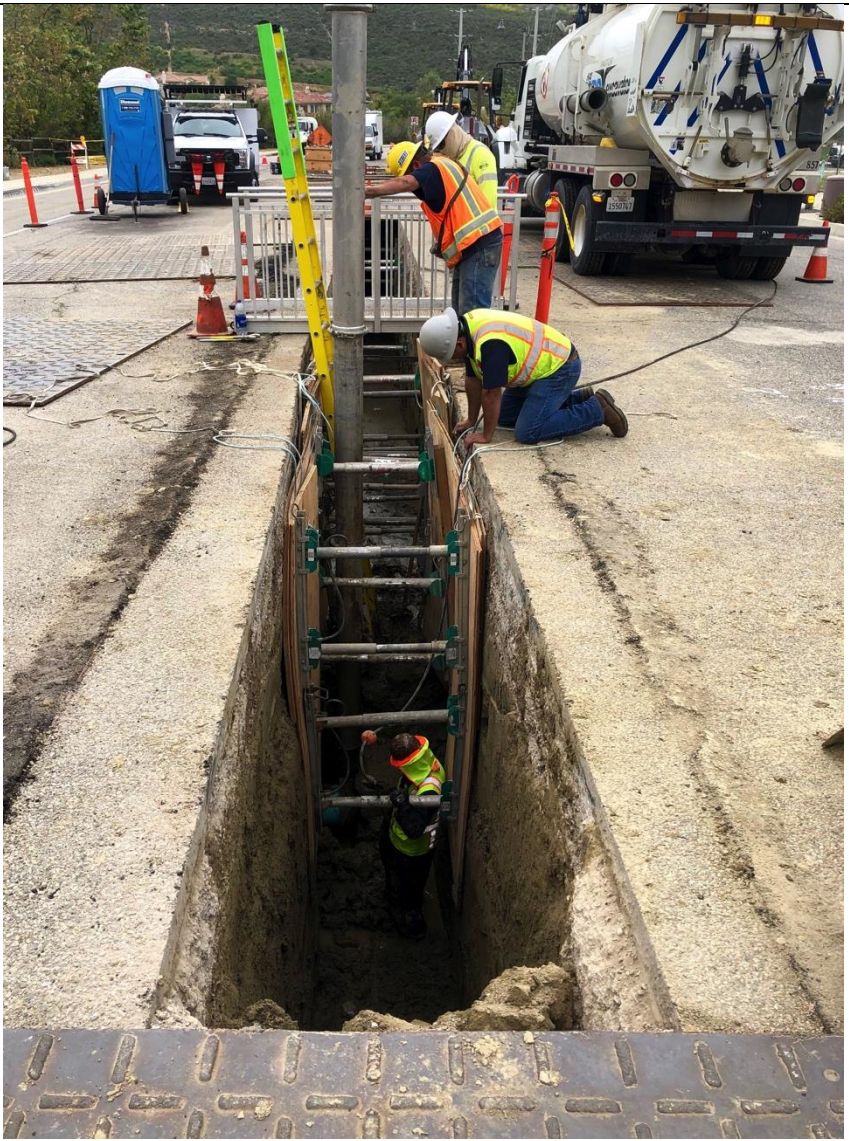
| Date | Location | Photo | Description |
|---|--|--|--|
| 04/29/20 | SOCRE transmission corridor | A long, narrow trench has been dug into a road surface. A worker in a high-visibility vest is kneeling at the edge of the trench, while another worker is visible inside the trench. A large concrete mixer truck is parked in the background, and a blue portable toilet is visible to the left. The scene is set on a paved road with some construction equipment and safety barriers. | Photo 14 – Trenching work within Stallion Ridge Road. Photo facing west. |
