August 26, 2020

**Re: Monthly Report Summary #33 for the South Orange County Reliability Enhancement (SOCRE) Project**

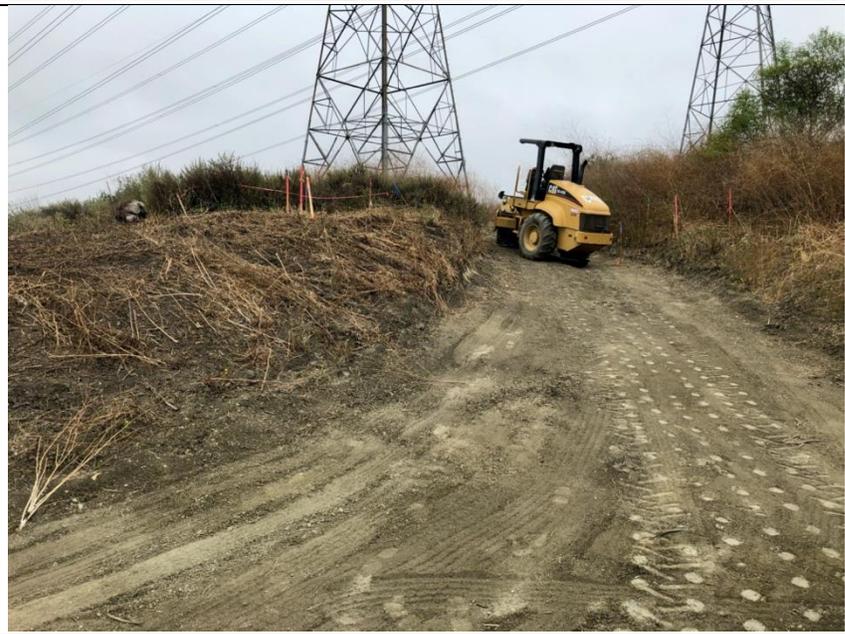
Photo 3 – Tower location 37 had been cleared and equipment delivered in preparation for pad construction. Photo facing south.

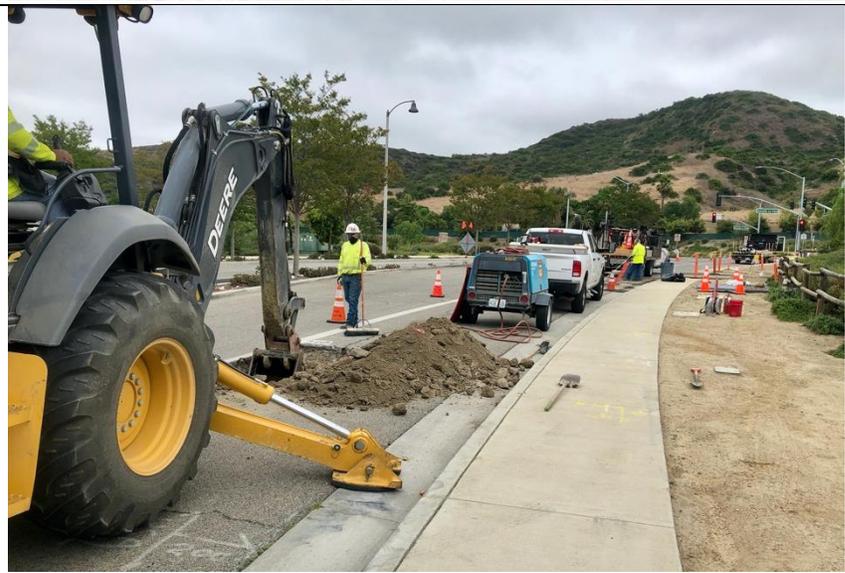
Photo 5 – Conduit work within Stallion Ridge Road. Photo facing east.

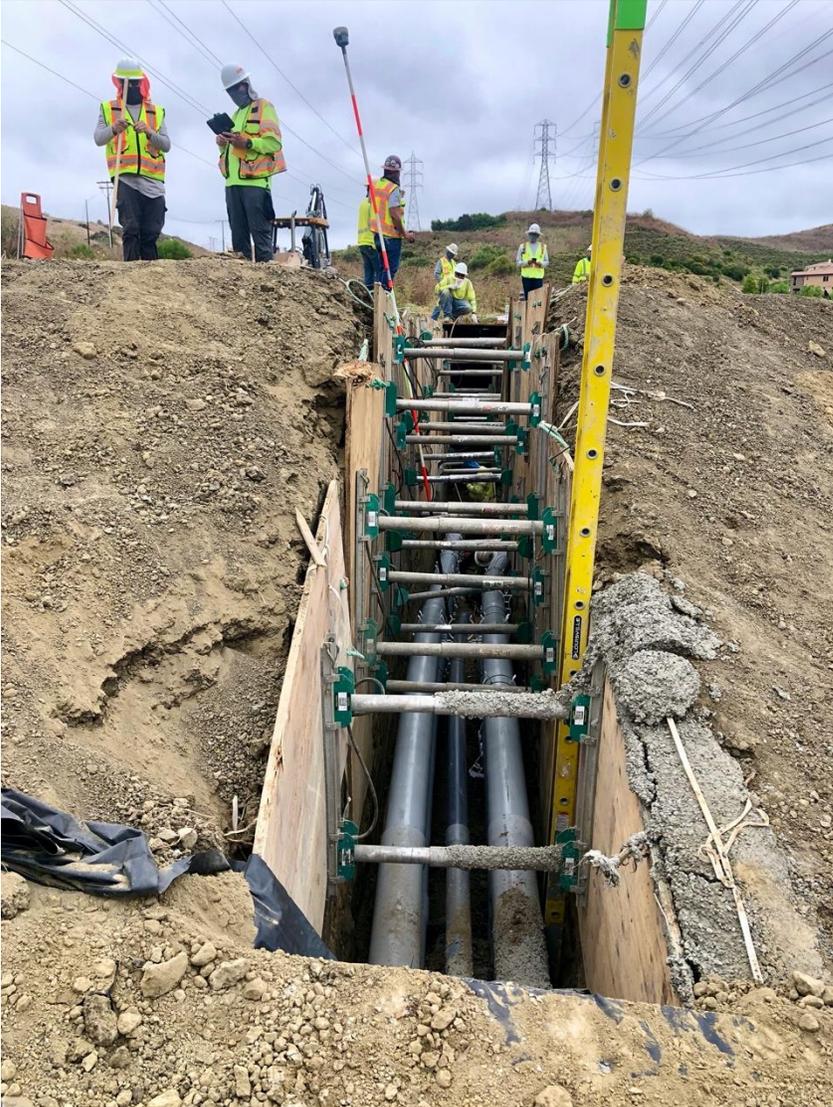
Photo 6 – Conduit installation at tower locations 18 and 19. Photo facing south.

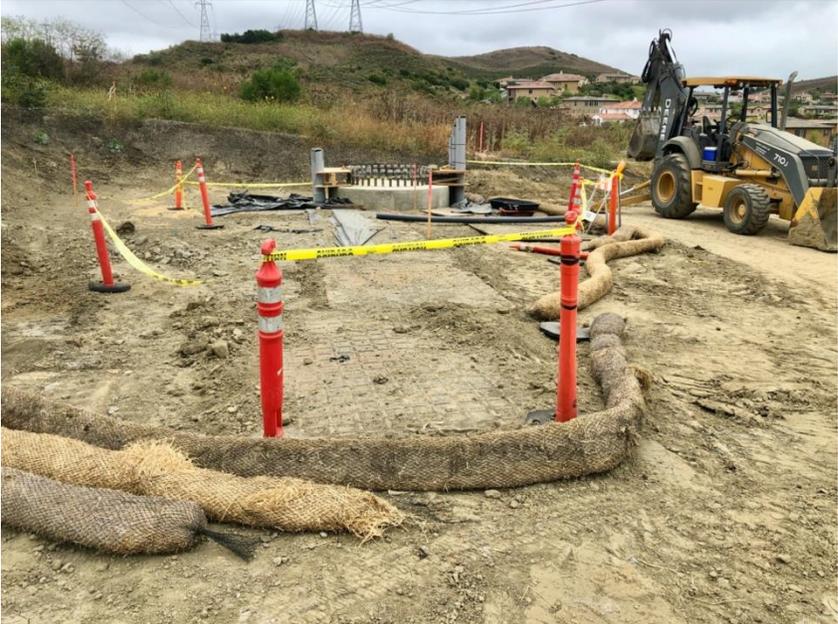
Photo 7 – The covered conduit trench at tower locations 18 and 19. Photo facing south.

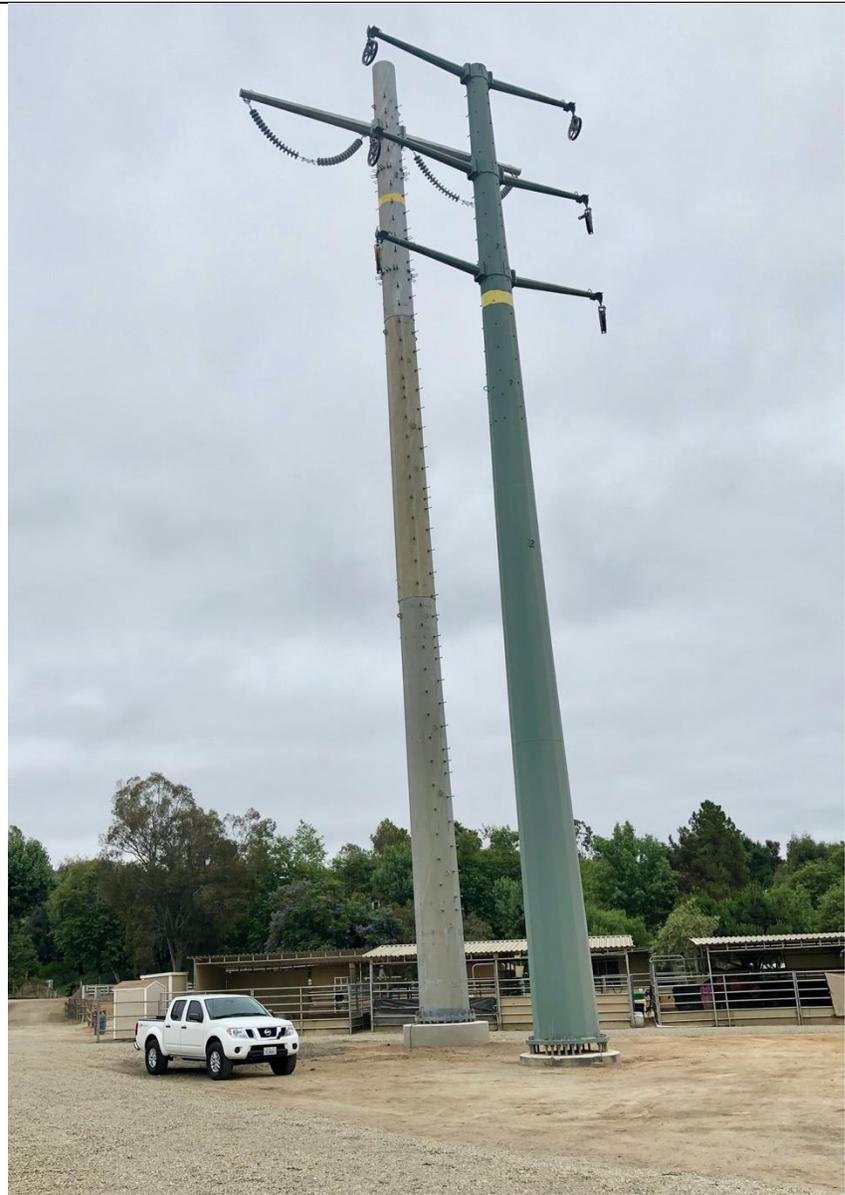
Photo 9 – Partially erected tower at tower location 10. Photo facing south.
07/02/20	SOCRE transmission corridor

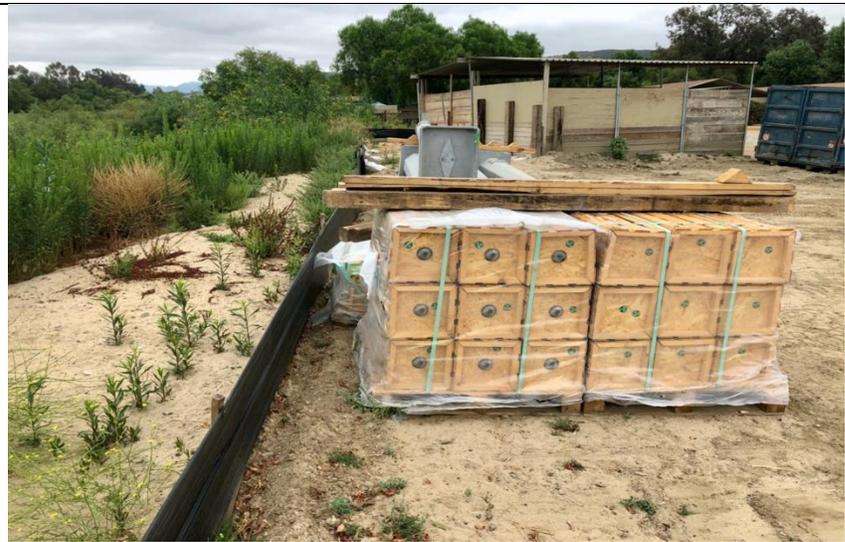
Photo 10 – Materials staged near the stream channel at tower location 10. Photo facing east.

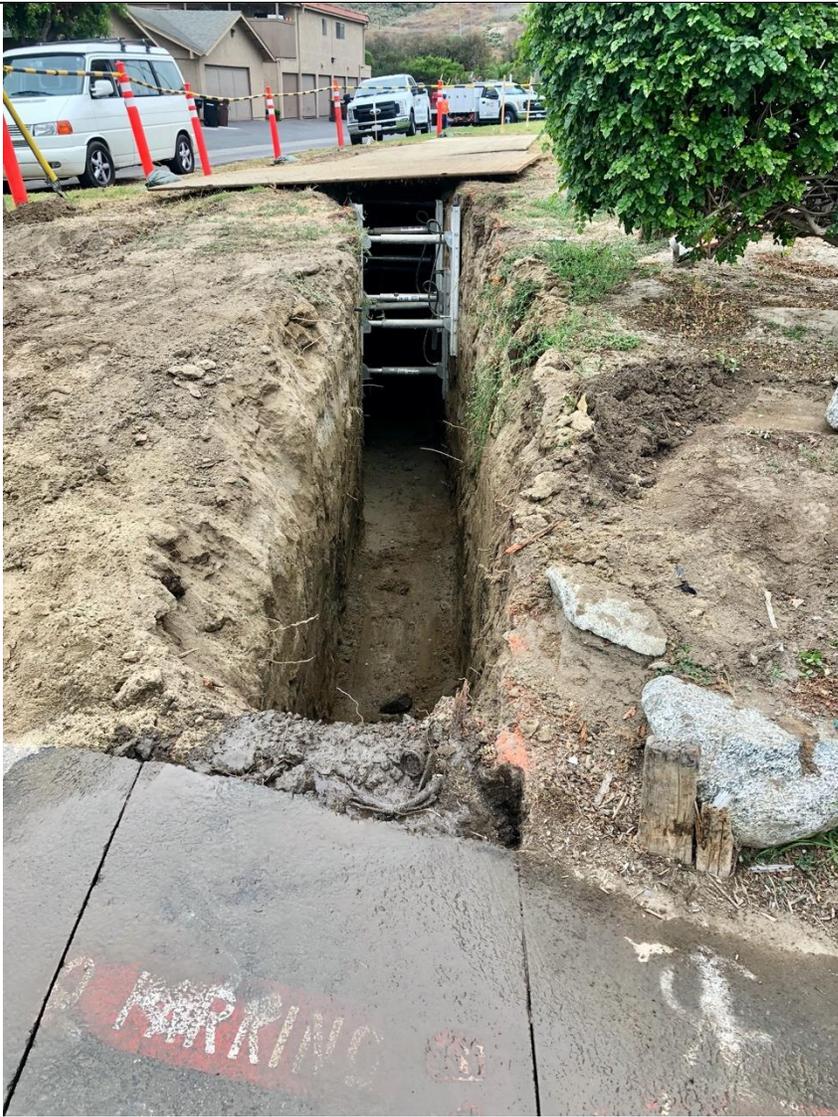
Photo 12 – Excavation for the conduit trench west of the jack and bore exit hole. Photo facing west.

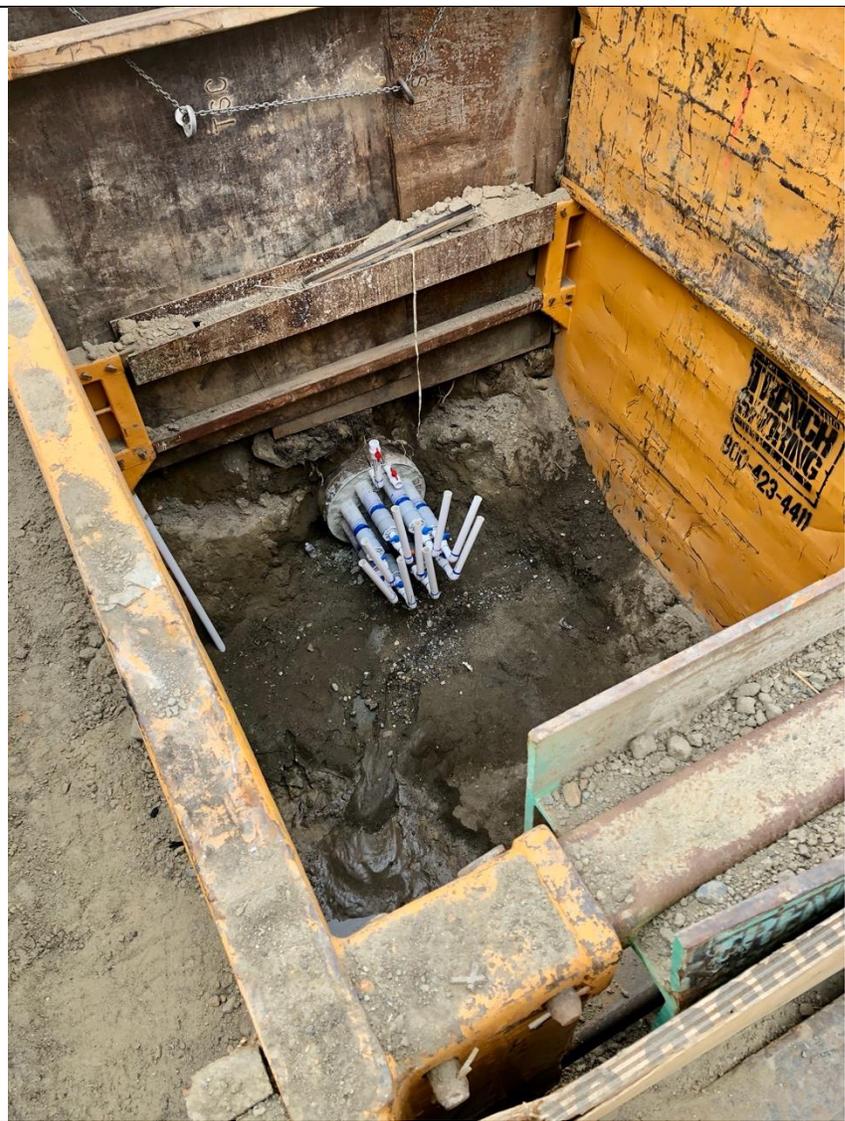
.Photo 13 – Jack and bore exit hole with visible conduit leading out of the piping.
07/02/20	West of San Juan Capistrano Substation – jack and bore site

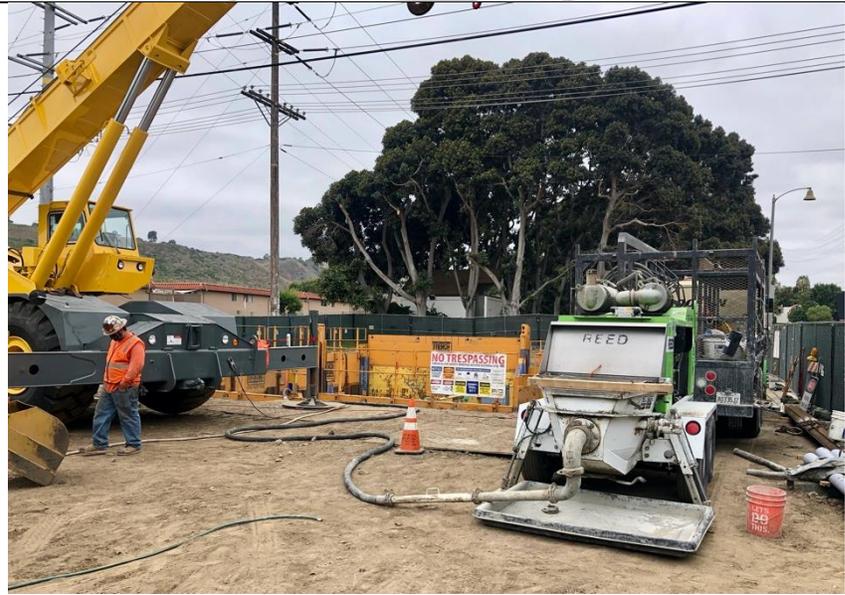
Photo 14 – Pumper truck at the jack and bore entry hole site. Photo facing west.

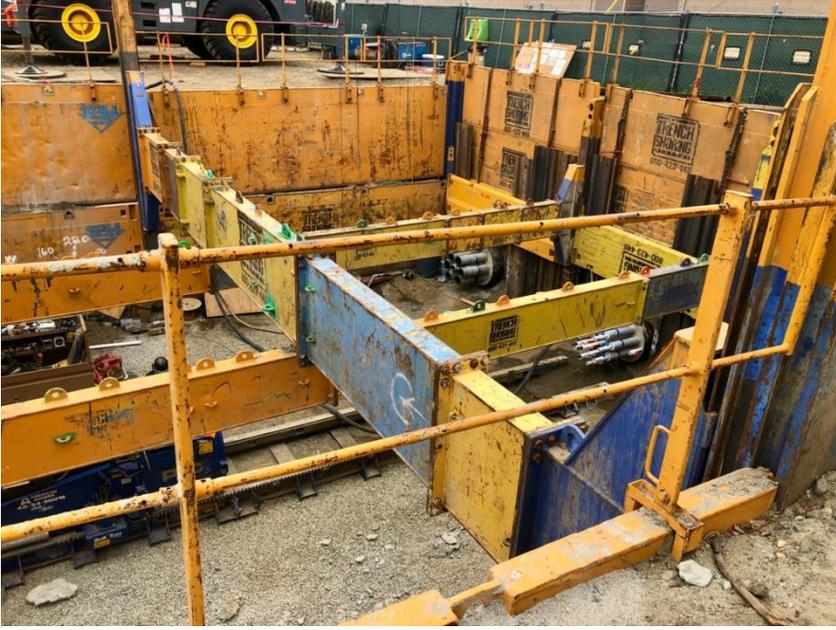
Photo 15 - The jack and bore entry hole site.
07/02/20	San Juan Capistrano Substation

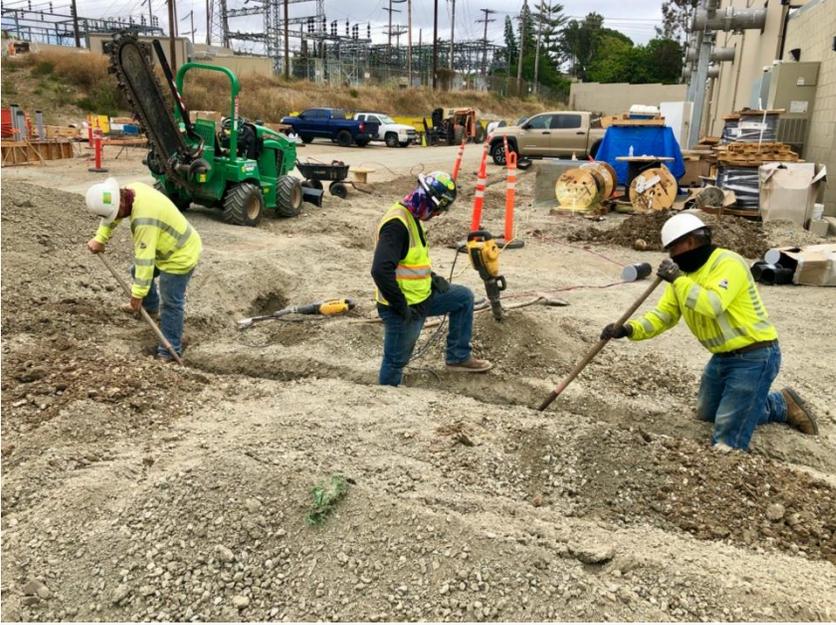
Photo 16 – Crews digging the grounding wire trench. Photo facing south.

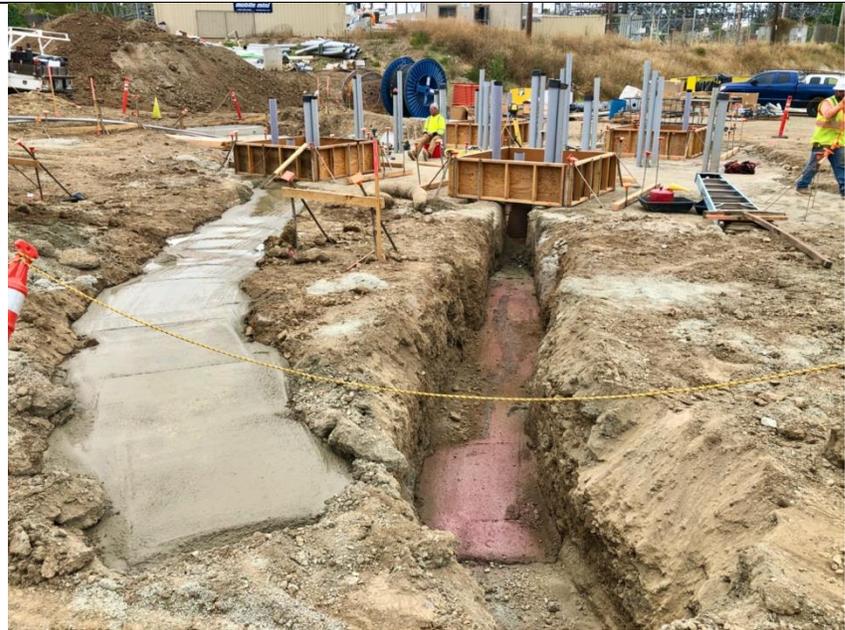
Photo 17 – Conduit trench with slurry added. Photo facing south.
07/02/20	San Juan Capistrano Substation

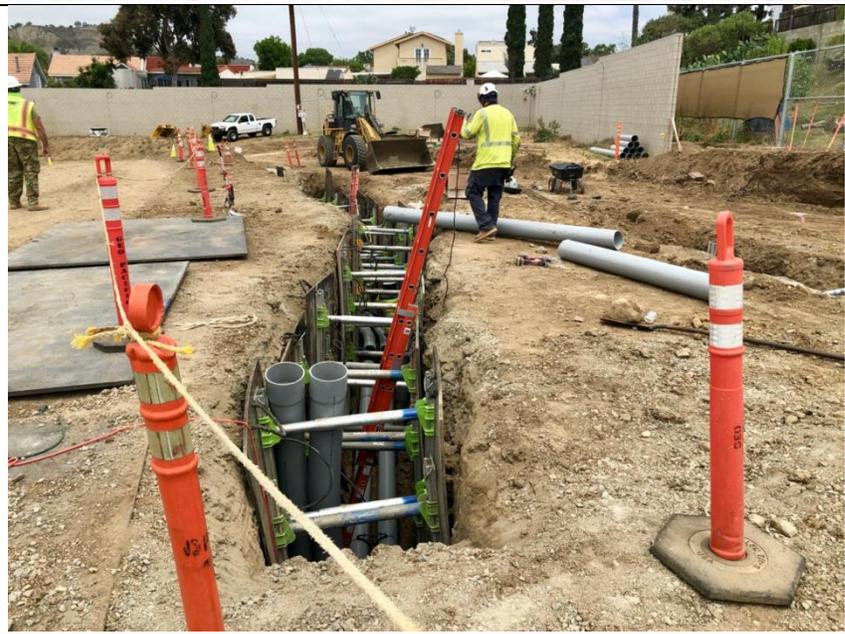
Photo 18 – Conduit trenching being completed at the substation. Photo facing north.

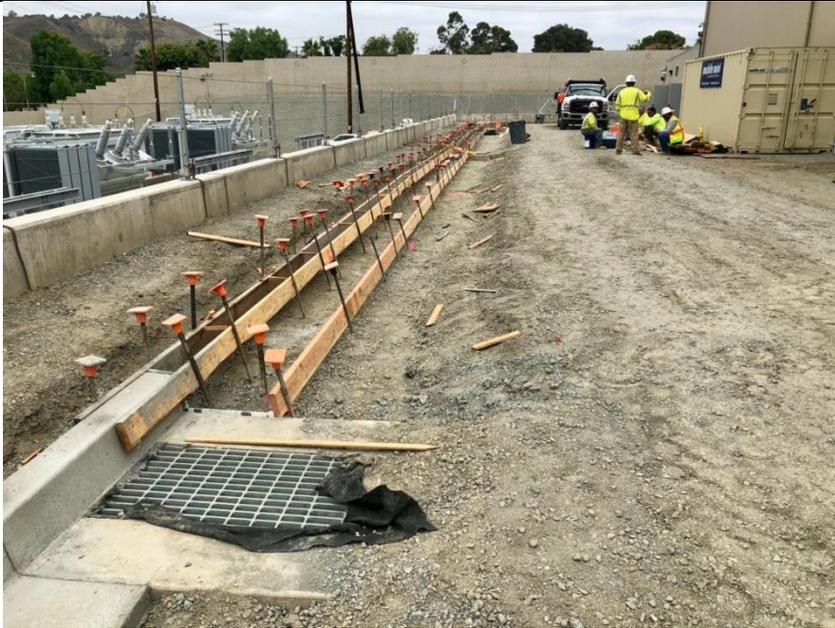
Photo 19 – Curb and gutter being formed and poured around the 138-kV GIS building. Photo facing north.
07/02/20	San Juan Capistrano Substation

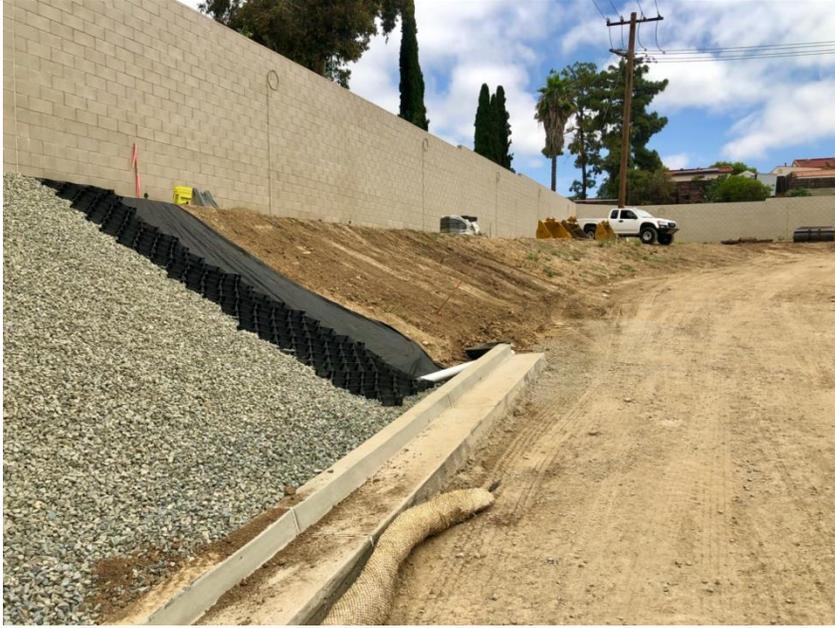
Photo 20 – Armoring of the northern slope continued. Photo facing east.

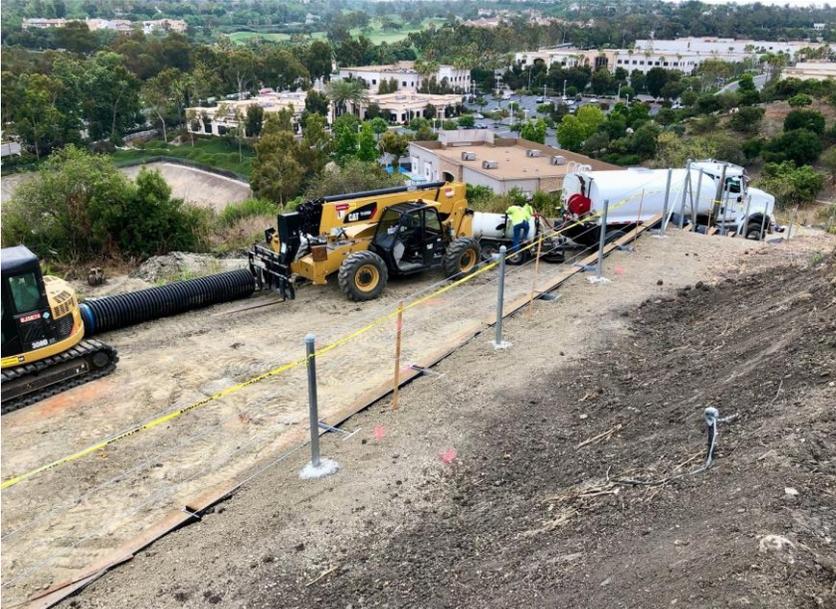
The EI and I drove south to tower location 36 where crews continued to build the tower pad (Photo 1). The crews were installing a black plastic corrugated drain culvert under an access road near the tower pad (Photo 2). The trench for the drainpipe was straight walled and had a 2-foot by 4-foot wooden board placed inside to act as an escape structure for trapped wildlife. I suggested using old straw wattle as a climbing structure to facilitate trapped wildlife climbing out of the trench. Another EI was spot-checking the construction site.

Photo 1 – Tower location 36. Photo facing east.

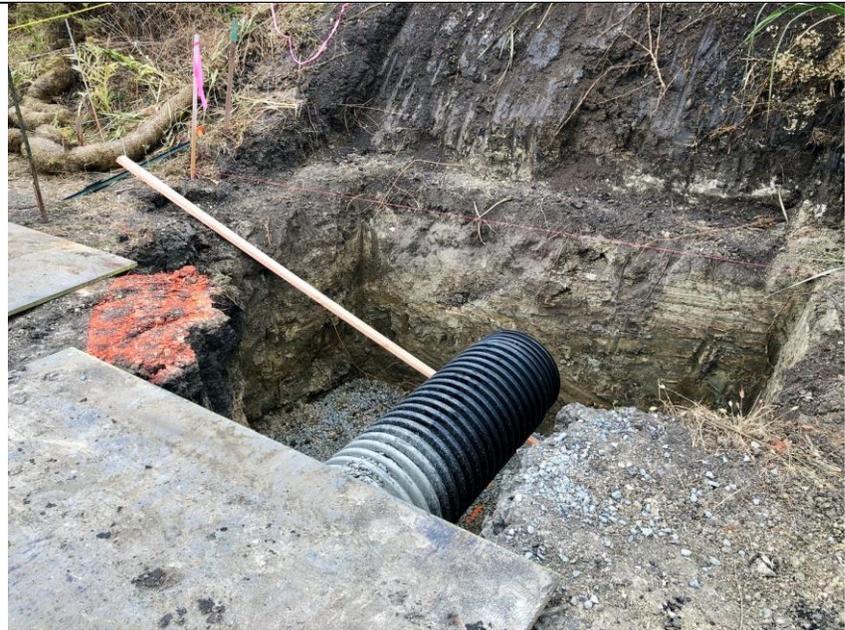
Photo 2 – Drain installation under an access road near tower location 36.
07/08/20	SOCRE transmission corridor

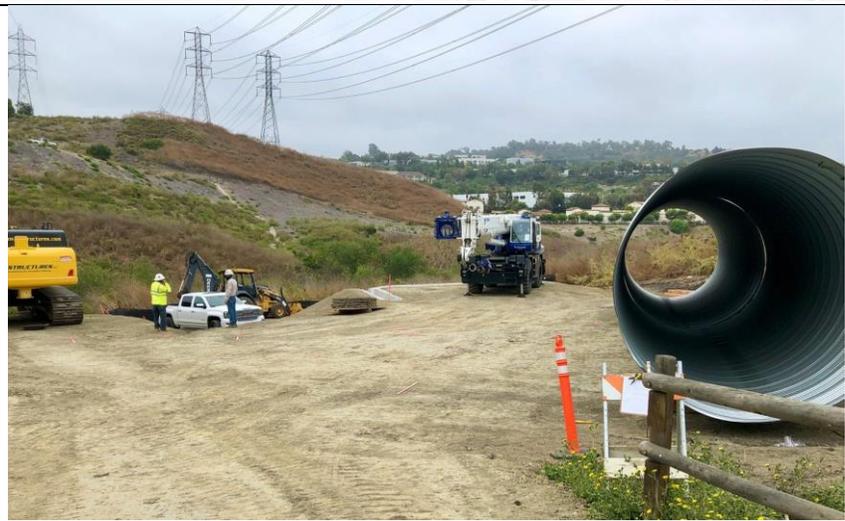
The next stop was at tower location 34 where the KV Structures crew was preparing to drill the tower foundation (Photo 3). Bird surveys had been done at this location and no new nesting activity was observed. The brow ditch and energy dissipater had been installed (Photo 4). A large metal culvert was delivered that would be installed in the drilled hole. The drilling operation would be extensive with a large, deep foundation hole needed; groundwater was anticipated during drilling. The access road was dusty with no exit or entry BMPs in place; we discussed a possible action of laying down a road base since there would be heavy traffic for the next several weeks. The day after my site visit, the EI sent me a photo of the access road with rock and rumble plates installed (Photo 5).

Photo 3 – Crew preparing to drill at tower location 34. Photo facing south.

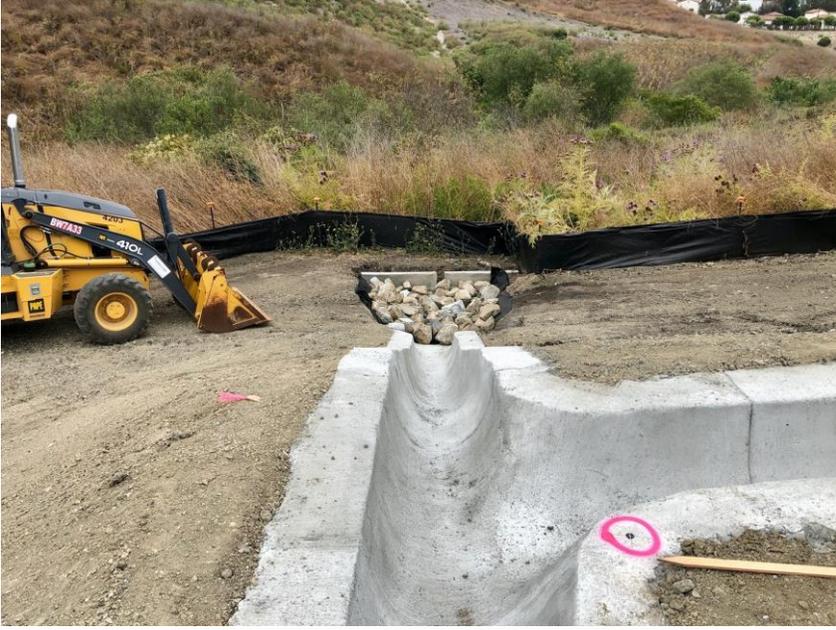
Photo 4 – Brow ditch and energy dissipater at tower location 34. Photo facing south.
07/08/20	SOCRE transmission corridor

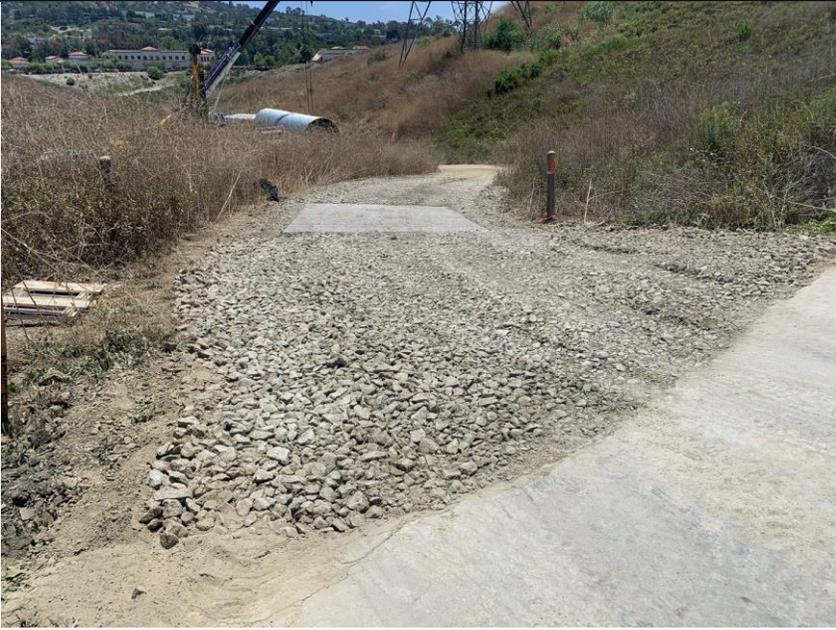
Photo 5 – Exit and entry BMPs installed at the tower location 34 access road. Photo provided by the EI. Photo facing south.

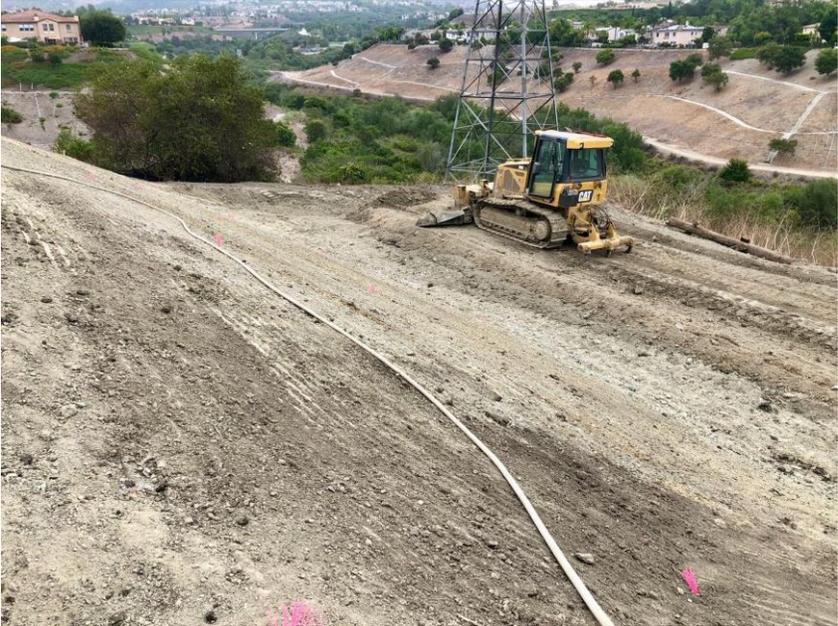
At tower location 32, a crew continued to dig out the pad below the brow ditch; the work was anticipated to be completed soon (Photo 6).

Photo 6 – Completing the new tower pad at tower location 32. Photo facing south.

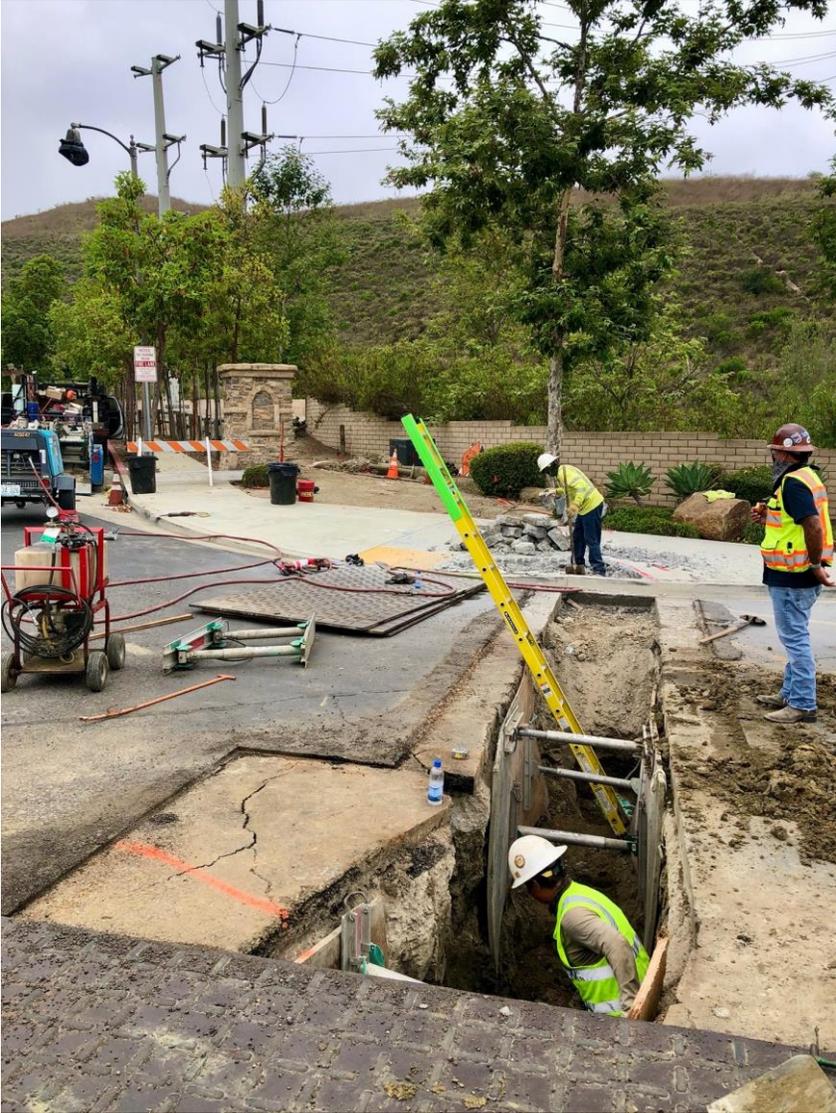
At Stallion Ridge Road, crews were working on delivering conduit to tower locations 16 and 17 (Photo 7). No nesting birds were present in the area since all the American kestrel (*Falco sparverius*) nests had fledged. With no nesting birds the avian biologists were only conducting morning sweeps and spot checking throughout the day. At tower locations 18 and 19, crews had completed the conduit connections and were cleaning up excess soil as they waited to backfill the trenches (Photo 8).

Photo 7 – Conduit work at tower locations 16 and 17. Photo facing southwest.
07/08/20	SOCRE transmission corridor

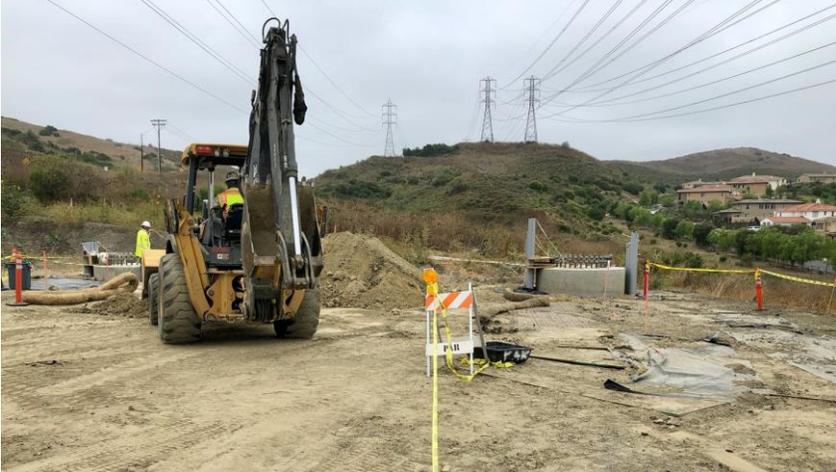
Photo 8 – Cleanup work at tower locations 18 and 19. Photo facing south.

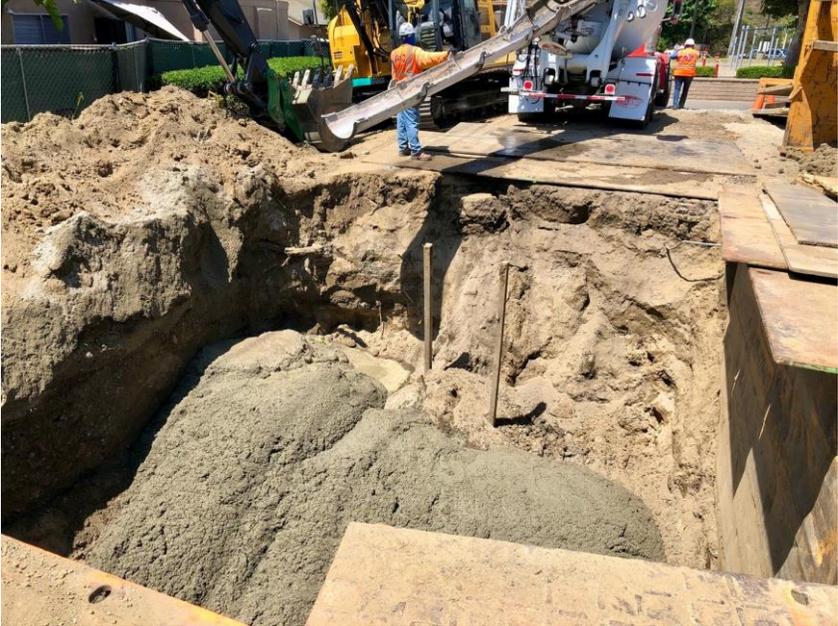
I drove to the jack and bore operation west of the substation where I met with the EI covering the substation work. At the exit hole location west of the railroad tracks, a crew was pouring slurry into the second bore hole (Photo 12). The third and fourth bore operations were underway and would continue through the day until the required point past the tracks had been reached (Photo 13). The work appeared to be going smoothly.

Photo 12 – Poured slurry in the second bore exit hole. Photo facing west.

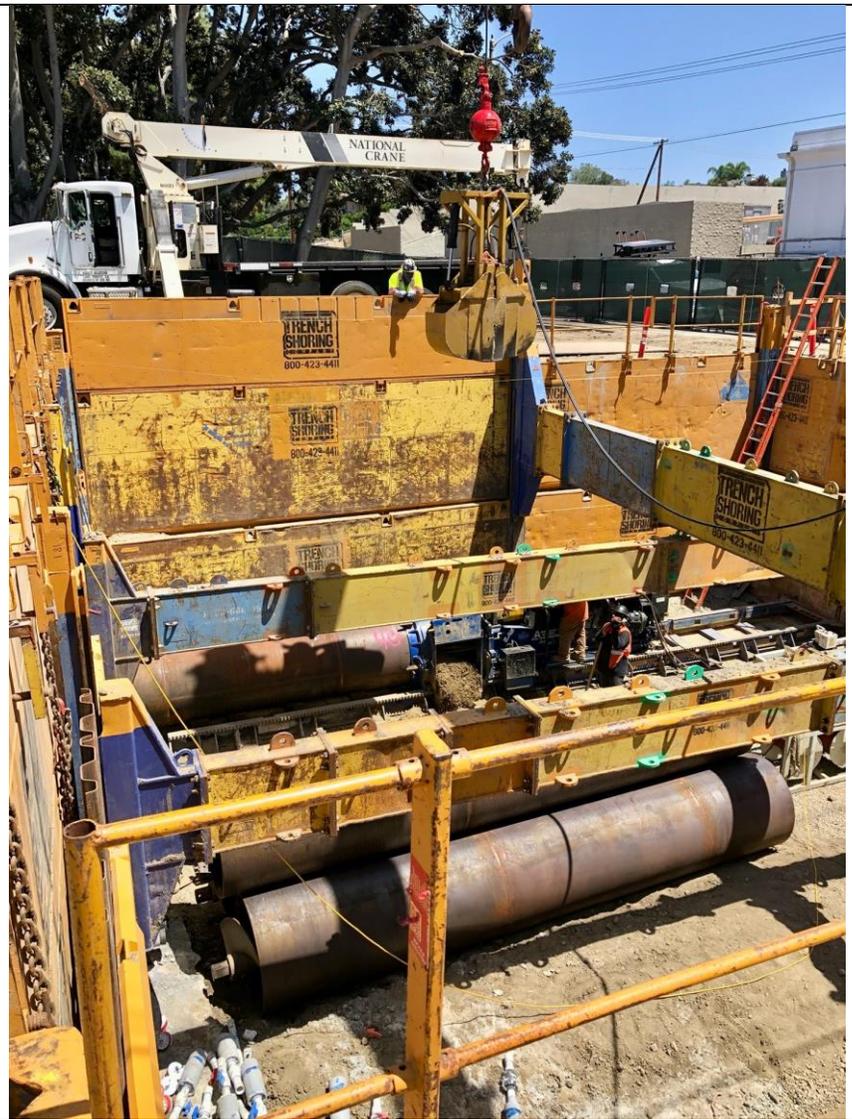
Photo 13 – Jack and bore work at the entrance hole. Photo facing north.

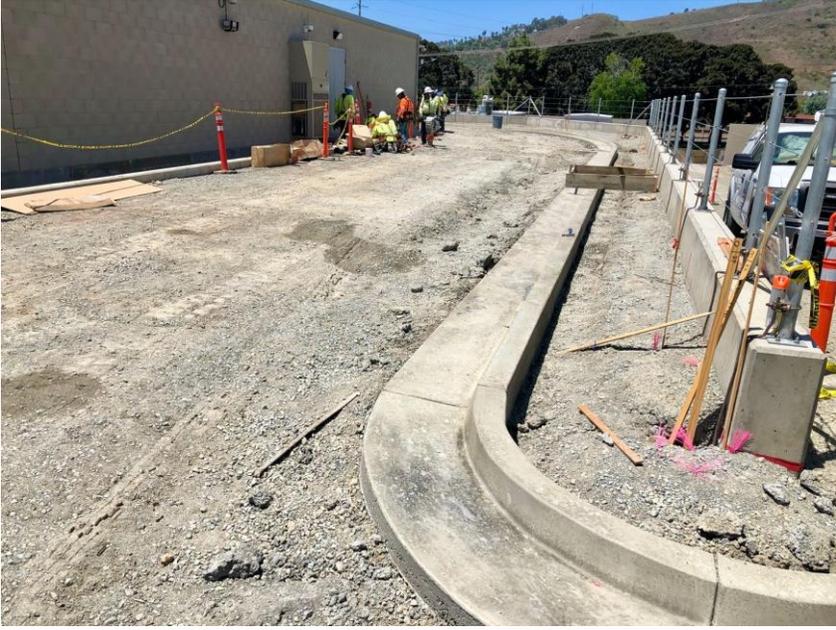
The curb and gutter installation had been completed around the 138-kV GIS building with paving to be completed soon (Photo 16).

Photo 16 – Curb and gutter around the 138-kV GIS building was complete. Photo facing west.
07/08/20	San Juan Capistrano Substation

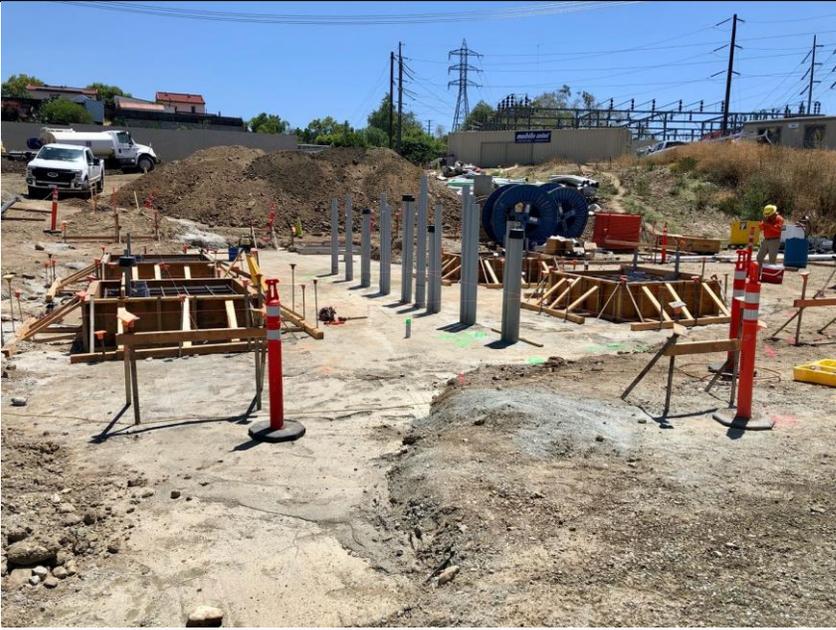
Photo 17 – Newly installed conduit. Photo facing east.

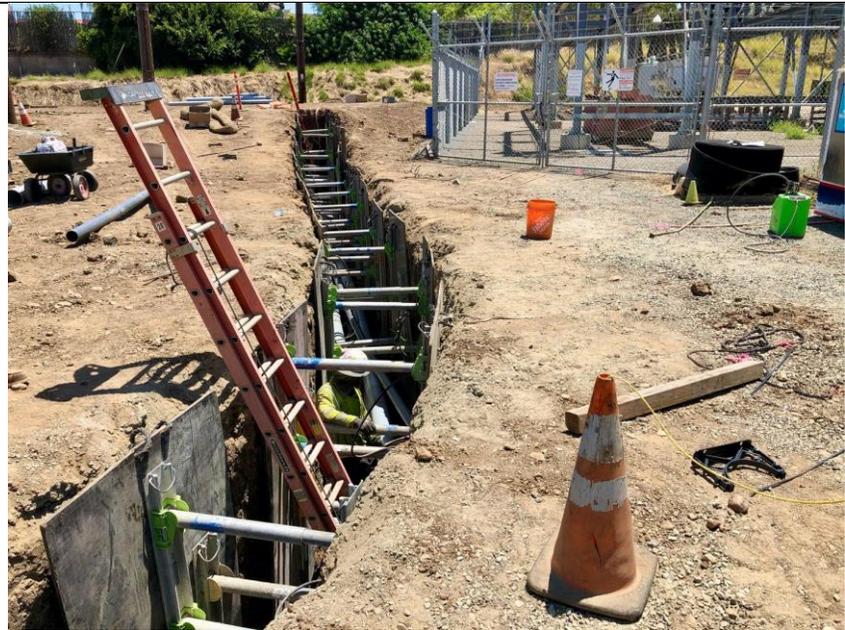
Photo 18 – Conduit trenching and installation at the substation. Photo facing east.
07/08/20	San Juan Capistrano Substation

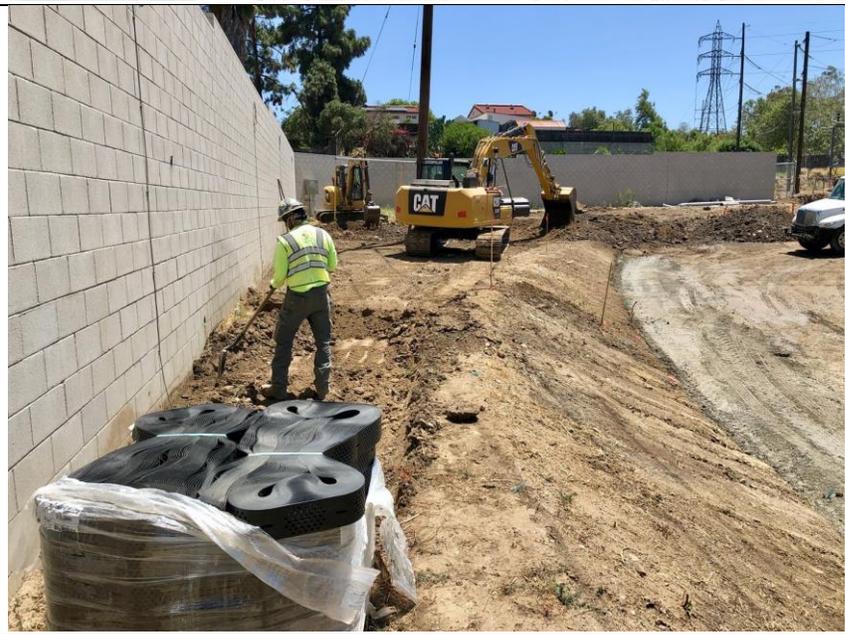
Some earthwork was being completed on the northern slope in preparation for armoring the last remaining portion (Photo 19).

Photo 19 – Preparation for armoring the north slope of the substation. Photo facing east.

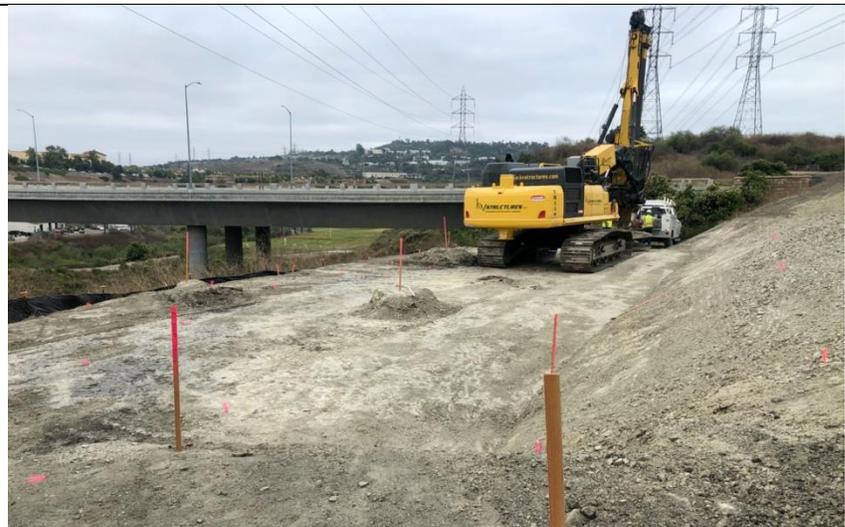
Further down the road at tower location 32, the pad grading work was complete and the drilling rig had been delivered (Photo 4). The brow ditch and the energy dissipater installation above the tower pad had been completed (Photo 5). A dump truck arrived to remove the drill tailings. A paleontology monitor was scheduled to inspect the site once the drilling began.

Photo 4 – Drilling rig onsite at tower location 32. Photo facing south.
07/16/20	SOCRE transmission corridor

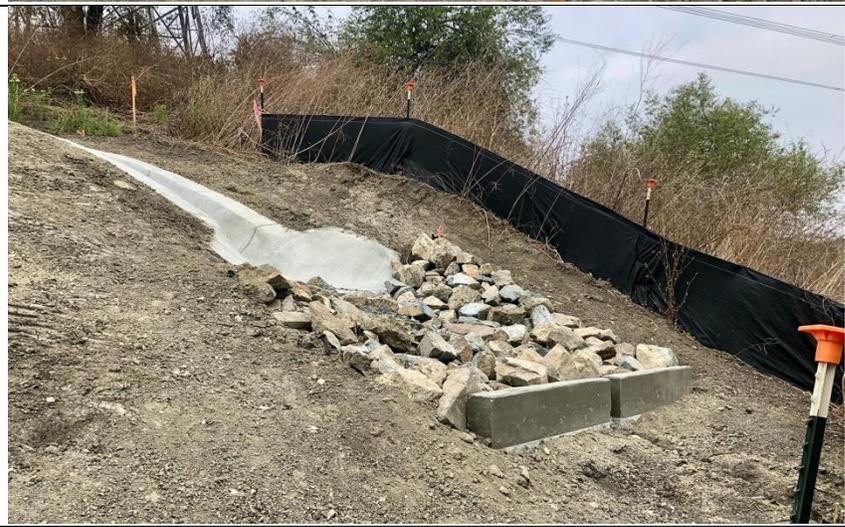
Photo 5 – Brow ditch and energy dissipator in place above tower location 32. Photo facing northwest.
07/16/20	SOCRE transmission corridor

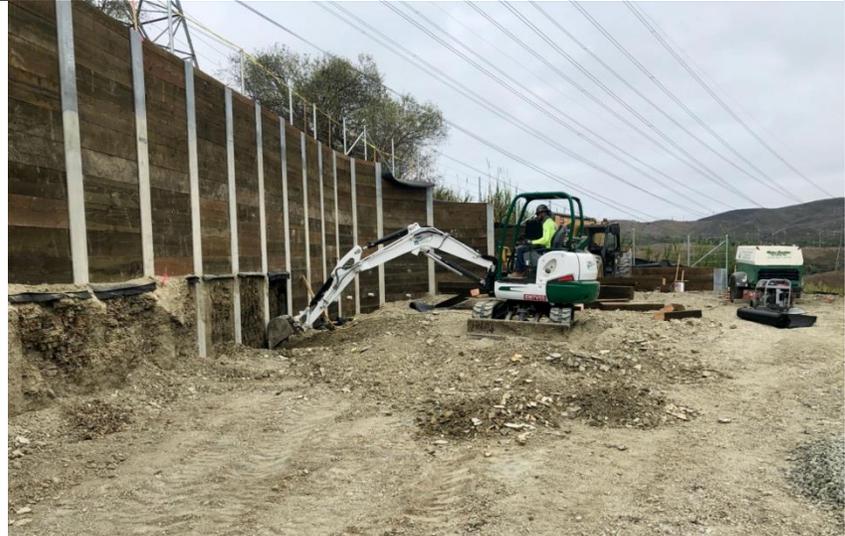
Photo 6 – Tower pad work at tower location 36. Photo facing northwest.

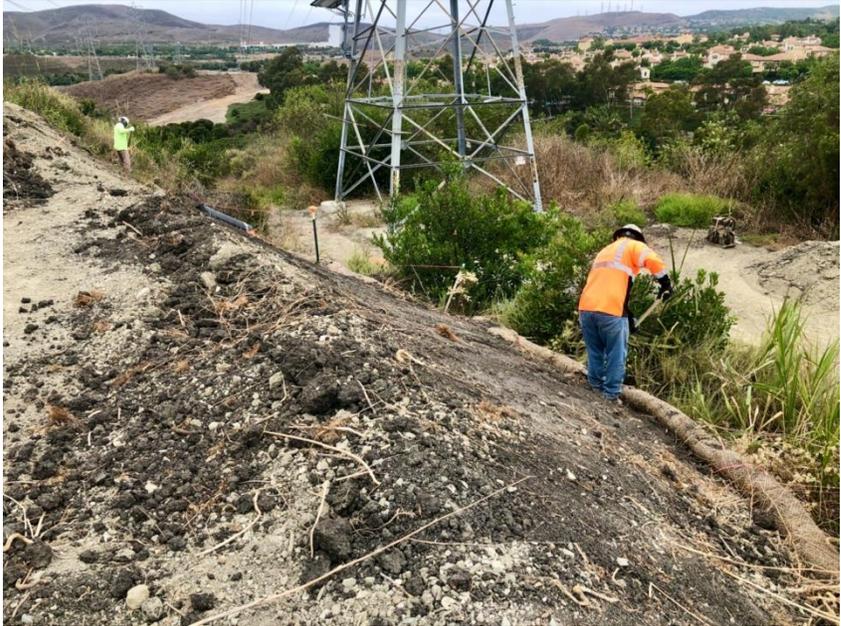
Photo 7 – BMP upgrades at tower location 36. Photo facing north.

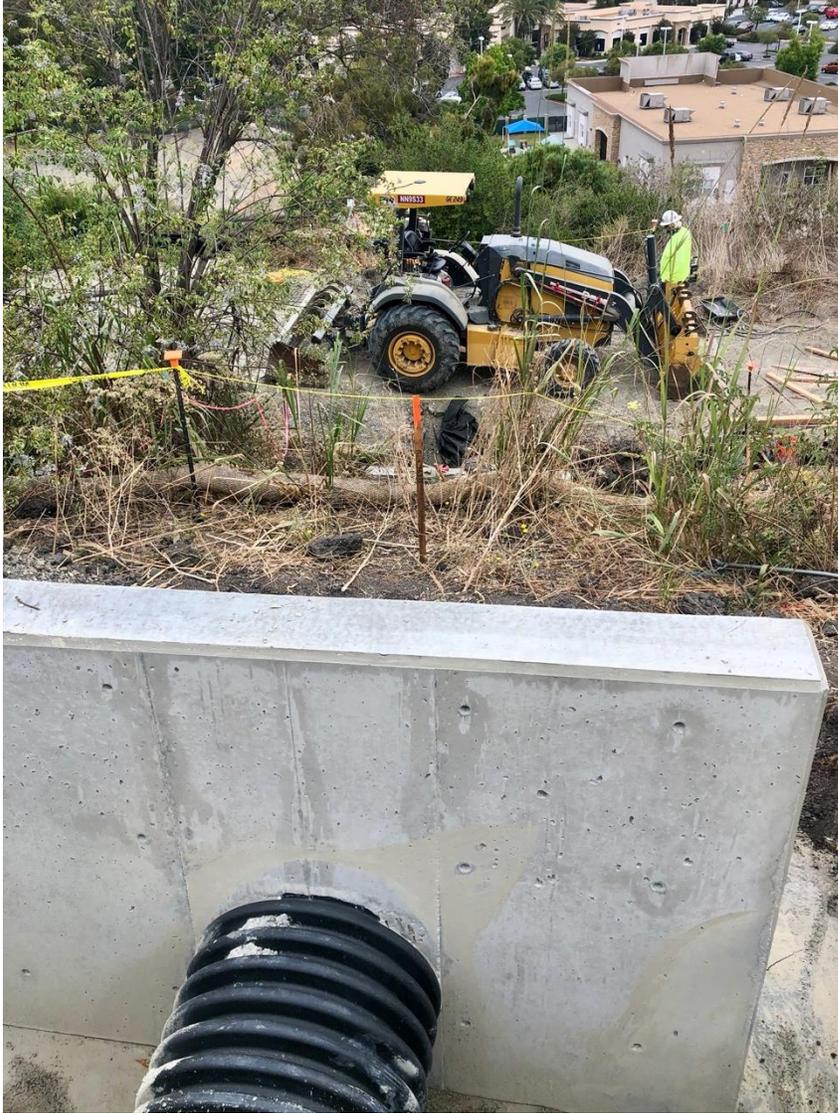
Photo 8 –  
Installation of  
access road  
drains at tower  
location 36.  
Photo facing  
northeast.

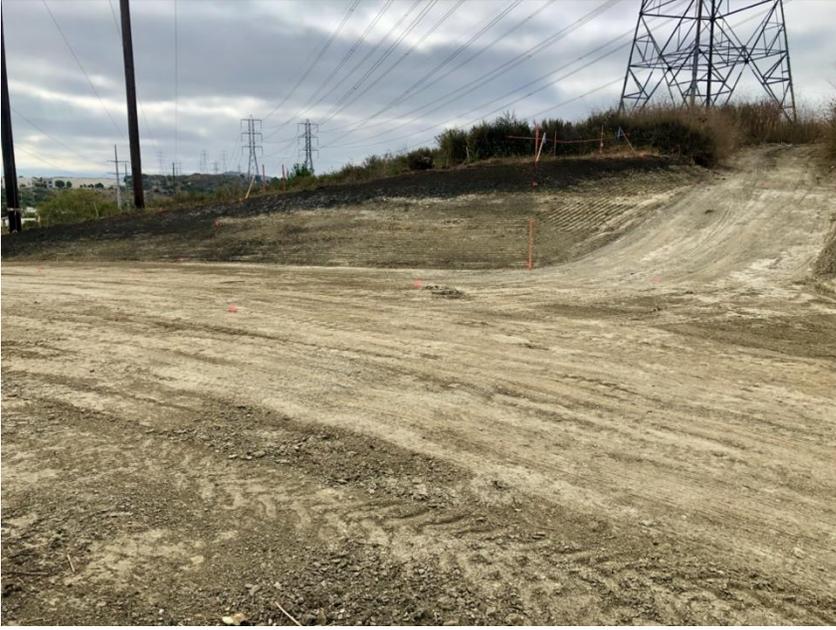
Photo 9 – Newly graded pad at tower location 37. Photo facing south.
07/16/20	SOCRE transmission corridor

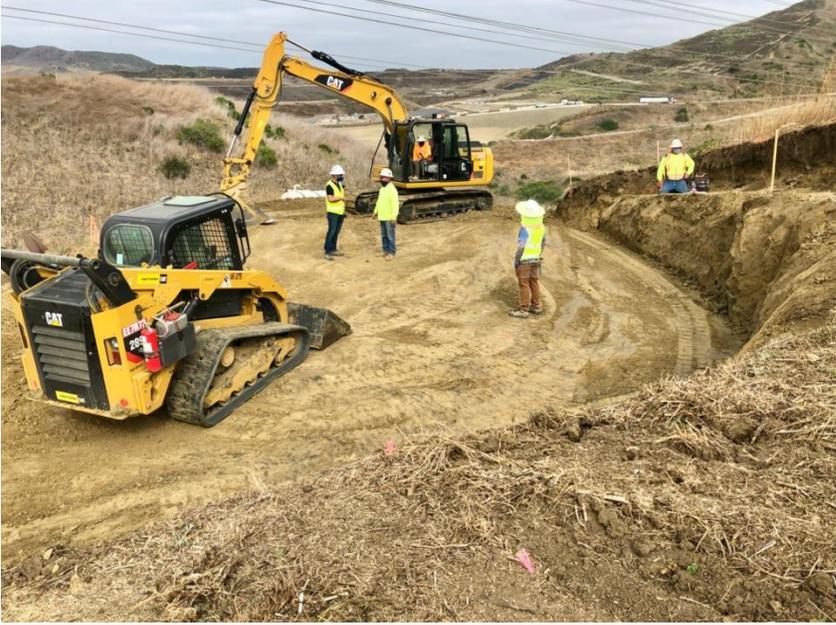
Photo 10 – Crew grading the pad at tower location 24. Photo facing west.
