August 26, 2020

**Re: Monthly Report Summary #33 for the South Orange County Reliability Enhancement (SOCRE) Project**

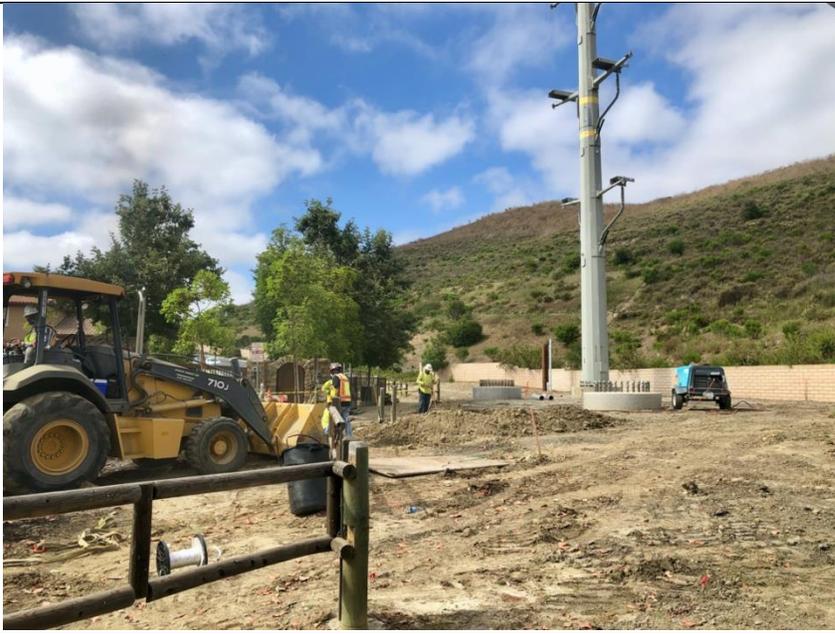
Photo 11 – Conduit installation at tower locations 16 and 17. Photo facing southwest.

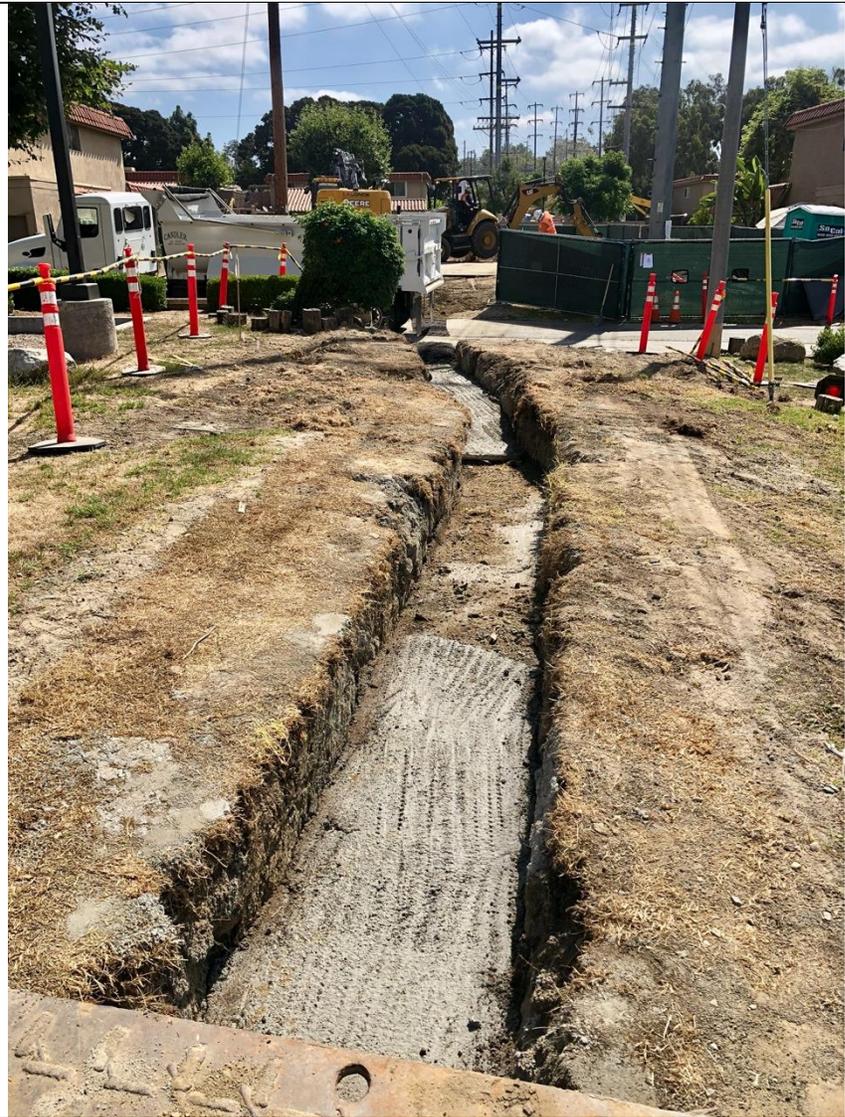
Photo 12 – Conduit trench west of the jack and bore site had been backfilled with slurry. Photo facing east.

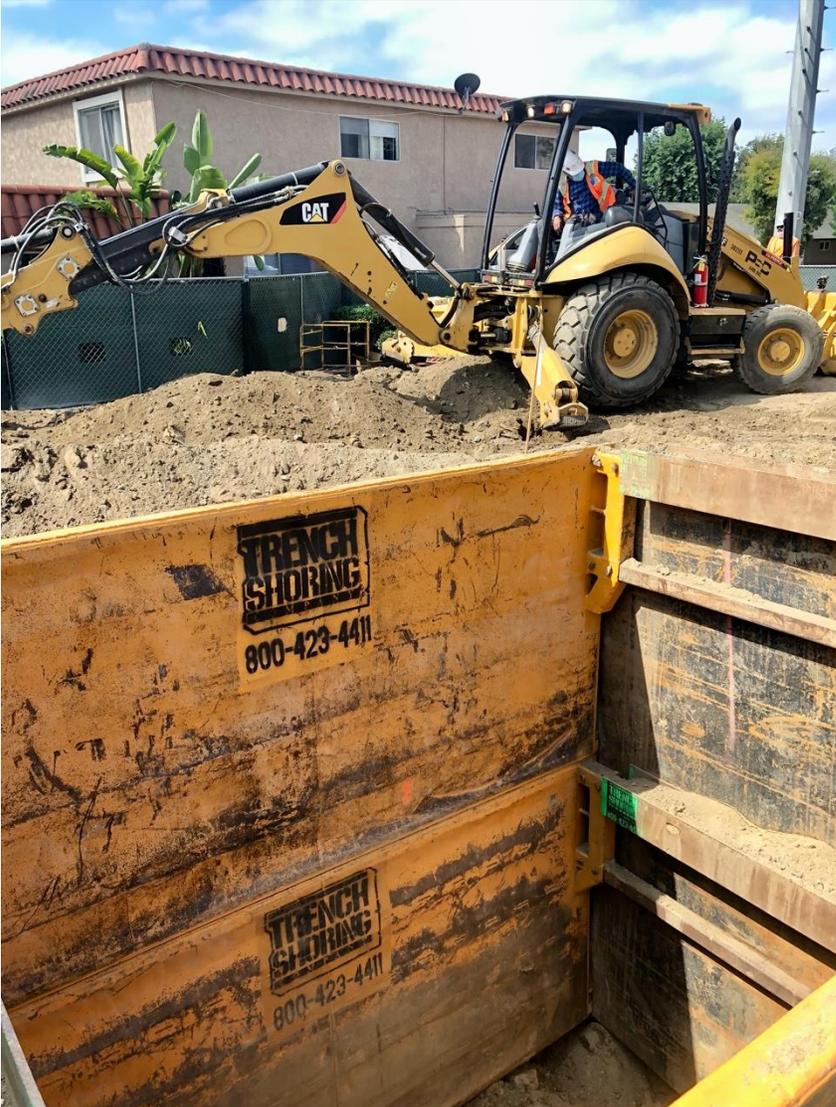
Photo 13 – Removing excess soil from the third bore operation. Photo facing southwest.

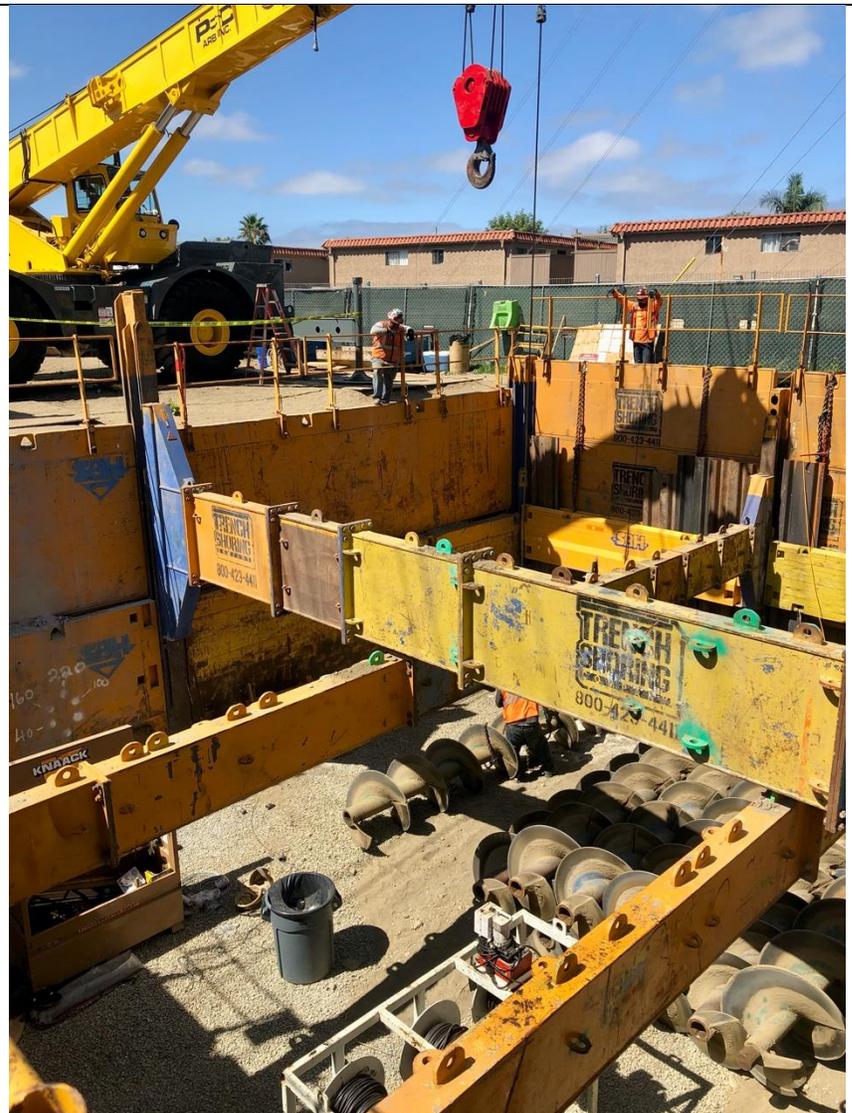
Photo 14 – Boring operation was completed and the crew had removed the auger bits. Photo facing southwest.
07/16/20	San Juan Capistrano Substation

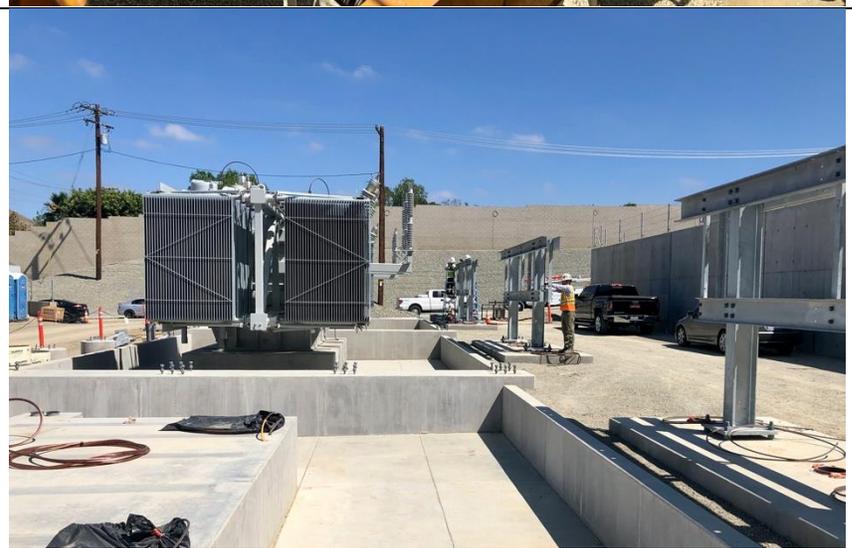
The EI and I toured the substation noting the ongoing work activities. A crew was installing equipment around the transformers (Photo 15). Slope stabilization work was being conducted on the northern slope (Photo 16) and conduit work continued in the area between the 138-kilovolt (kV) gas-insulated substation (GIS) building and the existing substation (Photos 17 and 18).

Photo 15 – Equipment installation around the transformers. Photo facing north.

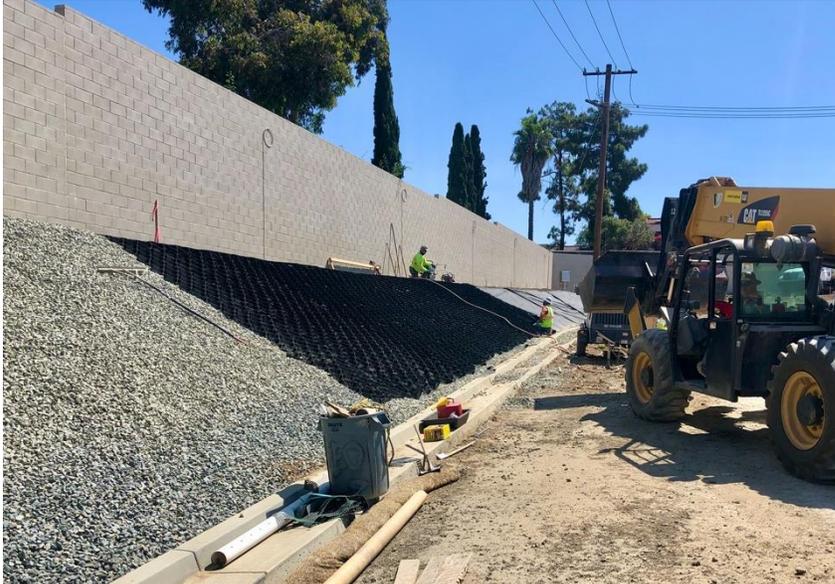
Photo 16 – Armoring the north slope of the substation. Photo facing east.
07/16/20	San Juan Capistrano Substation

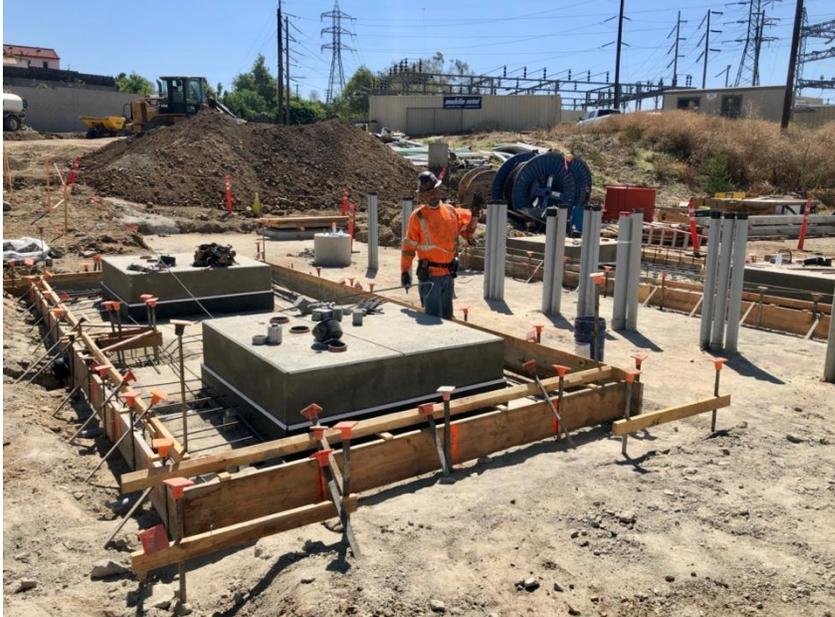
Photo 17 – Newly installed conduit. Photo facing east.

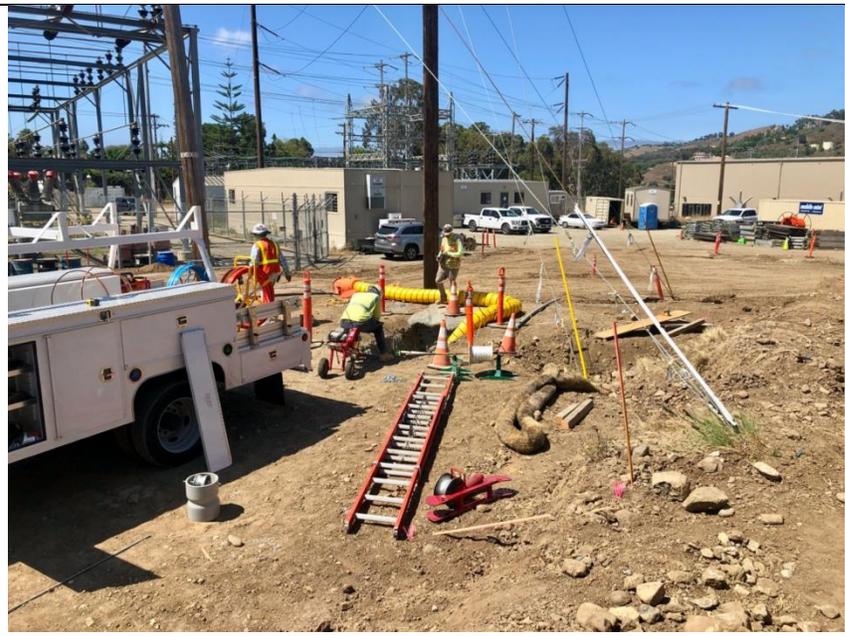
Photo 18 – Conduit trenching and installation. Photo facing southwest.
07/16/20	San Juan Capistrano Substation

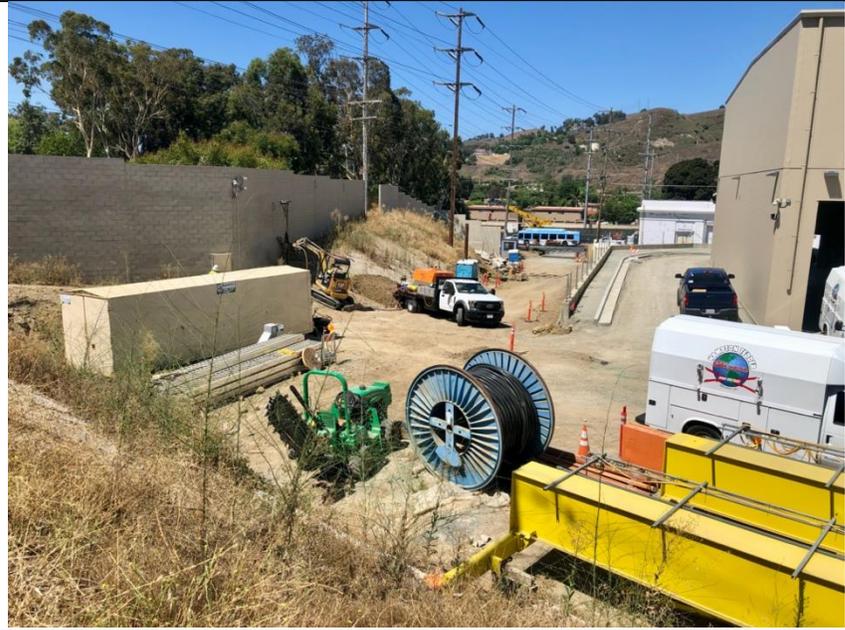
Security towers and grounding work was being completed along the southern boundary wall (Photo 19).

Photo 19 – Security tower work on the southern boundary wall. Photo facing west.

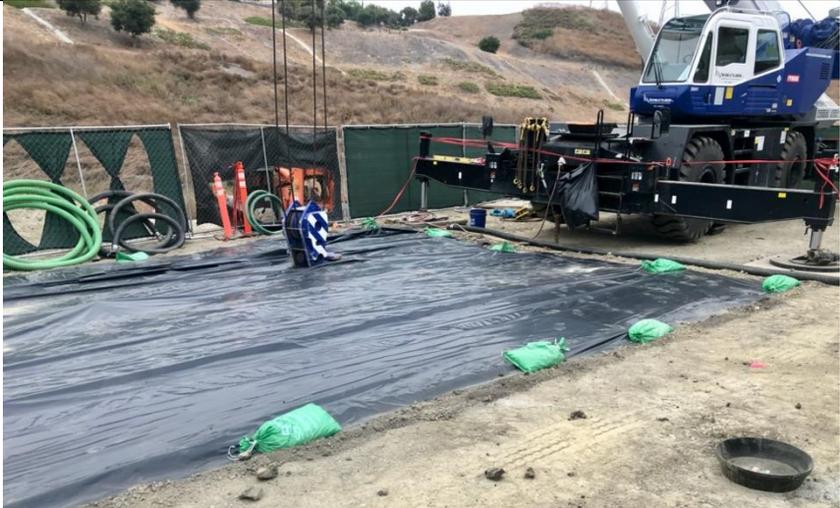
I arrived onsite at the San Juan Capistrano Substation at 0600 and proceeded immediately to tower location 34 before construction began for the day. They had done an excellent job of sealing the hole with visqueen plastic sheeting and gravel bags (Photo 1). The avian biologist arrived at the site to do the morning inspection and we discussed the sealing work and the nesting bird issues around this tower location. There was only one kingbird (*Tyrannus verticalis*) nest in the nearby lattice towers.

Photo 1 – Foundation hole coverage at tower location 34. Photo facing south.

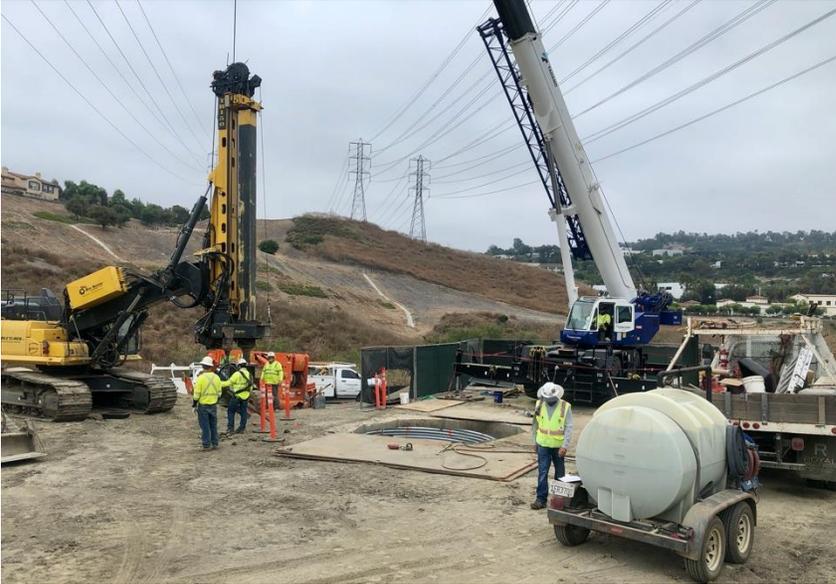
Later in the morning, I revisited the tower location 34 site as the KV Structures crew began work (Photo 2). There was an issue with the hole collapsing and the crew needed to remove the metal culvert and then evaluate how to proceed. Work may continue at this site for several more weeks. The avian biologist had discovered the kingbird nest had fallen below the tower and deduced the nest had been predated (Photo 3).

Photo 2 – Crews working at tower location 34. Photo facing south.
07/22/20	SOCRE transmission corridor

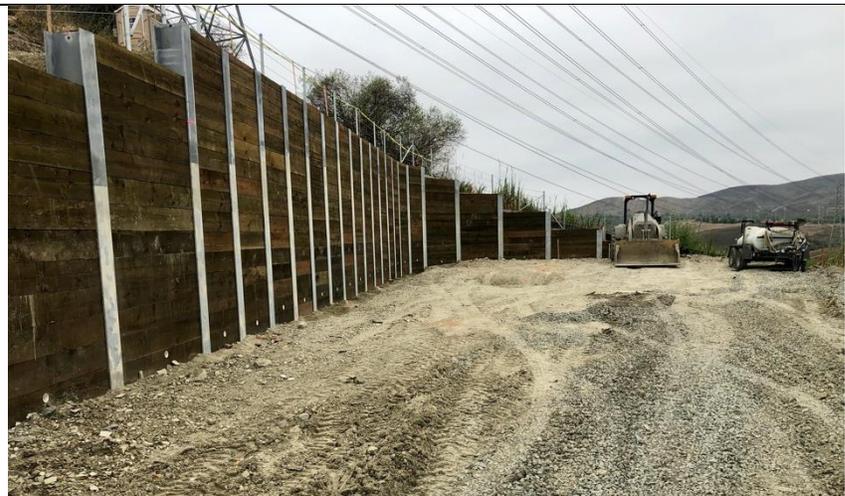
The Environmental Inspector (EI) and I drove to tower location 36 where it appeared work was nearly complete on the pad construction (Photo 4). The only remaining work was grading the pad. They had upgraded the site BMPs below the pad (Photo 5) and had some additional work to do on the site drainage pipe (Photo 6).

Photo 4 – Tower pad at tower location 36 was nearly complete. Photo facing northwest.
07/22/20	SOCRE transmission corridor

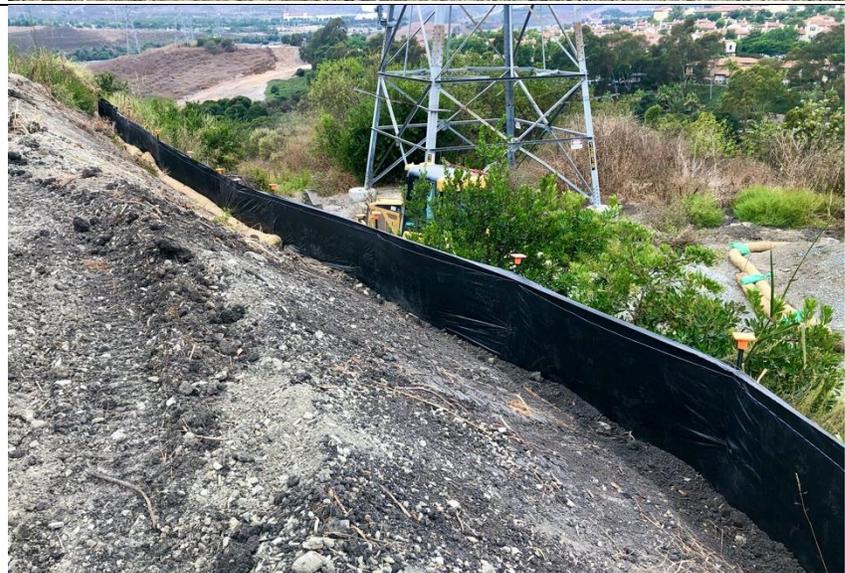
Photo 5 – BMPs at tower location 36 had been upgraded. Photo facing northwest.
07/22/20	SOCRE transmission corridor

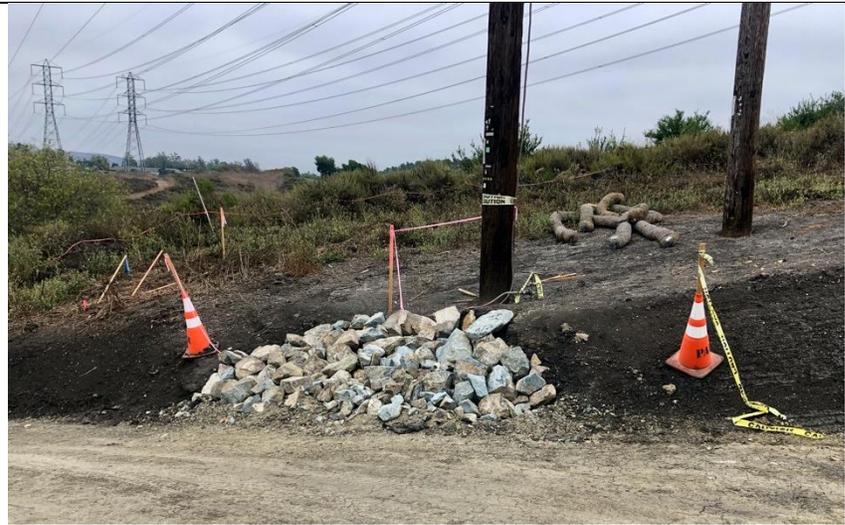
A photograph showing a pile of grey and white rocks at the base of a wooden utility pole. The ground is dark and appears to be a construction site. There are two orange traffic cones with white stripes, one on the left and one on the right, and yellow caution tape strung across the area. In the background, there are other utility poles and power lines against a cloudy sky.	Photo 7 – Some rock added at tower location 37. Photo facing south.
07/22/20	SOCRE transmission corridor

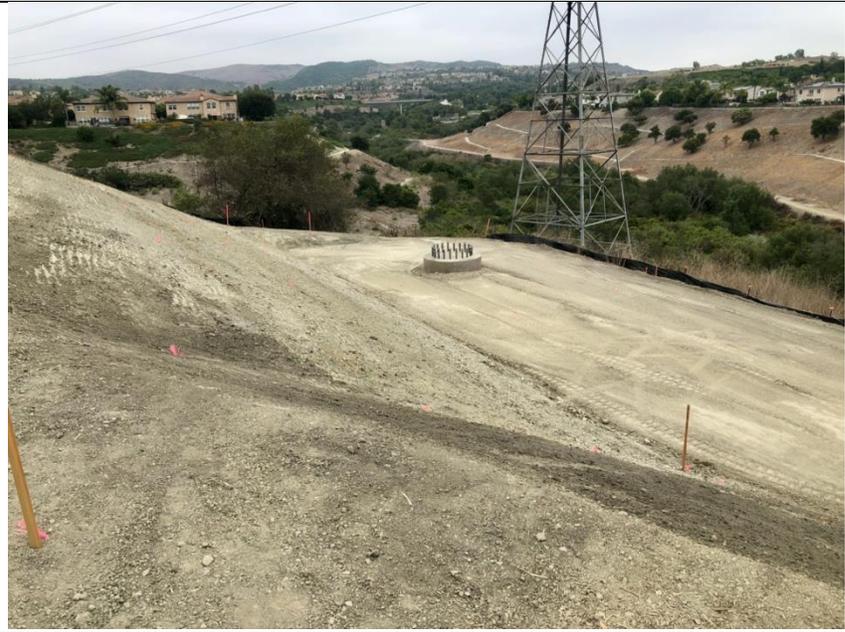
A wide-angle photograph of a dirt construction site on a hillside. In the center, there is a circular concrete foundation for a tower. A large metal lattice tower structure is visible in the background. The terrain is uneven and covered in dirt. There are some orange traffic cones and wooden stakes scattered around the site. In the distance, there are houses and hills under a cloudy sky.	Photo 8 – Installation of the tower foundation was completed at tower location 32. Photo facing northeast.

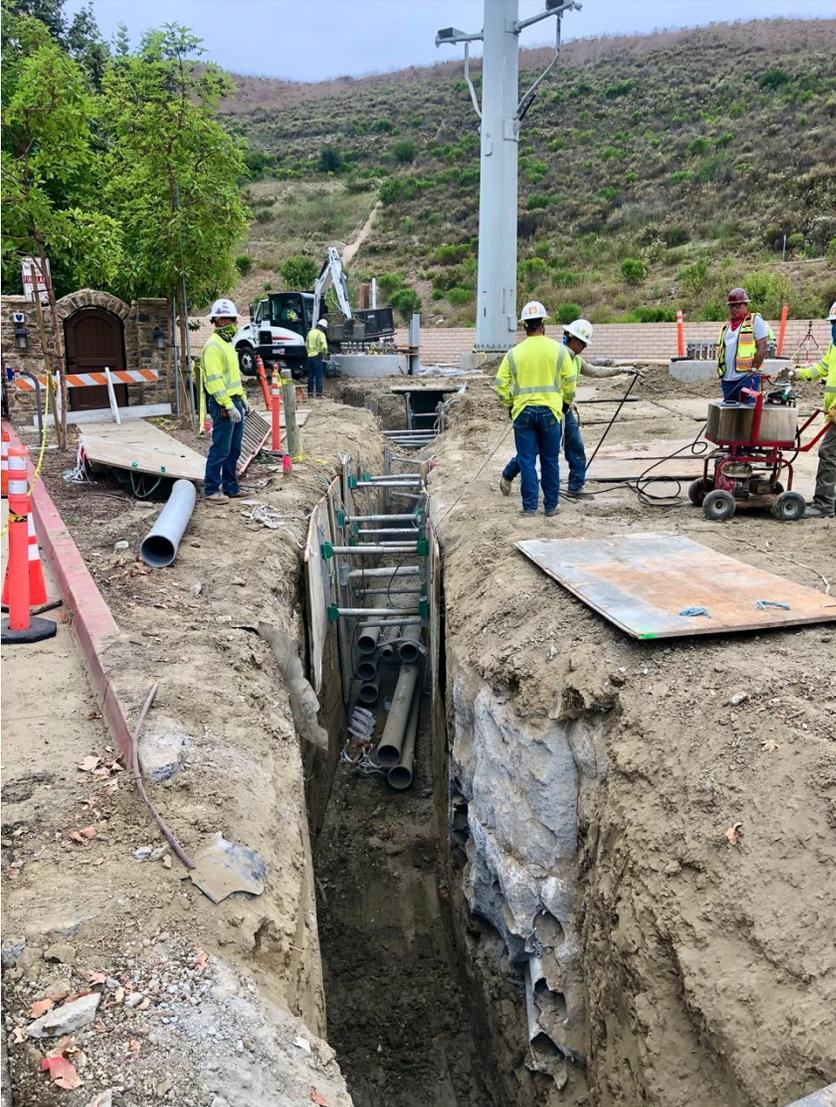
At tower locations 16 and 17, a crew continued the trenching and conduit installation from Stallion Ridge Road to the tower sites (Photo 9). The trench was quite deep here and was being spot-checked by the paleontology monitor. The EI, again, reminded the crew foreman about sealing the trenches before leaving for the day.

Photo 9 – Conduit installation continued at tower locations 16 and 17. Photo facing southwest.

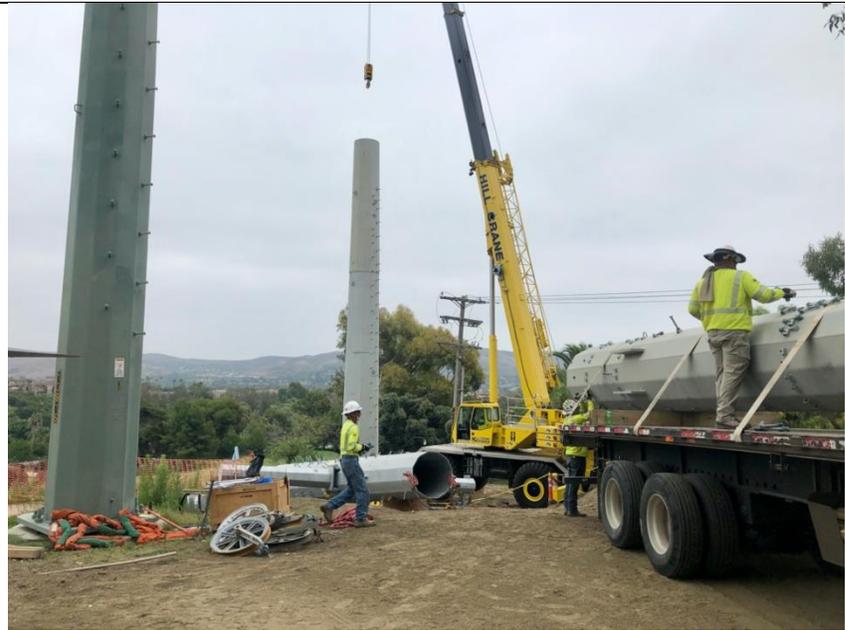
We stopped at tower location 5 where a crew was installing the tubular steel pole (TSP) (Photo 10).

Photo 10 – Tower installation at tower location 5. Photo facing south.
07/22/20	West of San Juan Capistrano Substation – jack and bore site

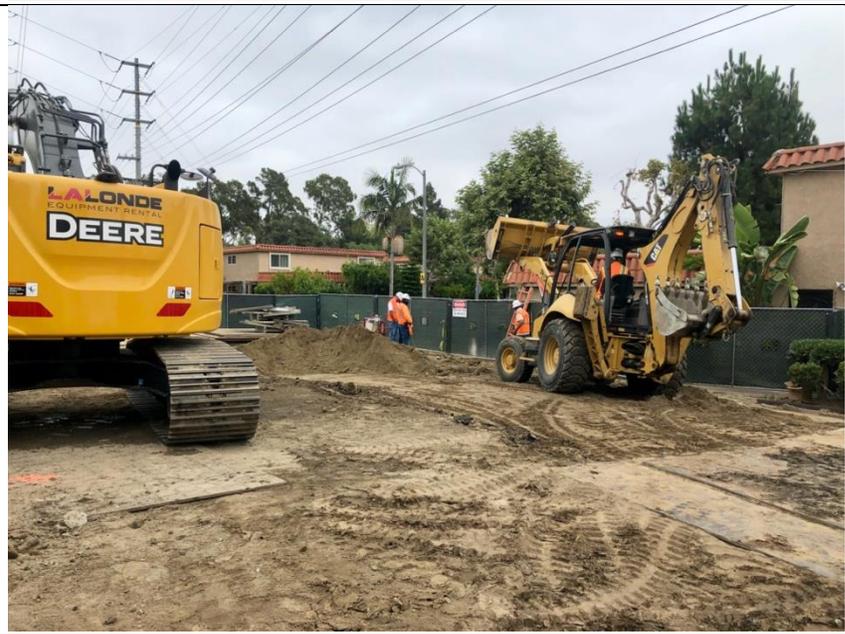
At the jack and bore exit hole location west of the substation, the crew was removing excess soil from the work site (Photo 11). The third bore hole remained open with shoring in place. The bore hole work east of the railroad tracks included grouting the conduit in the third bore hole and the removal of the drilling equipment (Photo 12).

Photo 11 – Removing excess soil from the third bore operation. Photo facing southwest.

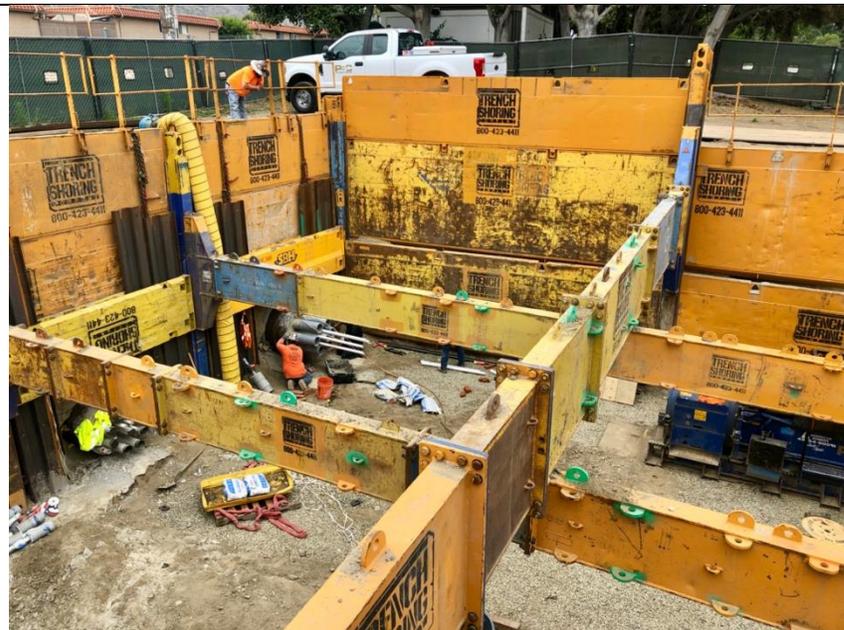
Photo 12 – Bore hole where crews were grouting in the conduit.
07/22/20	San Juan Capistrano Substation

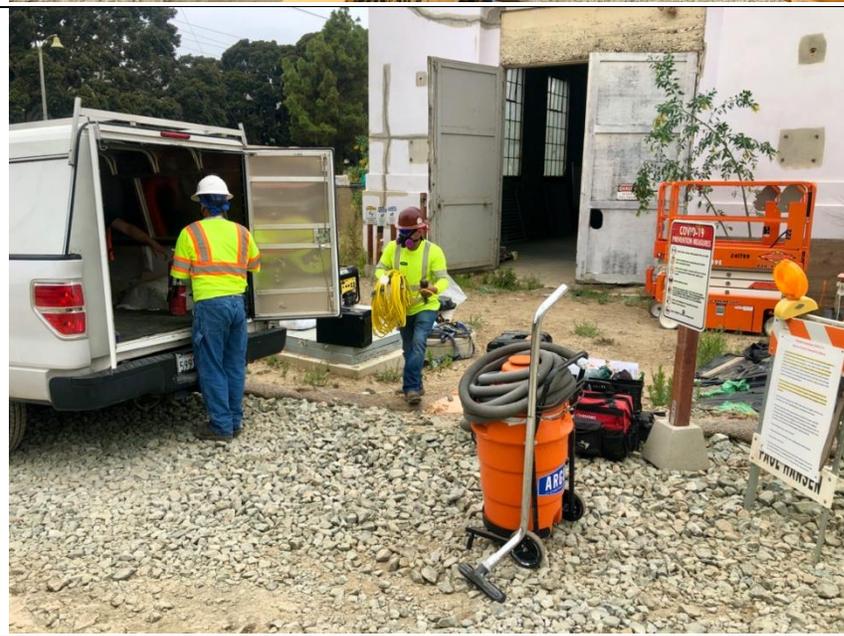
I met with the substation EI and we walked through the construction zone. A crew had completed work in the former utility structure using equipment and techniques associated with handling any hazardous materials (Photo 13).

Photo 13 – HAZMAT specialists working in the former utility structure. Photo facing northwest.

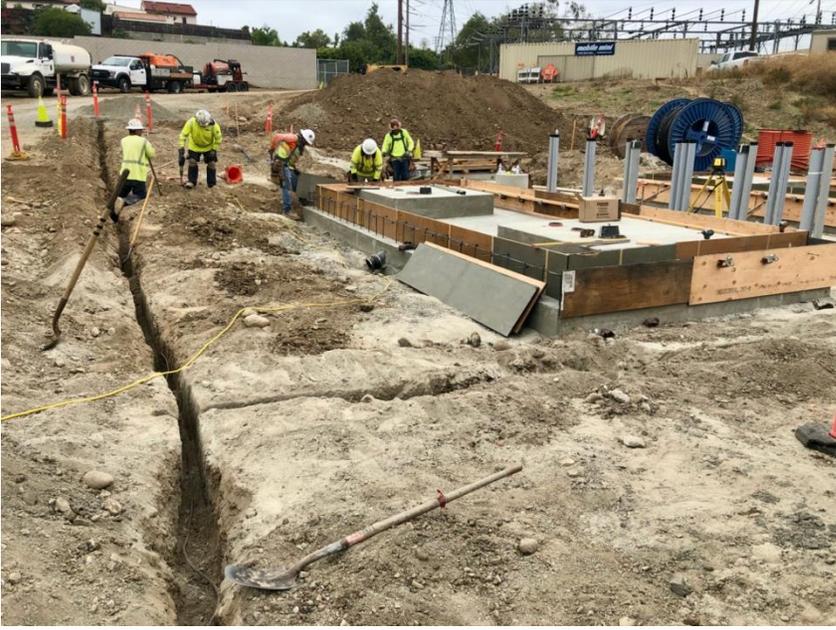
Foundation work was underway near the 138-kilovolt (kV) gas-insulated substation (GIS) building, around the newly installed conduit (Photo 14). The conduit trench connecting to the existing substation had been backfilled and the area regraded (Photo 15).

Grounding wire installation also continued near the new conduit (Photo 14) and along the southern boundary wall (Photo 17).

Photo 14 – Foundation work around the newly installed conduit. Grounding work was also underway. Photo facing east.
07/22/20	San Juan Capistrano Substation

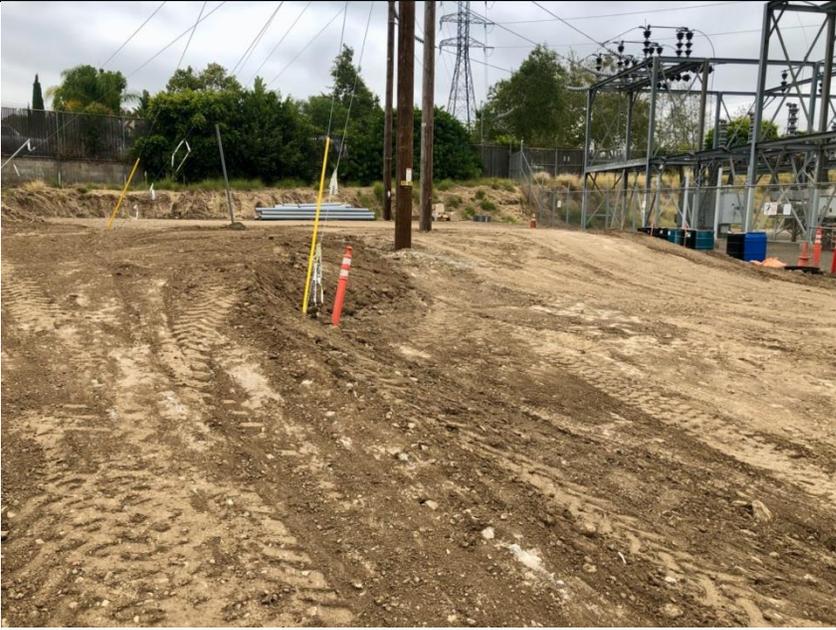
Photo 15 – Conduit trench had been backfilled near the existing substation and the area had been regraded. Photo facing east.

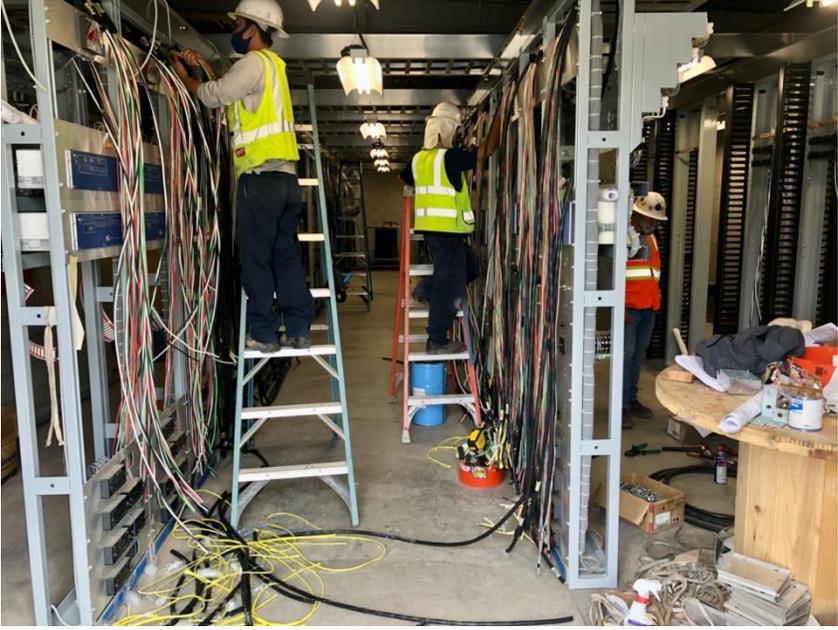
Inside the 138-kV GIS building, crews were working on wiring (Photo 16).

Photo 16 – Wiring work within the 138-kV GIS building.
07/22/20	San Juan Capistrano Substation

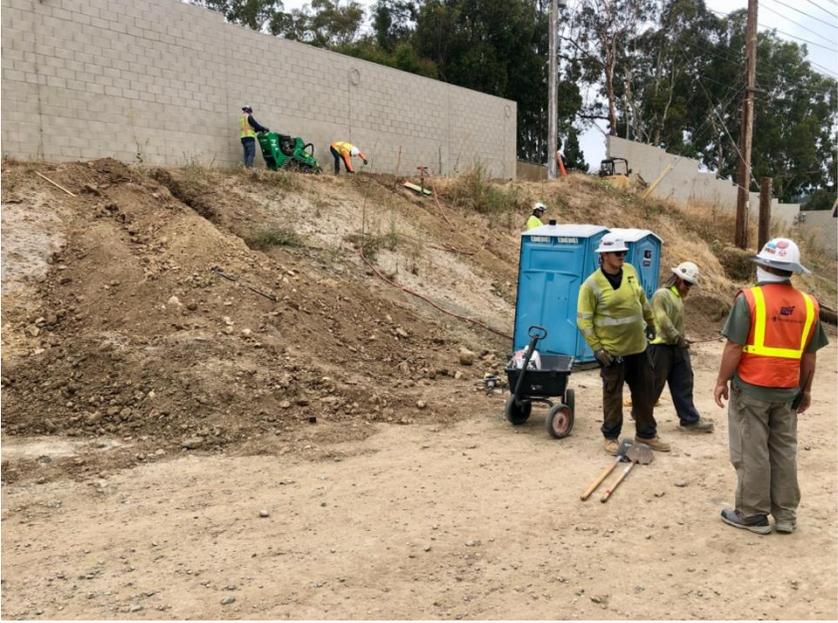
Photo 17 – Grounding wire installation along the southern boundary wall. Photo facing southwest.
