October 1, 2020

Re: Monthly Report Summary #34 for the South Orange County Reliability Enhancement (SOCRE) Project

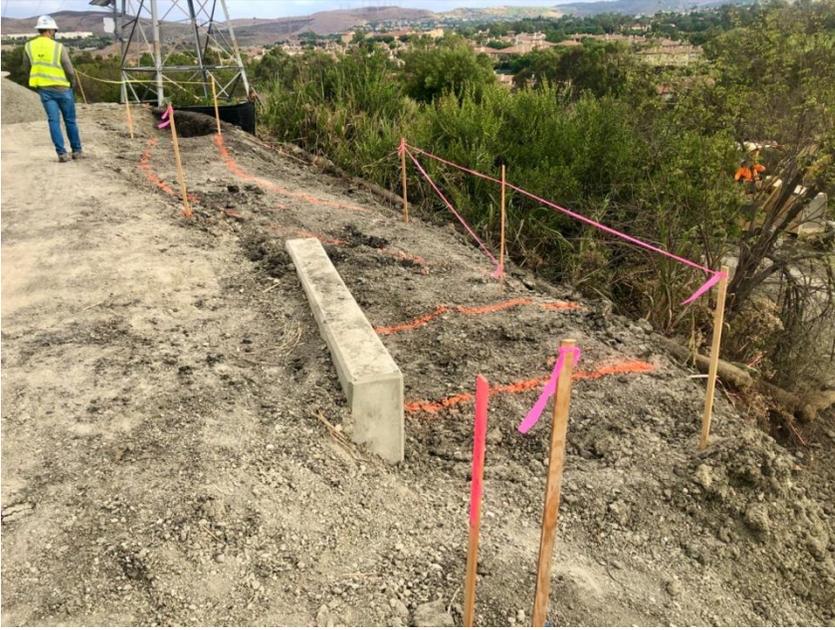
Photo 4 – Brow ditch work at tower location 36. Photo facing northwest.
08/06/20	SOCRE transmission corridor

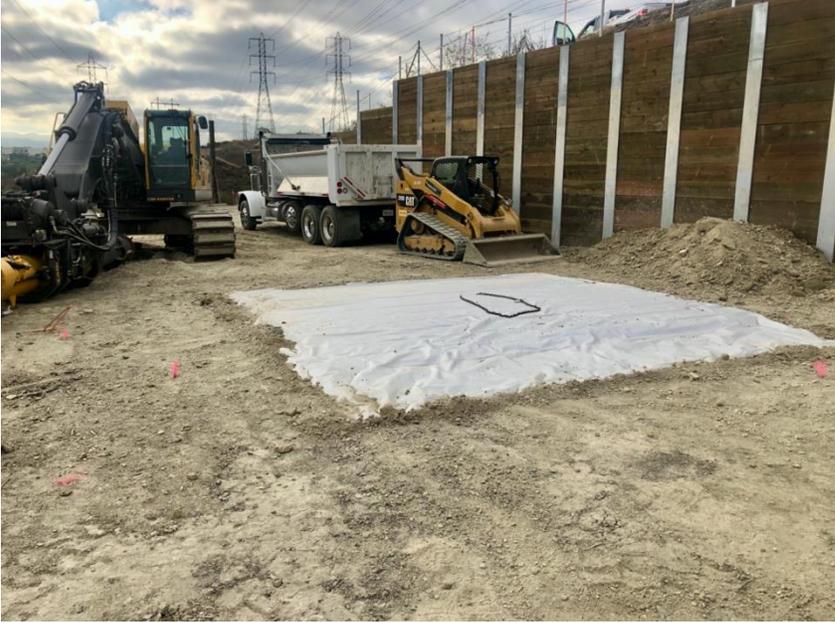
Photo 5 – The foundation hole at tower location 36 was covered overnight. Photo facing southeast.
08/06/20	SOCRE transmission corridor

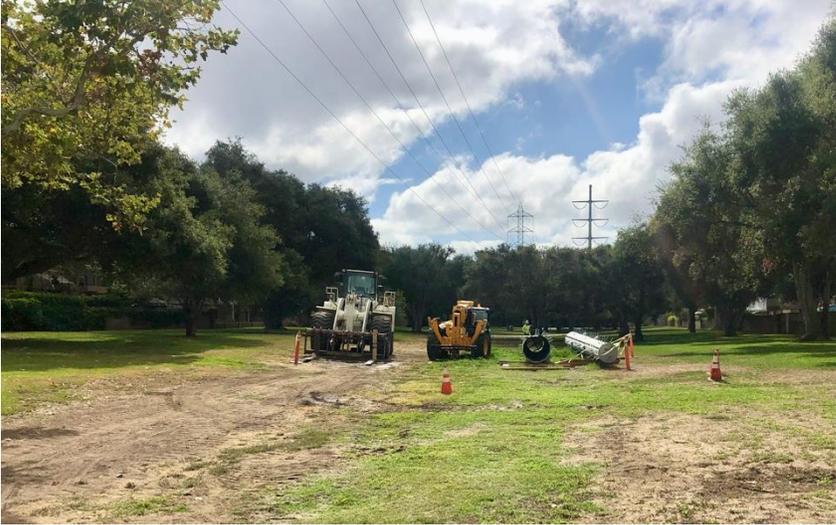
Photo 8 – Staging area for TSP installation at tower location 8. Photo facing south.

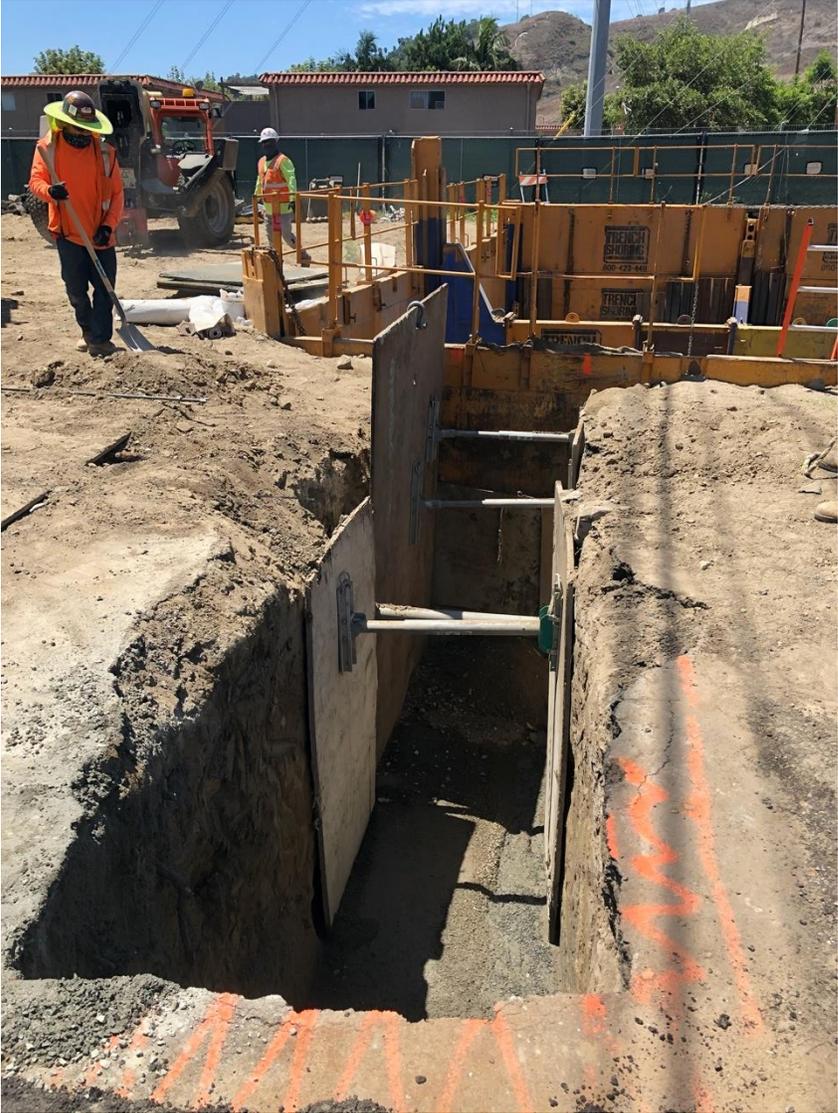
Photo 2 – Conduit trenching and installation between the bore hole and Camino Capistrano. Photo facing west.
08/12/20	San Juan Capistrano Substation

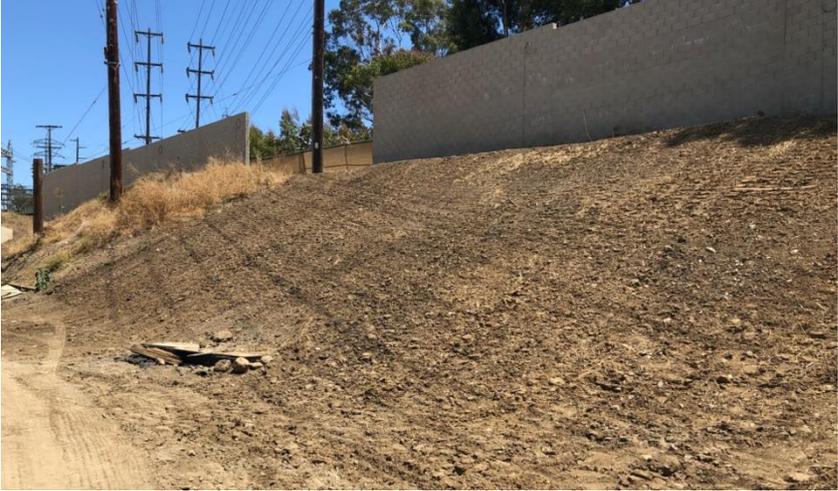
Photo 3 – Grounding wire installation along the southern boundary wall area was completed. Photo facing southeast.

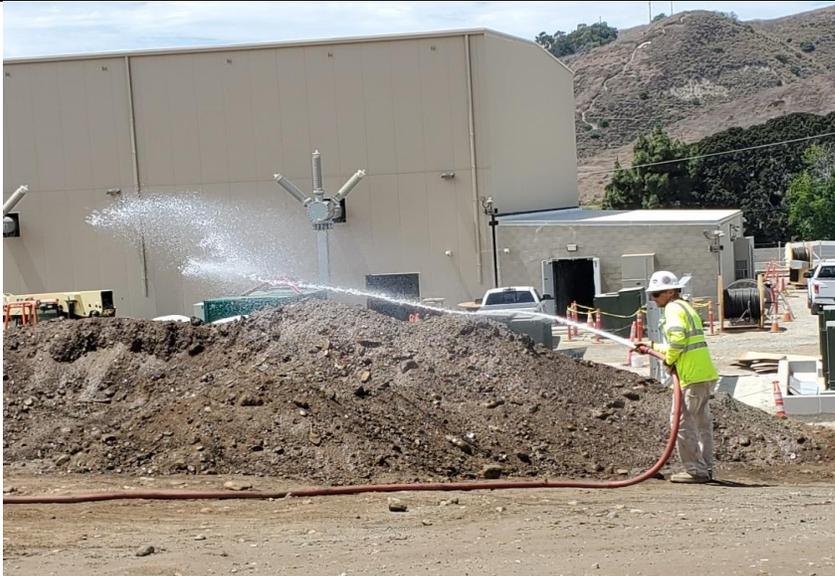
The EI and I walked into the substation noting wire installation and grounding work had been completed and the work areas within the southern slope had been regraded (Photo 3). Some testing equipment had been installed outside of the 138-kilovolt (kV) gas-insulated substation (GIS) building with testing underway (Photo 4). Retrofitting of the two cranes was being conducted prior to their installation in the GIS building (Photo 5). Excess soil remained onsite; the EI suggested it be used to backfill the bore pit (Photo 6). I inquired about dust control for the soil pile and the EI sent a photo later that day showing the pile being watered (Photo 7).

Photo 7 – Dust control on stockpiled soil east of the 138-kV GIS building. Photo taken by the onsite EI. Photo facing west.
08/12/20	SOCRE transmission corridor

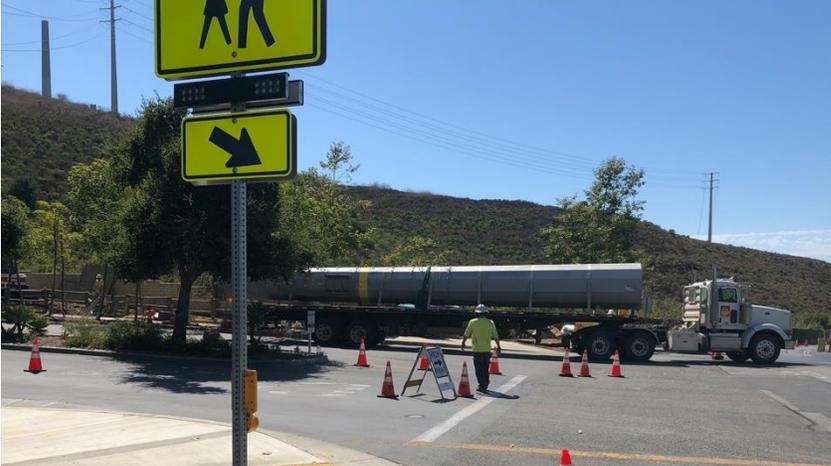
Photo 12 – New TSP segments delivered to location 15. Photo facing west.

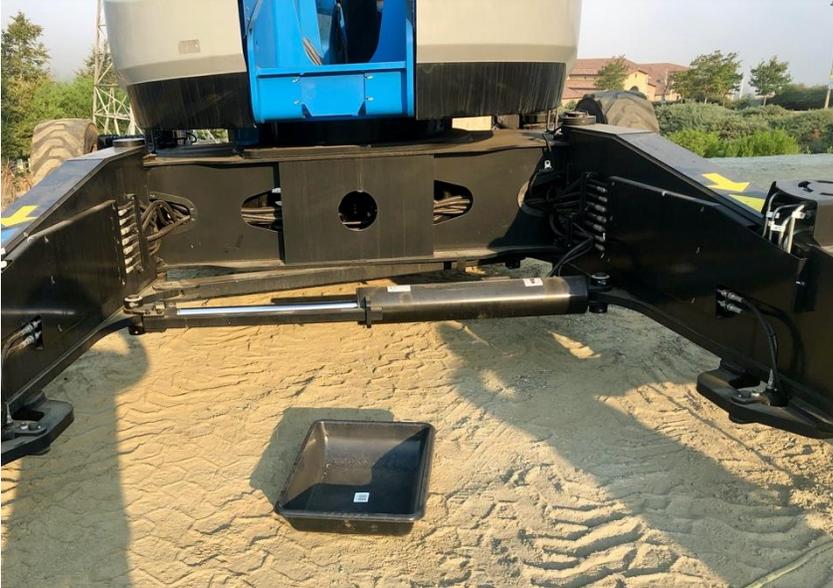
We drove to tower locations 18 and 19 where an Minor Project Refinement (MPR) had been requested for work outside the approved workspace. The proposed work would be to install scaffolding around the newly installed poles to allow the crew to work on them (Photo 1). To anchor the scaffolding, two wires would be run from the scaffolding to "K" rails placed beyond the work limits. Stakes were placed in the vegetation indicating the location of the "K" rail anchors (Photo 2). The impacts appeared to be minimal, since the "K" rails would be placed with a crane, and the vegetation at the preferred rail locations consisted of non-native weeds. The workspace area required dust control and secondary containment bins appeared to be misplaced. I observed later in the day that secondary containment bins were placed under equipment at locations 18 and 19 (Photo 3).

Photo 3 – Secondary containment under equipment at locations 18 and 19.

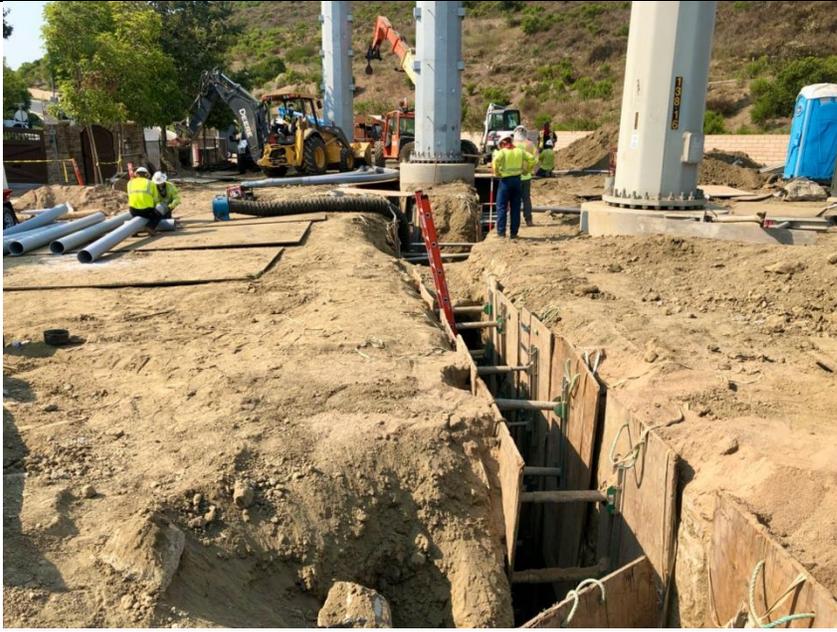
At tower locations 16 and 17, a crew continued to work on the conduit installation to the new towers (Photo 8). Equipment was present within the work areas at various tower foundations (Photo 9). A water truck was onsite to provide dust control.

Photo 8 – Conduit trenching continued near tower locations 16 and 17. Photo facing southwest.

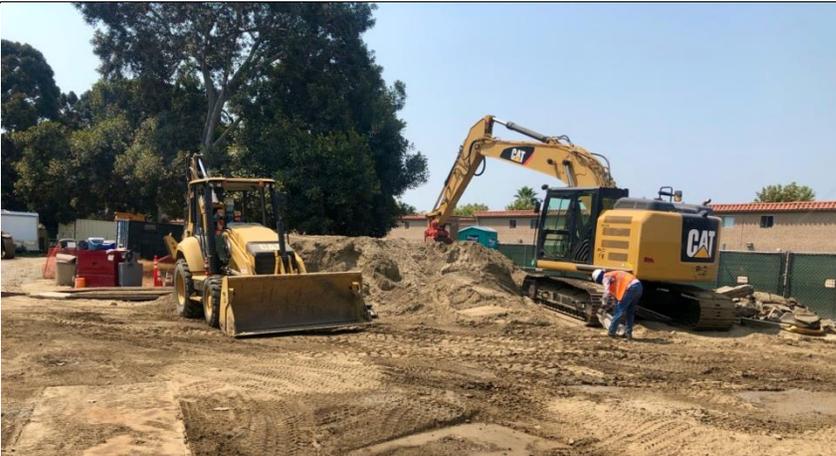
Photo 12 – Stockpiled soil for the final backfill of the bore hole. Photo facing southwest.
