November 30, 2020

Re: Monthly Report Summary #36 for the South Orange County Reliability Enhancement (SOCRE) Project

This report provides a summary of the compliance monitoring activities that occurred during the period from **October 1 to 31, 2020**, for the South Orange County Reliability Enhancement (SOCRE) Project in Orange County, California. Compliance monitoring was performed four times between October 1 and 31, 2020, to ensure all project-related activities conducted by San Diego Gas and Electric (SDG&E) and its contractors were in compliance with the Final Environmental Impact Report (Final EIR) for the SOCRE Project, as adopted by the California Public Utilities Commission (CPUC) on December 15, 2016.

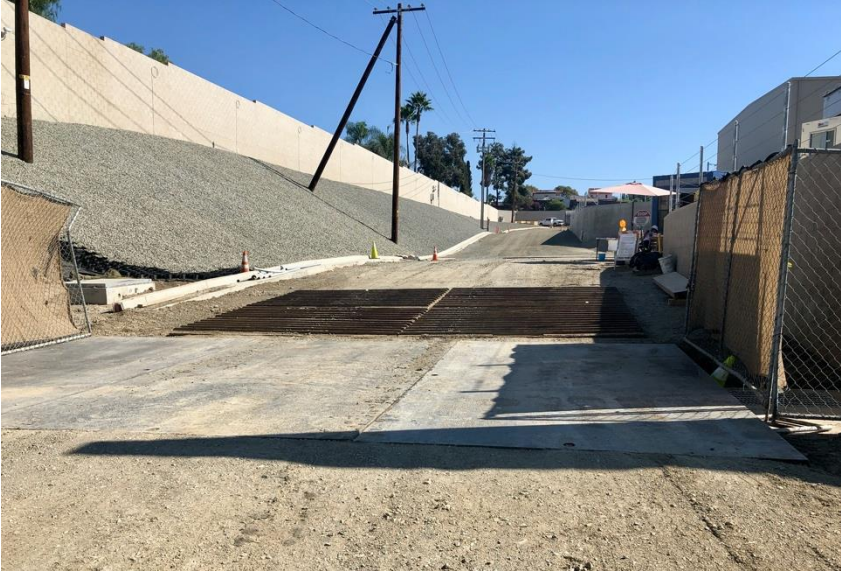
The northern entrance to the substation was open (Photo 13) as crews excavated the hole for a vault to be installed near the southern entrance (Photo 14). The work area between the existing utility building and Camino Capistrano was being utilized and required dust control (Photo 15). I mentioned this to the onsite EI who responded that it would be addressed. I received a photo later showing a water truck at the site watering the area.

A photograph showing the northern entrance to the San Juan Capistrano Substation. The view is from a paved area looking down a dirt path. On the left is a tall, light-colored retaining wall with a chain-link fence in front. On the right is another chain-link fence. In the background, there are utility poles and a clear blue sky.	Photo 13 – Northern entrance to substation. Photo facing east.
10/15/20	San Juan Capistrano Substation

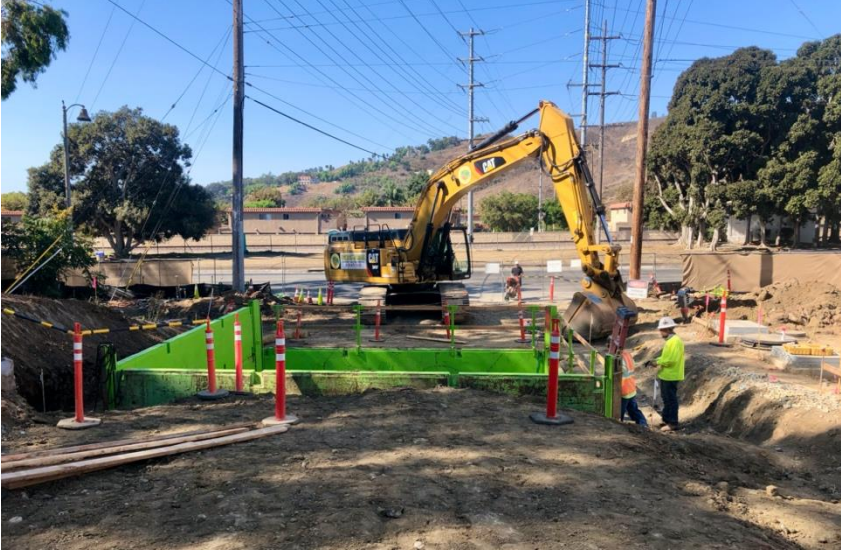
A photograph of a construction site at the San Juan Capistrano Substation. A yellow excavator is working in a large, deep excavation. The site is surrounded by green shoring and safety barriers. Several workers in high-visibility vests are visible. In the background, there are utility poles and trees under a clear blue sky.	Photo 14 – Vault excavation and shoring activities. Photo facing west.

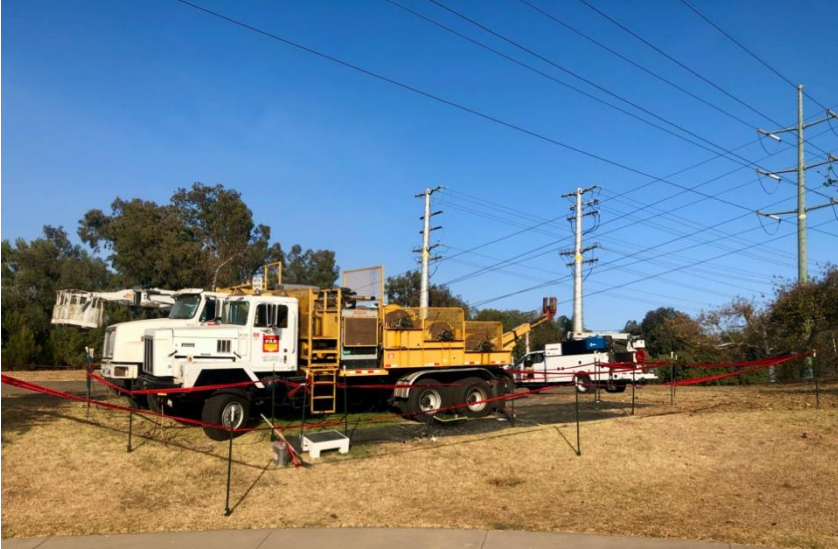
I headed to Serra Park where the wire pulling equipment was parked in the temporary staging area for the tower installation (Photo 5). Secondary containment was in place under the equipment. Wire continued to be pulled over Interstate 5 with netting remaining in place over the freeway (Photo 6).

A white and yellow wire pulling truck is parked in a field. In the background, there are several utility poles with power lines stretching across the sky. The ground is dry and grassy. A red safety line is visible in the foreground.	Photo 5 – Wire pulling equipment parked in Serra Park near Interstate 5. Photo facing east.
10/21/20	SOCRE transmission corridor – Serra Park

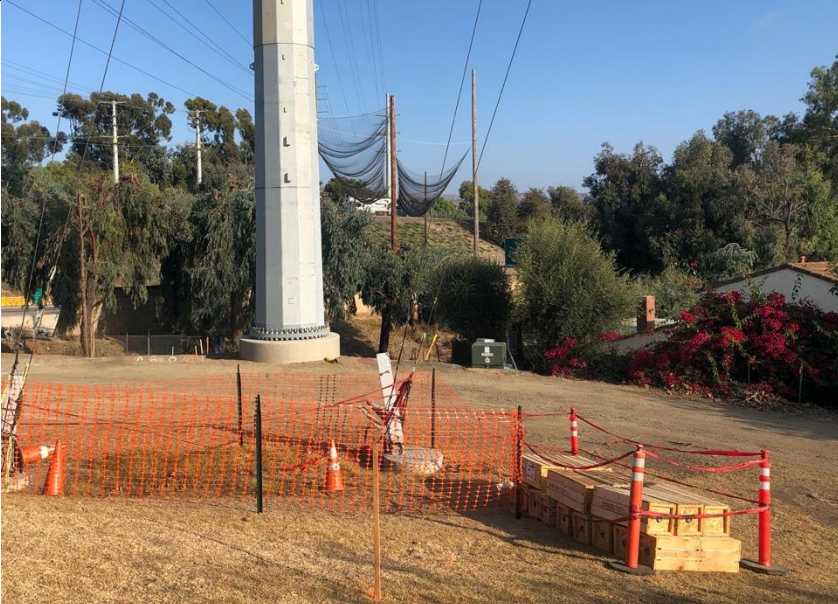
A tall, white utility pole stands in the center. A large net is suspended from the pole, extending towards the right. In the foreground, there is a construction site with orange safety fencing, orange traffic cones, and a yellow pallet. The background shows trees and a clear blue sky.	Photo 6 – Netting extending from Serra Park east over Interstate 5. Photo facing southeast.

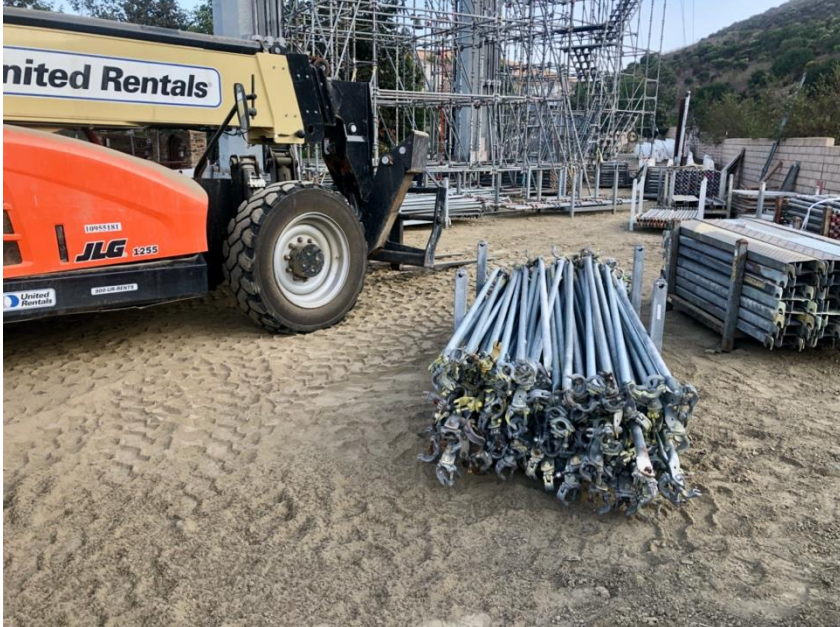
A photograph of a construction site. In the foreground, a yellow and orange JLG scissor lift is parked on a dirt surface. To its right is a large pile of metal rods or pipes. In the background, a steel tower structure is under construction, with scaffolding and other equipment visible. The sky is clear and blue.	Photo 11 – Work area at tower locations 16 and 17 where crews had left for the day and dust control had been performed except around equipment. Photo facing southwest.
