Garcia and Associates
2601 Mission Street, Suite 600
San Francisco, CA 94110
Phone: (415) 642-8969
Fax: (415) 642-8967

RE: Fulton-Fitch Reconductoring Project, Water Crossing Mapping

Appendix A. Fulton-Fitch Work Area and Crossing Photos

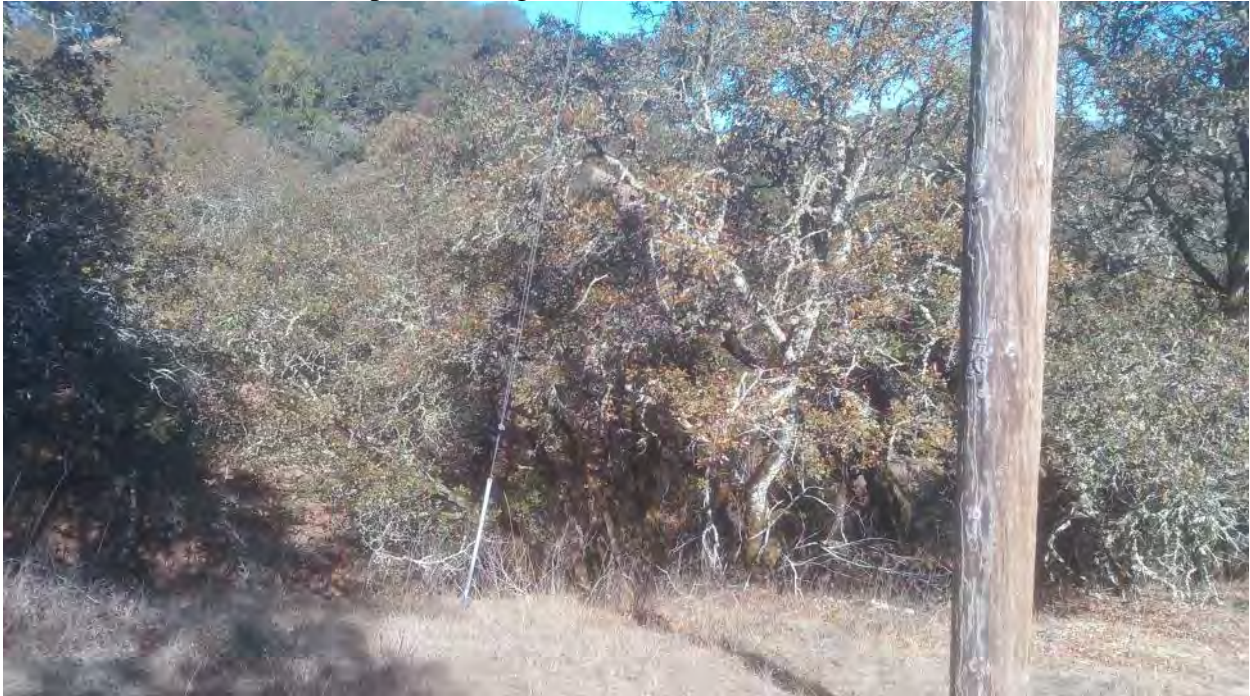
FFW10 – Pole 46; SEW16 (photo facing north)

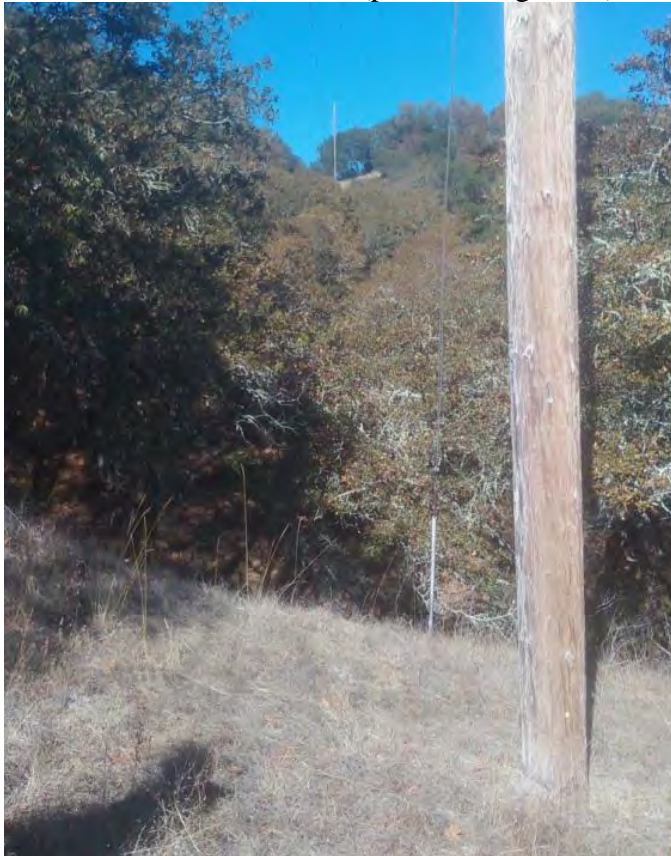
FFW10 – Pole 46; SEW16 (photo facing north)

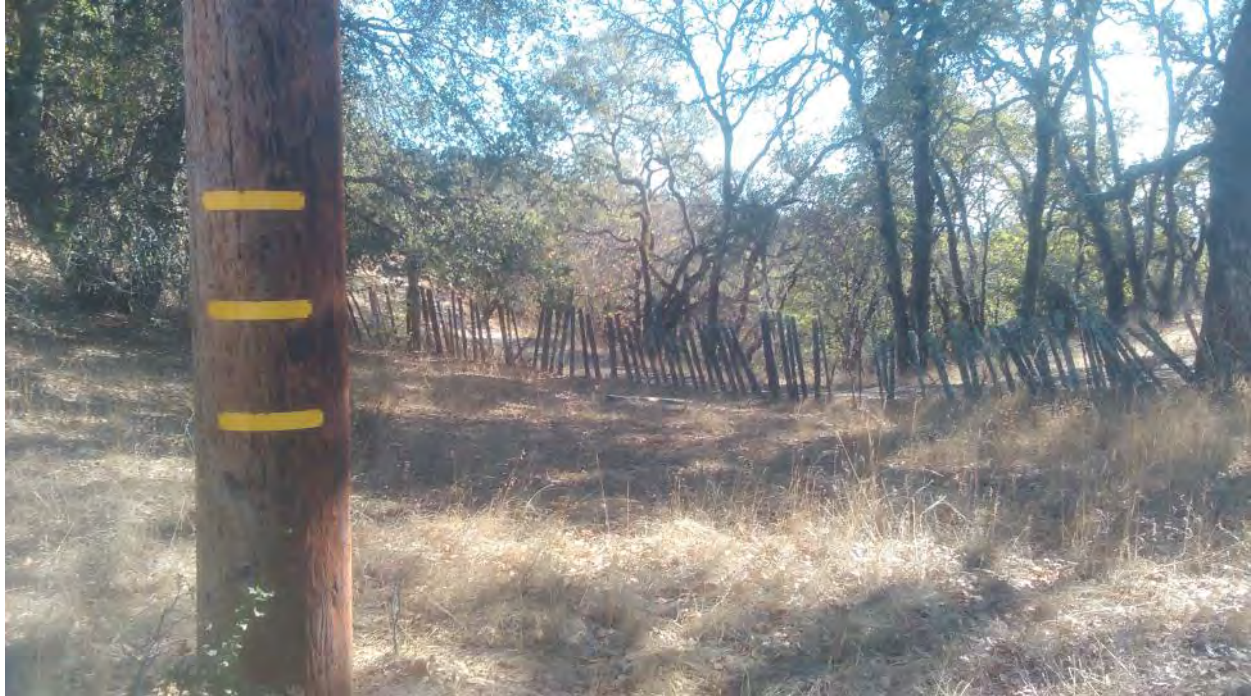
FFW13 – Pole 57; SEW24; Work area upslope from seasonal watercourse (photo facing south)

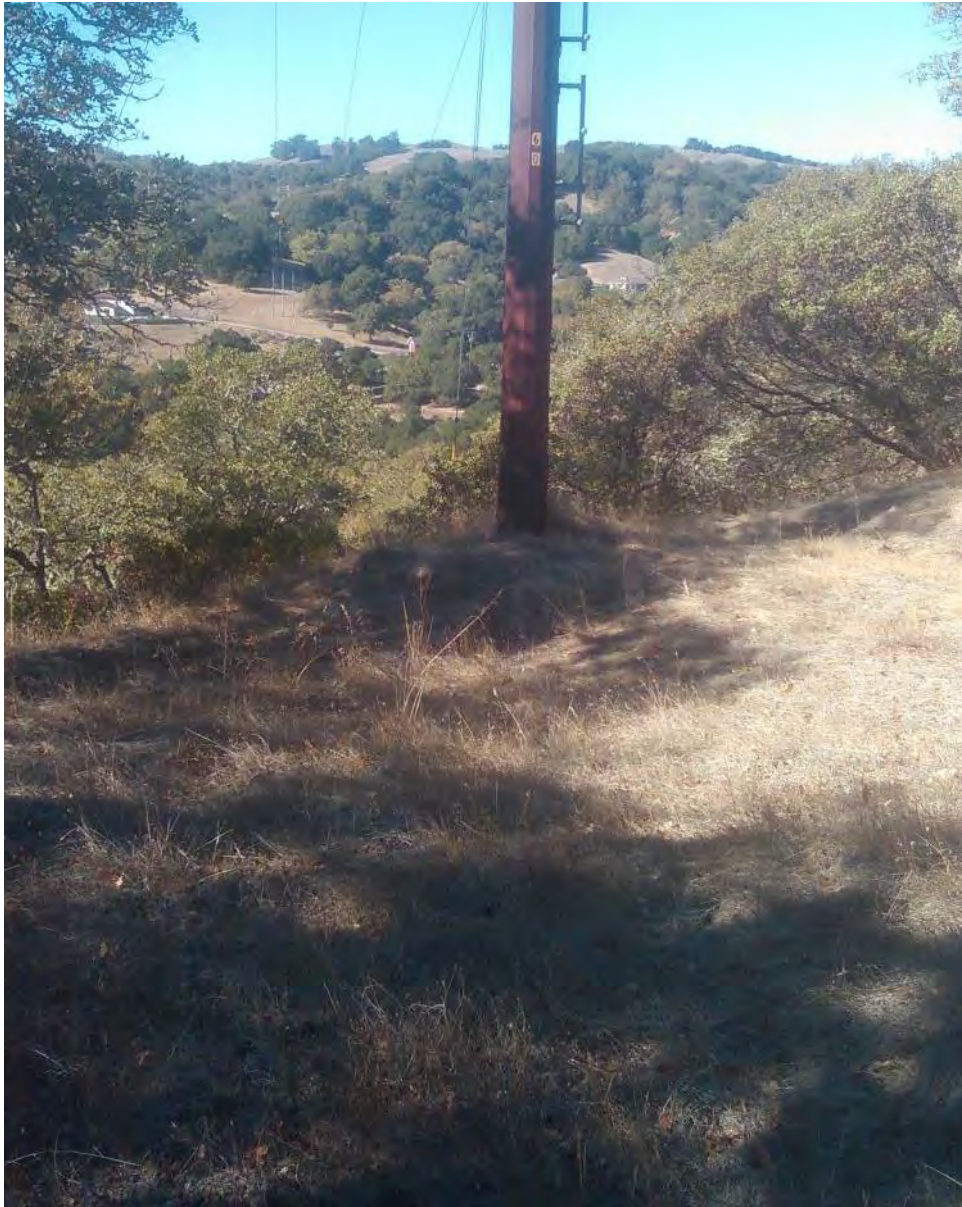
FFX6 – SW3 (photo facing north)

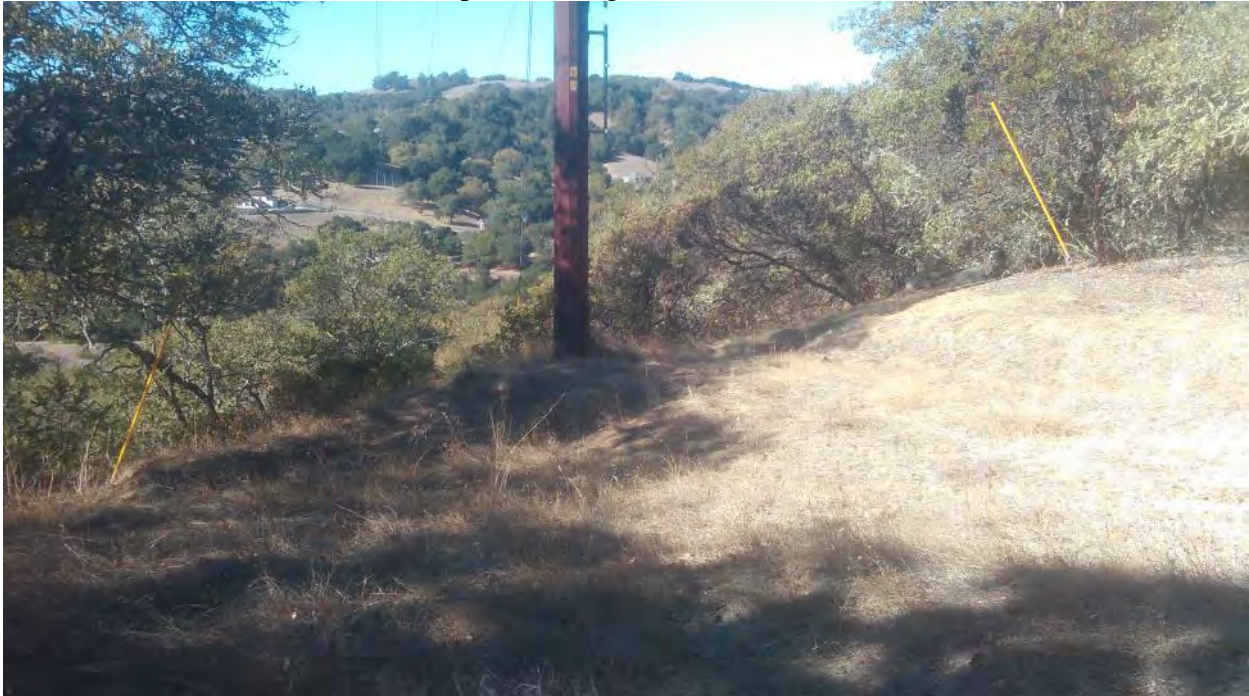
FFW14/15 – PS10; Pole 62; SW3 (photo facing north)

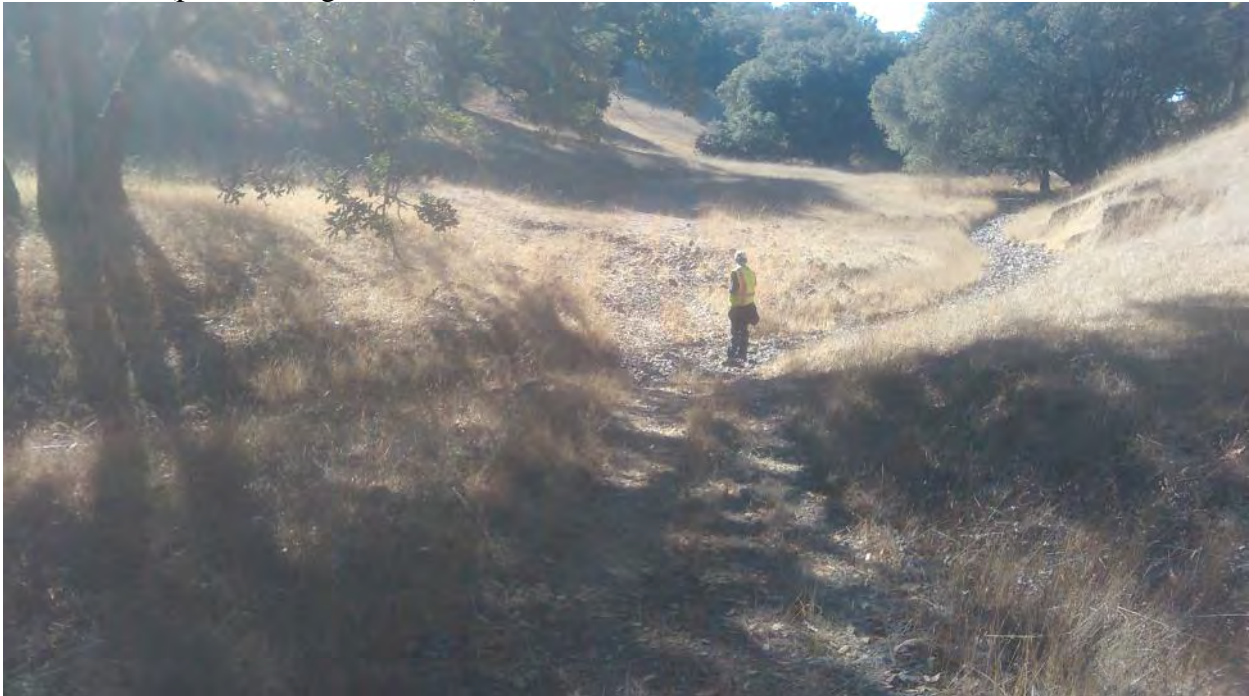
FFX11 – SEW2; Roadway crosses dry creek bed and terminates into a tributary to the seasonal watercourse (photo facing southwest)

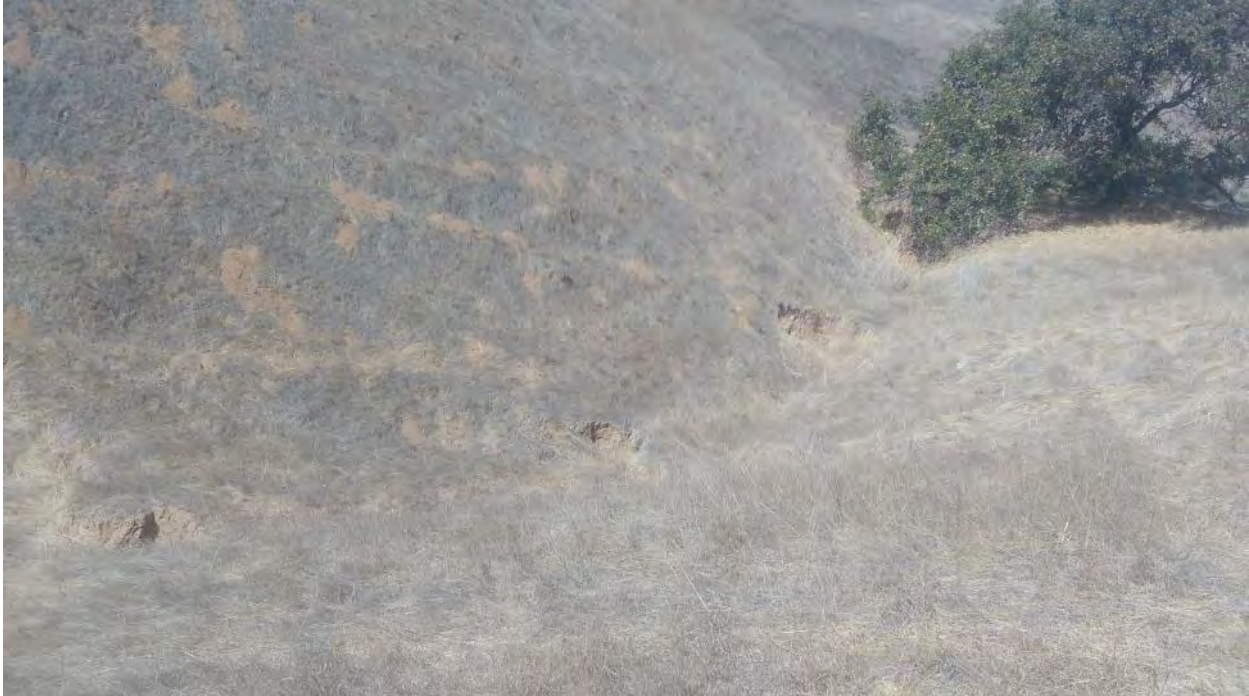
FFW19 – Pole 71; SEW35; Work area upslope of drainage (photo facing north)

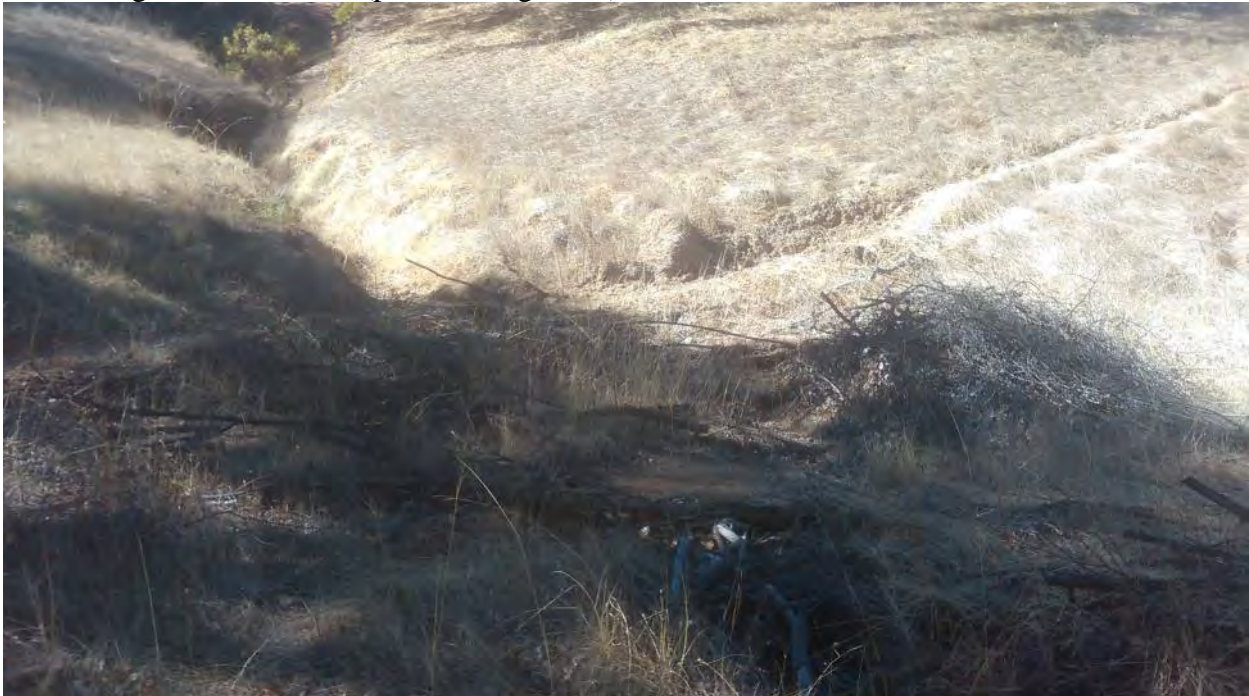
FFX14 – SEW8; Overland access route has multiple stacks of cut brush piled along the roadway, obstructing vehicular travel (photo facing north)

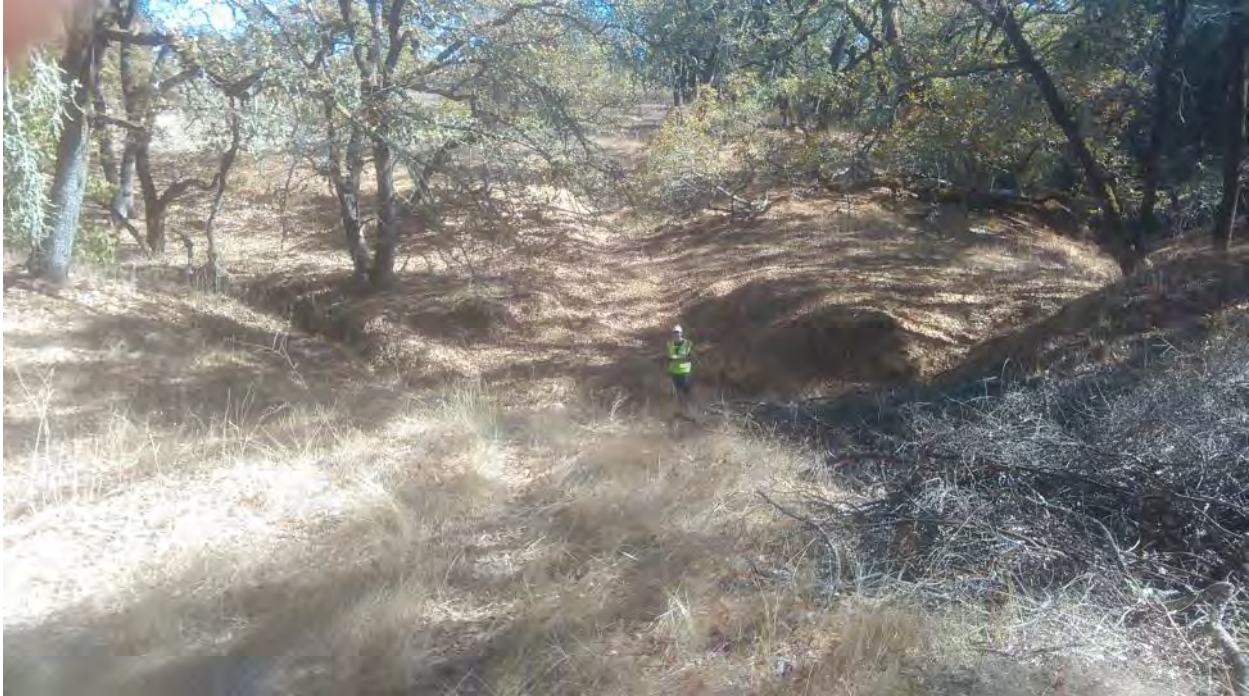
FFX16	4271537	516037	RIWO11	Riparian Woodland	2	5	Crossing point at bottom of dry creek bed	No Culvert	Dispersal	Access during dry season; off-highway vehicles only	Recommend parking before reaching creek and walking to work area; if vehicles and road improvements are necessary, USACE 404, RWQCB 401, and CDFW 1602 permit may be required
FFX17	4271643	515648	D5	Drainage Ditch	1	2	Main entrance/driveway to Weston Ranch, well maintained, gravel	1ft diameter, 20ft corrugated steel in good condition	Dispersal	No Action	No permitting required.
FFX18	4271502	515341	SEW46	Seasonal Watercourse	1	1	Main entrance/driveway to Weston Ranch, well maintained, gravel	1ft diameter, 25ft pvc in good condition	Dispersal	No Action	No permitting required.

FFX16 - RIWO11; Crossing point at bottom of dry creek bed (photo facing south)

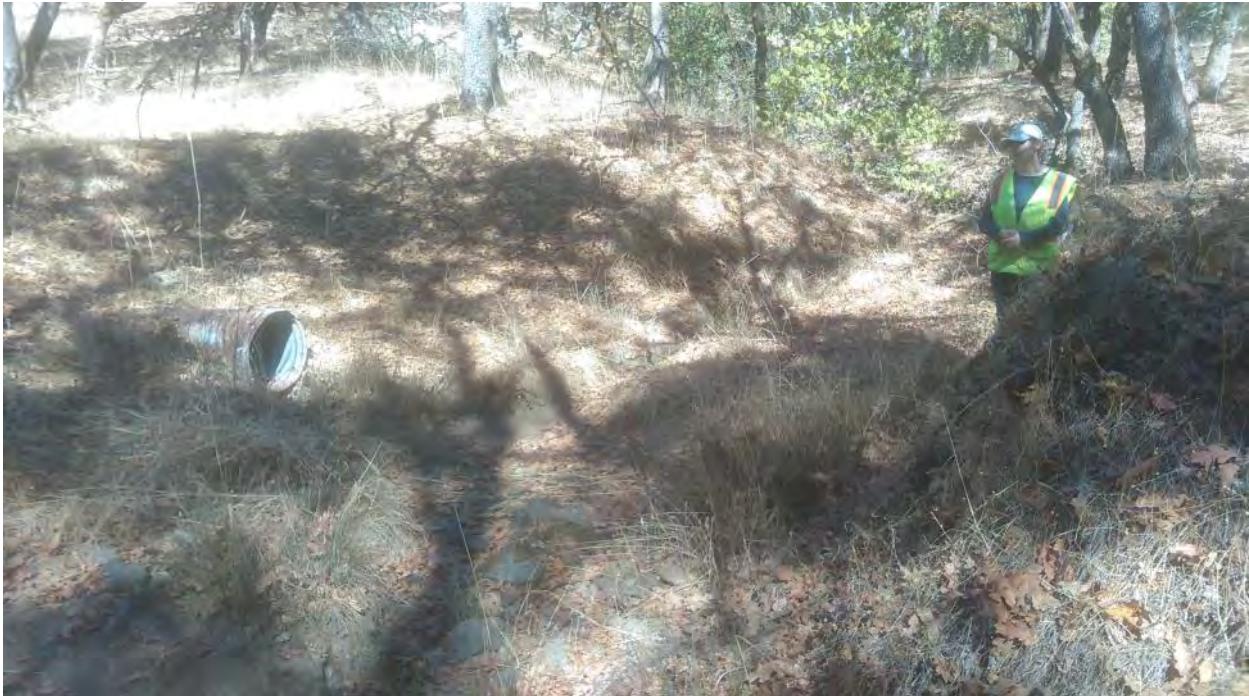
FFX16 - RIWO11; Crossing point just below culvert, at bottom of dry creek bed (photo facing northeast)

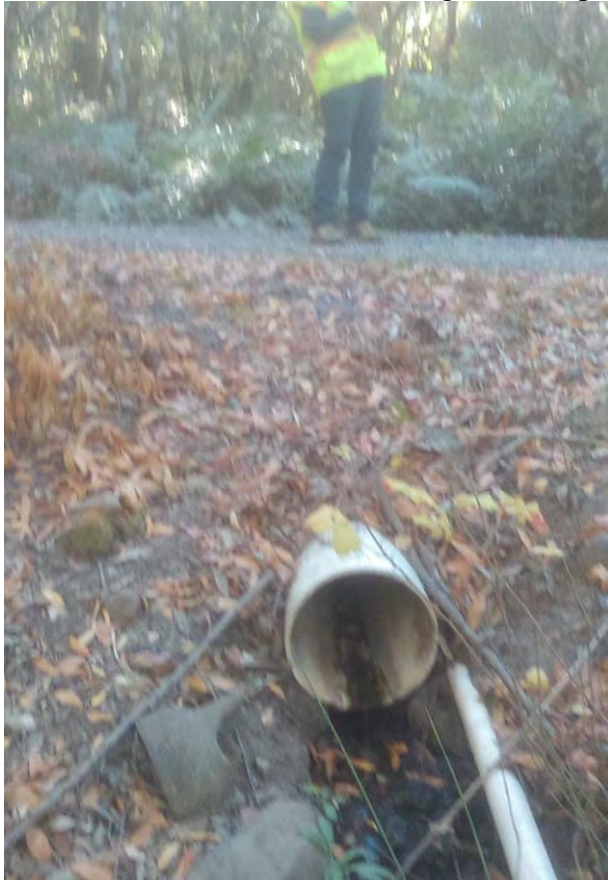
FFX18 – SEW46; Culvert crossing under improved road (photo facing east)

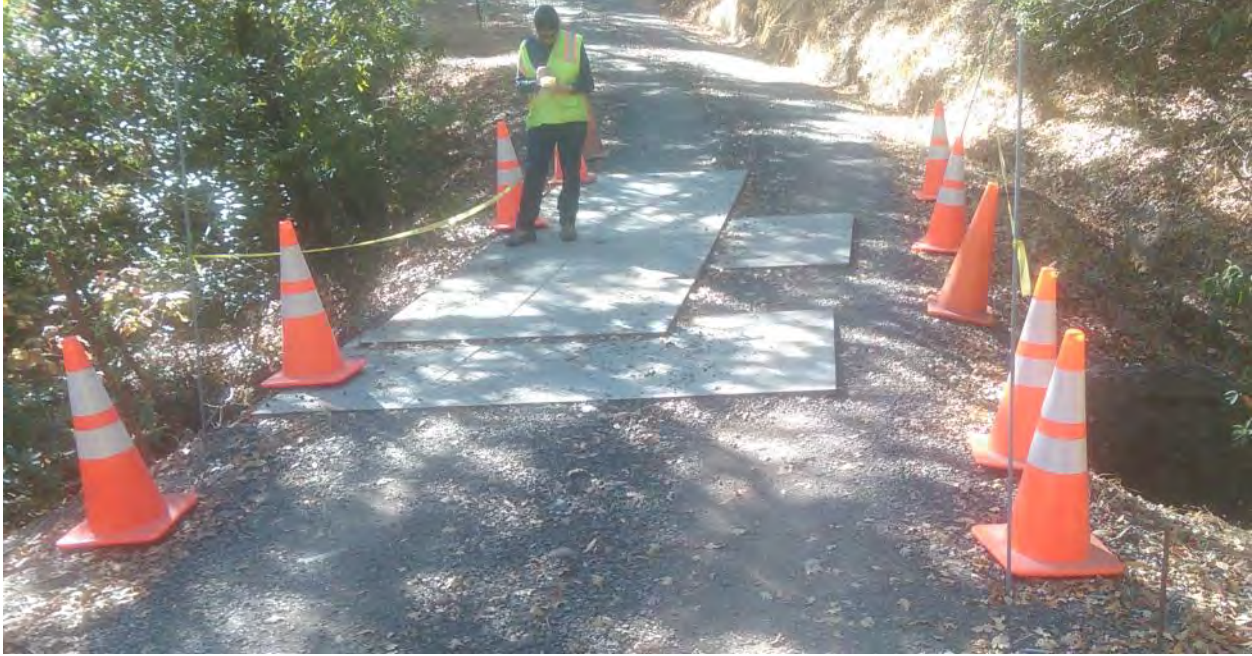
ID	Northing	Easting	Feature Name	Feature Type	Depth (feet)	Width (feet)	Description	Culvert Information	CRLF	Avoidance and Minimization Recommendation	Permit Recommendation
FFX19	4271488	515127	RIWO12	Riparian Woodland	13	8	Bridge crossing with several steel plates reinforcing the road surface and PG&E cones marking the route, and signage stating limit to small vehicles under 8 feet wide	7ft diameter, 11ft concrete eroded and in poor condition	Breeding	No heavy equipment	USACE 404, RWQCB 401, and CDFW 1602 permit required for improvements to bridge; CRLF monitor required for work occurring during breeding season
FFX20	4272741	514318	SEW6	Seasonal Watercourse	1-2	3-5	Unimproved dirt road crossing small, ephemeral stream	No Culvert	Dispersal	No Action	No permitting required.
FFX21	4272641	514353	SEW5	Seasonal Watercourse	1	3	Unimproved dirt road crossing small, ephemeral stream	No Culvert	Dispersal	No Action	No permitting required.

FFX19 – RIWO12; Bridge crossing over perennial watercourse within riparian woodland, on access road to Weston Ranch (photo facing west)

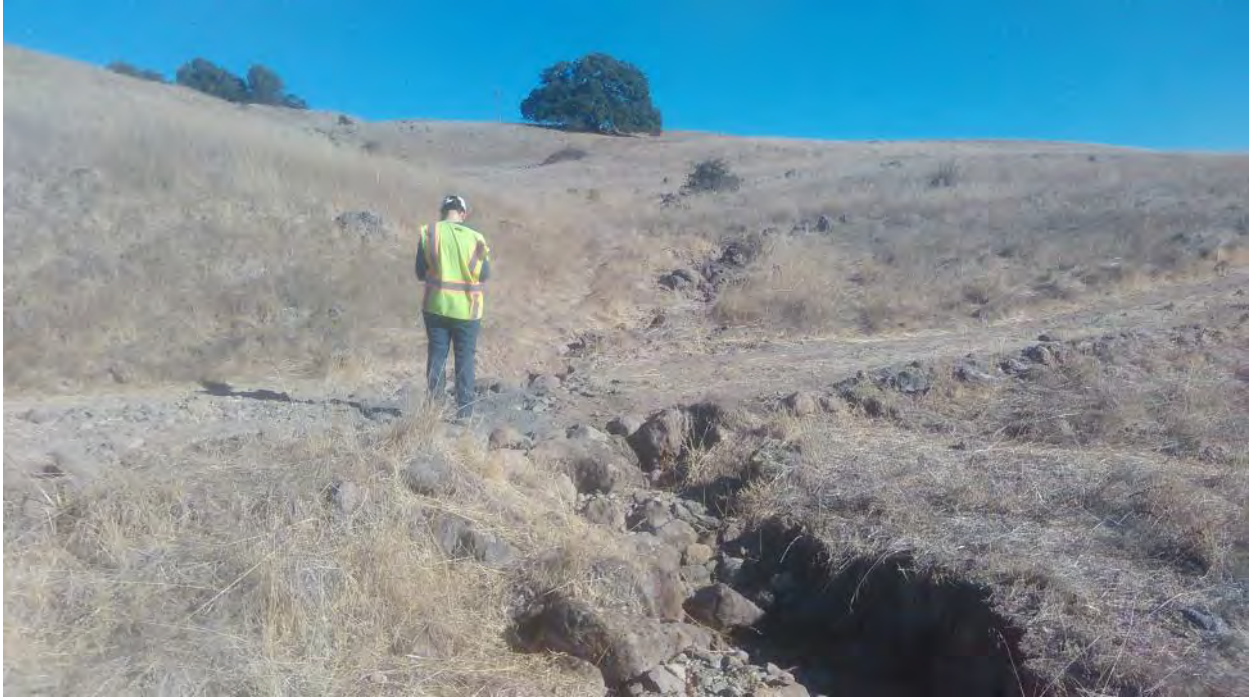
FFX21 – SEW5; Crossing point for seasonal watercourse (photo facing southeast)

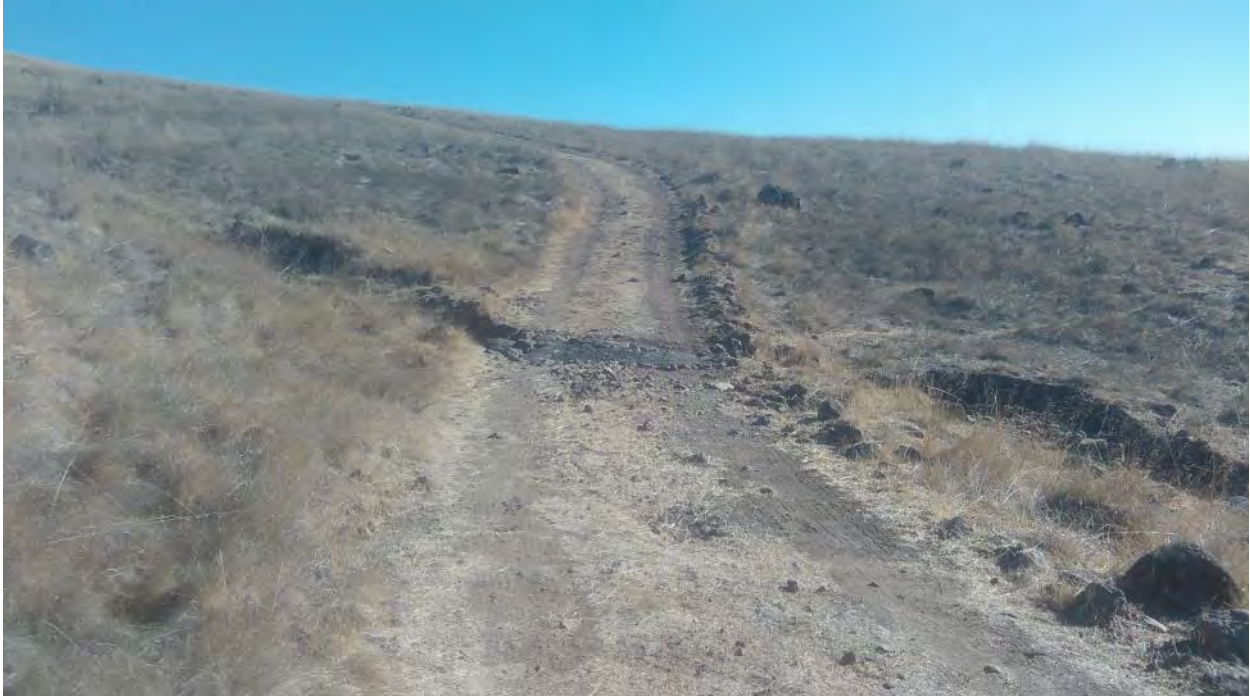
FFX21 – SEW5; Crossing point for seasonal watercourse (photo facing southwest)

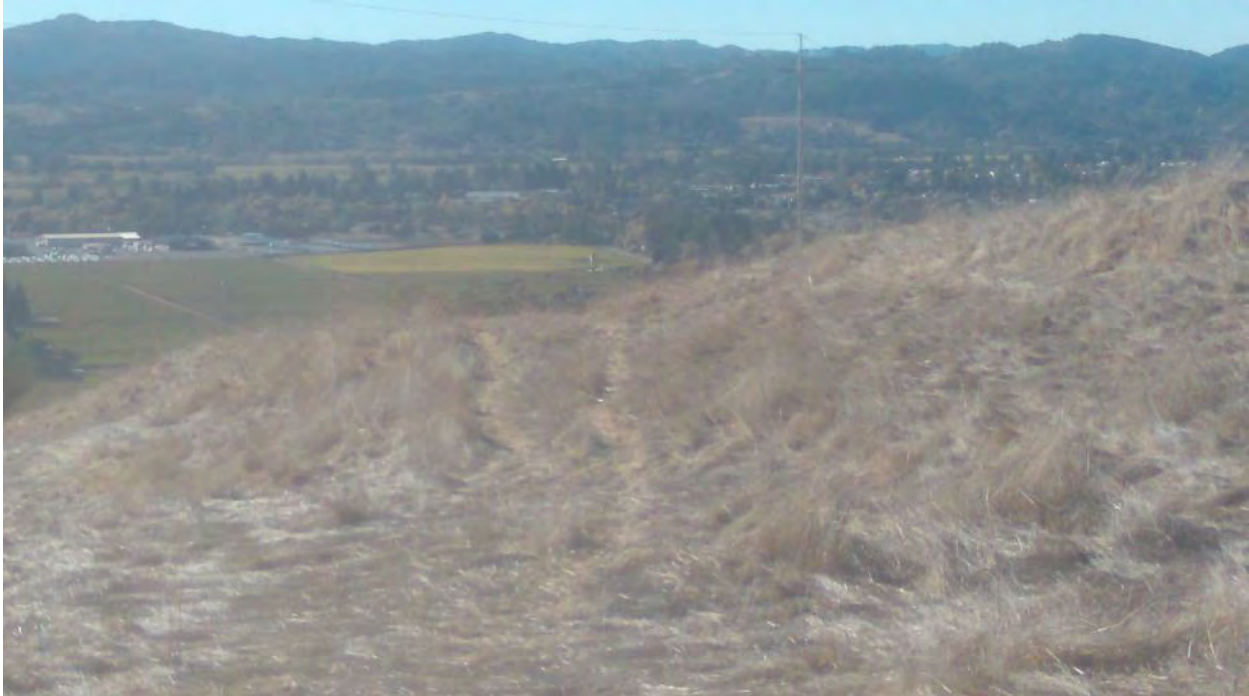
FFX23 – SW13; Overland route and crossing point for seasonal watercourse (photo facing west)

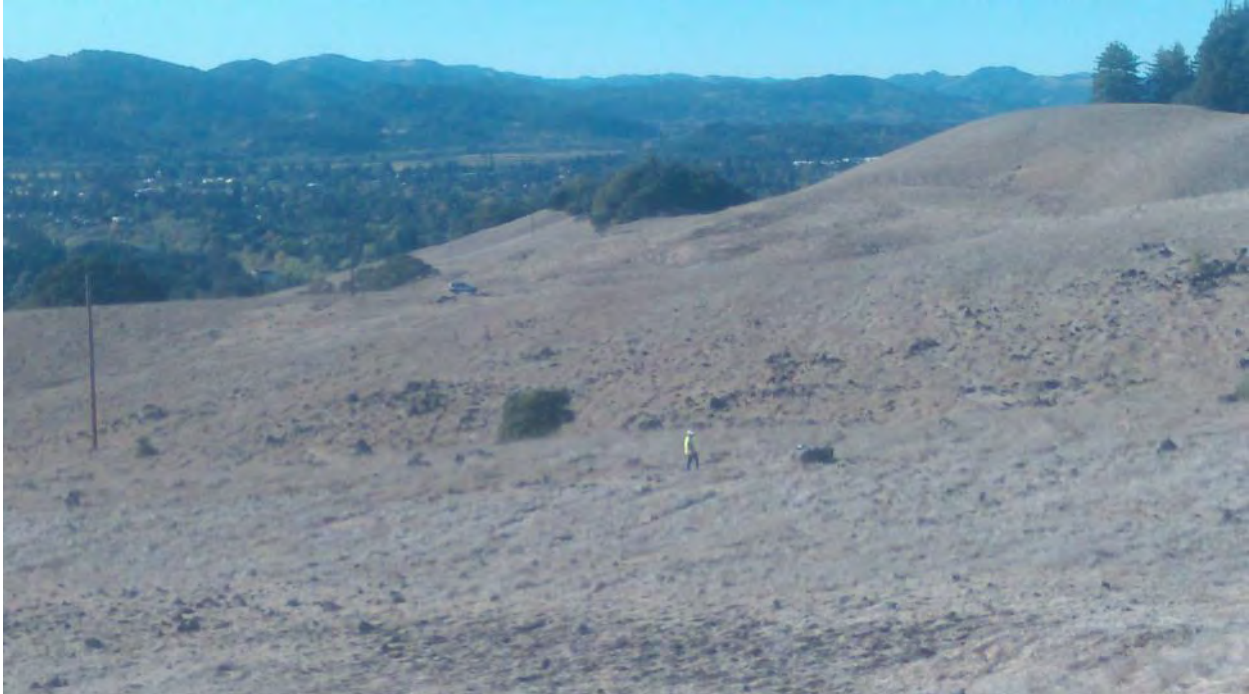
FFW20 – Pole 84; SEW40; Work area is downslope from seasonal wetland (photo facing west)

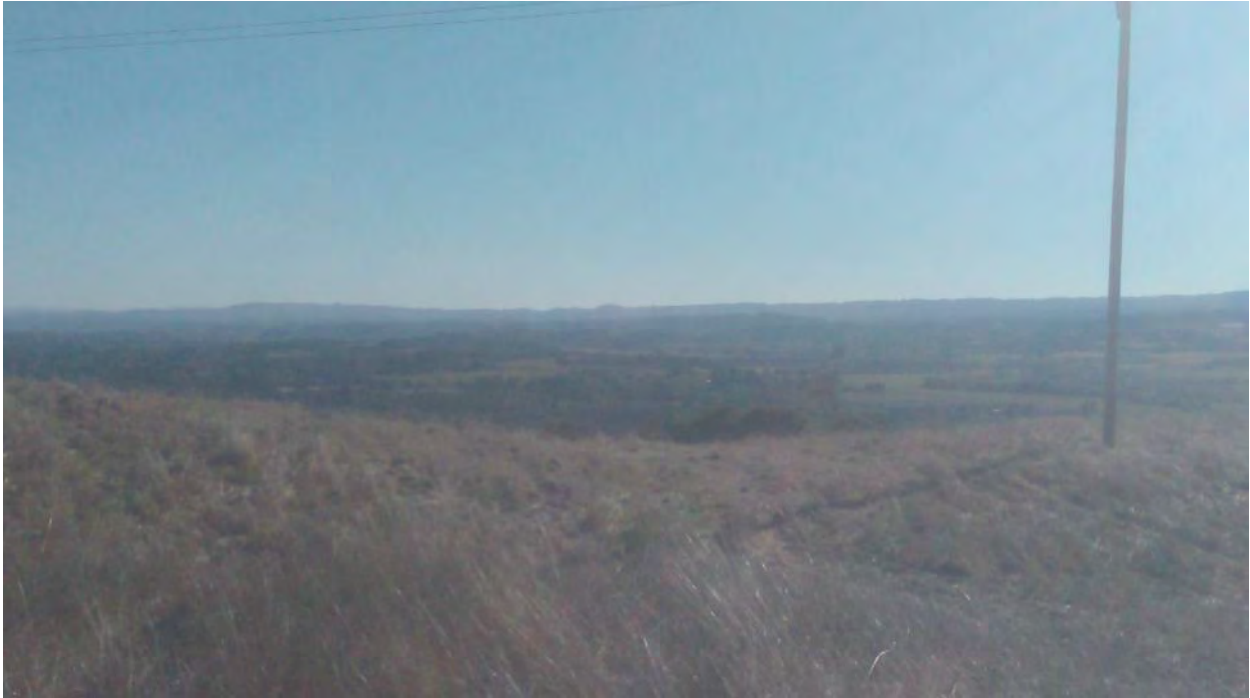
FFW21 – Pole 83; SW12; Work area is downslope from seasonal wetland (photo facing southeast)
