Garcia and Associates

RE: Fulton-Fitch Reconductoring Project, Water Crossing Mapping

Appendix A. Fulton-Fitch Work Area and Crossing Photos

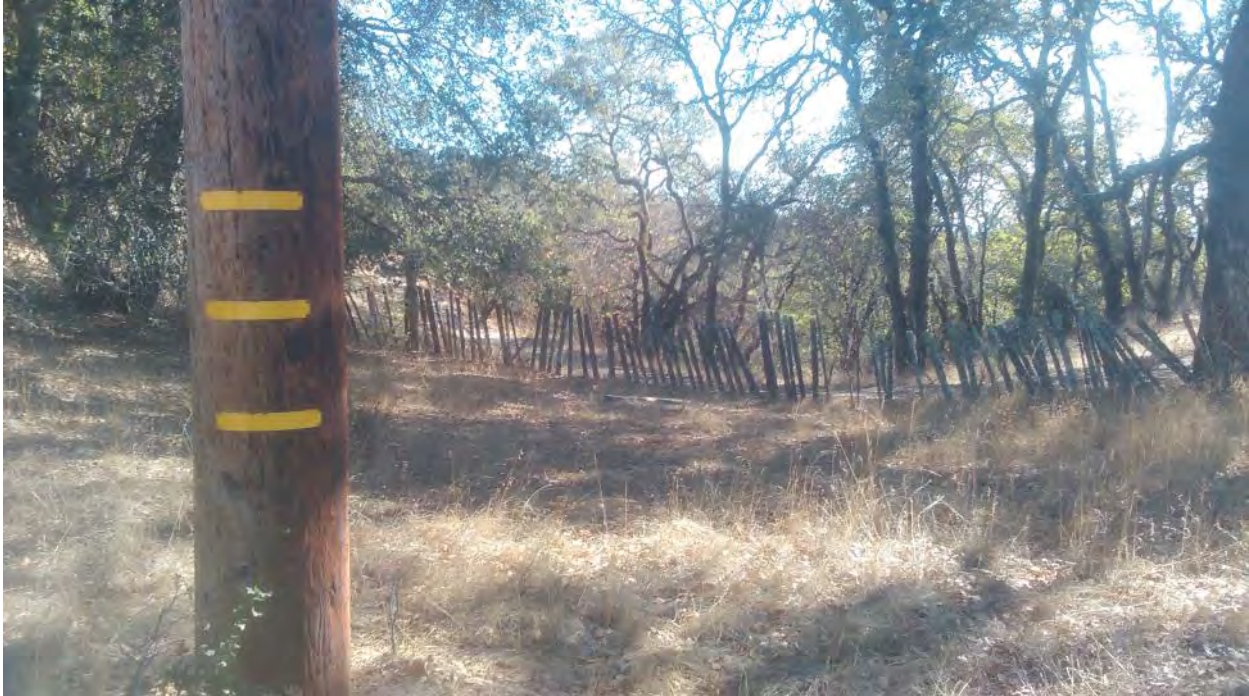
FFW13 – Pole 57; SEW24; Work area upslope from seasonal watercourse (photo facing south)

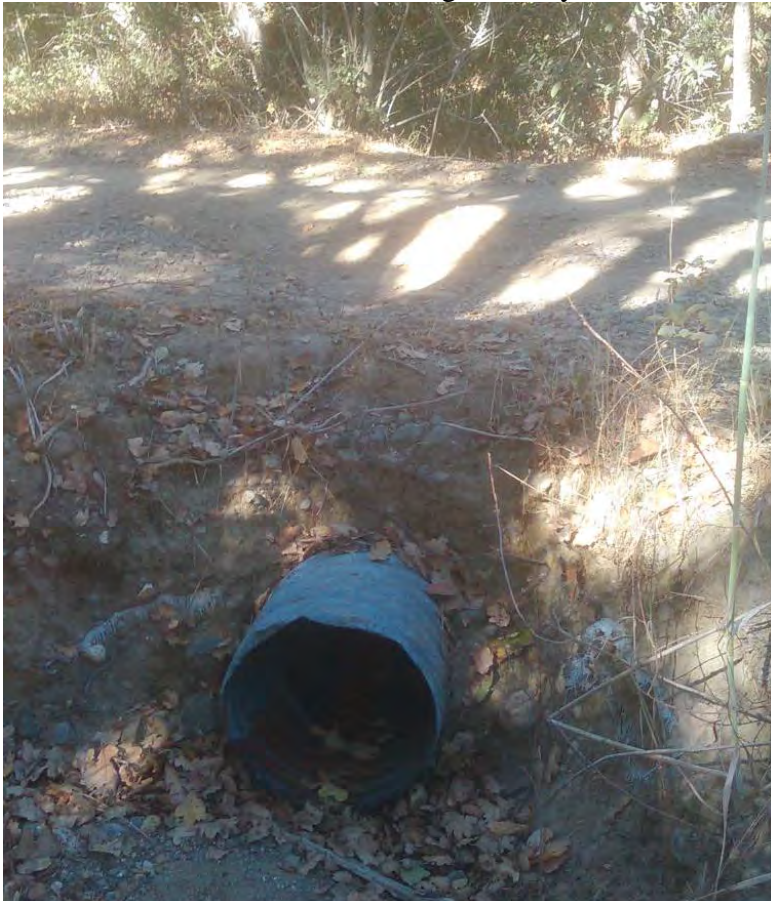
FFX12	4270976	516794	RIWO9	Riparian Woodland	3-6	5	Major access road between vineyards, crosses seasonal creek at this location	1.5ft diameter, 20ft length, corrugated steel pipe in good condition	Dispersal	No Action	No permitting required.

FFX12 – RIWO9; Culvert crossing on vineyard access road (photo facing west)

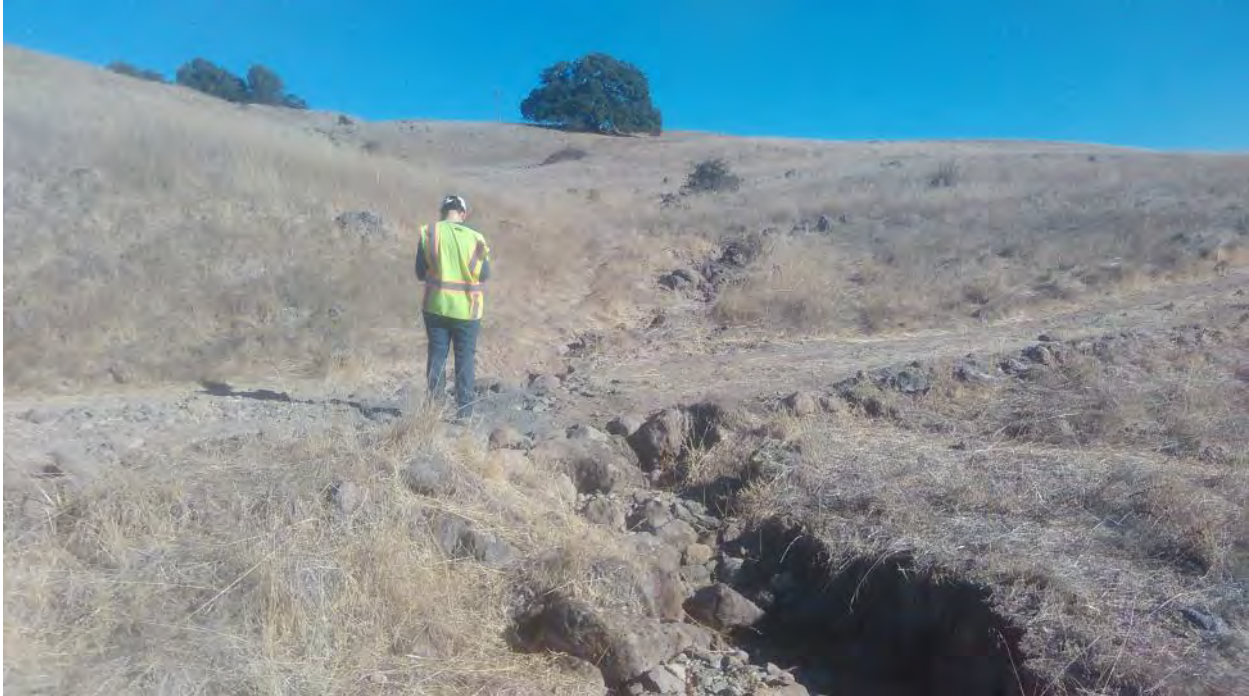
FFX21 – SEW5; Crossing point for seasonal watercourse (photo facing southeast)

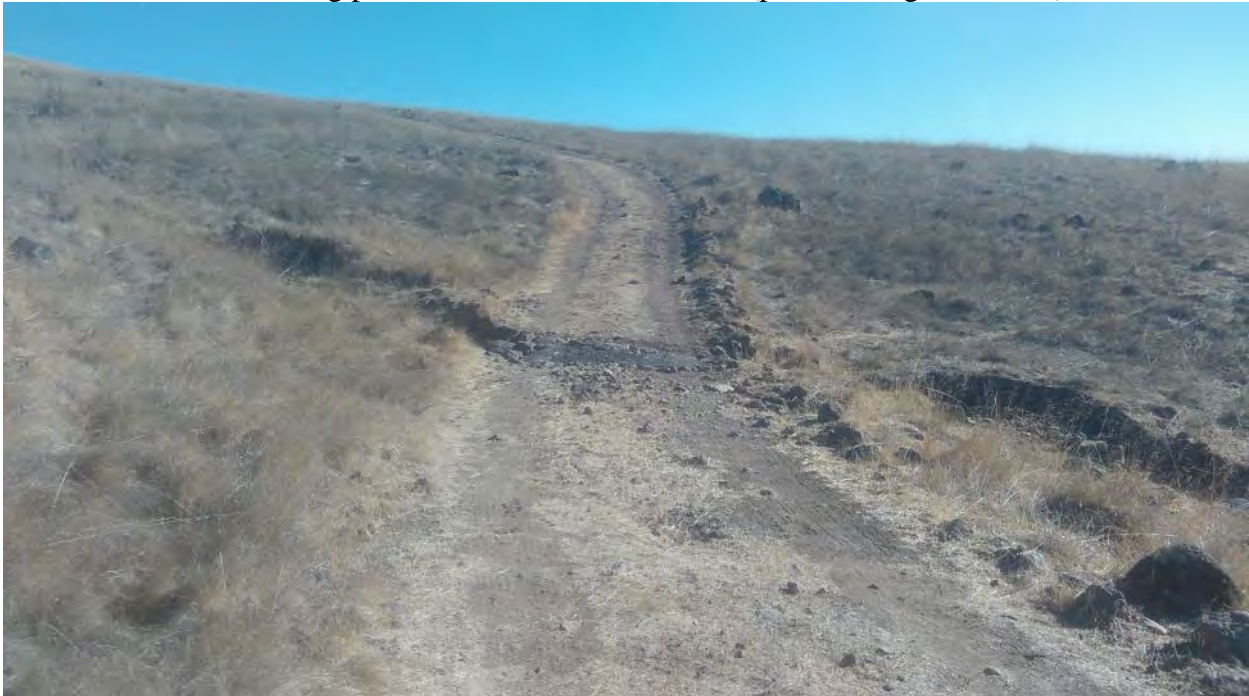
FFX22	4272703	514656	SEW5	Seasonal Watercourse	0-1	4	Overland route crossing small, ephemeral stream; mapped crossing point not suitable due to abrupt bank (see suggested alternate route)	No Culvert	Dispersal	Access during dry season; full size vehicles okay; recommended alternate overland route approximately 130 feet northeast of mapped route; stay high to avoid deep crossing	No permitting required.
FFX23	4272696	514615	SW13	Seasonal Wetland	0-1	30	Overland route crossing small seasonal wetland	No Culvert	Dispersal	Access during dry season; full size vehicles okay	No permitting required.

FFX21 – SEW5; Crossing point for seasonal watercourse (photo facing southwest)

The overland route from the end of Grant Road to Poles 80 through 89 crosses two seasonal watercourses, SEW 5 and SEW 6. The preliminarily identified overland route between Poles 85 and Pole 86 crosses SEW 5 where the banks have become steep since the overland route was first identified; therefore an alternate route is recommended approximately 130 feet east of the mapped route (Figure 1). Standard-sized vehicles and equipment may be used on these access roads.

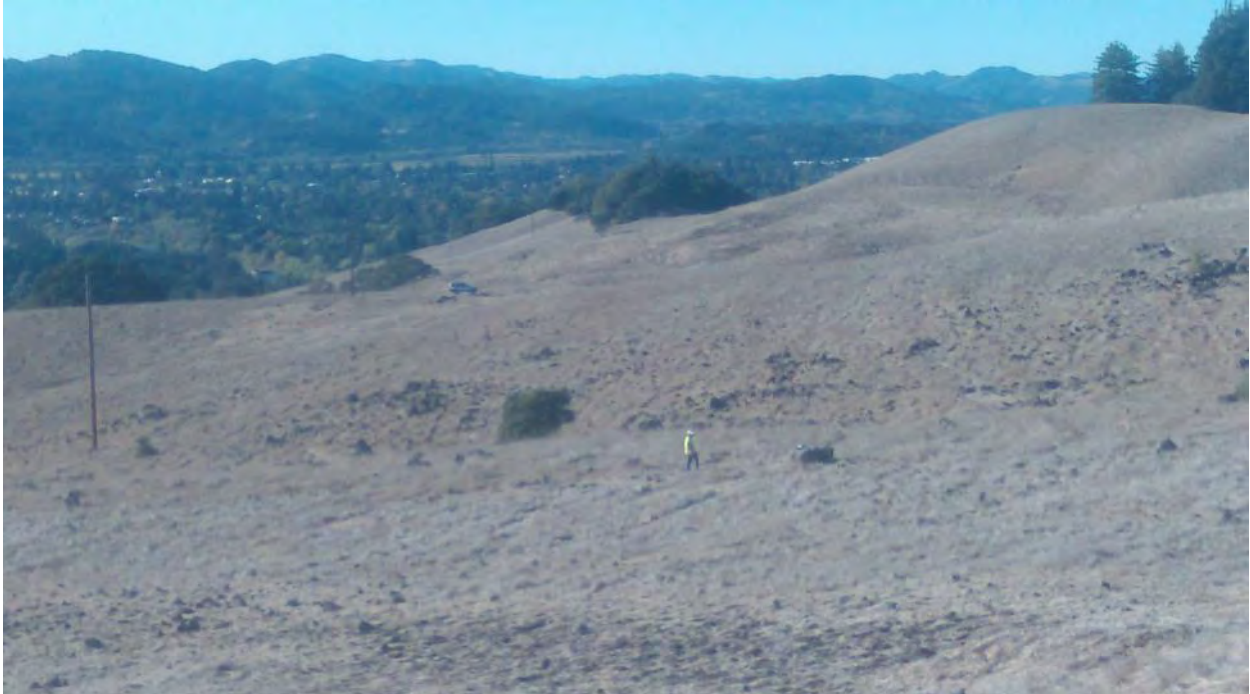
FFW20 – Pole 84; SEW40; Work area is downslope from seasonal wetland (photo facing west)
