PROJECT MEMORANDUM SYCAMORE-PEÑASQUITOS 230-KV TRANSMISSION LINE PROJECT

Date:	January 20, 2017
To:	Billie Blanchard, CPUC Project Manager
From:	Sheila Hoyer, CPUC Monitoring Supervisor
Subject:	Weekly Report #2 – January 9 to January 14, 201

2017-01-13 SycPen Inspection Report

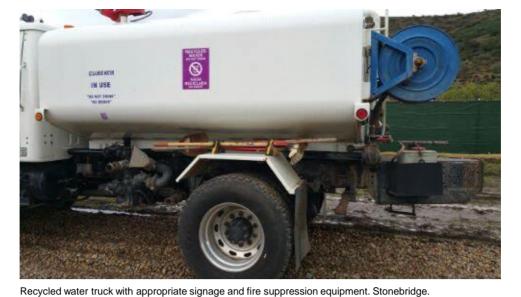
Photo Attributes Capture Date/Time: Fri Jan 13 2017 09:21:46 GMT-0800 (PST) Coordinates: 32.921799, -117.031399 View Direction: East
