**GEOTECHNICAL INVESTIGATION**  
**BAUER PROPERTY BRIDGE**  
**SUNRISE POWERLINK PROJECT**  
**ALPINE, CALIFORNIA**

**Subject: Geotechnical Investigation  
Bauer Property Bridge  
Sunrise Powerlink Project  
Alpine, California**

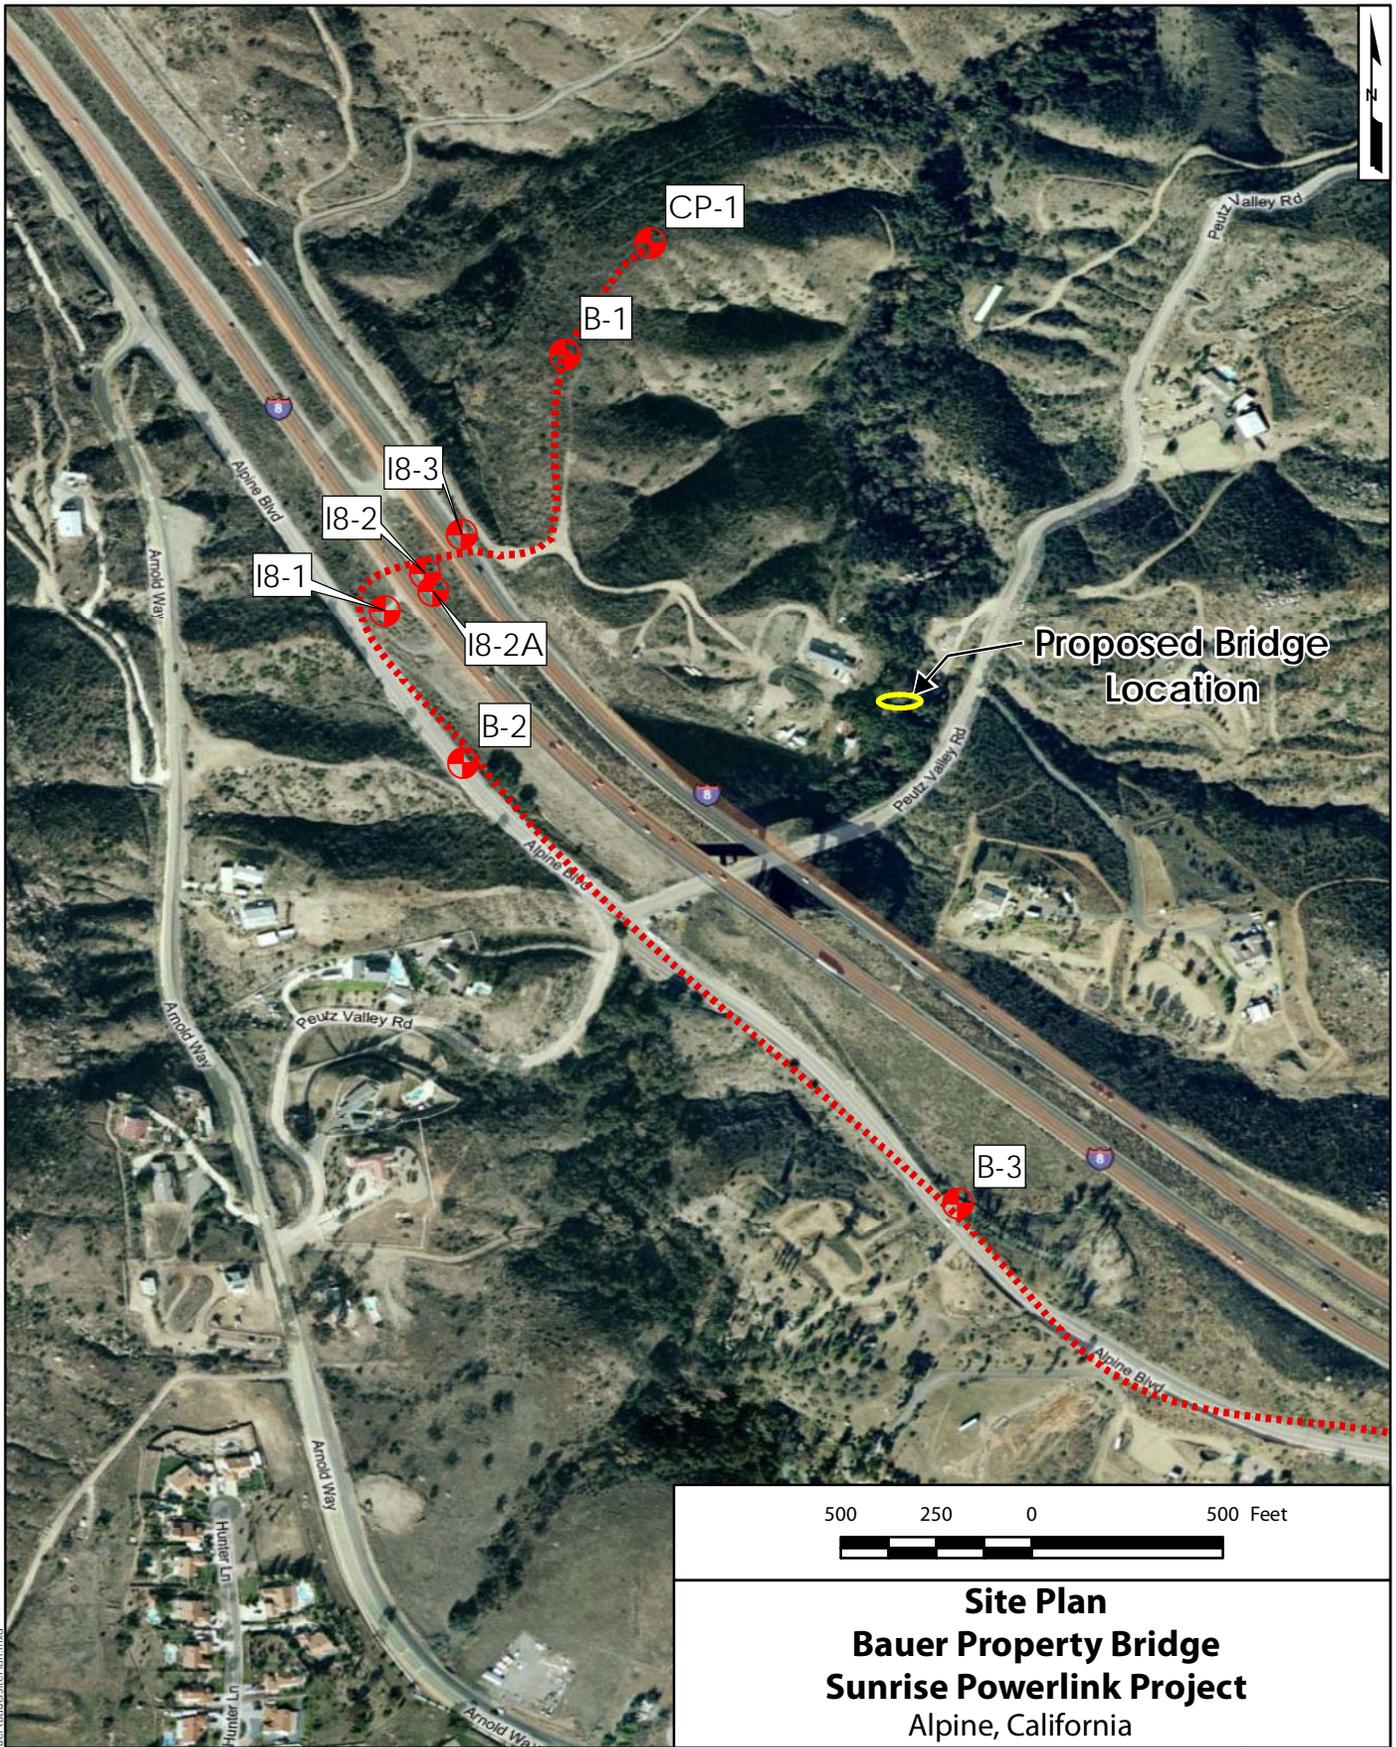
<b>Figure</b>  <b>2</b>
San Diego	July 2009

**Site Plan**  
**Bauer Property Bridge**  
**Sunrise Powerlink Project**  
 Alpine, California

We understand that SDG&E is proposing to replace an existing private bridge to provide permanent access to the western end of the underground segment of the Sunrise Powerlink transmission line north of Interstate 8 (I-8). The proposed bridge is located on the Bauer property within Peutz Valley, approximately 450 feet north of the I-8 overpass along the western side of Peutz Valley Road (Figure 1). The proposed bridge, described as a 22 foot wide *STEADFAST* steel stringer bridge, will replace an existing private bridge that crosses a major tributary drainage to Peutz Valley. At the time of this report the exact length of the bridge had yet to be determined. The location of the proposed bridge is shown on Figure 2.

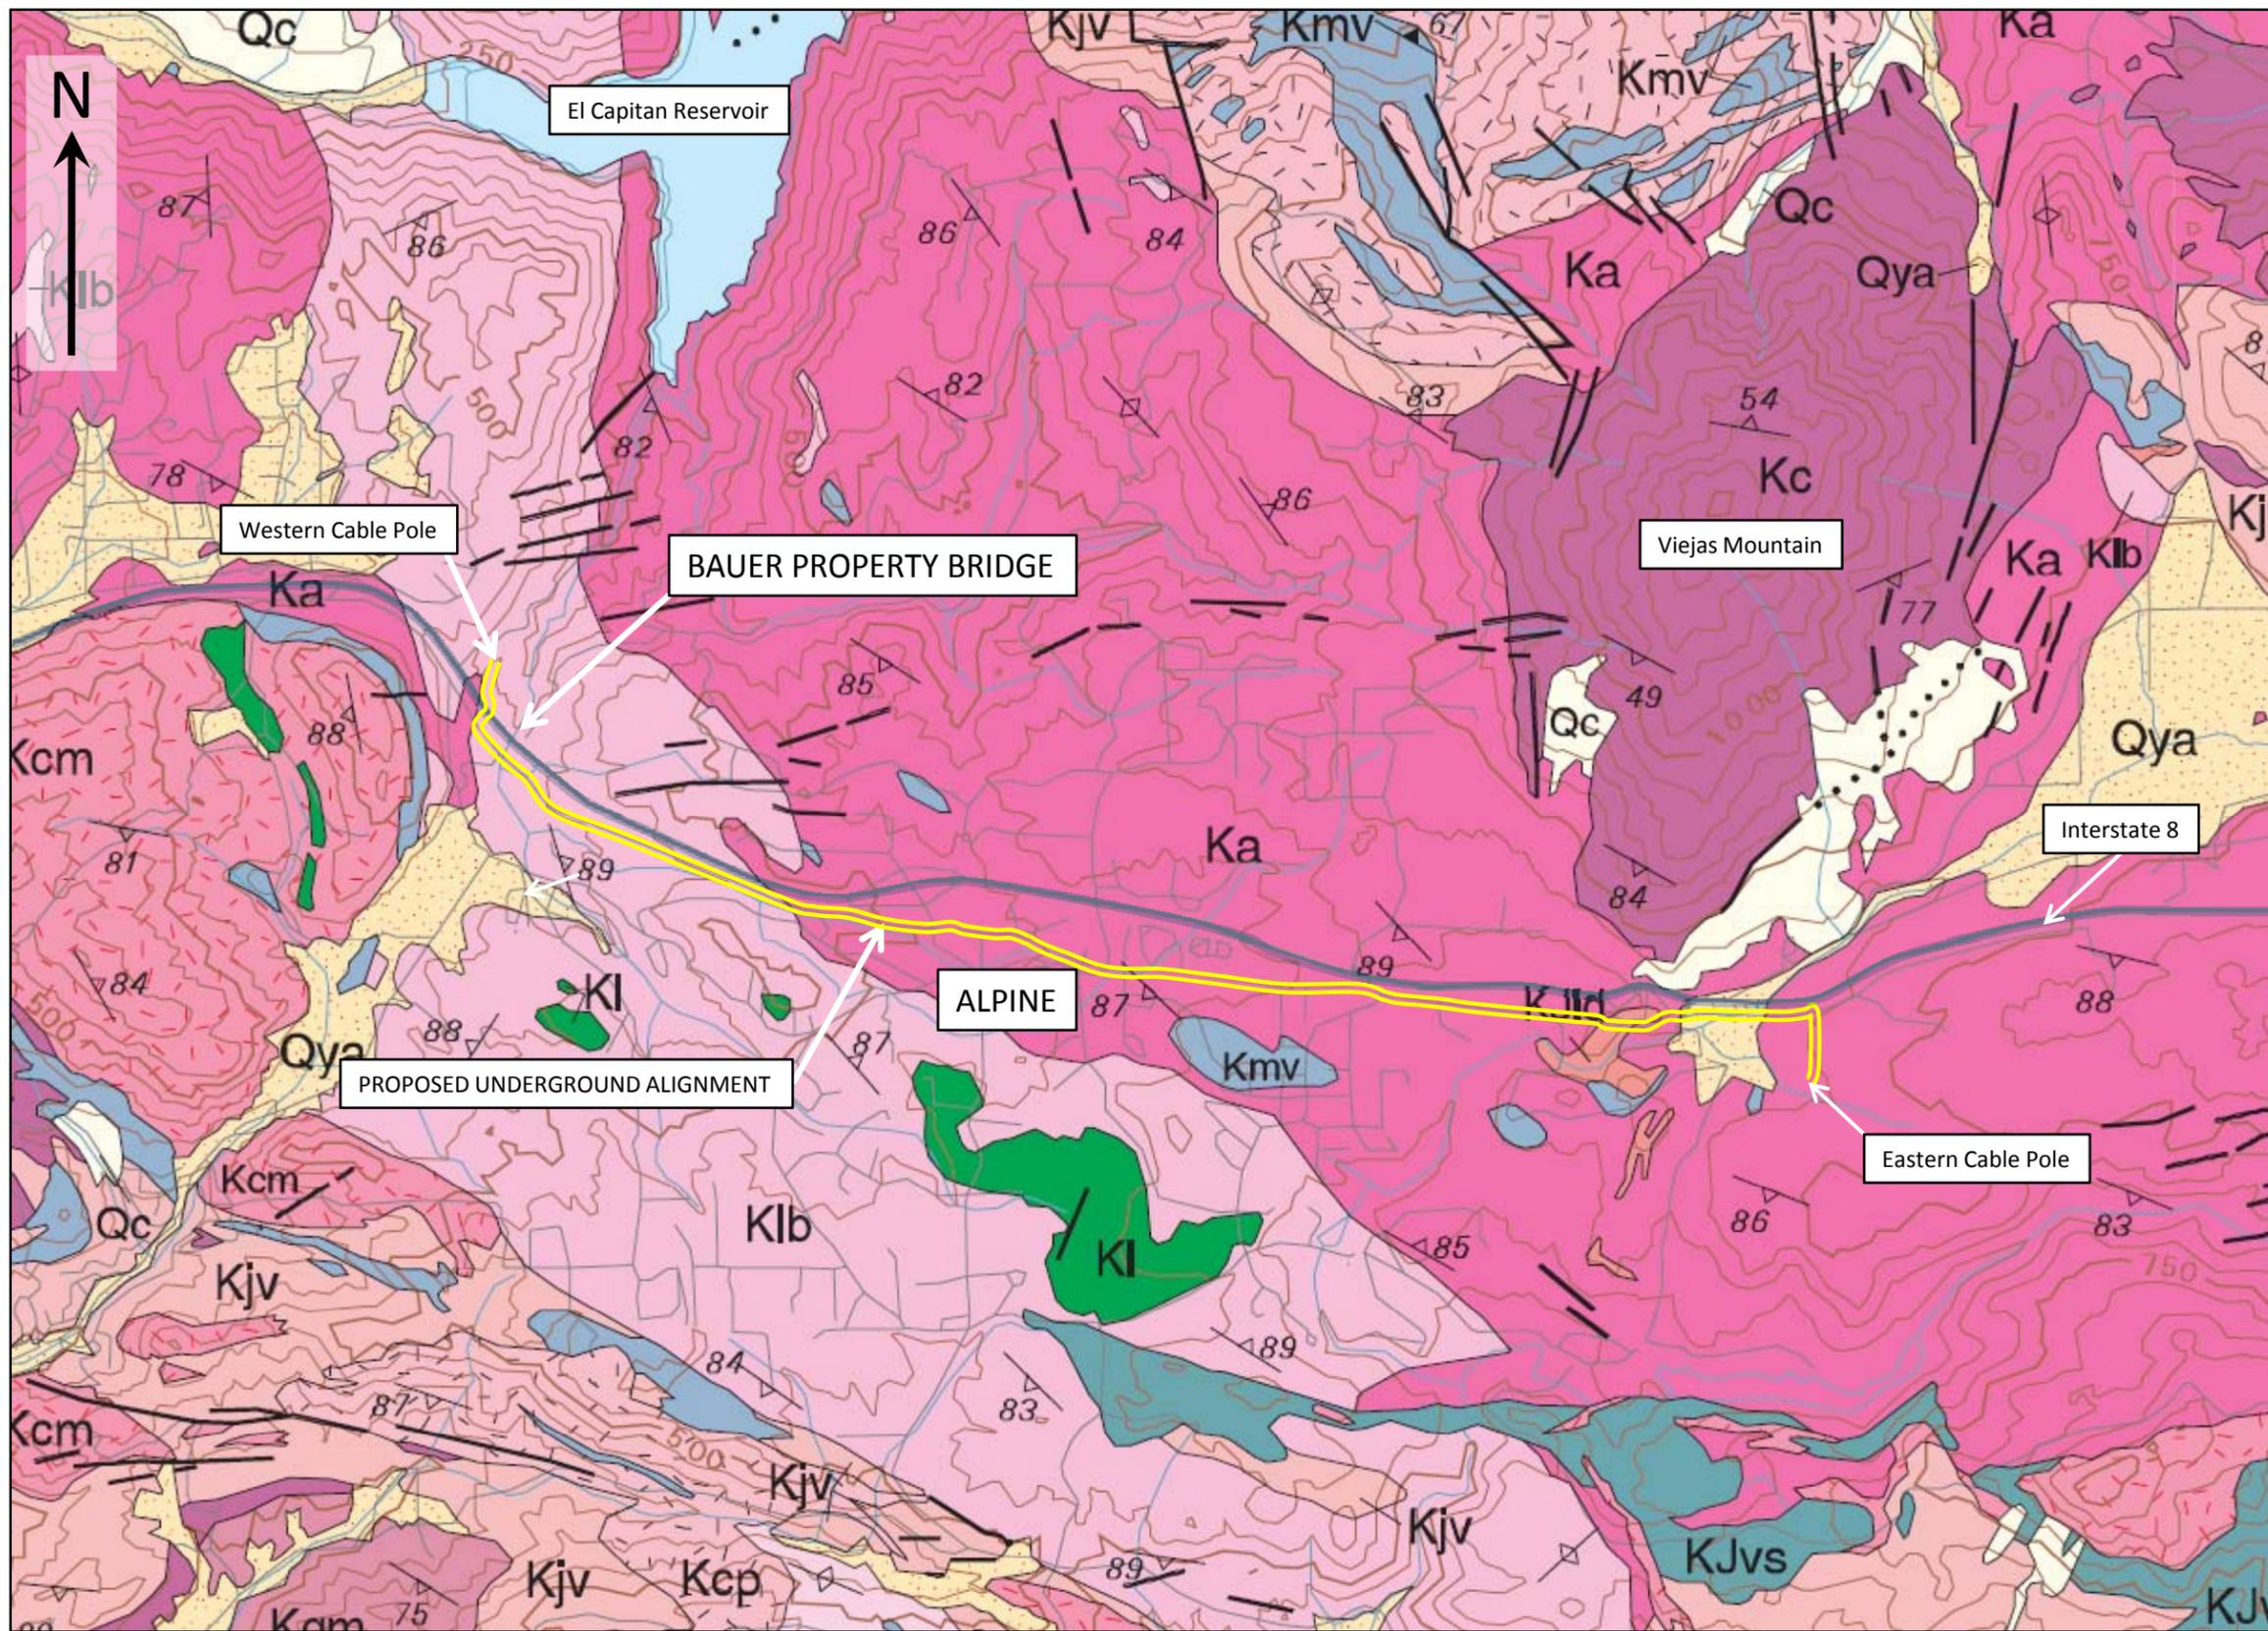
- Qya Young Alluvium
- Qc Colluvium
- Kl Lusardi Formation (Late Cretaceous)
- Klb Tonalite of Las Bancas (Early Cretaceous)
- Kc Cuyamaca Gabbro (Early Cretaceous)
- Kcm Corte Madera Monzogranite (Early Cretaceous)
- Kcp Chiquito Peak Monzogranite (Early Cretaceous)
- Kjv Japatul Valley Tonalite (Early Cretaceous)
- Ka Tonalite of Alpine (Early Cretaceous)
- KJld Leucocratic dikes (Late Cretaceous and Late Jurassic)
- Kmv Metavolcanic rocks (Early Cretaceous)
- KJvs Metavolcanic and metasedimentary rocks (Cretaceous and Jurassic)

<b>Regional Geologic Map</b>		
<b>Bauer Property Bridge – Alpine, California</b>		
<b>Sunrise Powerlink Project</b>		
	DATE: JULY, 2009	<b>Figure 3</b>
	PROJECT NO. SC0368-16-05

Variably weathered tonalitic rock associated with the Las Bancas pluton underlies the entire site area at depth (Figure 3) and is exposed in the steep slopes and road cuts along the eastern side of the drainage extending up above Peutz Valley Road. Within the western PRB the tonalite exhibits a distinctive morphology, typically characterized by relatively low, rolling terrain with scattered dark gray outcrops and grayish soils (Walawender, 2000). The geologic reconnaissance of road cuts along the Bauer driveway and Peutz Valley Road noted the presence of a localized weathering phenomenon known as “core stones” in the exposed crystalline bedrock. The core stones occur as resistant spheroidal boulders in a more weathered matrix and are highly variable in size ranging up to multiple feet in diameter.

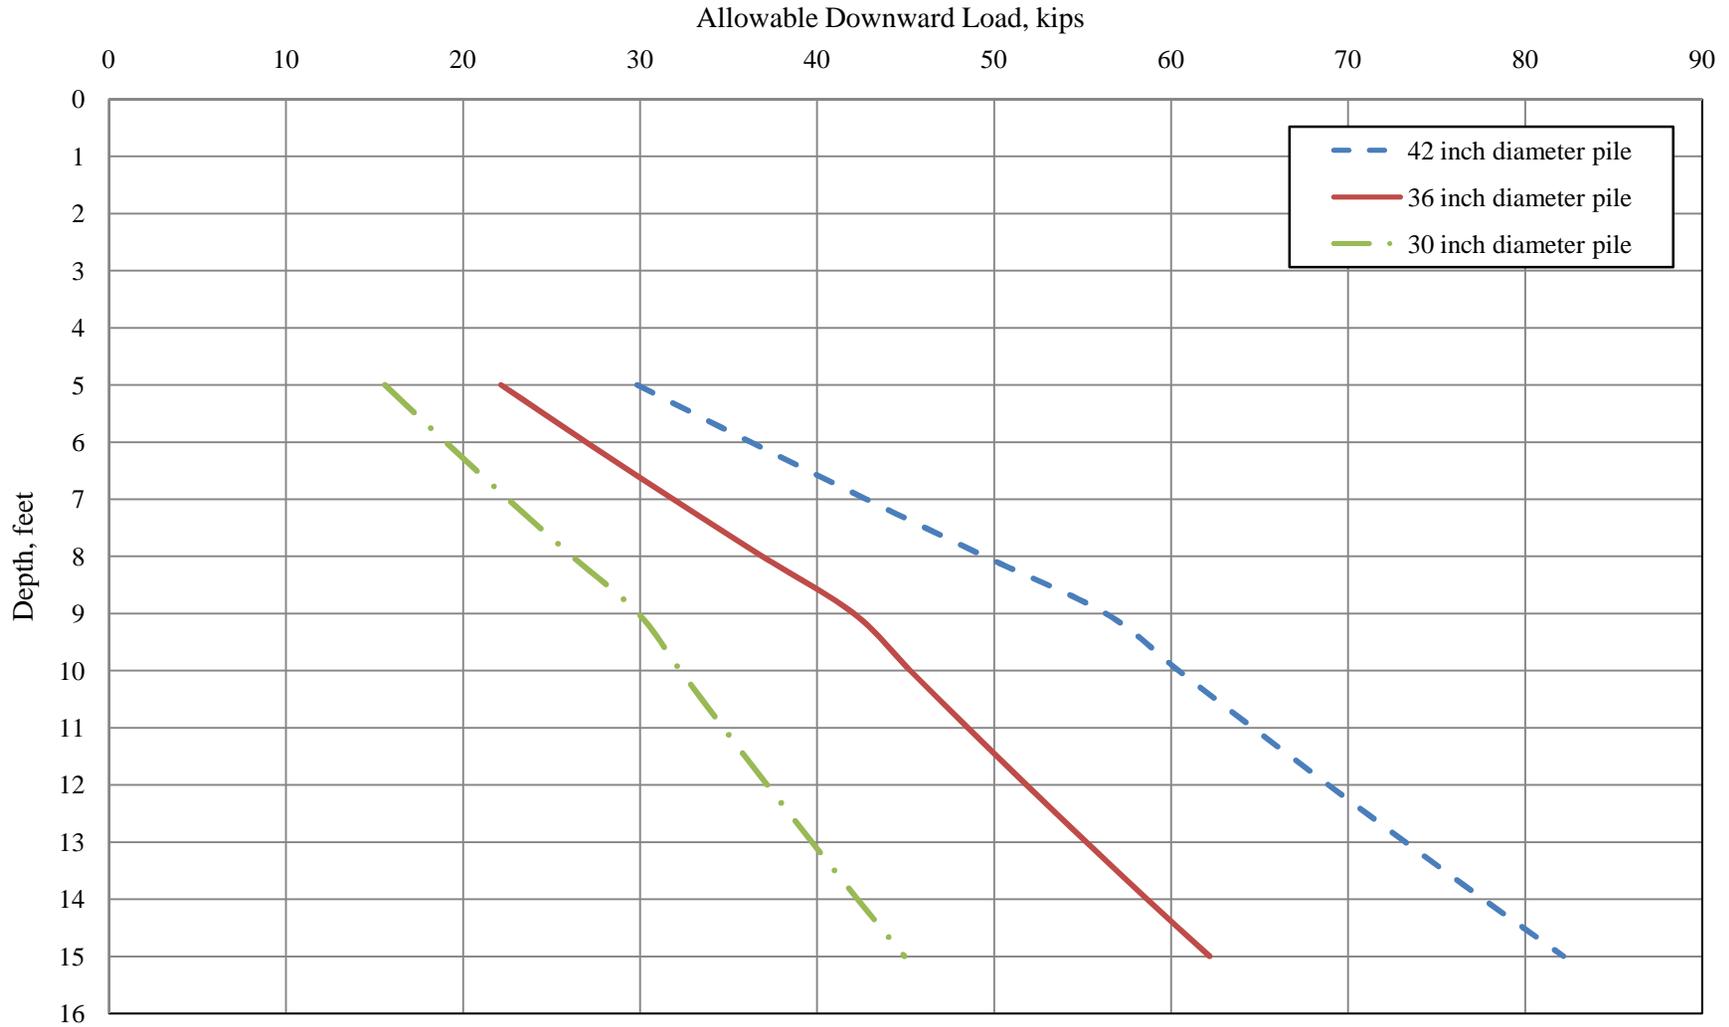
**Figure 5**

# Allowable Downward Load vs. Embedment Depth Bauer Property Bridge Sunrise Powerlink Project

Note: Water table is assumed to be at 9 feet below ground surface (bgs).

Drilled pier foundations should extend a minimum of 5 feet below the existing ground surface, bear in weathered granitic rock, and should have a minimum diameter of 30 inches. Drilled pier foundations may be designed for an allowable downward load as presented in Figure 5 for 30, 36, or 42 inch diameter piers. This value may be increased by one-third for wind and seismic loading. The bearing strata for the foundations should be verified in the field by the geotechnical engineer. Lateral loading on the drilled piers may be resisted by a uniform pressure of 250 pounds per square foot on an area that is twice the diameter of the pier. For instance, a two foot diameter pier that is five foot deep will be resisted by a uniform pressure over an area of 20 square feet. To
