**IMPACT OF THE PROPOSED CAMPO LANDFILL  
ON THE HYDROLOGY OF THE TIERRA DEL SOL WATERSHED  
A REFERENCE STUDY**

The impact that the proposed Campo landfill will have on the hydrology of the Tierra del Sol watershed is examined using an interdisciplinary perspective. Analysis of precipitation and well data suggests the presence of an effective hydraulic connection between surface water and groundwater in the region. Existing fracture maps and other geologic evidence reveal the extent to which the underlying aquifer is fractured. The presence of numerous springs and photogeologic lineaments indicates that water flows readily from the fractured-rock aquifer to the creeks, streams, and wells of the Tierra del Sol watershed.

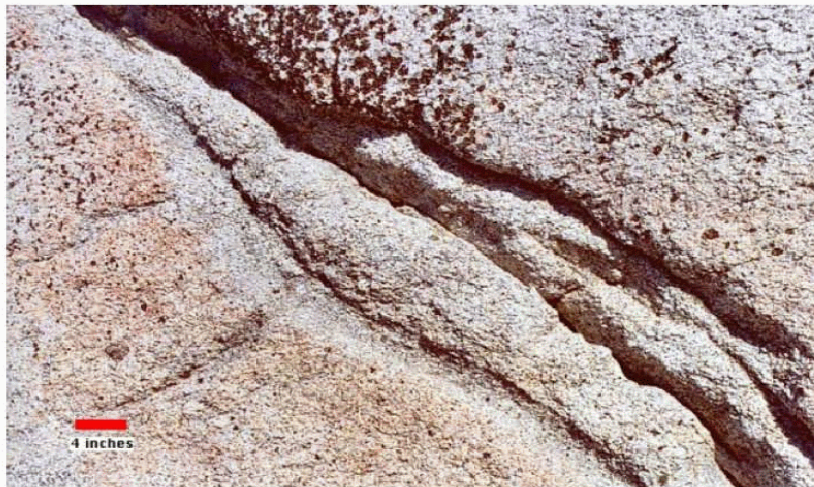
Fig. 1 Closeup of fracture in rock outcrop in the Tierra del Sol watershed.

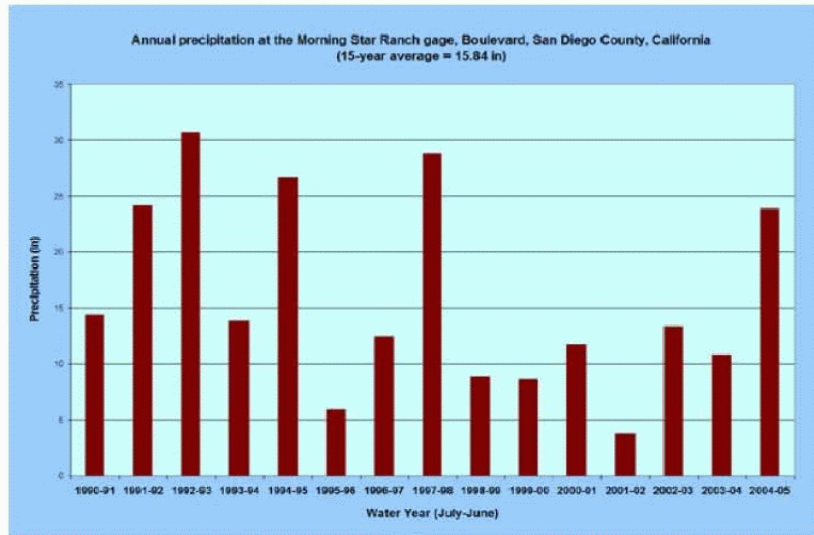
Fig. 4 Annual precipitation at the Morning Star Ranch, 1990-91 to 2004-05.

The record of annual precipitation, with the water year defined from July to June, is shown in Fig. 4. The average precipitation for the 15-year period is 15.84 inches. The record shows two very wet years, 1992-93 and 1997-98; and three other significantly wet years, 1991-92, 1994-95, and 2004-05. The years 1991-92, 1992-93, 1994-95, and 1997-98 were El Niño years. In the year 2004-05, monthly and annual precipitation were near record highs.

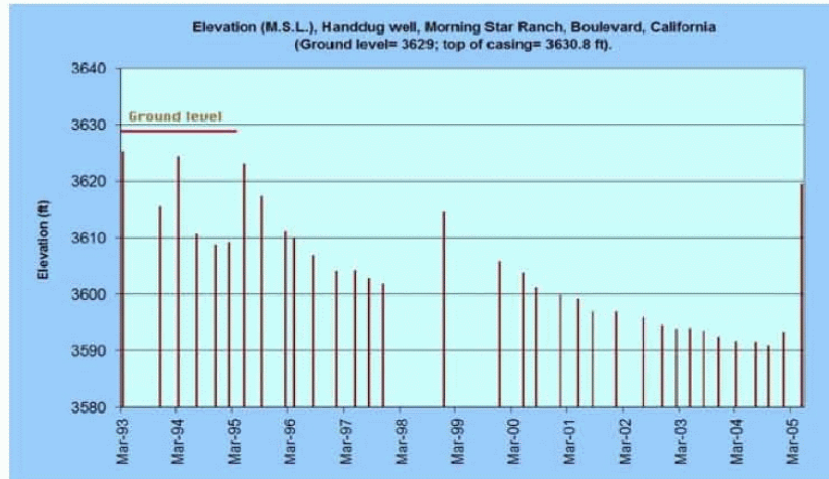
Fig. 6 Water-surface elevation at Handdug well.

**Well data.** Well data spanning the 12-year period from 1993 to 2005 is shown in Figs. 6 to 8. Fig. 6 shows the Handdug well, Fig. 7 shows the Playhouse well, and Fig. 8 shows the Utz well. The measurements were performed by San Diego County personnel as part of the county's groundwater monitoring program. The elevations shown are the water surface in the well, above mean sea level.

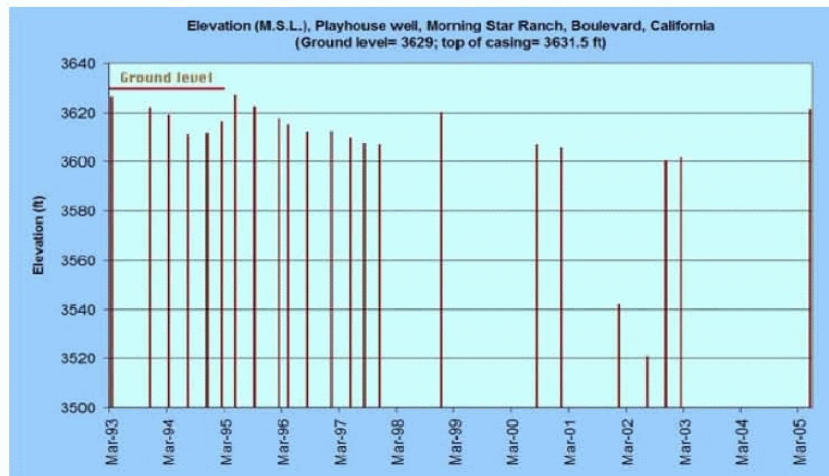
Fig. 7 Water-surface elevation at Playhouse well.

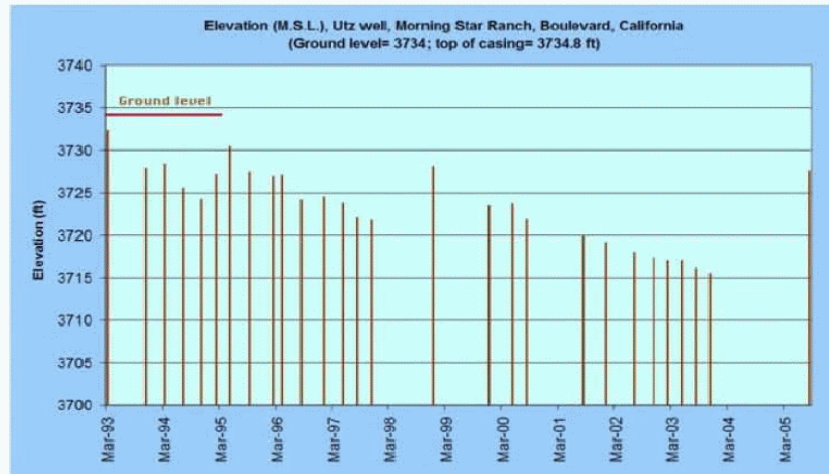
Fig. 8 Water-surface elevation at Utz well.

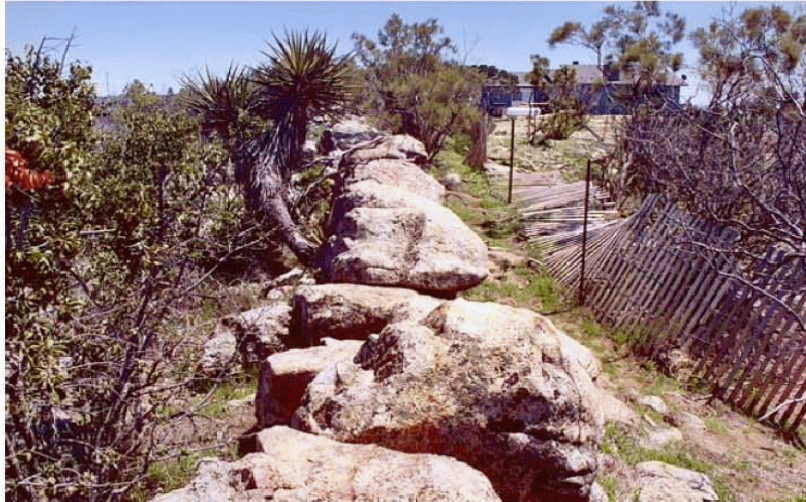
Fig. 10 Major dike in Turner Ranch, Tierra del Sol.<sup>8</sup>

It is not immediately apparent which one of the above two scenarios is more plausible. If the fractures preceded the dikes, an east-west preference in dike orientation would suggest that less energy was required to shoulder aside the rock in an orthogonal (i.e., north-south) direction. In turn, this would imply denser fracture spacing and/or greater fracture lengths and widths in the east-west direction. One significantly major dike located on the Turner Ranch in Tierra del Sol, is about 5-ft wide and 1,465-ft long (Fig. 10). Notably, this dike trends east-west almost exactly (Fig. 20). A geologic fault crosses this dike near its eastern edge, in an approximate NE-SW direction. Significantly, the Turner Ranch's well is located at or near this fault.
