GEOTECHNICAL SITING STUDY

SAN DIEGO GAS & ELECTRIC PROPOSED OCEAN RANCH SUBSTATION PACIFIC COAST BUSINESS PARK – PARCELS 7, 16 AND 17 OCEANSIDE, CALIFORNIA

June 26, 2012

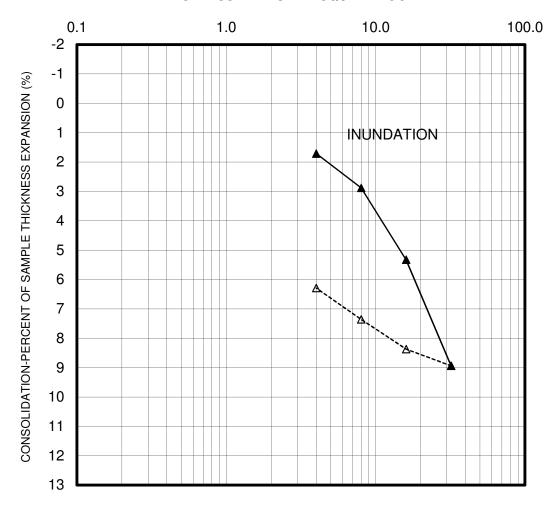
STRESS IN KIPS PER SQUARE FOOT

Seating Cycle
Loading Prior to Inundation
Loading After Inundation

Rebound Cycle

Two consolidation tests were performed on soils samples of the alluvium / colluvium to aid in evaluating the compressibility of the soils when subjected to new loads. The tests were performed in general accordance with ASTM Test Method D 2435. The results of the test are presented on Plates B1 and B2.

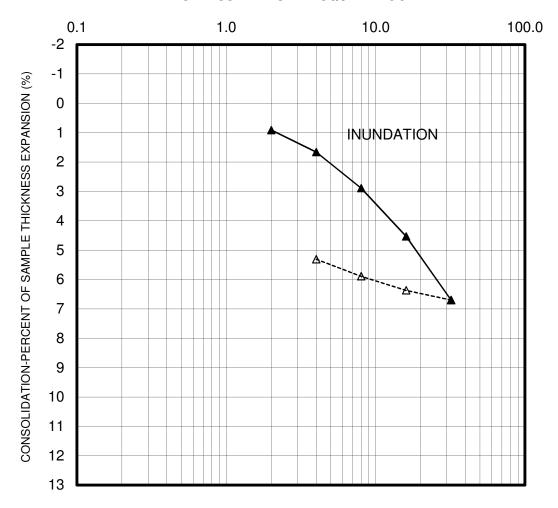
B2

STRESS IN KIPS PER SQUARE FOOT

Seating Cycle
Loading Prior to Inundation
Loading After Inundation
Rebound Cycle

Boring No. B6 Sample No. 11 Depth 75'-76.5'

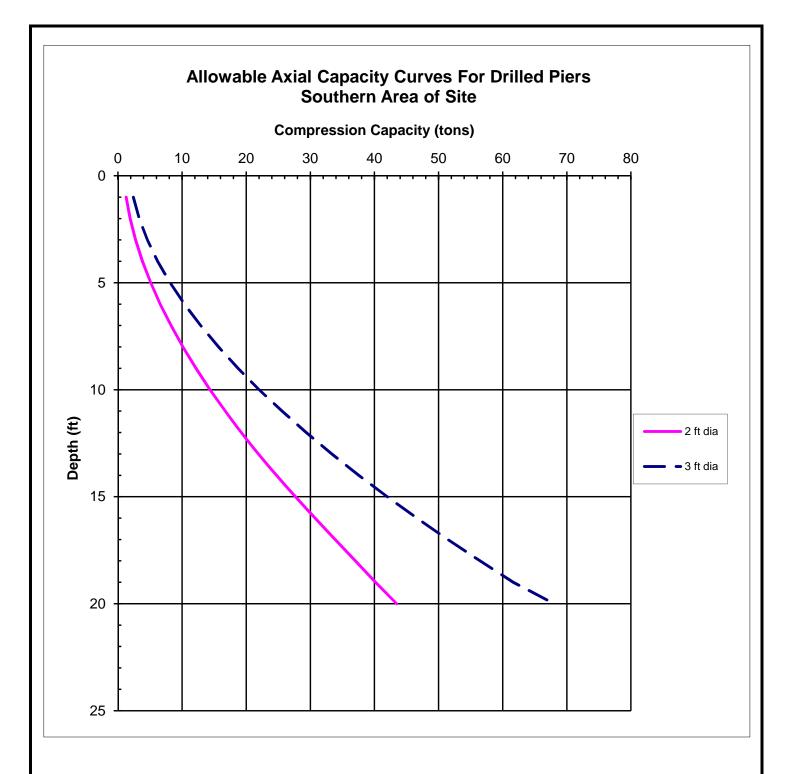
7

These results are based on the following assumptions and conditions. Piles with conditions different from those assumed should be re-evaluated by Kleinfelder.

- Soil profile is coarse grain fill from the ground surface to 25 feet, and then underalin by fine grained fill.
- Pile modulus of elasticity, E = 0.410E+07 lb/sq. in
- End bearing was utilized
- Ground water was not encountered

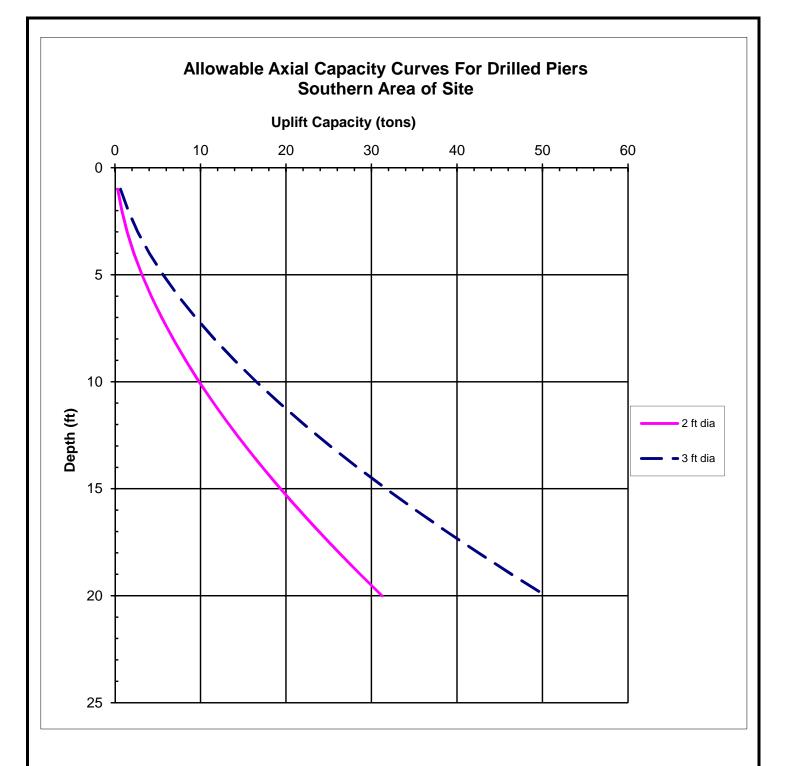
These results are based on the following assumptions and conditions. Piles with conditions different from those assumed should be re-evaluated by Kleinfelder.

- Soil profile is coarse grain fill from the ground surface to 25 feet, and then underalin by fine grained fill.
- Pile modulus of elasticity, E = 0.410E+07 lb/sq. in
- End bearing was utilized
- Ground water was not encountered

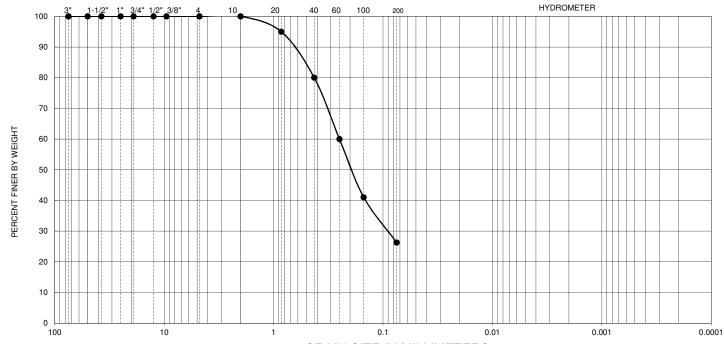
GRA	/EL		SAN	D	FINES		
Coarse	Fine	Coarse	Medium	Fine	Silt Clay

GRAIN SIZE IN MILLIMETERS

Boring No.	Sample No.	Depth (ft)	Passing 200 (%)	USCS Classification
В3	2	2.5-4	26.3	SC

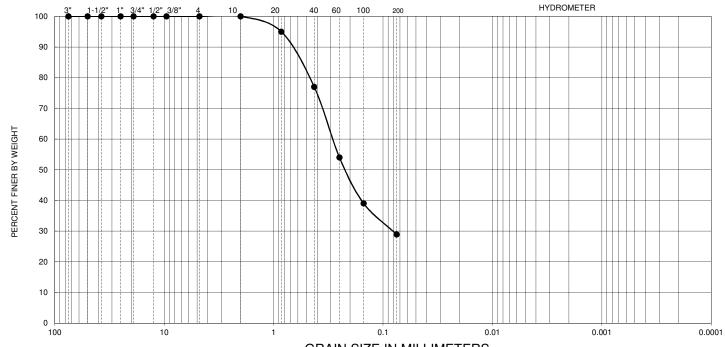
GRA	/EL		SAN	D	FINES		
Coarse	Fine	Coarse	Medium	Fine	Silt Clay

GRAIN SIZE IN MILLIMETERS

Boring No.	Sample No.	Depth (ft)	Passing 200 (%)	USCS Classification
B4	4	10-11.5	28.9	SM

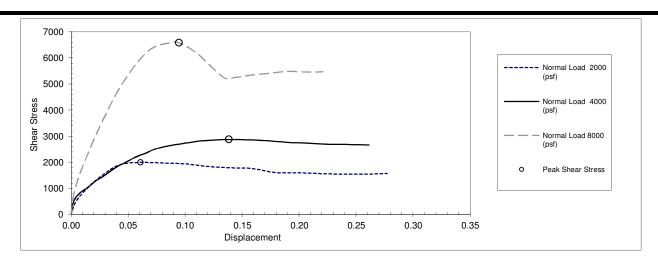
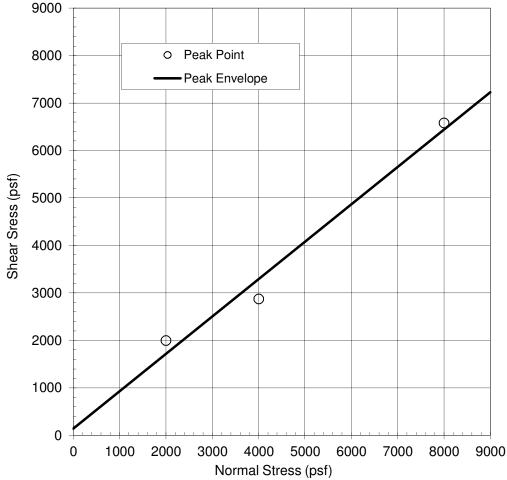
Strain Rate =	0.0118	inch/min		I	nterpreted S	Shear Strength	
Date Tested:	4/29/2015			Pea	ak		
					Friction		
				Cohesion	Angle		
Boring No.	Sample No.	Depth	UCSC	(psf)	(deg)		
B-2	2	2.5'-4'	SM	140	38.2

Direct Shear Test Results (ASTM D 3080)

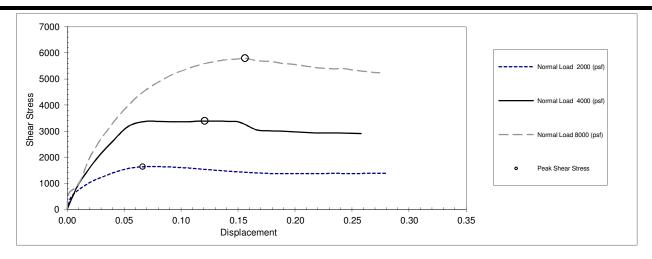
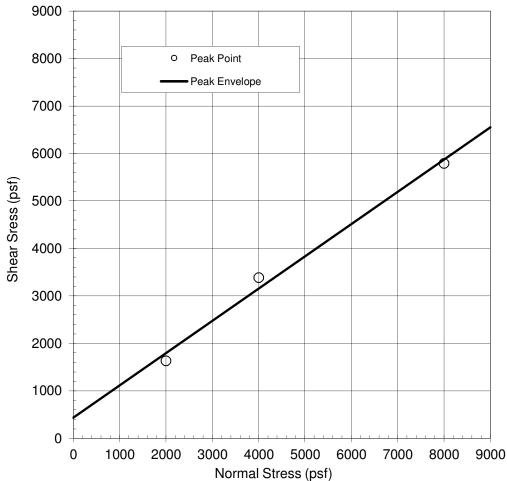
Strain Rate =	0.0118	inch/min		I	nterpreted S	Shear Strength	
Date Tested:	4/30/2015			Pea	ak		
					Friction		
				Cohesion	Angle		
Boring No.	Sample No.	Depth	UCSC	(psf)	(deg)		
B-4	2	2.5'-5'	SC	435	34.2

Direct Shear Test Results (ASTM D 3080)

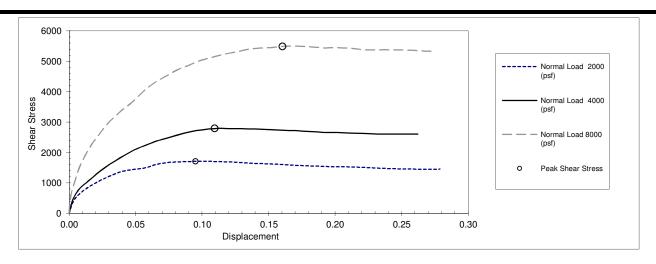
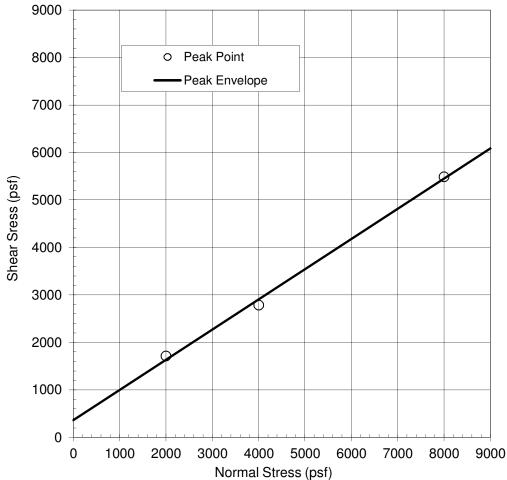
Strain Rate =	0.0118	inch/min		I	nterpreted S	Shear Strength	
Date Tested:	5/4/2015			Pea	ak		
					Friction		
				Cohesion	Angle		
Boring No.	Sample No.	Depth	UCSC	(psf)	(deg)		
B-5	2	2.5'-4'	SM	362	32.4

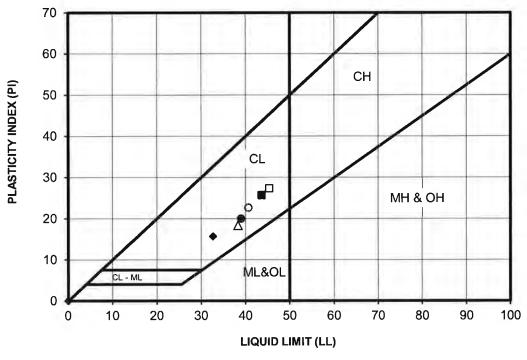
SYMBOL	SAMPLE NAME	DEPTH (ft)	LL	PL	PI	USCS CLASSIFICATION (Minus No. 40 Sieve Fraction)	USCS (Entire Sample)
•	B-1-4	10-11.5'	39	19	20	CL	CL
	B-3-1	0.5-5'	44	18	26	CL	SC
•	B-4-2	2.5-4'	33	17	16	CL	SC
0	B-4-8	30-31.5'	41	18	23	CL	CL
	B-4-15	65-66.5'	45	18	27	CL	CL
Δ	B-6-5	15-16.5'	38	20	18	CL	CL
+							
\$				-			
				100

PERFORMED IN GENERAL ACCORDANCE WITH ASTM D 4318

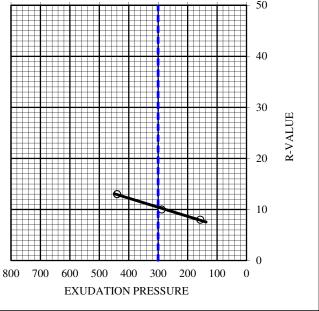
R-Value (ASTM D2844)

Boring No.	Sample No.	Depth			Date Tested	
В7	1	0.5-5'		SAND	5/6/2015	
				1	Ī	
TEST SPECIM	EN			_	_	
MOLD NO.			2	1	9	
FOOT PRESSU			80	60	50	
INITIAL MOIS			13.1	13.1	13.1	
"AS-IS" WEIG			1200	1200	1200	
DRY WEIGHT			1060.9	1060.9	1060.9	
WATER ADDI			40	52	64	
	N MOISTURE, %	S	16.9	18.0	19.1	
HEIGHT OF B	RIQUETTE, in.		2.58	2.6	2.62	
WEIGHT BRIQ	QUETTE/MOLD,	,	3213	3203.4	3216.4	
WEIGHT OF M	MOLD, g		2109.2	2103.4	2114.5	
WEIGHT OF B	RIQUETTE, g		1103.8	1100	1101.9	
DRY DENSITY	Y, pcf		111.0	108.7	107.1	
STABILOMET	ER, 1000 lbs		55	61	64	
	2000lbs		134	139	144	
DISPLACEME	NT, in		3.59	3.66	3.84	
EXUDATION 1	LOAD, lbs		5515	3621	1972	
EXUDATION 1	PRESSURE, psi		439.1	288.3	157.0	
R-VALUE			12	9	7	
CORRECTE	D R-VALUE		13	10	8	
DIAL READIN	IG, END		0.0311	0.0302	0.0404	
DIAL READIN	IG, START		0.0300	0.0300	0.0400	
DIFFERENCE			0.0011	0.0002	0.0004	
EXPANSION F	PRESSURE, PSF		48.0	8.7	17.5	
						50
INITIAL MOISTURE						∄

INITIAL MOISTURE					
WET WEIGHT, g	433.8				
DRY WEIGHT, g	383.5				
WEIGHT OF WATER					
WEIGHT OF SAMPLE					
MOISTURE CONTENT %	13.1

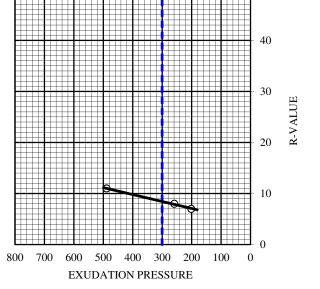
1					
Boring No.	Sample No.	Depth	Description			Date Tested
B10	1	0.5-5'	Light Olive Gray Clayey SAND			5/6/2015
TEST SPECIM	EN					
MOLD NO.	LLIN		6	3	8	
FOOT PRESSU	IRF nei		80	60	50	
INITIAL MOIS	*		14.5	14.5	14.5	
"AS-IS" WEIG			1200	1200	1200	
DRY WEIGHT			1048.0	1048.0	1048.0	
WATER ADDI			30	45	58	
	N MOISTURE, %	ć	17.4	18.8	20.0	
	RIQUETTE, in.		2.5	2.55	2.6	
	QUETTE/MOLD,	,	3170.7	3176.5	3174.6	
WEIGHT OF M			2101	2105.4	2112.6	
WEIGHT OF B			1069.7	1071.1	1062	
DRY DENSITY	Y, pcf		110.6	107.2	103.2	
STABILOMETER, 1000 lbs		57	61	66		
	2000lbs		136	142	145	
DISPLACEME	NT, in		3.5	3.74	3.92	
EXUDATION :	LOAD, lbs		6142	3253	2529	
EXUDATION :	PRESSURE, psi		489.0	259.0	201.4	
R-VALUE			11	8	6	
CORRECTE	D R-VALUE		11	8	7	
DIAL READIN	IG, END		0.0478	0.0285	0.0476	
DIAL READIN	IG, START		0.0475	0.0285	0.0482	
DIFFERENCE		0.0003	0.0000	-0.0006		
EXPANSION PRESSURE, PSF		13.1	0.0	0.0		
						50
INITIAL M	OISTURE

INITIAL MOISTURE	
WET WEIGHT, g	506.0
DRY WEIGHT, g	441.9
WEIGHT OF WATER	
WEIGHT OF SAMPLE	
MOISTURE CONTENT %	14.5

R-VALUE:	9
Location:

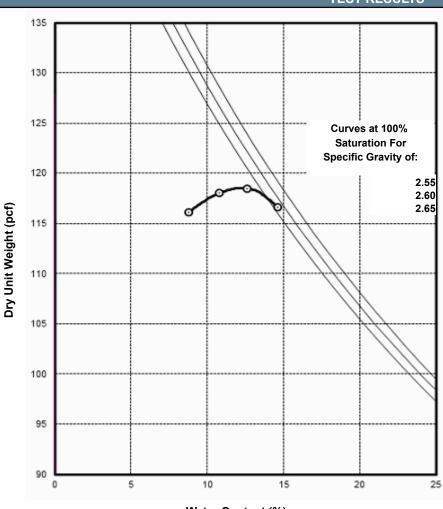
TEST RESULTS

Sample No.: SD_20154777.B5.1
