**Figure 3.14-19a**  
**Existing Conditions**  
**for KOP-Center-4**  
**Southbound Angeles**  
**Forest Highway**  
**(Alternative 2, Segment 6)**

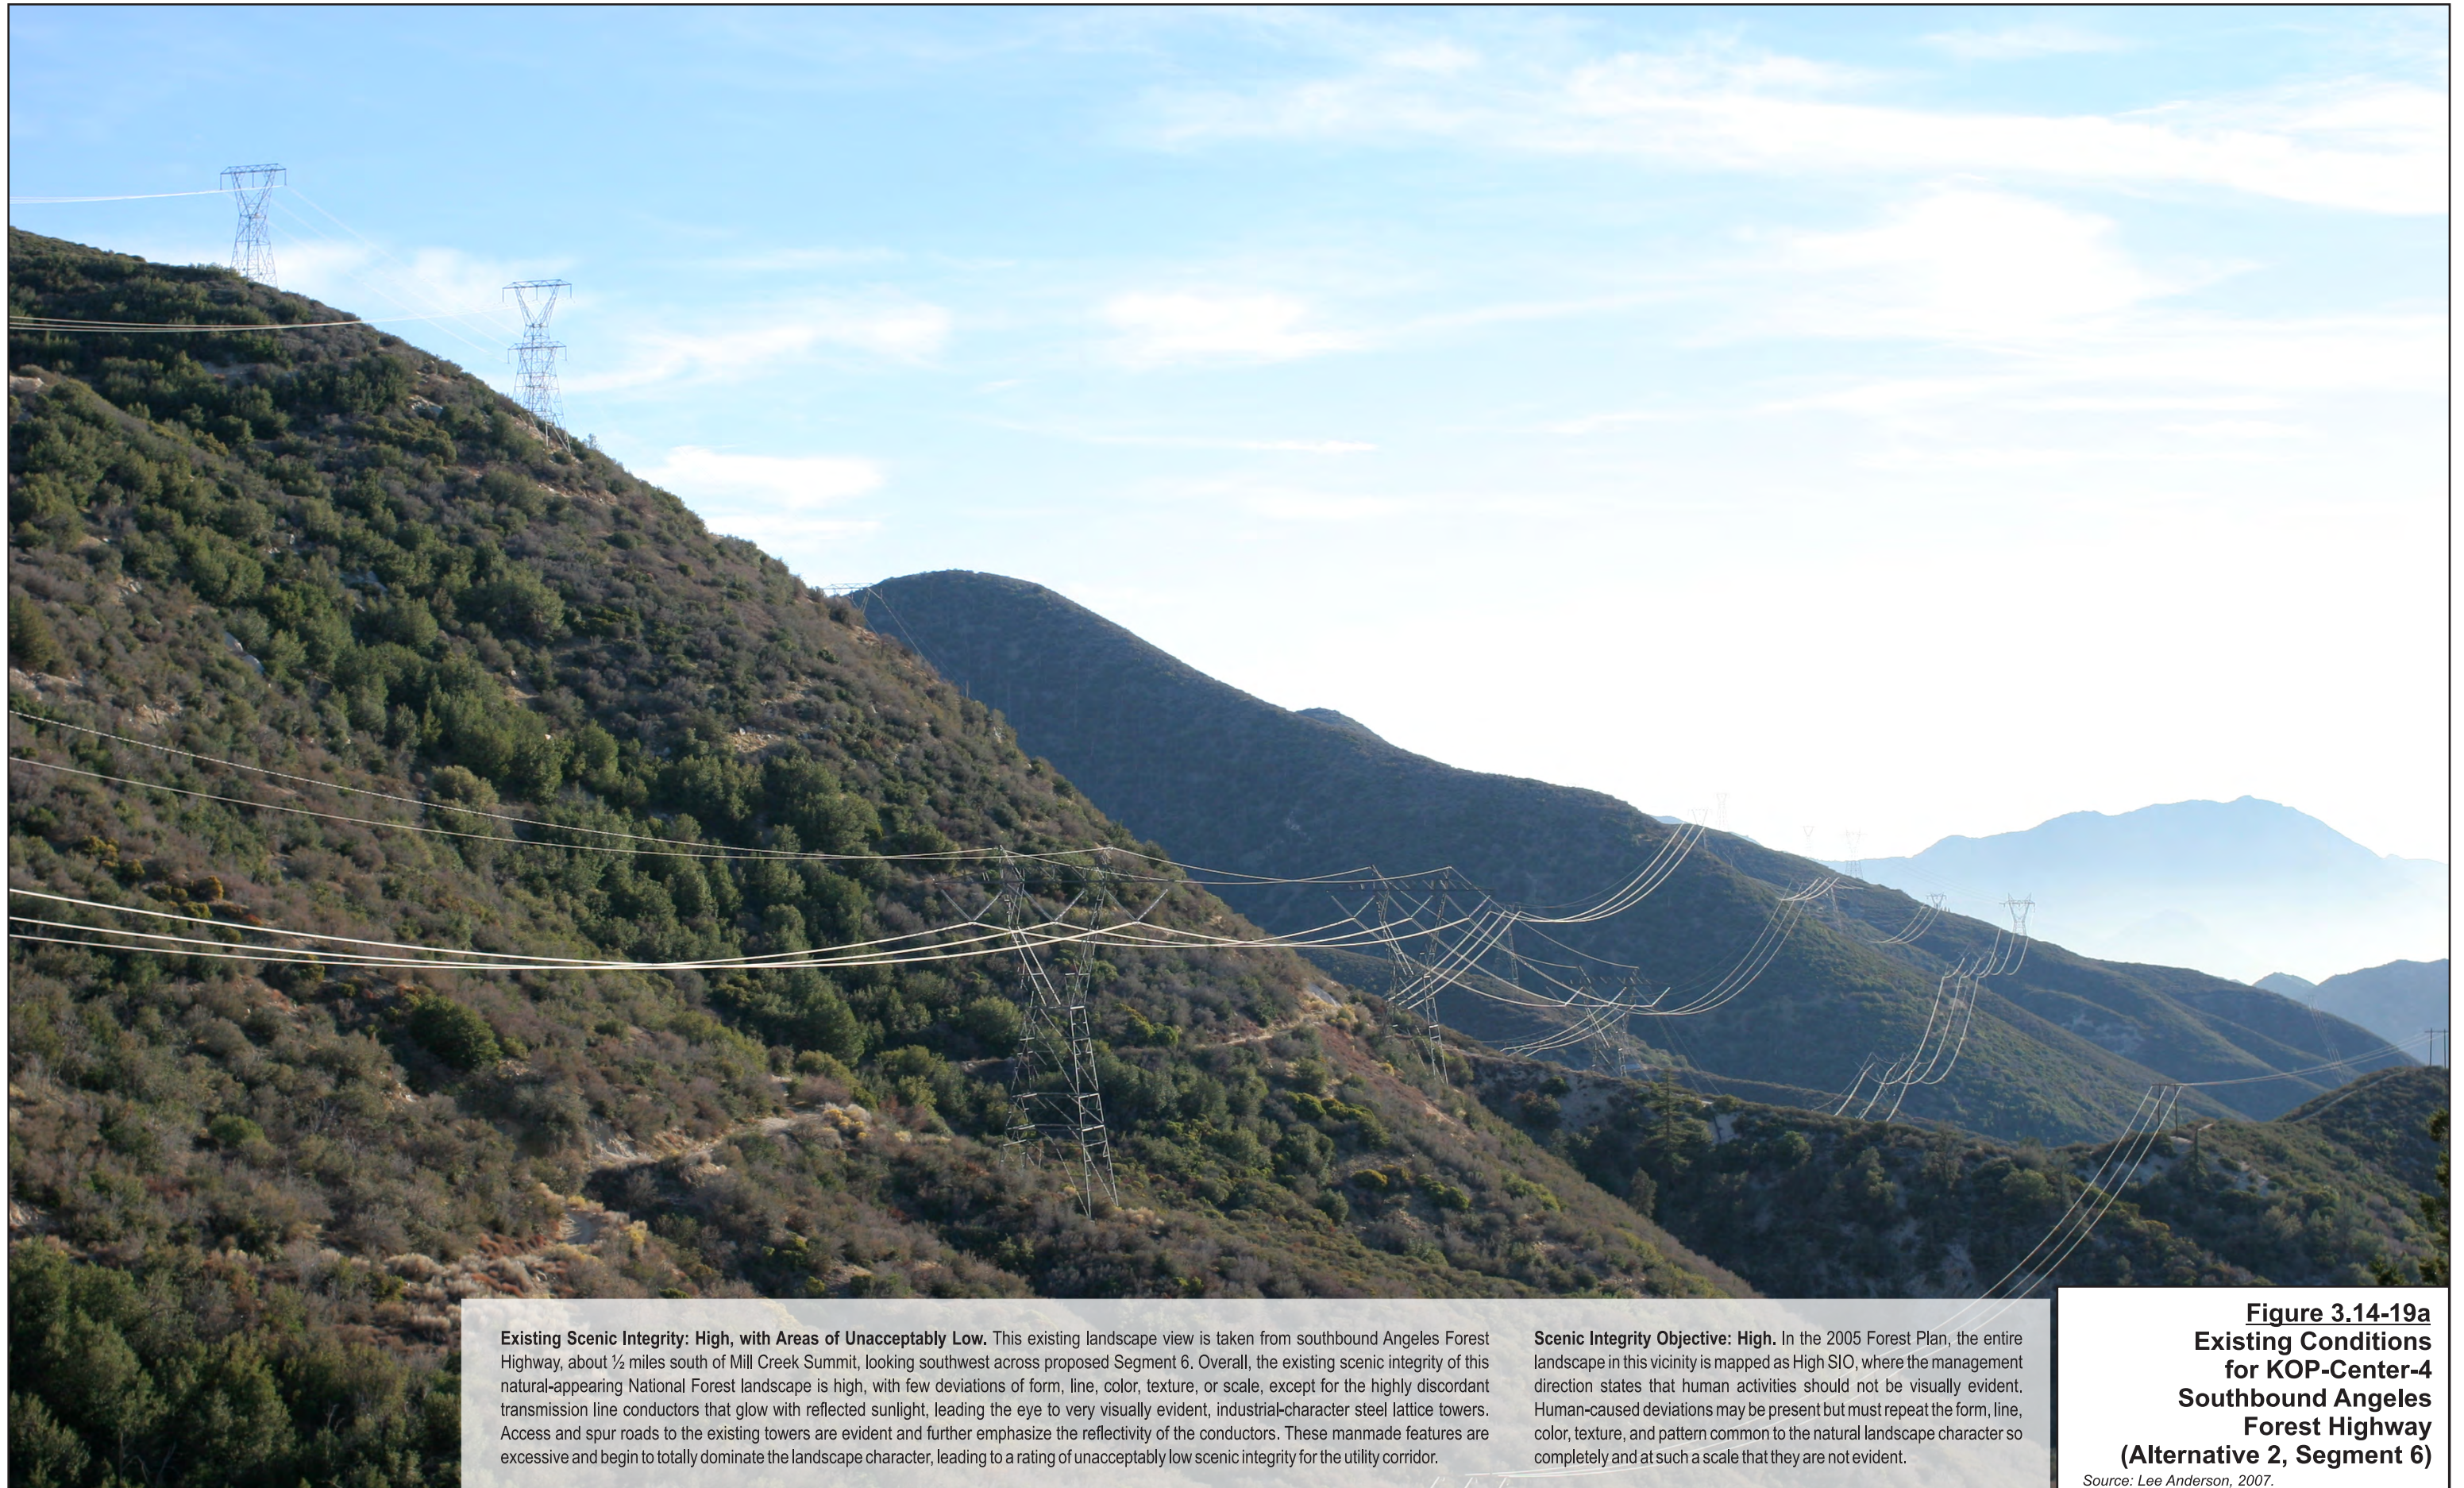
**Existing Scenic Integrity: High, with Areas of Unacceptably Low.** This existing landscape view is taken from southbound Angeles Forest Highway, about ½ miles south of Mill Creek Summit, looking southwest across proposed Segment 6. Overall, the existing scenic integrity of this natural-appearing National Forest landscape is high, with few deviations of form, line, color, texture, or scale, except for the highly discordant transmission line conductors that glow with reflected sunlight, leading the eye to very visually evident, industrial-character steel lattice towers. Access and spur roads to the existing towers are evident and further emphasize the reflectivity of the conductors. These manmade features are excessive and begin to totally dominate the landscape character, leading to a rating of unacceptably low scenic integrity for the utility corridor.

**Scenic Integrity Objective: High.** In the 2005 Forest Plan, the entire landscape in this vicinity is mapped as High SIO, where the management direction states that human activities should not be visually evident. Human-caused deviations may be present but must repeat the form, line, color, texture, and pattern common to the natural landscape character so completely and at such a scale that they are not evident.
