Figure 3.14-66a
Existing Conditions
for KOP-Center-3
Mount Gleason Road
(Alternative 6, Segment 6)

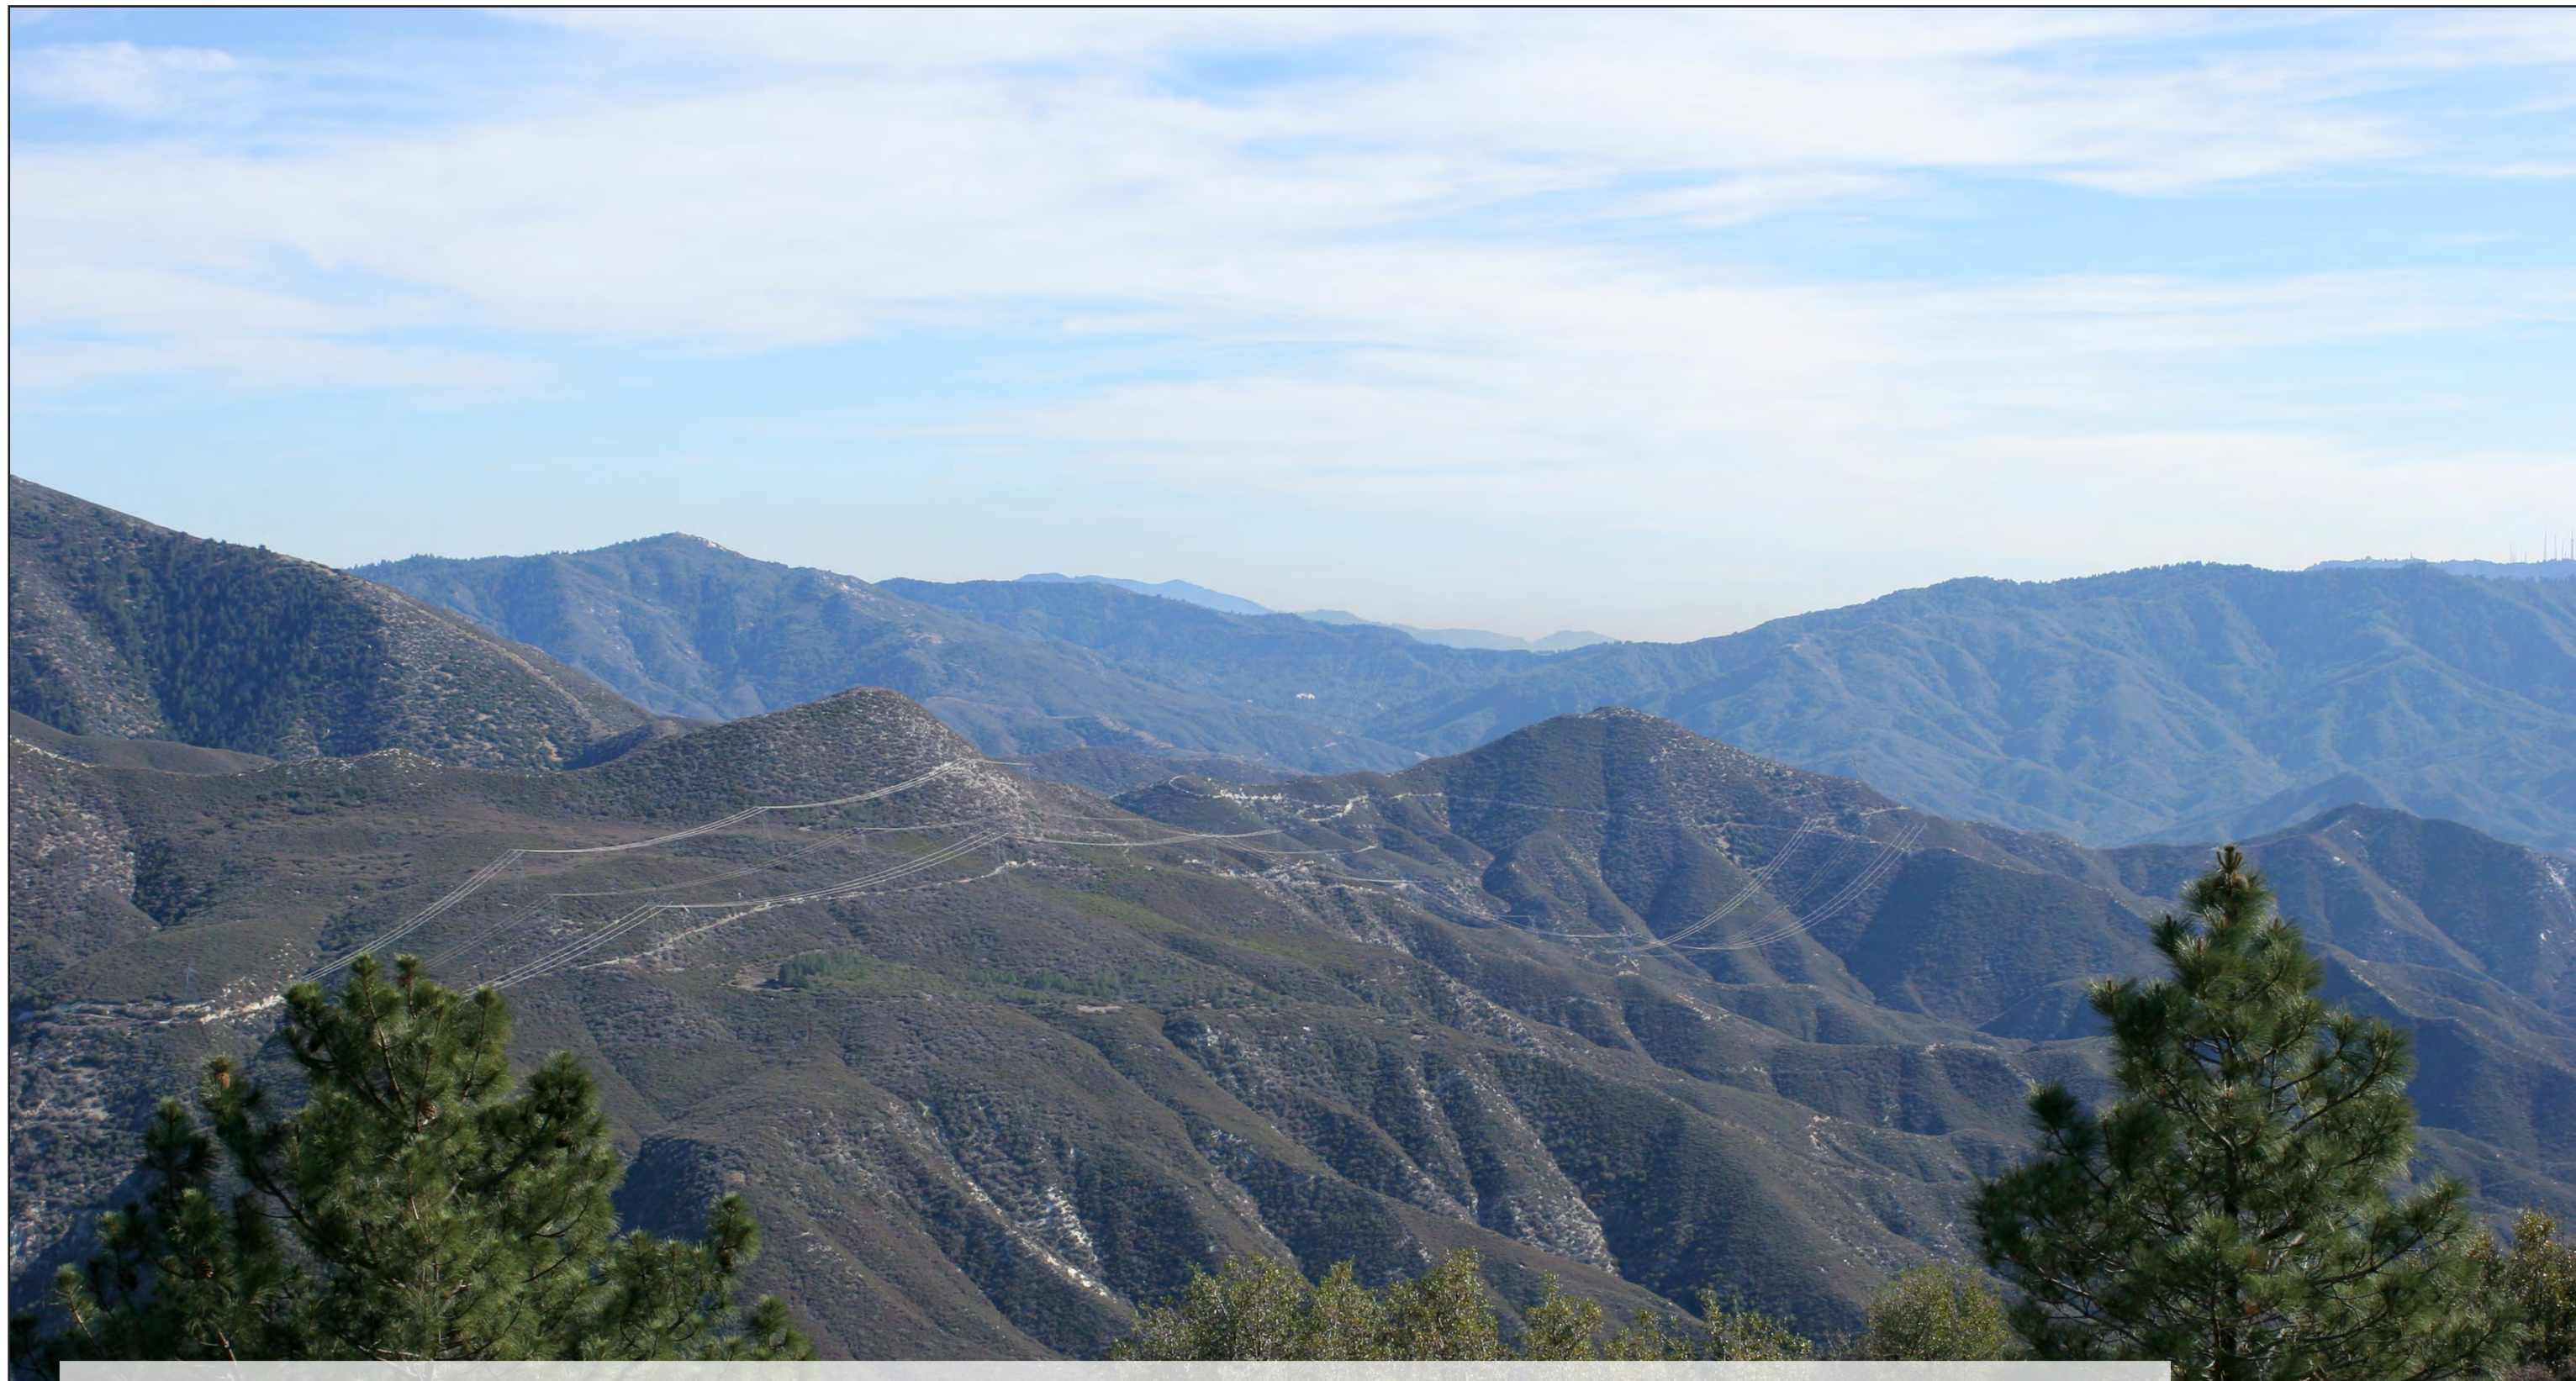
Existing Scenic Integrity: High, with Areas of Very Low. This existing landscape view is from the Mount Gleason Road, about three miles west of Mill Creek Summit, looking southeast down toward Segment 6. The PCT, west of Mill Creek Summit, shares much of this same viewshed. The landscape visible from Mount Gleason Road is predominantly natural-appearing, consisting of foreground, middleground, and background landscapes with dense, dark green chamise and chaparral covered mountainsides. There is very little vegetative pattern in this landscape and the sun angle and shadows emphasize the ruggedness of the steep slopes and broken terrain. The natural landscape has a coherent form and character with substantial visual variety created by the rugged, folded terrain. The natural landscape exhibits a high degree of intactness and scenic integrity, except for the highly discordant transmission line conductors that glow with reflected sunlight, leading the eye to the almost transparent, industrial-character steel lattice towers. Access and spur roads to the existing towers are visually evident and further emphasize the reflectivity of the conductors, causing the valued landscape character to appear heavily altered. This leads to a rating of very low scenic integrity for the utility corridor.

Scenic Integrity Objective: High. In the 2005 Forest Plan, the entire landscape in this vicinity is mapped as High SIO, where the management direction states that human activities should not be visually evident. Human-caused deviations may be present but must repeat the form, line, color, texture, and pattern common to the natural landscape character so completely and at such a scale that they are not evident.
