Figure 3.14-68a
Existing Conditions
for KOP-Center-5
Northbound Angeles
Forest Highway
(Alternative 6, Segment 6)

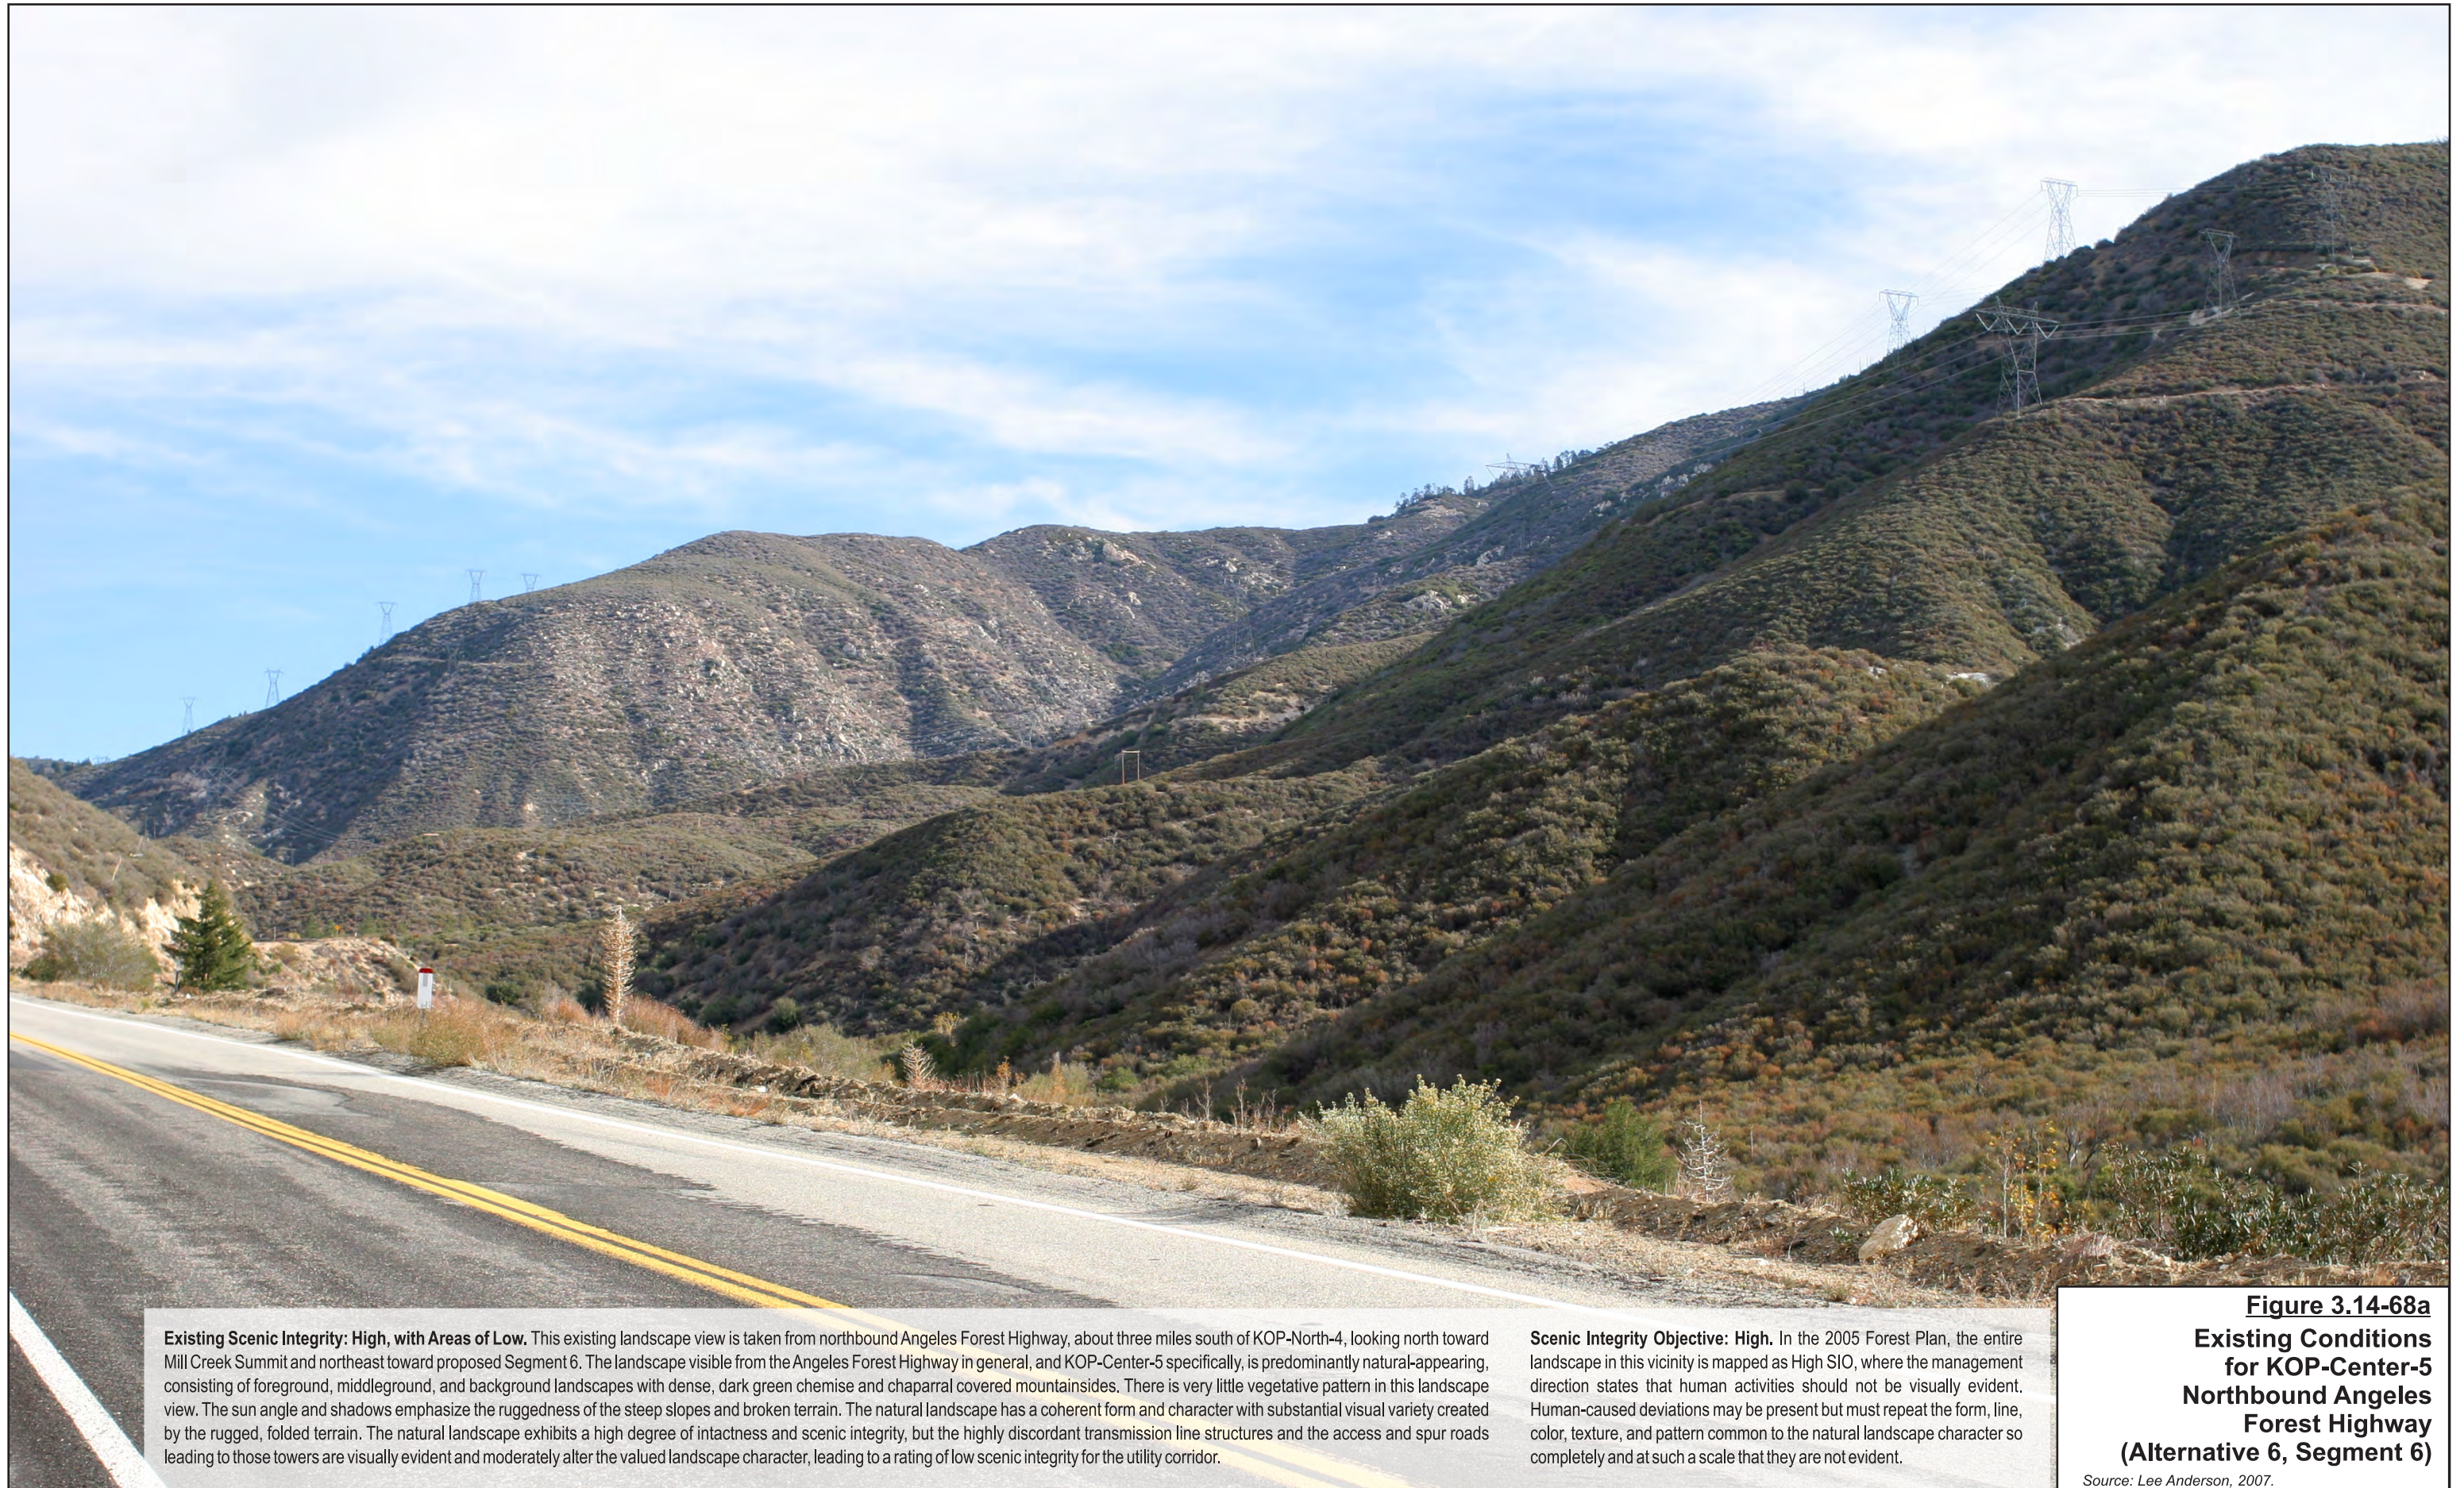
Existing Scenic Integrity: High, with Areas of Low. This existing landscape view is taken from northbound Angeles Forest Highway, about three miles south of KOP-North-4, looking north toward Mill Creek Summit and northeast toward proposed Segment 6. The landscape visible from the Angeles Forest Highway in general, and KOP-Center-5 specifically, is predominantly natural-appearing, consisting of foreground, middleground, and background landscapes with dense, dark green chemise and chaparral covered mountainsides. There is very little vegetative pattern in this landscape view. The sun angle and shadows emphasize the ruggedness of the steep slopes and broken terrain. The natural landscape has a coherent form and character with substantial visual variety created by the rugged, folded terrain. The natural landscape exhibits a high degree of intactness and scenic integrity, but the highly discordant transmission line structures and the access and spur roads leading to those towers are visually evident and moderately alter the valued landscape character, leading to a rating of low scenic integrity for the utility corridor.

Scenic Integrity Objective: High. In the 2005 Forest Plan, the entire landscape in this vicinity is mapped as High SIO, where the management direction states that human activities should not be visually evident. Human-caused deviations may be present but must repeat the form, line, color, texture, and pattern common to the natural landscape character so completely and at such a scale that they are not evident.
