**Appendix 3-J**  
Preliminary Geotechnical Assessment – Burns & McDonnell

## Preliminary Geotechnical Narrative

Project: SoCalGas Ventura Compressor Modernization – Site Alternatives Assessment

Site: Ventura Steel

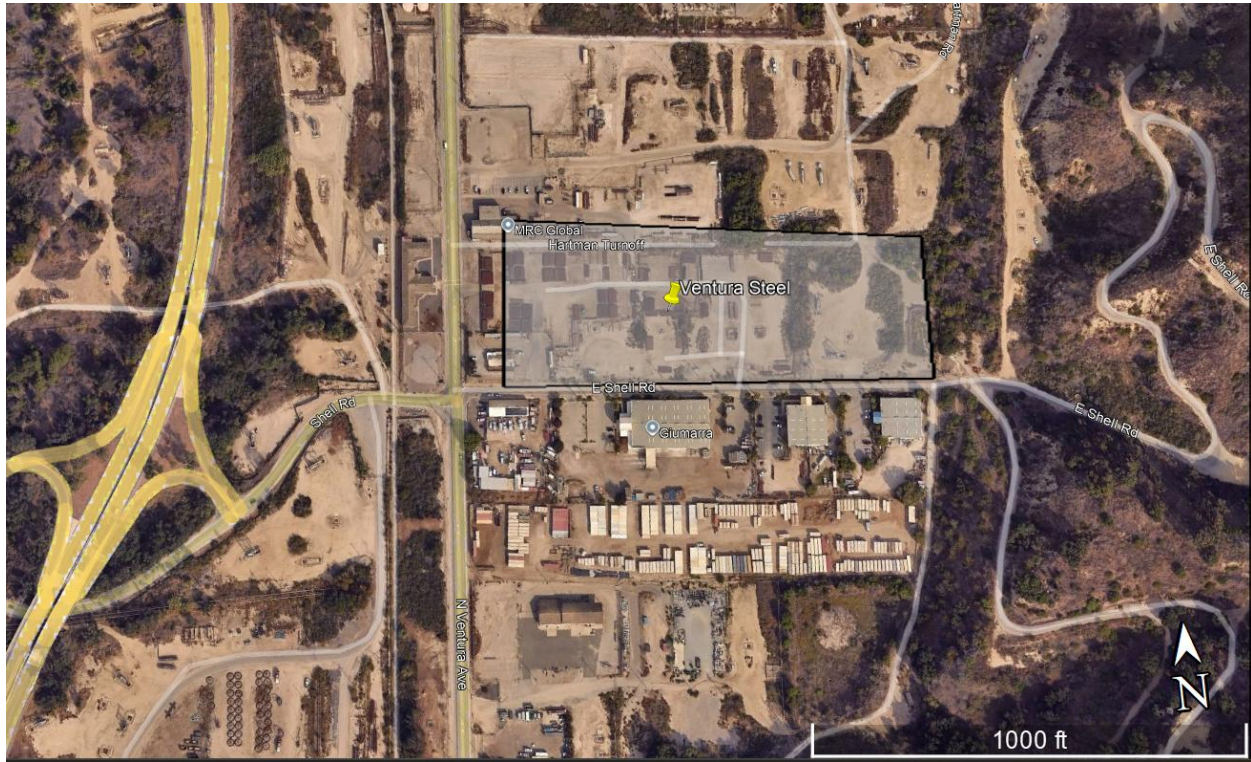
The Ventura Steel site is located approximately 7000-feet north of the existing Ventura Compressor Station on the east side of the SR-33 corridor in Ventura County, CA. The site is located within an approximately 9-acre brownfield oil extraction area situated within the alluvial valley of the Ventura River. The site is relatively flat and is bounded by North Ventura Avenue to the west, East Shell Rd to the south, and foothills containing active oil fields to the east. An aerial image of the proposed site is presented in Figure 1.

Figure 1: Aerial Image of the Ventura Steel Site (Google Earth, 2025)
