### GEOTECHNICAL INVESTIGATION FOR SALT CREEK SUBSTATION PROPONENT'S ENVIRONMENTAL ASSESSMENT (PEA)

Prepared by Geosyntec Consultants 10875 Rancho Bernardo Road, Suite 200 San Diego, CA 92127

# GEOTECHNICAL INVESTIGATION 69KV TRANSMISSION LINE TL6965 SALT CREEK SUBSTATION TO MIGUEL SUBSTATION CHULA VISTA, CALIFORNIA

22 August 2012

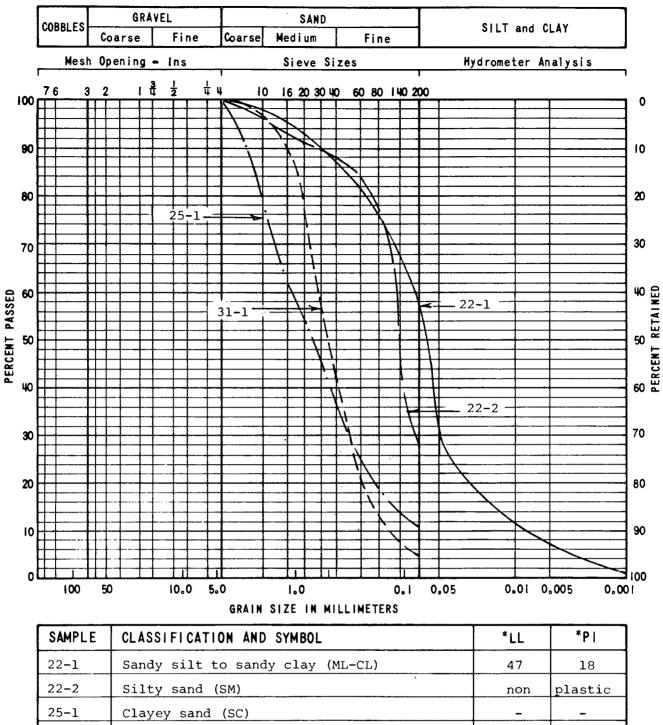
GR	AIN SIZE DISTRIBUTION C	URVES	
	MIGUEL -	MEXICO 230 KV TRANSMIS	SION LINE	
DRAWN BY: ch	CHECKED BY:	PROJECT NO: 51157S-SIO3	DATE: 10-16-81	FIGURE NO: A-

22-1	Sandy silt to sandy clay (ML-CL)	4 /	18
22-2	Silty sand (SM)	non	plastic
25 <b>-</b> 1	Clayey sand (SC)	-	-
31-1	Silty fine to medium sand (SM-SP)	_	_
		· · · · · · · · · · · · · · · · · · ·	<u>.</u>

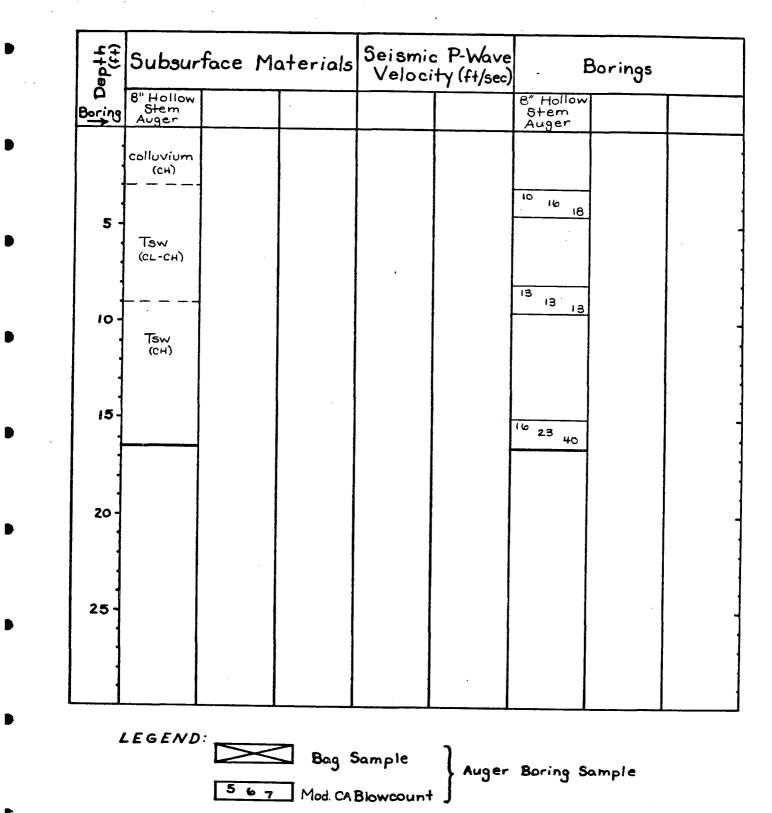
### Tower Site <u>6</u>

# SUBSURFACE INVESTIGATION SUMMARY

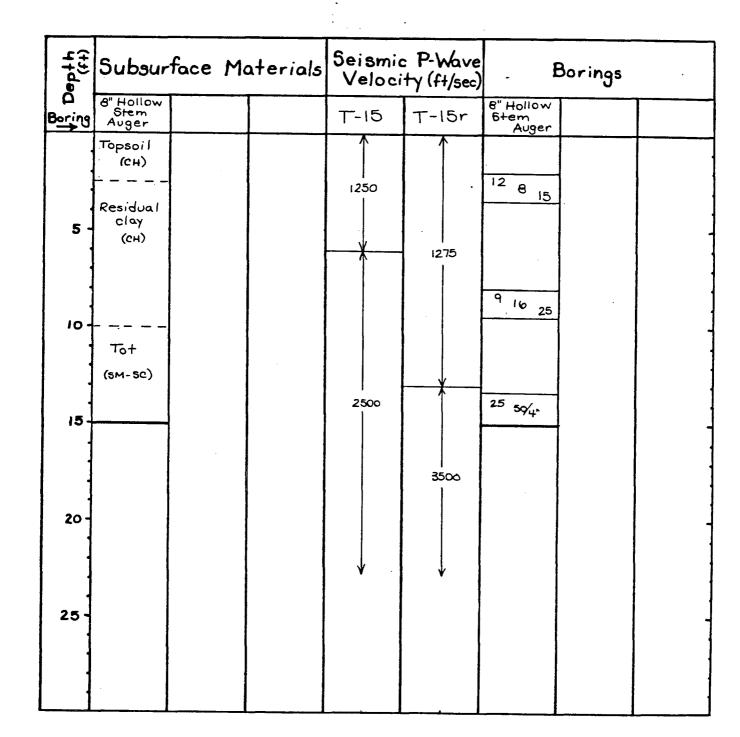
### Tower Site 15

## SUBSURFACE INVESTIGATION SUMMARY
