## **GEOTECHNICAL INVESTIGATION**

**SDG&E TL695 AND TL6971  
WOOD TO STEEL IMPROVEMENTS  
BRADY PROJECT NO. SDGEC1.023.000  
SDG&E IO NO. 200424511  
SAN DIEGO, CALIFORNIA**

**AUGUST 17, 2015  
REVISED SEPTEMBER 10, 2015  
PROJECT NO. G1818-32-05A**

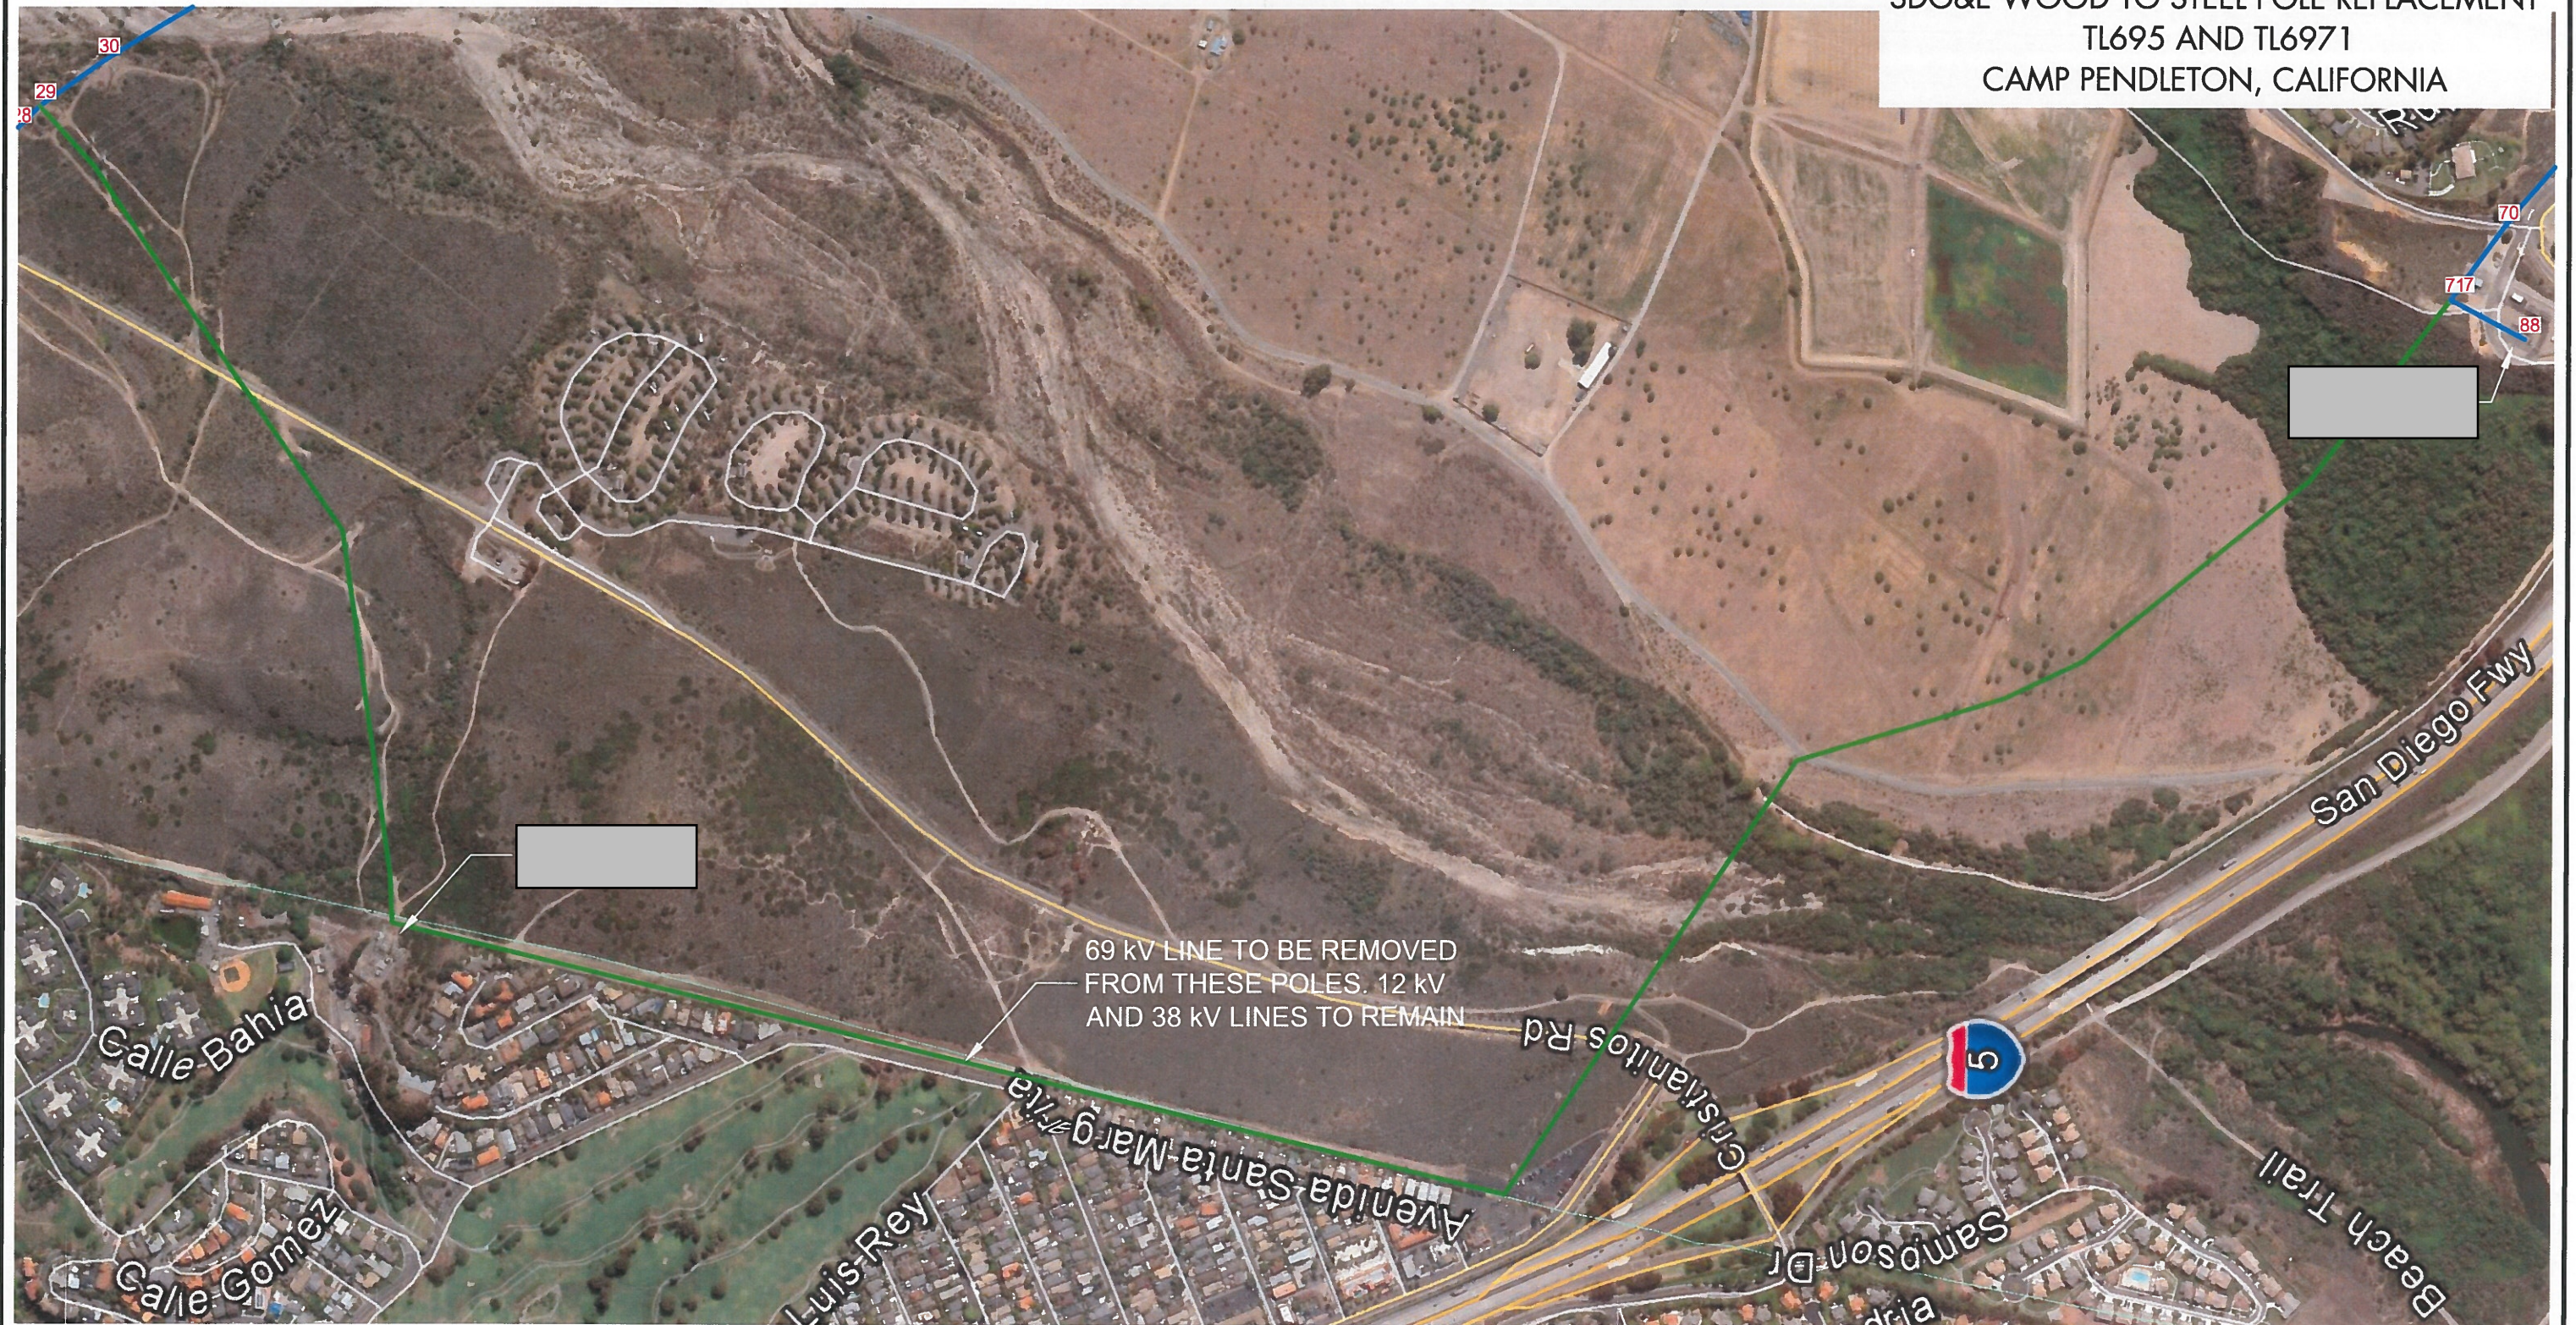
SITE PLAN

**GEOCON**  
INCORPORATED  
GEOTECHNICAL ■ ENVIRONMENTAL ■ MATERIALS  
6960 FLANDERS DRIVE - SAN DIEGO, CALIFORNIA 92121 - 2974  
PHONE 858 558-6900 - FAX 858 558-6159  
PROJECT NO. G1818 - 32 - 05A  
FIGURE 12  
DATE 09 - 10 - 2015

Figure 1, Vicinity Map  
Figure 2, Site Plan Index  
Figures 3 to 12, Site Plans  
Figure 13, Regional Geologic Map  
Figure 14, Geologic Map Index  
Figures 15 – 21, Geologic Maps

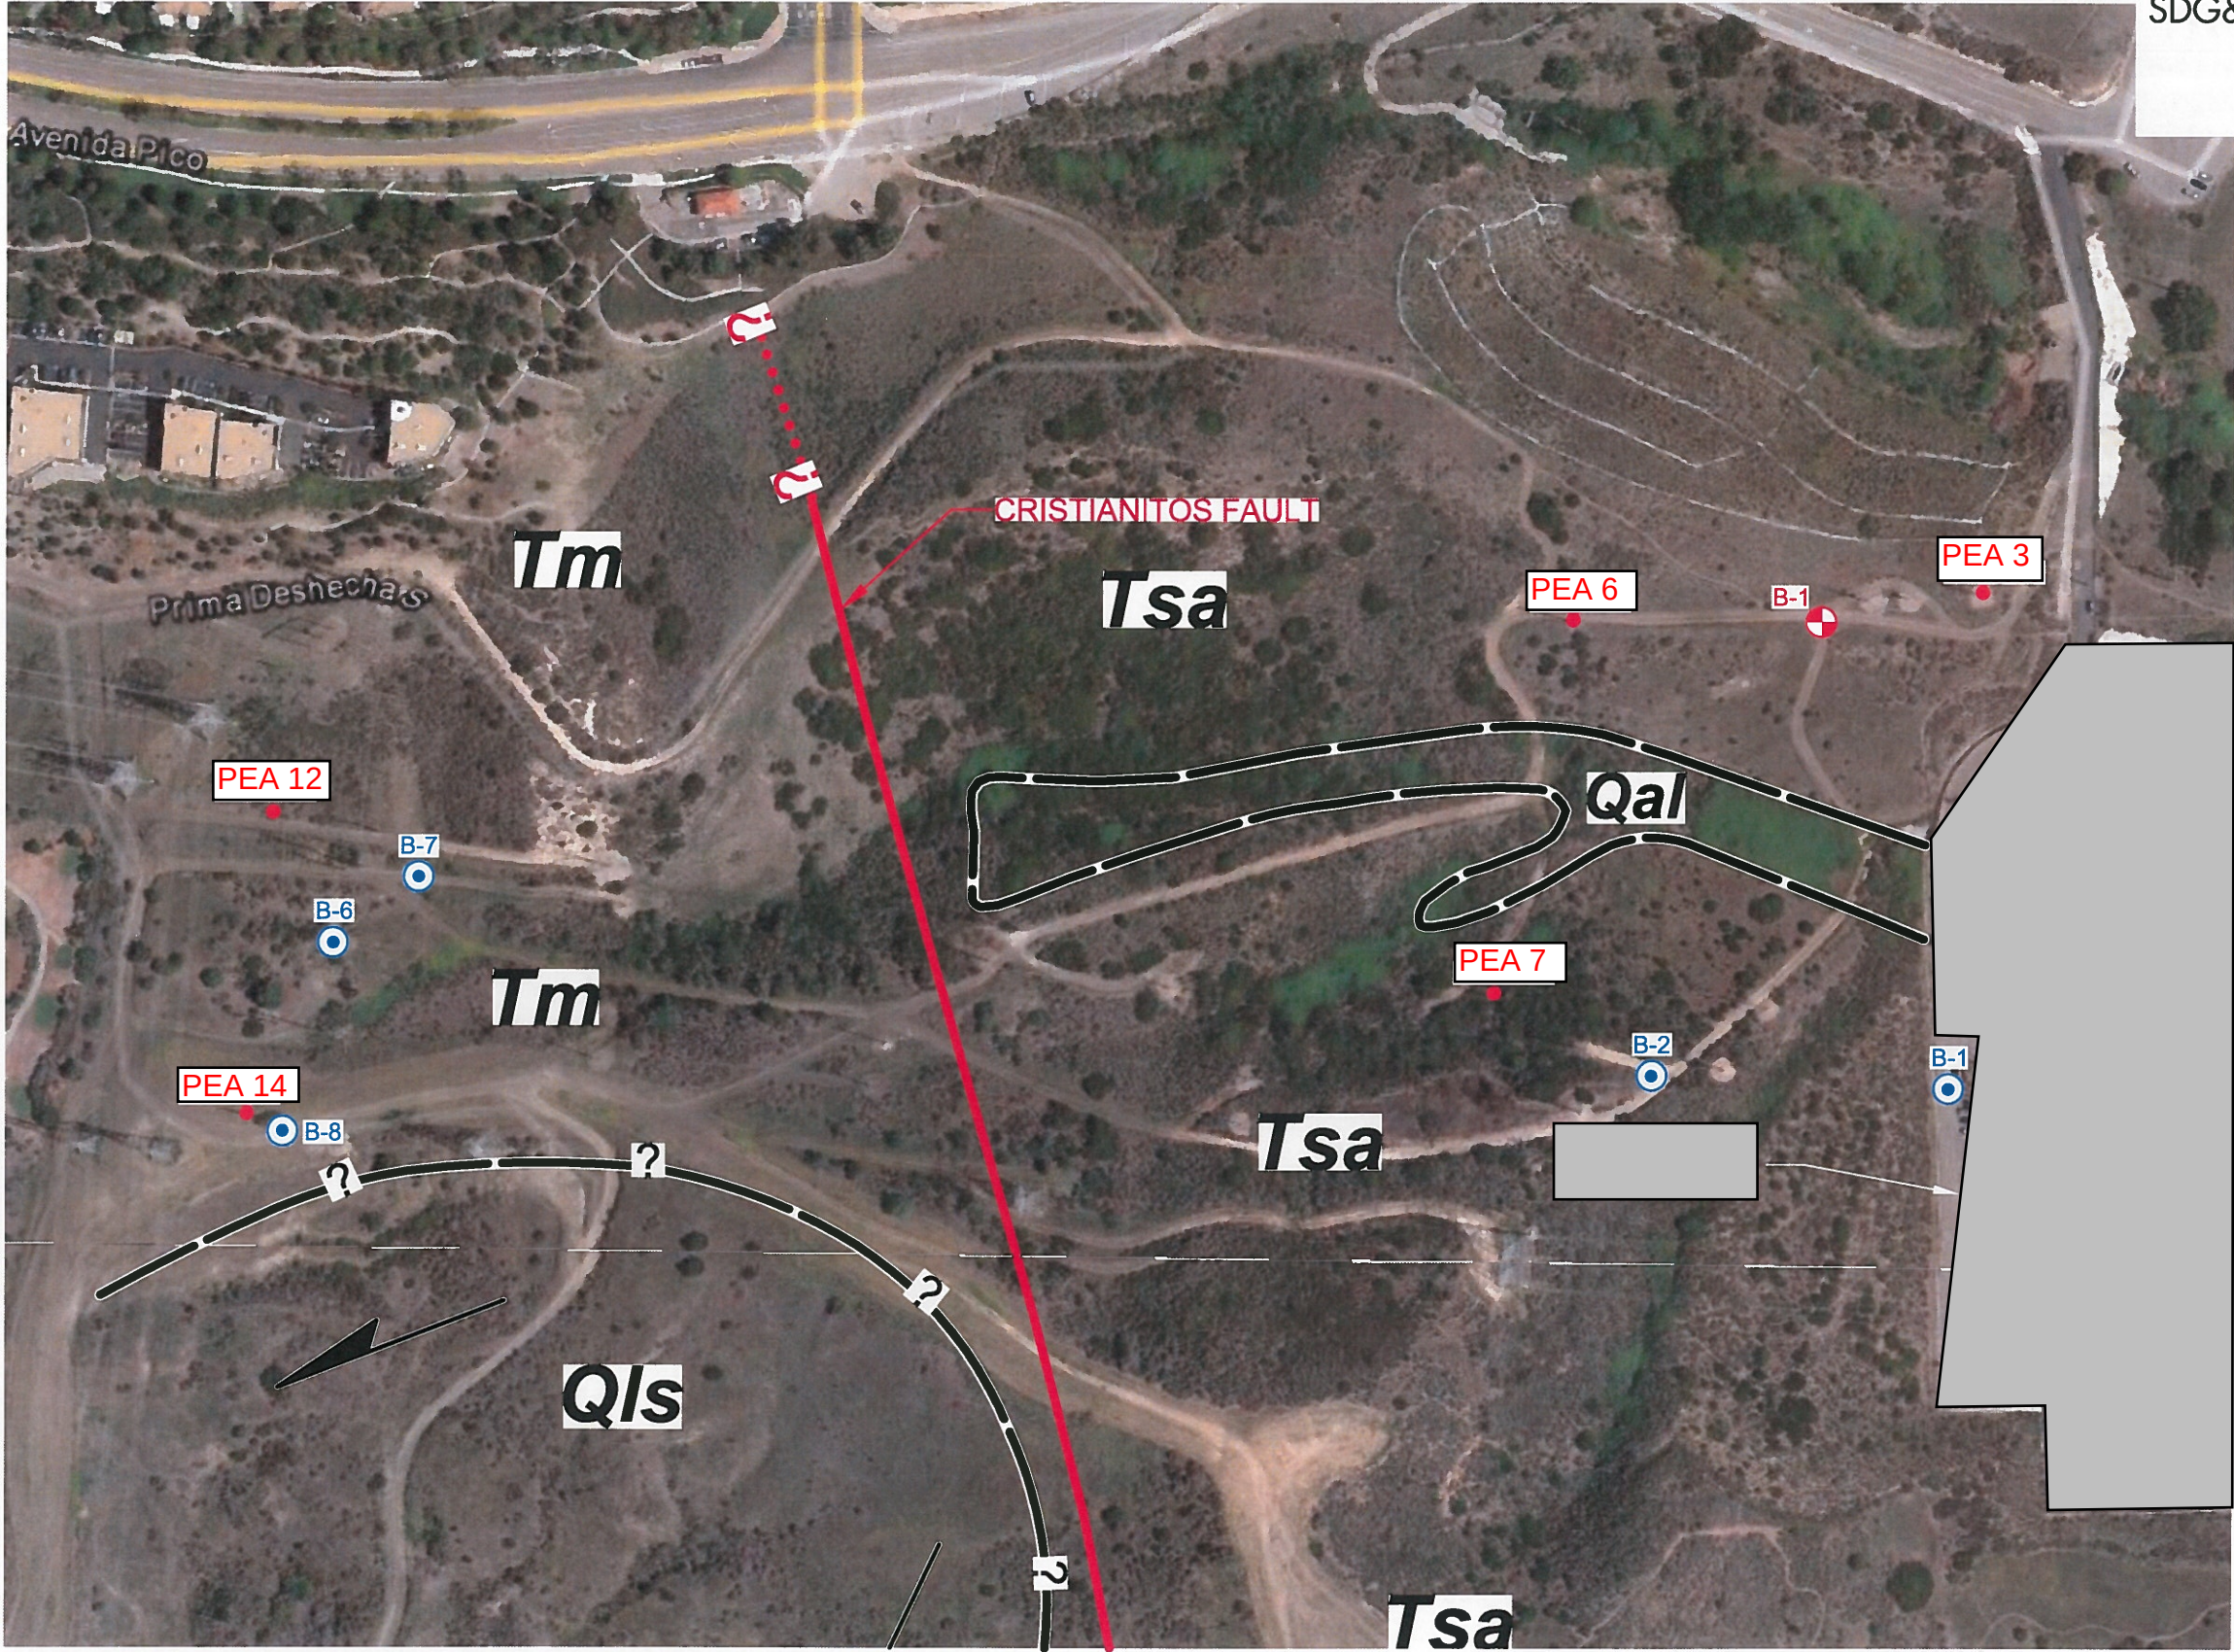
GEOLOGIC MAP

- Z171179 .....SDG&E ANGLE POLE LOCATION AND NUMBER
- B-14 .....APPROX. LOCATION OF EXPLORATORY BORING (THIS INVESTIGATION)
- B-8 .....APPROX. LOCATION OF EXPLORATORY BORING (Geocon Inc. 10-29-2009)
- B-3 .....APPROX. LOCATION OF EXPLORATORY BORING (Geocon Inc. 09-10-2012)
- B-3 .....APPROX. LOCATION OF EXPLORATORY BORING (URS 05-02-2012)
- B-4 .....APPROX. LOCATION OF EXPLORATORY BORING (Leighton & Assoc. 06-17-2011)
- Qal .....ALLUVIUM
- Qls .....LANDSLIDE DEPOSITS
- Qoa .....OLD ALLUVIAL FLOOD-PLAIN DEPOSITS
- Qop .....OLD PARALIC DEPOSITS
- Tcs .....CAPISTRANO FORMATION
- Tsm .....SAN MATEO FORMATION
- Tm .....MONTEREY FORMATION
- Tsa .....SANTIAGO FORMATION
- .....APPROX. LOCATION OF GEOLOGIC CONTACT (Queried Where Uncertain)
- .....APPROX. LOCATION OF INACTIVE FAULT (Dotted Where Buried; Queried Where Uncertain)

**GEOCON**  
INCORPORATED  
GEOTECHNICAL ■ ENVIRONMENTAL ■ MATERIALS  
6960 FLANDERS DRIVE - SAN DIEGO, CALIFORNIA 92121 - 2974  
PHONE 858 558-6900 - FAX 858 558-6159  
PROJECT NO. G1818 - 32 - 05A  
FIGURE 15  
DATE 09 - 10 - 2015

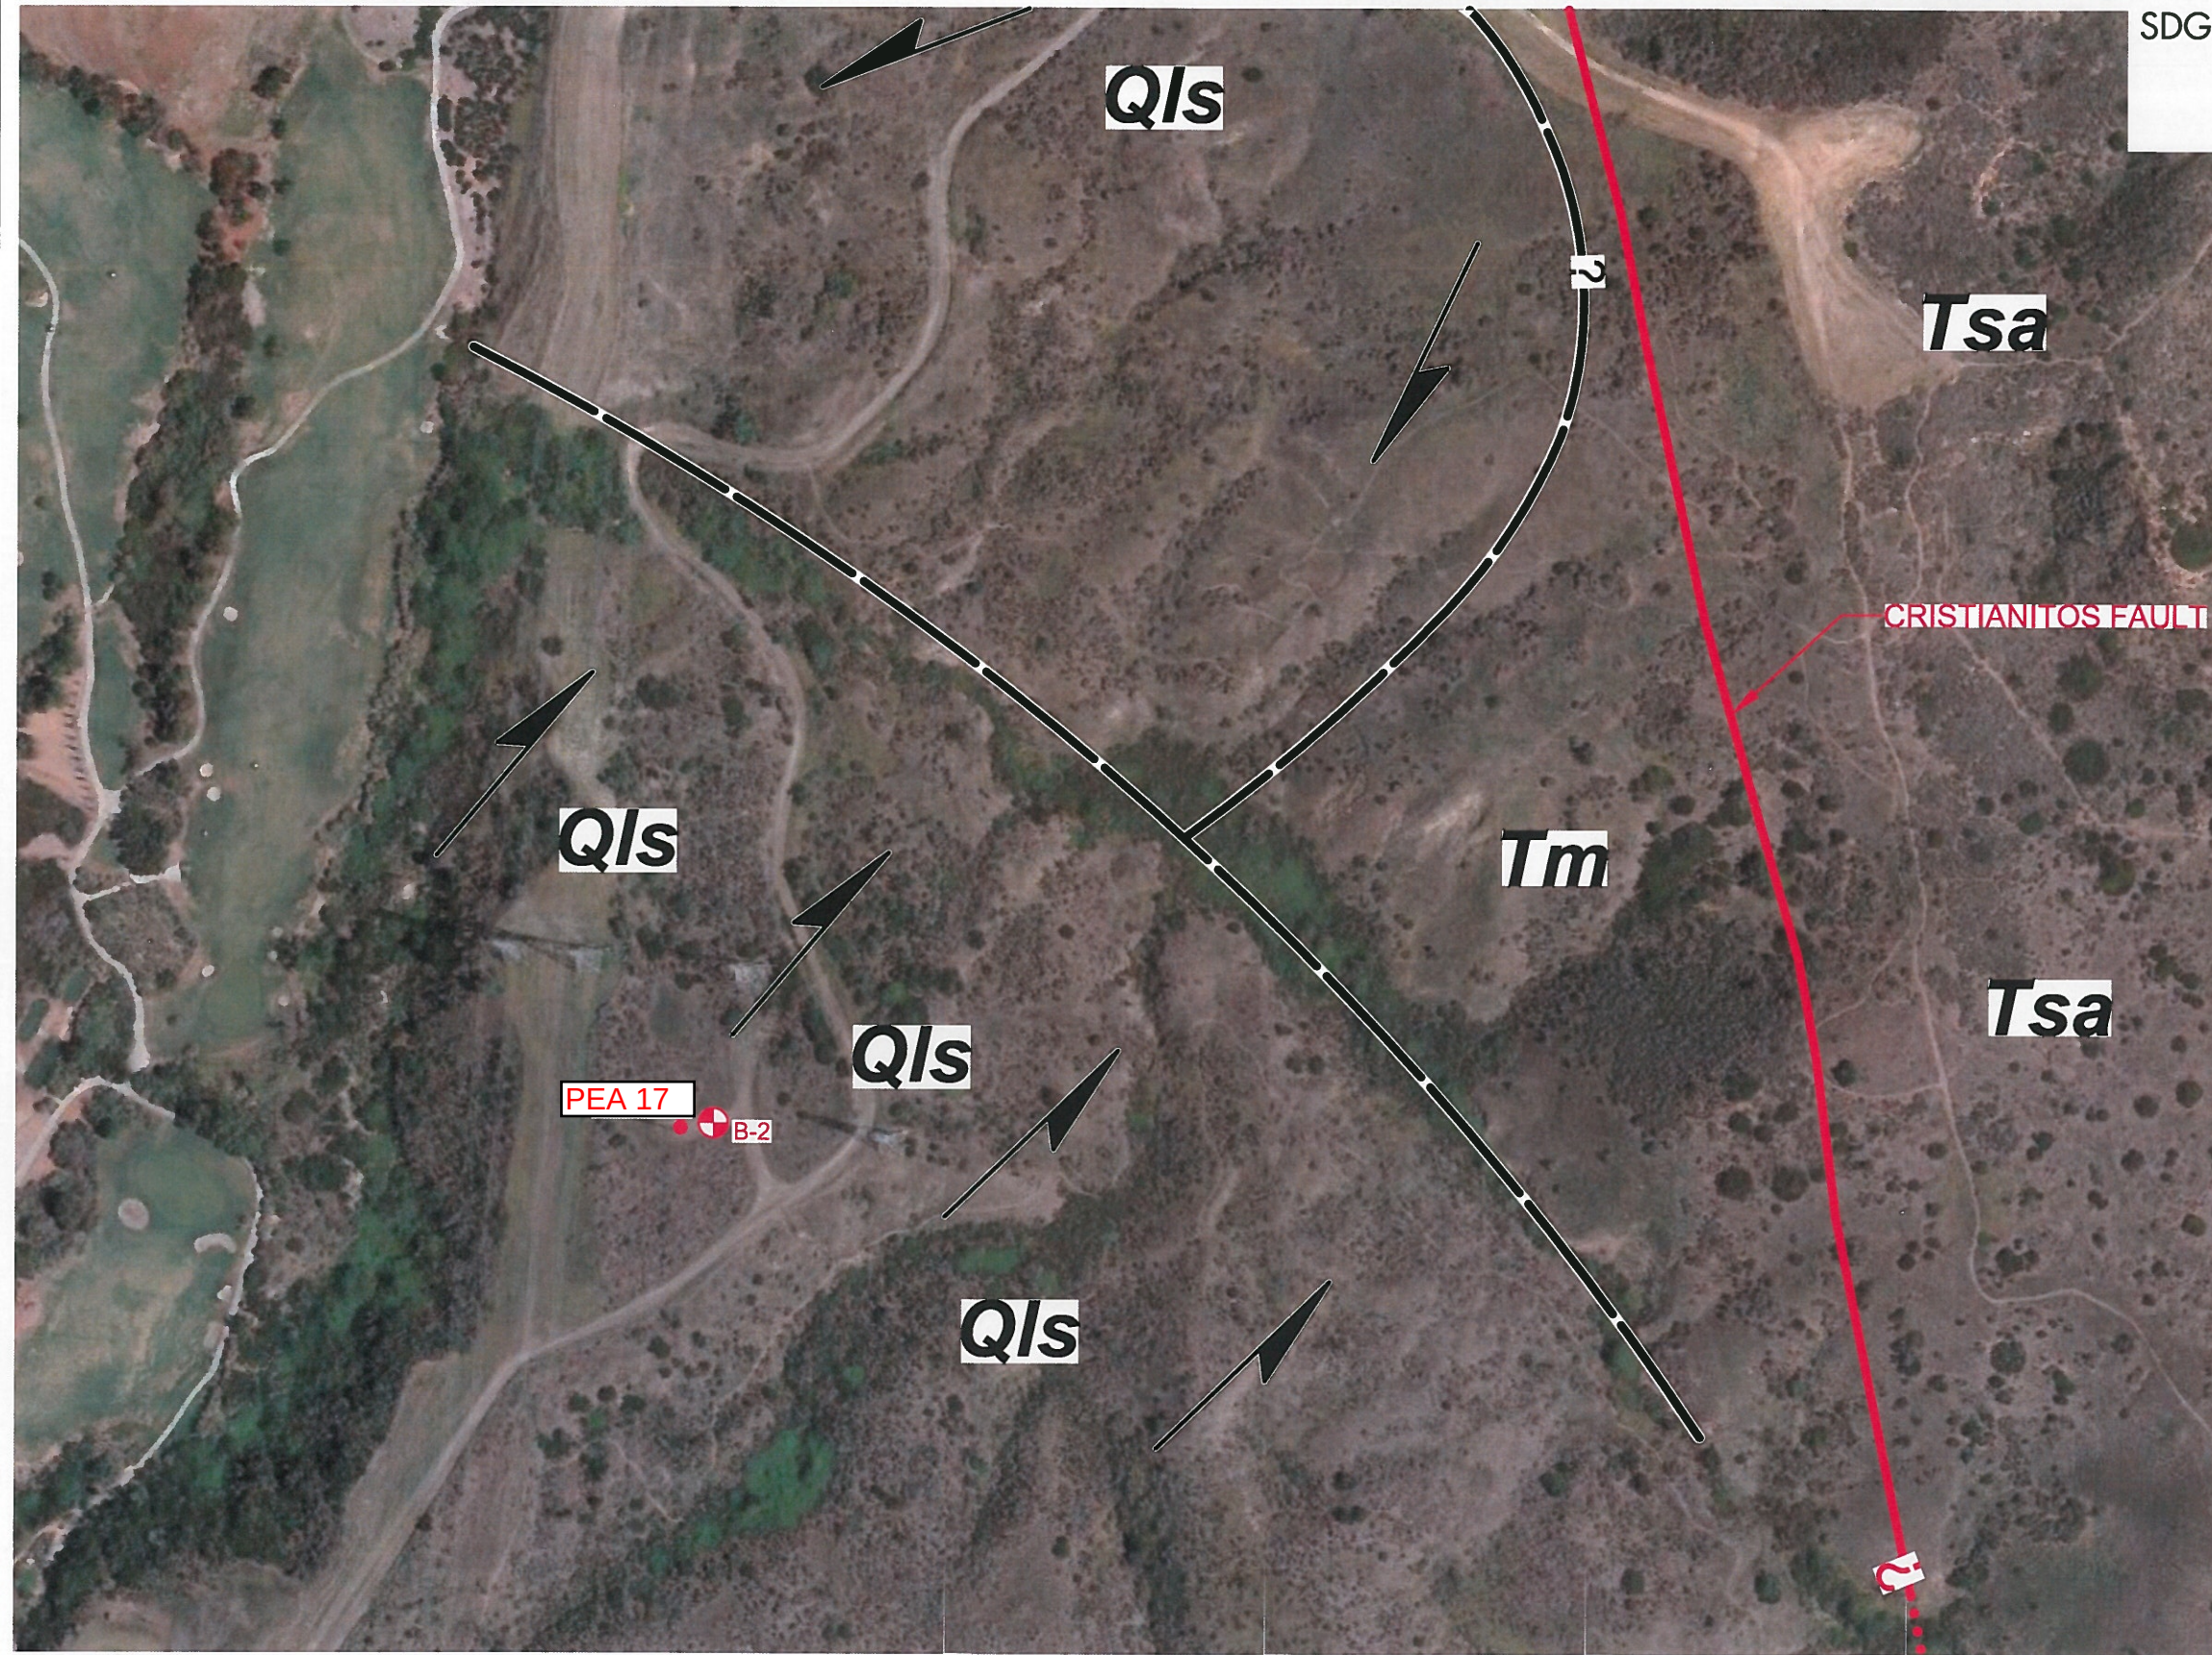
GEOLOGIC MAP

- Z171179 .....SDG&E ANGLE POLE LOCATION AND NUMBER
- ⊕ B-14 .....APPROX. LOCATION OF EXPLORATORY BORING (THIS INVESTIGATION)
- ⊕ B-8 .....APPROX. LOCATION OF EXPLORATORY BORING (Geocon Inc. 10-29-2009)
- ⊕ B-3 .....APPROX. LOCATION OF EXPLORATORY BORING (Geocon Inc. 09-10-2012)
- ⊕ B-3 .....APPROX. LOCATION OF EXPLORATORY BORING (URS 05-02-2012)
- ⊕ B-4 .....APPROX. LOCATION OF EXPLORATORY BORING (Leighton & Assoc. 06-17-2011)
- Qal** .....ALLUVIUM
- Qls** .....LANDSLIDE DEPOSITS
- Qoa** .....OLD ALLUVIAL FLOOD-PLAIN DEPOSITS
- Qop** .....OLD PARALIC DEPOSITS
- Tcs** .....CAPISTRANO FORMATION
- Tsm** .....SAN MATEO FORMATION
- Tm** .....MONTEREY FORMATION
- Tsa** .....SANTIAGO FORMATION
- ~? .....APPROX. LOCATION OF GEOLOGIC CONTACT (Queried Where Uncertain)
- ? .....APPROX. LOCATION OF INACTIVE FAULT (Dotted Where Buried; Queried Where Uncertain)

**GEOCON**  
INCORPORATED  
GEOTECHNICAL ■ ENVIRONMENTAL ■ MATERIALS  
6960 FLANDERS DRIVE - SAN DIEGO, CALIFORNIA 92121 - 2974  
PHONE 858 558-6900 - FAX 858 558-6159  
PROJECT NO. G1818-32-05A  
FIGURE 16  
DATE 09-10-2015

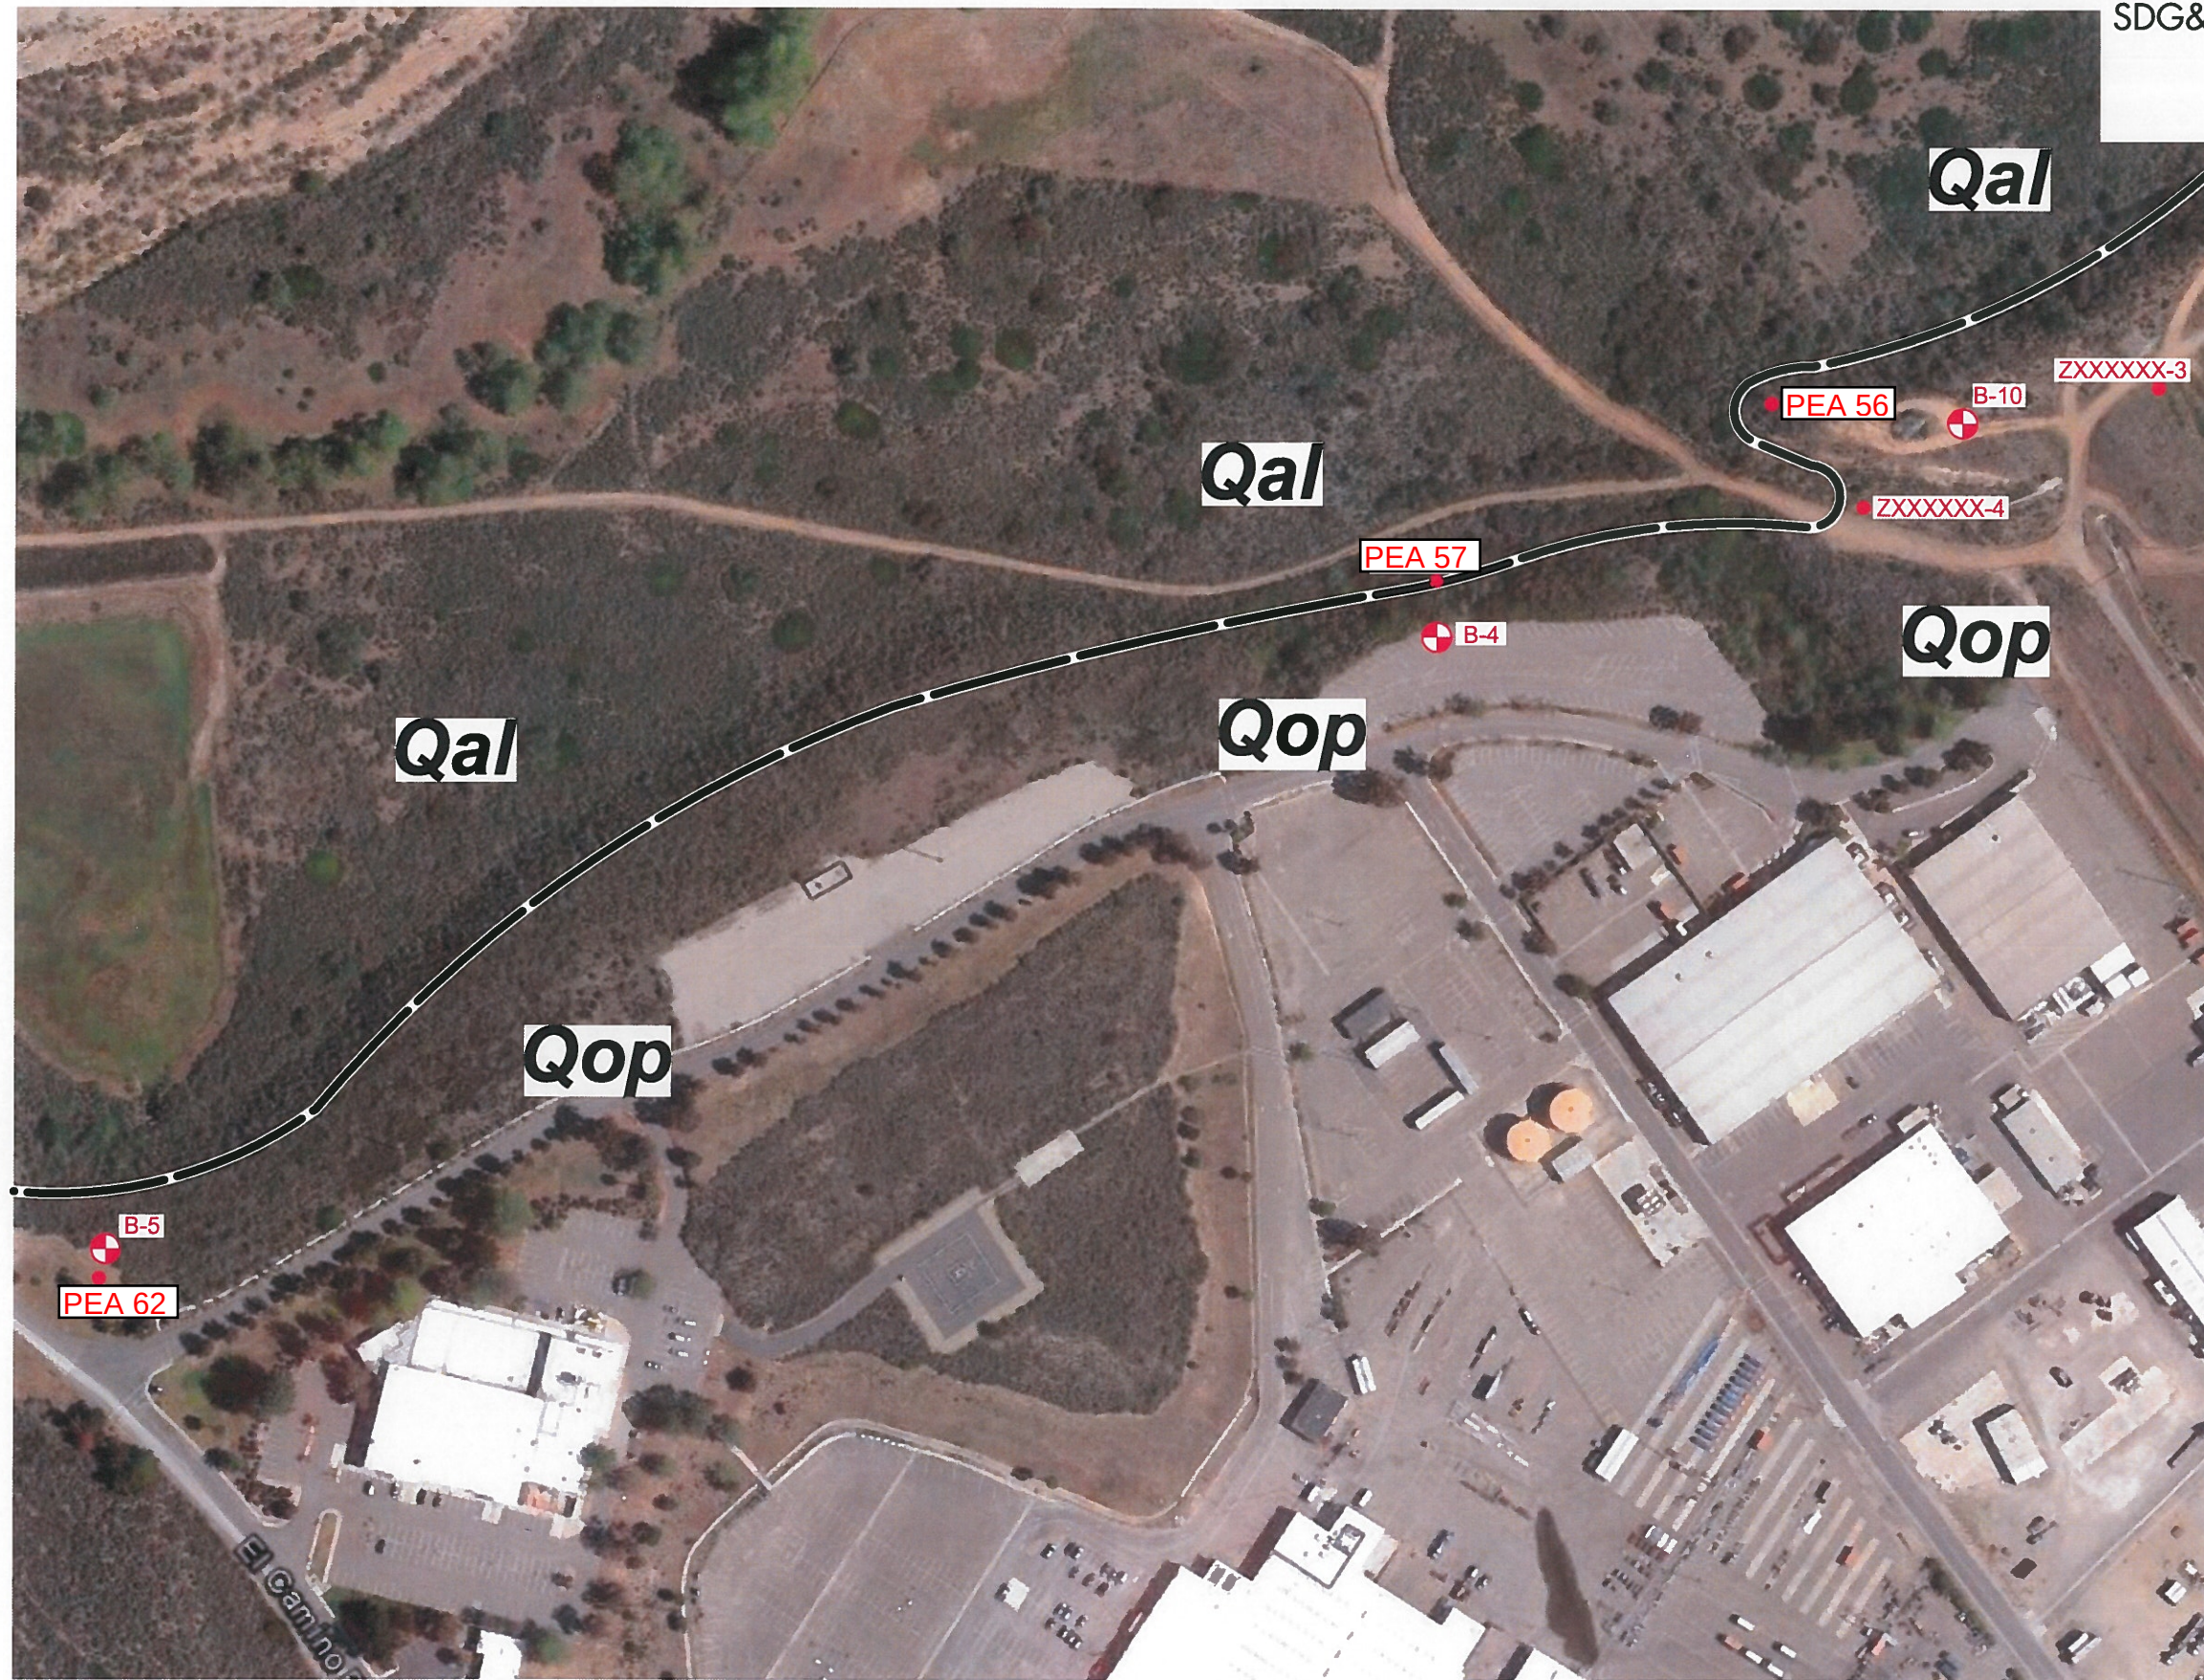
GEOLOGIC MAP

SDG&E WOOD TO STEEL POLE REPLACEMENT  
TL695 AND TL6971  
CAMP PENDLETON, CALIFORNIA

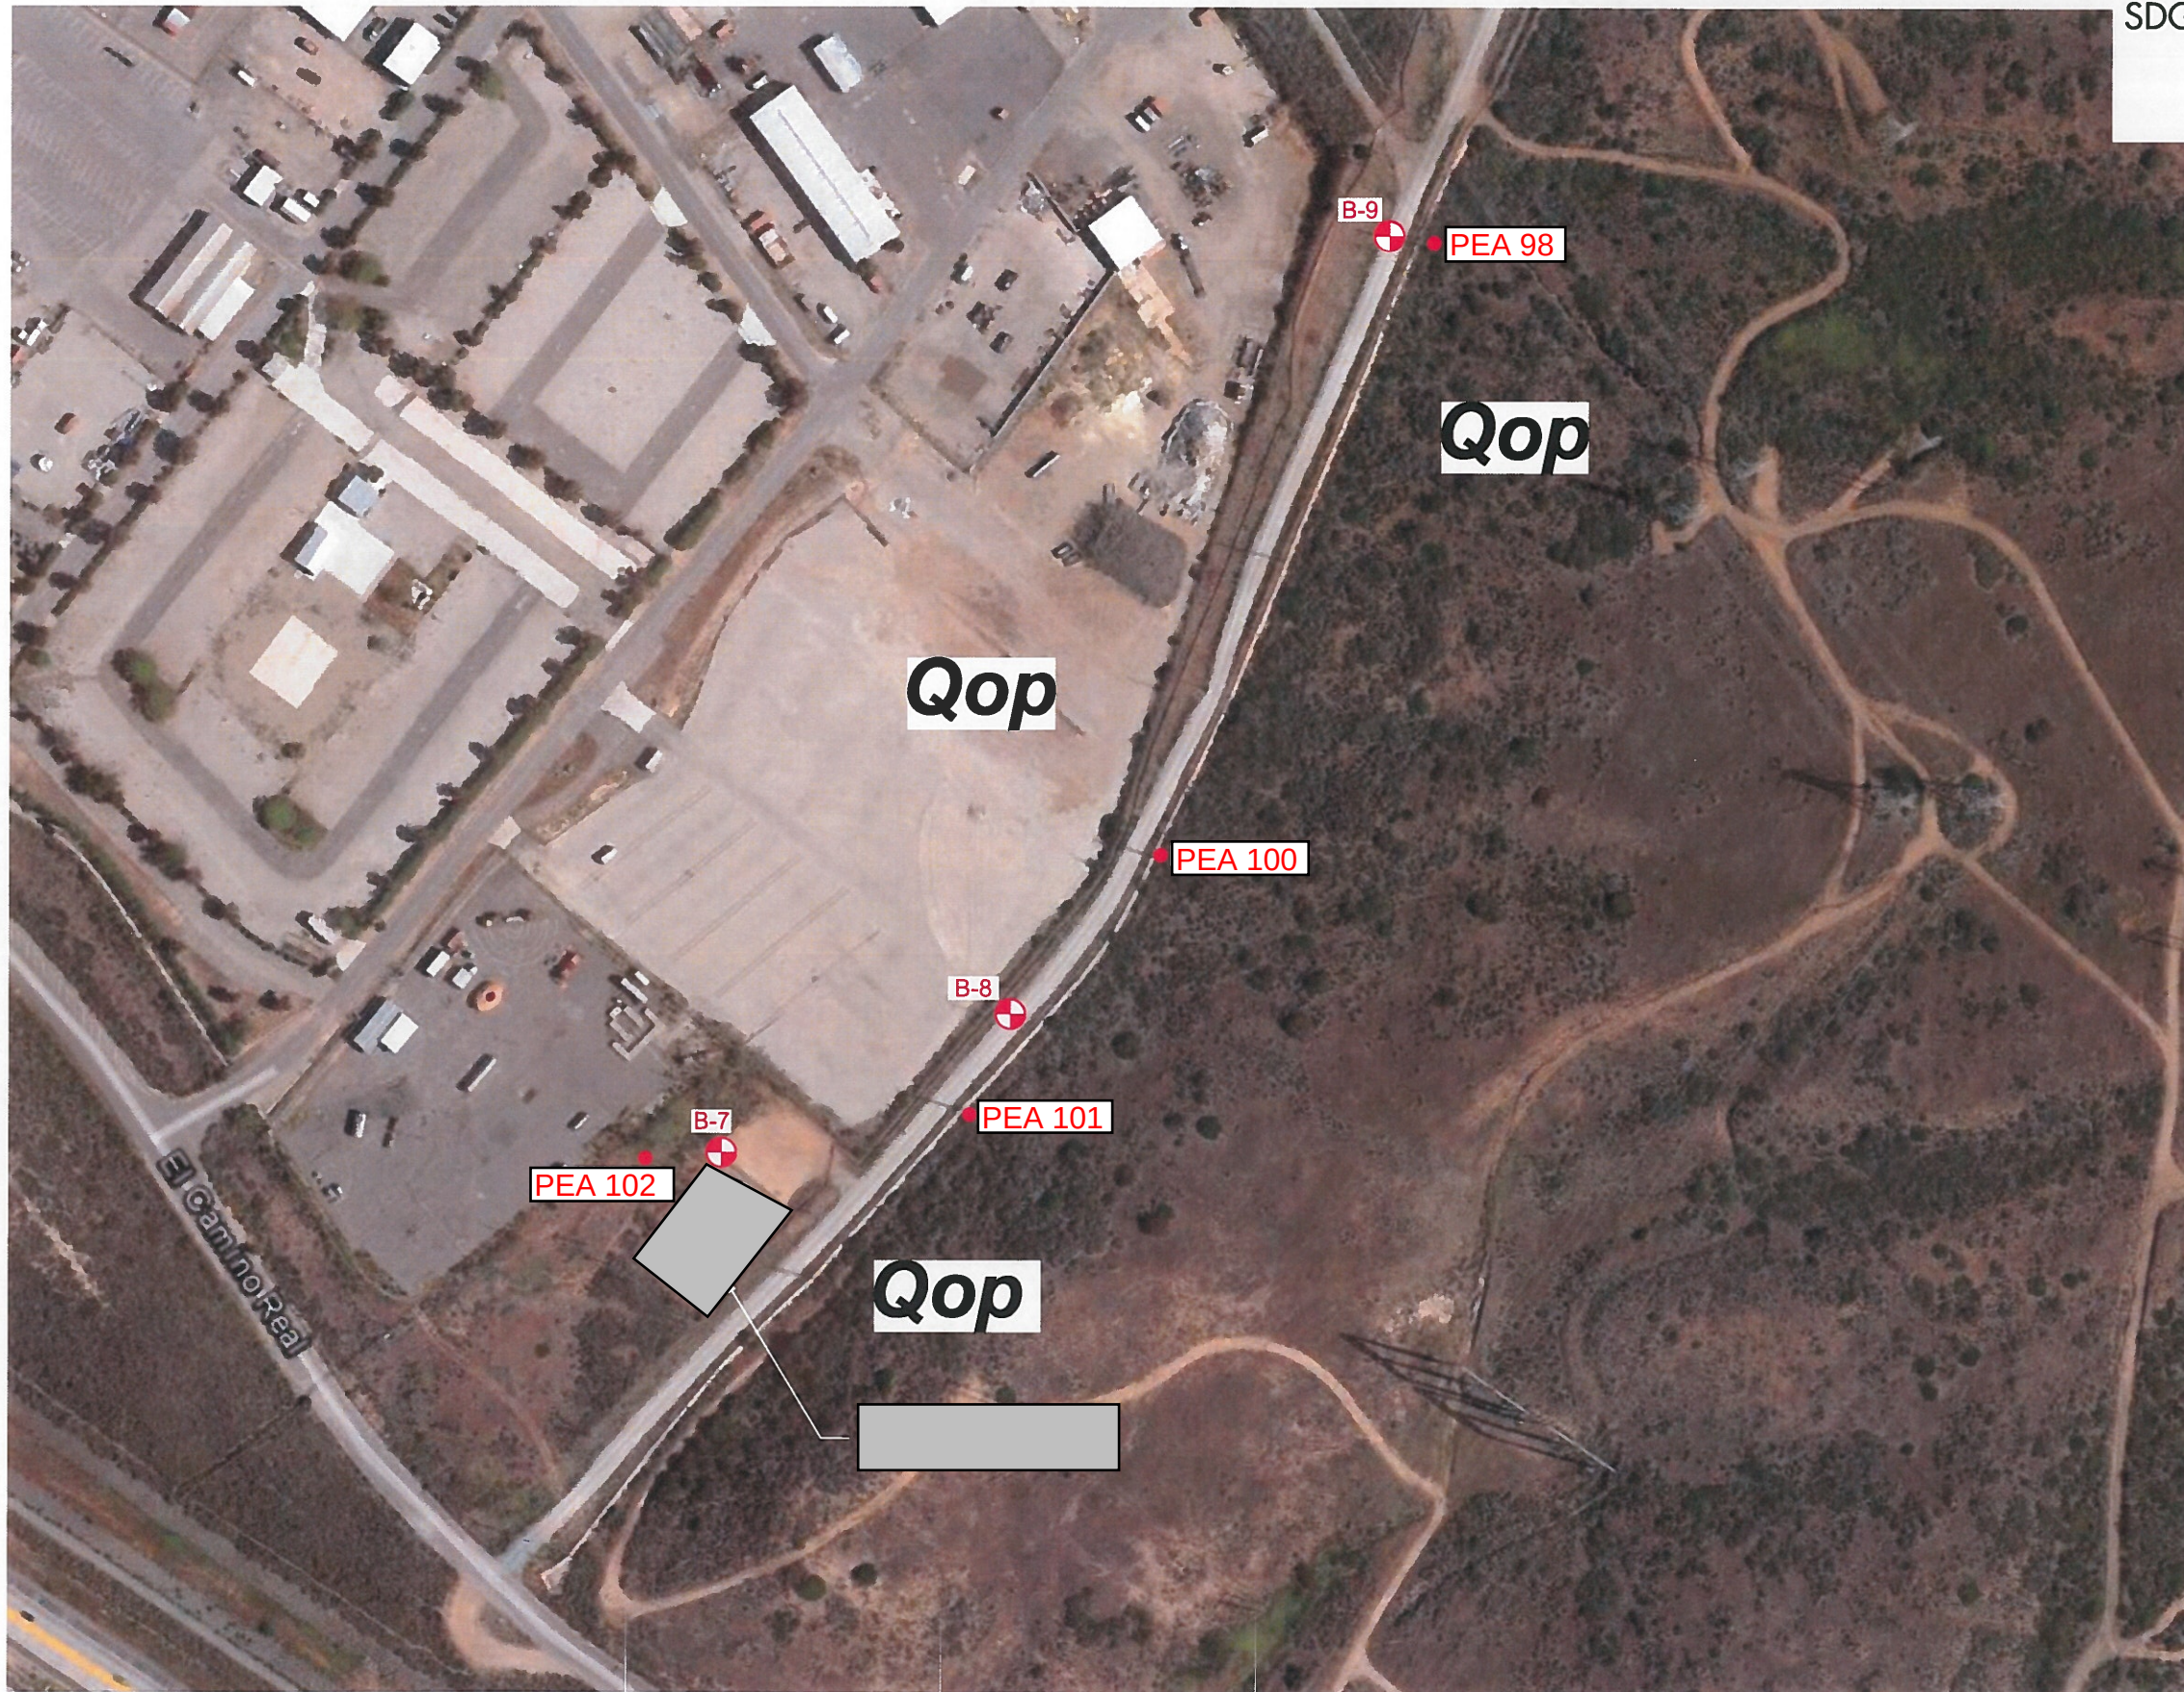
GEOLOGIC MAP

SDG&E WOOD TO STEEL POLE REPLACEMENT  
TL695 AND TL6971  
CAMP PENDLETON, CALIFORNIA
