PROJECT WEMORANDUMSDG&E - WIGUEL-MISSION 230 KV #2 PROJECTTo:Jensen Uchida, CPUCFrom:Vida Strong, Aspen Project ManagerDate:March 9, 2005Subject:Weekly Reports #31 and #32: February 27, 2004 – March 12, 2005CPUC Environmental Monitor (EM): Christopher Meyer

FANITA JUNCTION TO MIGUEL 138/69 KV ACTIVITIES, NTP #1 and #2 $\,$

MISSION TO MIGUEL SUBSTATION 230 KV ACTIVITIES, NTPS #3 AND #4

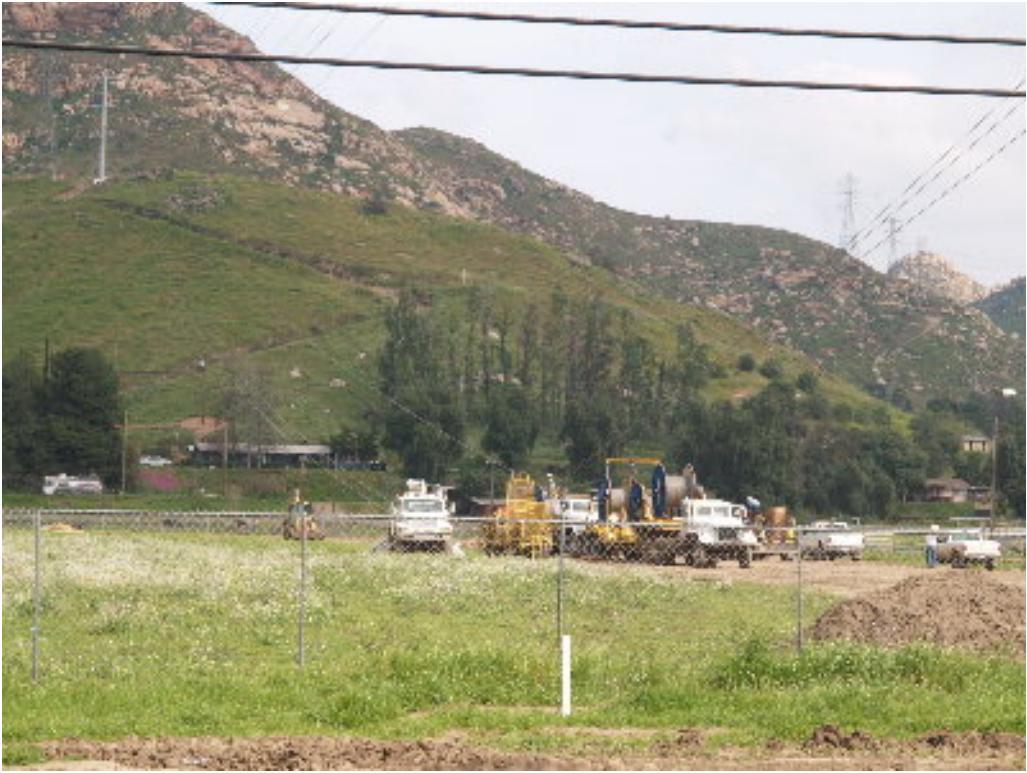
- 1. The transmission line crew worked to pull cable from Pole 1210 to Pole 1140 (see Figure 1). The crews worked in approved stringing locations and worked with the Essex Environmental Inspector (EI) to avoid impacts during the operation.

Figure 1 – The stringing operation set up across from Pole Site 1210 and pulled cable to Pole Site 1140.

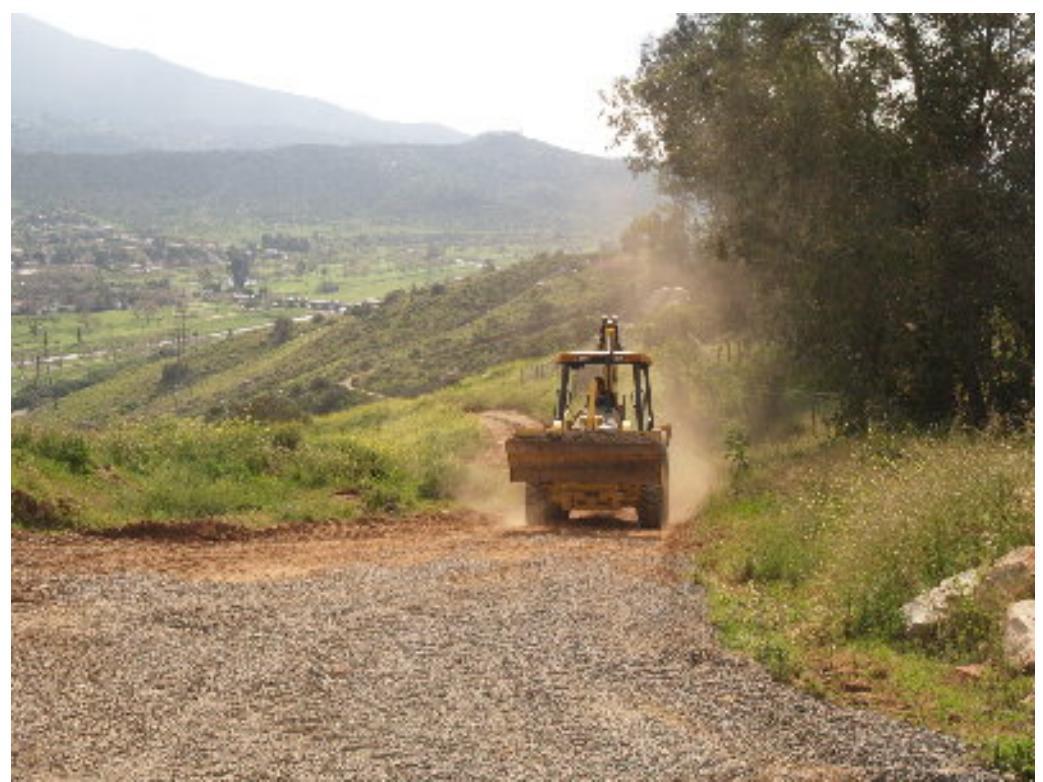
- 2. The foundation at Pole Site 481 has been completed and a crew was working to remove the excess spoils from the site. The conditions on the access road to the site were dry and fugitive dust was observed leaving the right-of-way (see Figure 2).

Figure 2 – The spoil removal operation at Pole Site 481 caused excessive fugitive dust that left the right-of-way.

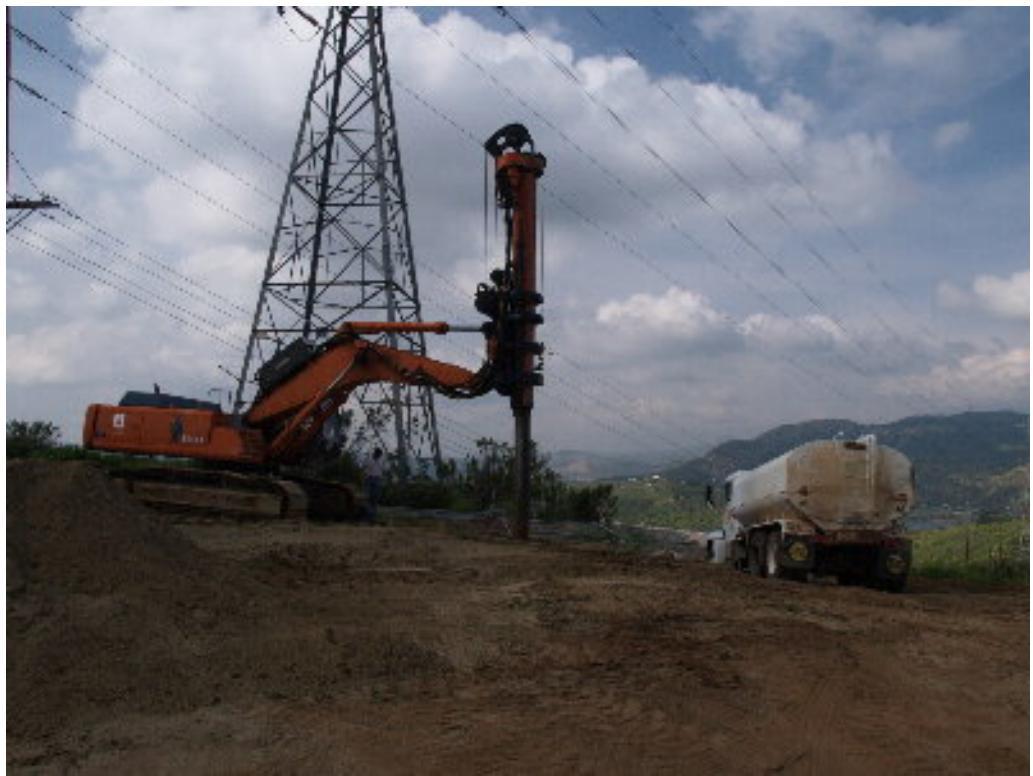
- 3. The Low Drill was working in hard material at Pole Site C during the site visit (see Figure 3). The foundation is almost to depth with the pilot hole and the drilling was completed by the end of the week of March 7.

Figure 3 – The drilling at Pole Site C continued during the site visit.

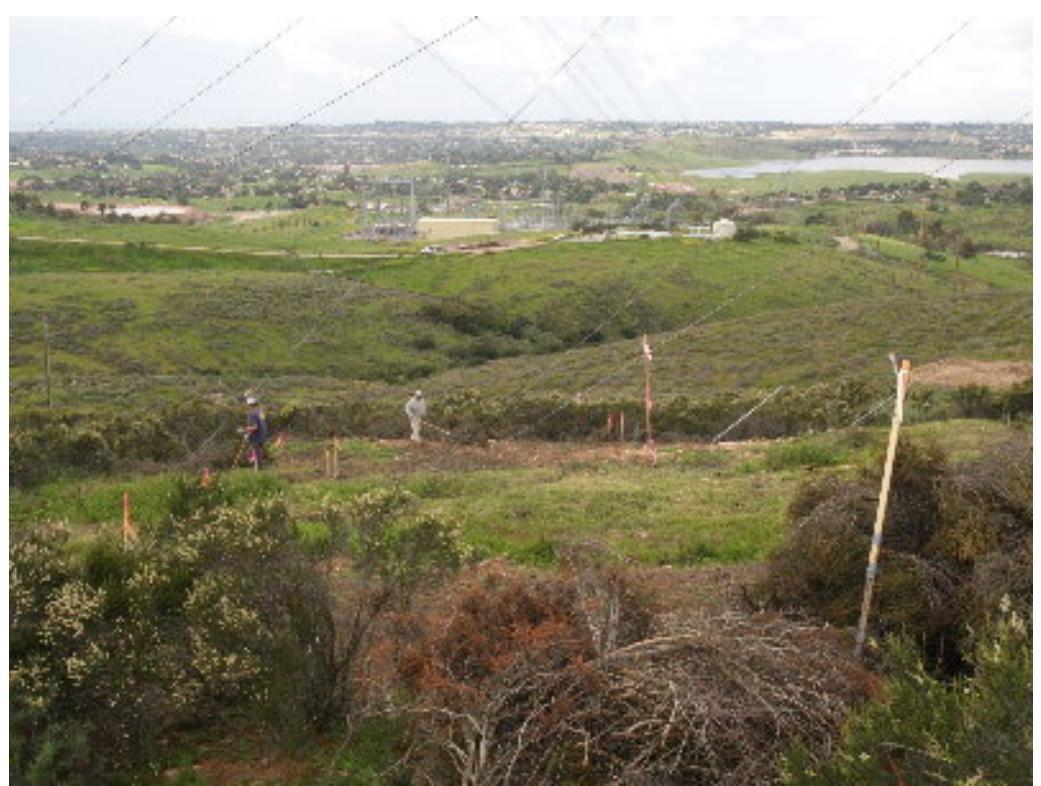
- 4. A crew worked to remove and chip vegetation from Pole Site 6510 on March 2. The vegetation had been cut prior to the March 1 deadline, but not pulled back from the habitat (see Figure 4). Silt fencing has been properly placed at Structure Site 6540 in preparation for rains predicted on the coming weekend.

Figure 4 – The clearing crew pulled back previously cut vegetation from the habitat for mulching.

- **3.** An Essex Environmental Inspector (EI) was on-site for spot-checking environmental compliance issues on the project. Biologists worked to survey gnatcatcher and Quino checkerspot butterfly areas prior to construction. Some surveys have been delayed due to weather conditions. The construction crews were reminded by Essex that surveys need to be conducted prior to work in many areas. Although brushing activities were scheduled to be completed by the March 1 deadline, some removal of previously cut vegetation did not occur until after March 1. The CPUC EM notified SDG&E that cut vegetation should be moved away from the contiguous habitat immediately and the previously cut vegetation that remained against the habitat is only removed under the supervision of an EI.

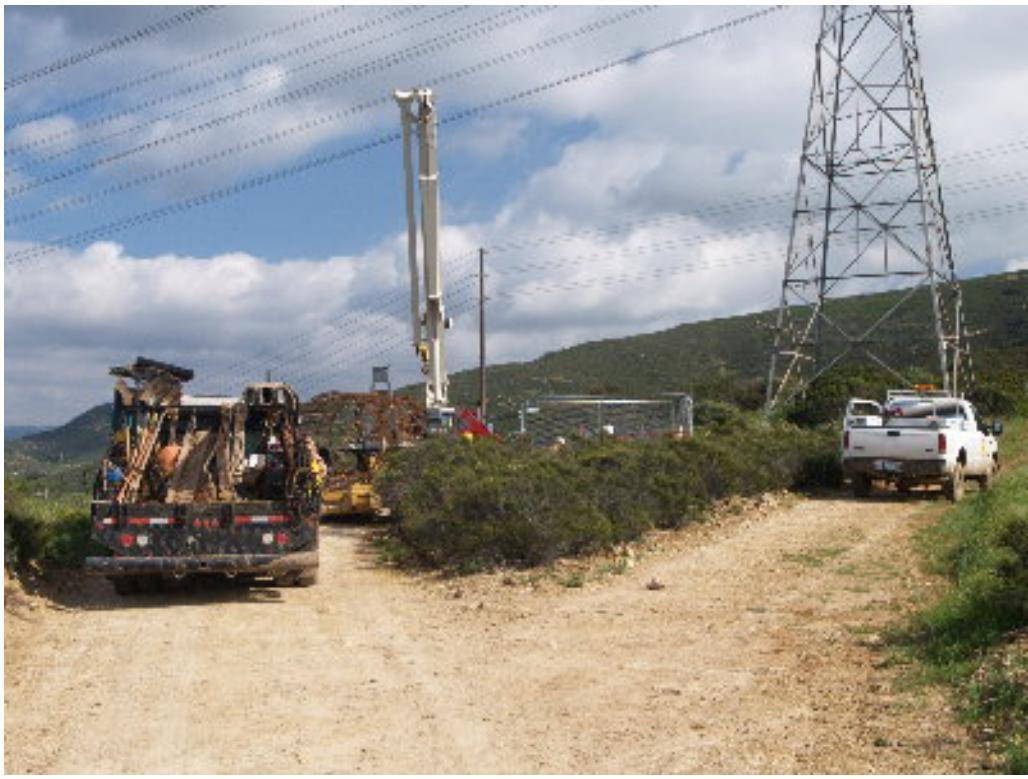
- 5. A crew moved the rebar cage and anchor bolts to Pole Site 191 (see Figure 5). The access road to the site was not easily passable and the truck was not able to make it to the site without assistance from a bulldozer. An operator worked with a backhoe to repair sections of the road and additional rock was brought in to improve access for concrete trucks that will need access to the site.

Figure 5 – The concrete crew moved into Pole Site 191 after initial problems getting the truck up the access road.

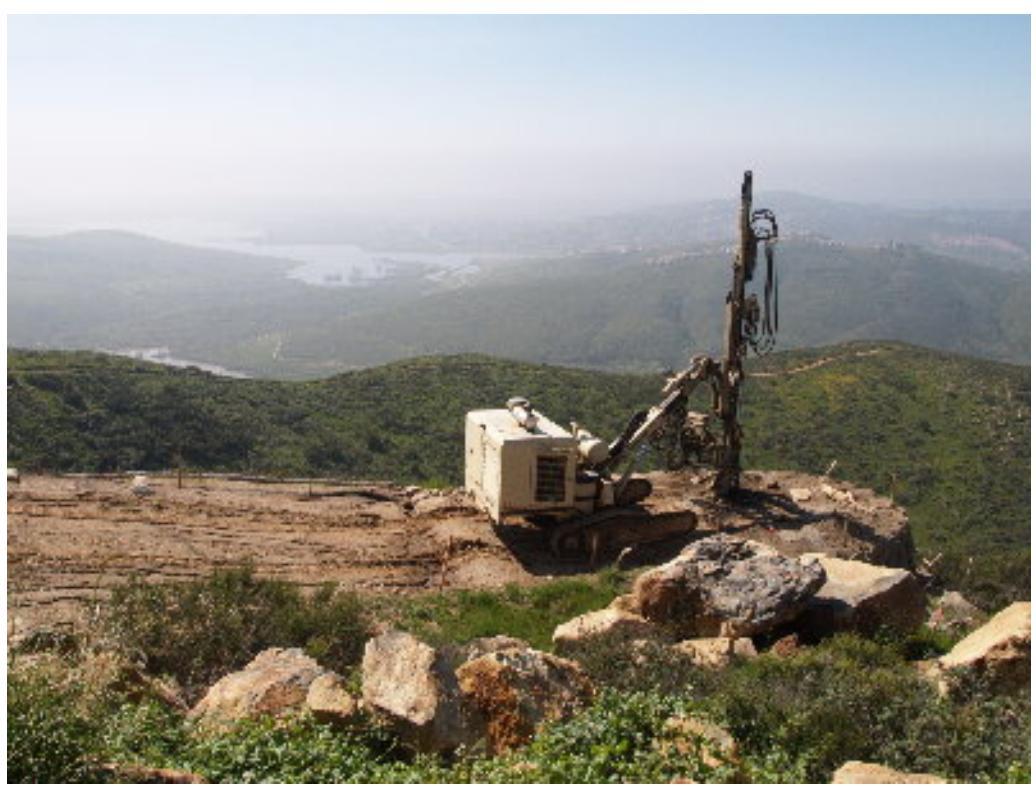
- 6. A small drilling machine worked at Pole Site 182 to complete several small diameter holes in the hard rock to make drilling the foundation easier (see Figure 6).

Figure 6 – A small drilling machine worked to prepare Pole Site 182 for the main drilling.

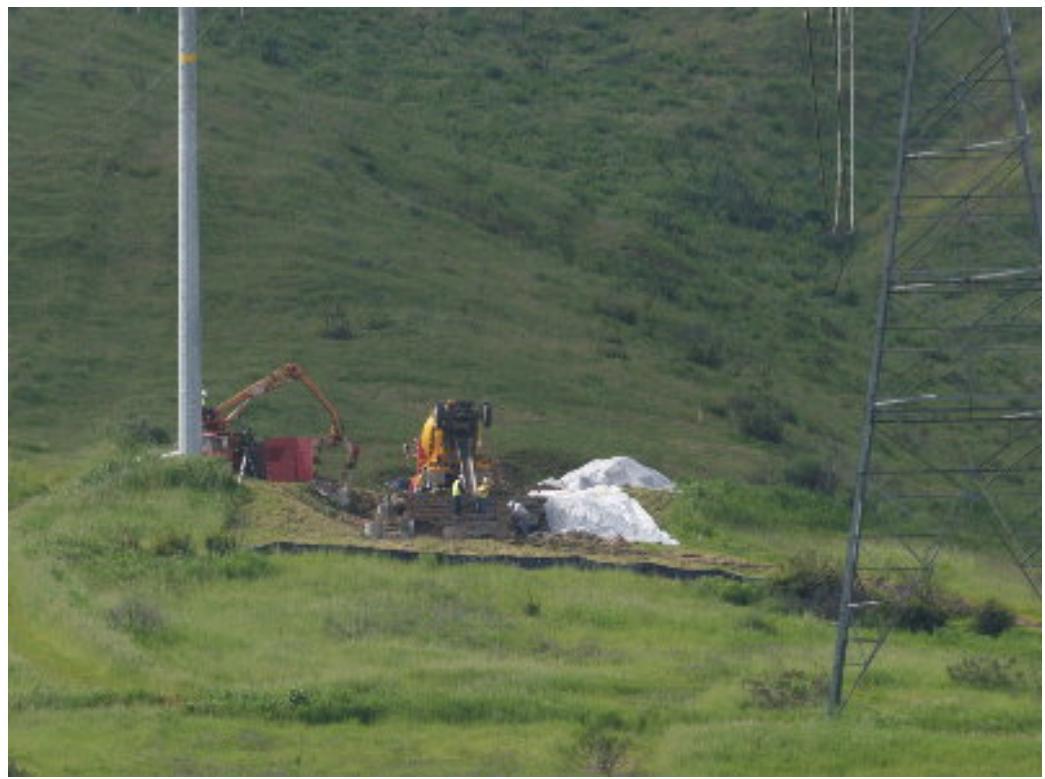
- 1. A Wilson crew continued working on rebuilding and construction of new 230 kV poles. Nine poles have been completed and three foundations have been poured and are awaiting pole structures.
- 2. The foundation for the new 230 kV Pole 576650 was poured during the site visit (see Figure 7). A special truck with a clamshell worked to remove saturated soils from the site. Erosion from the access road above the site directed a large amount of silt and water to the pad location and the top several feet of soil on the pad was muddy.
- 3. The upper section of a steel tower was set on the lower section in the Fanita Junction area using a large crane (see Figure 8). One the upper section had been set, worker were raised in a man-lift to secure the two sections (see Figure 9).

Figure 7 – The permanent 230 kV foundation for Pole 576650 was poured during the site visit.

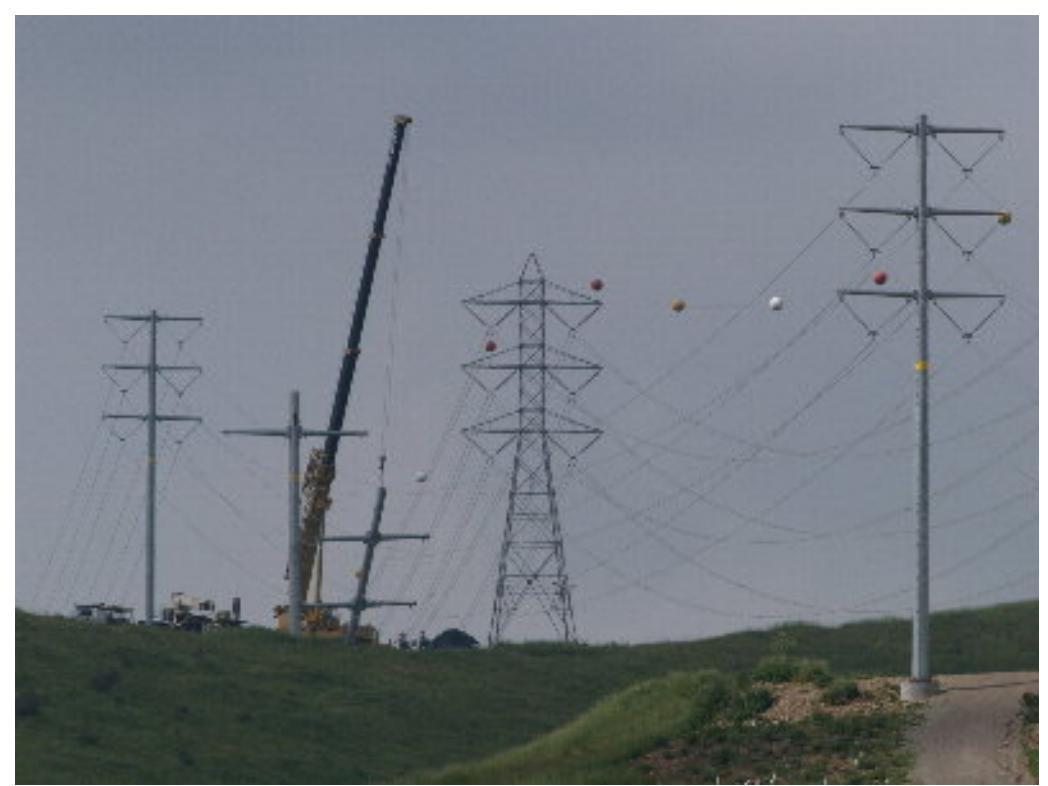
Figure 8 – The upper section of the permanent 230 kV Pole 871862 was set during the site visit.

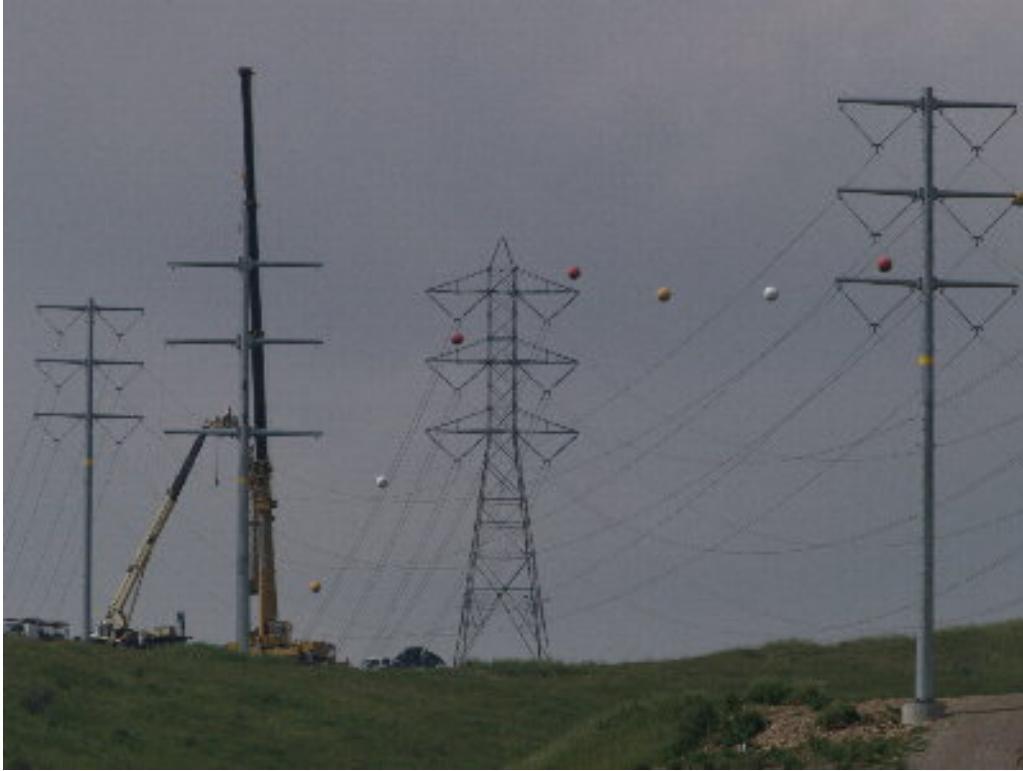
Figure 9 – Crews secured the upper section of the permanent 230 kV Pole 871862 once it was set in place.

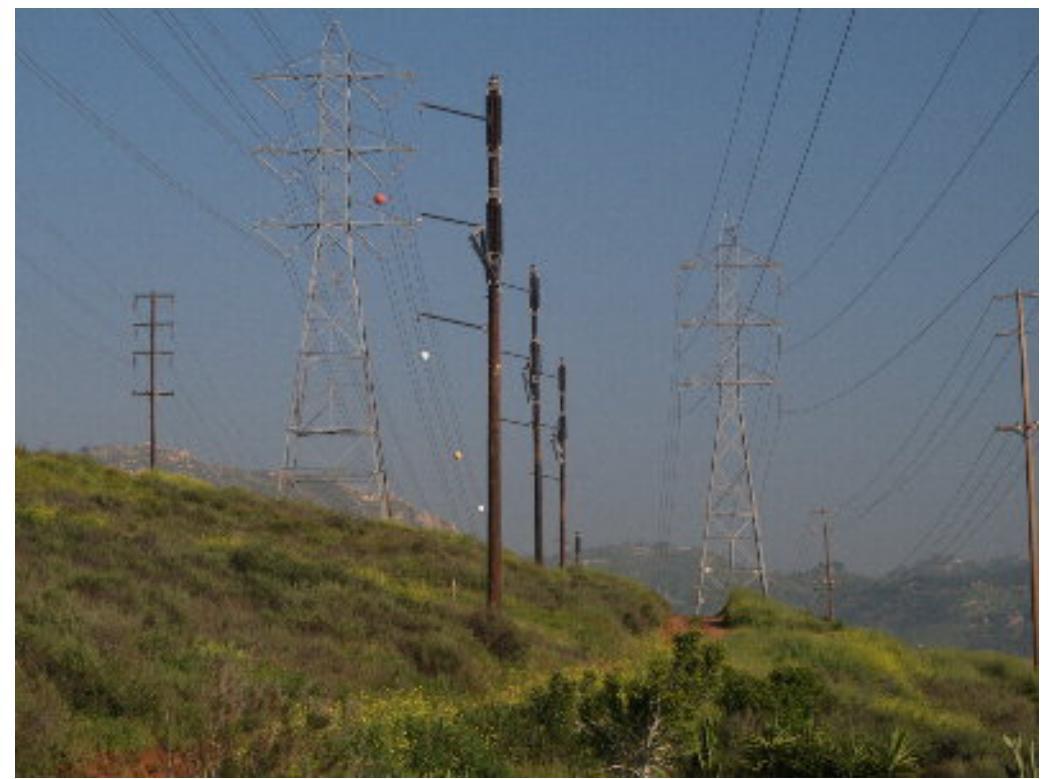
NTP #4 also addressed the installation of the 15-mile temporary 230 kV line from Miguel to Los Coches Substations. Other than clearing of vegetation prior to March 1, the temporary 230 kV work between Miguel to Los Coches Substations is awaiting the completion of work on the 138 kV system by PAR. Once PAR has finished work on the segment, the Wilson Construction crews will start the upgrades to the existing towers. The installation of the temporary wood poles started during the week of March 7. The crew placed 5 wood poles in the area south of Los Coches during the site visit (see Figure 10).

Figure 10 – Five temporary 230 kV wood poles were set during the site visit.
