PROJECT MEMORANDUM SCE EL CASCO SYSTEM PROJECT

To:Lynne Mosley, CPUCFrom:Vida Strong, Aspen Project ManagerDate:January 18, 2010Subject:Report 20: January 3, 2010 – January 9, 2010

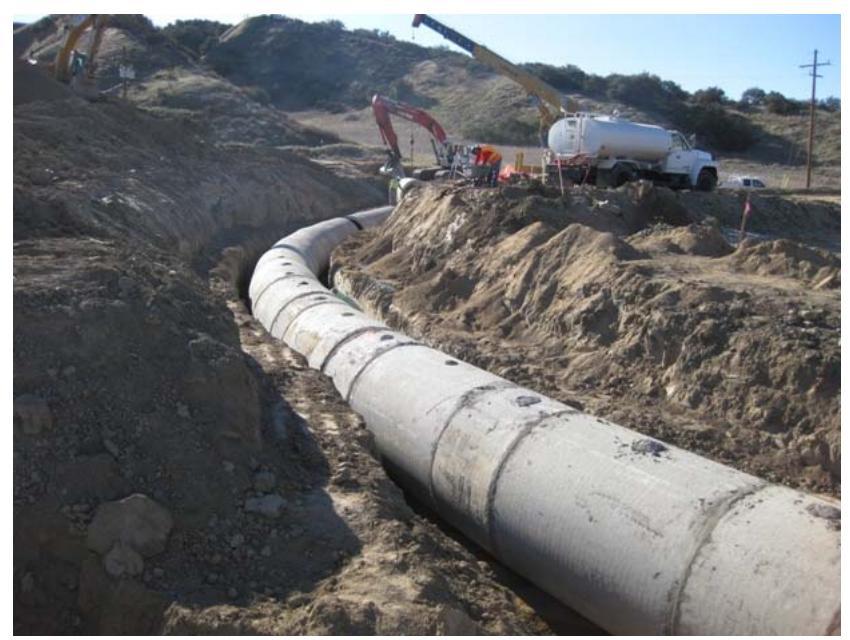
Figure 1: At El Casco Substation, a system consisting of V-ditches and concrete conduit (in photo) is being build to shunt run-off water from higher ground to the south and southwest of the station site around the western side of the station pad to San Timoteo Creek. The photograph faces southwestward.

During the subject week, work occurred Monday through Saturday. Construction continued on a V-ditch on the south side (uphill) of the new access road. Construction began on a second drainage V-ditch south of the Project trailers, and on a culvert leading to San Timoteo Creek around the western side of the substation site (see Figure 1).

- At the El Casco Substation, a system consisting of V-ditches and concrete conduit (see Figure 1) is being build to shunt run-off water from higher ground to the south and southwest of the station site around the western side of the station pad to San Timoteo Creek. During the subject week, riparian vegetation was cleared to the edge of the creek in preparation for the building of a concrete baffle which will direct and reduce the flow of run-off water to the creek. In anticipation of predicted winter storm events, the cleared riparian area was fitted with a network of straw wattling and sandbags to prevent erosion in case the creek rises before the baffle structure can be built (see Figure 6).

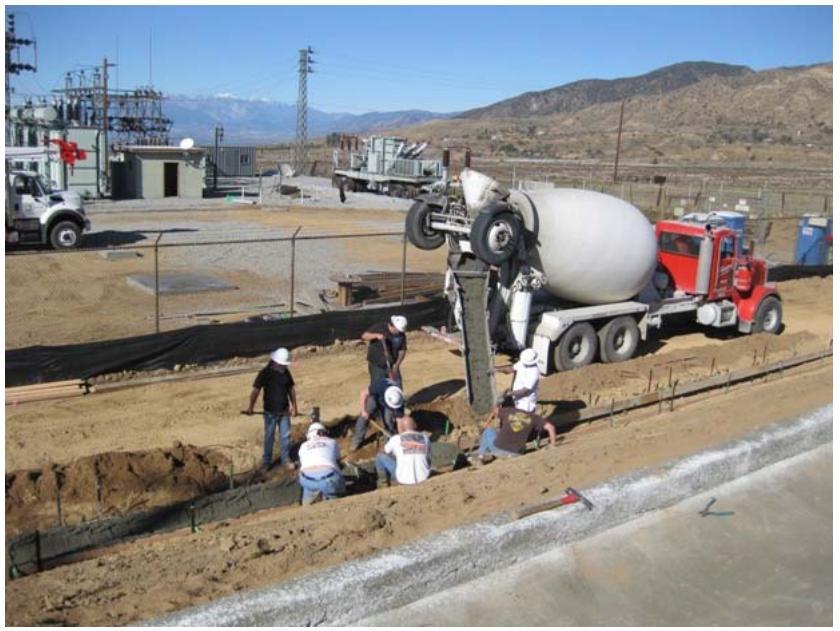
Figure 2: At Zanja Substation, drainage culverts were being built to the east of the proposed eastern expansion of the substation. The gravel blanket has been removed from the eastern portion of the substation (in middle distance) in preparation for construction. The photograph faces northwestward.

Construction continued during the subject week. A berm east of the substation was previously removed in preparation for the expansion of the substation in that direction. The spoils were spread on adjacent SCE land. During the subject week, two concrete V-ditches were in the process of being built (see Figure 2).

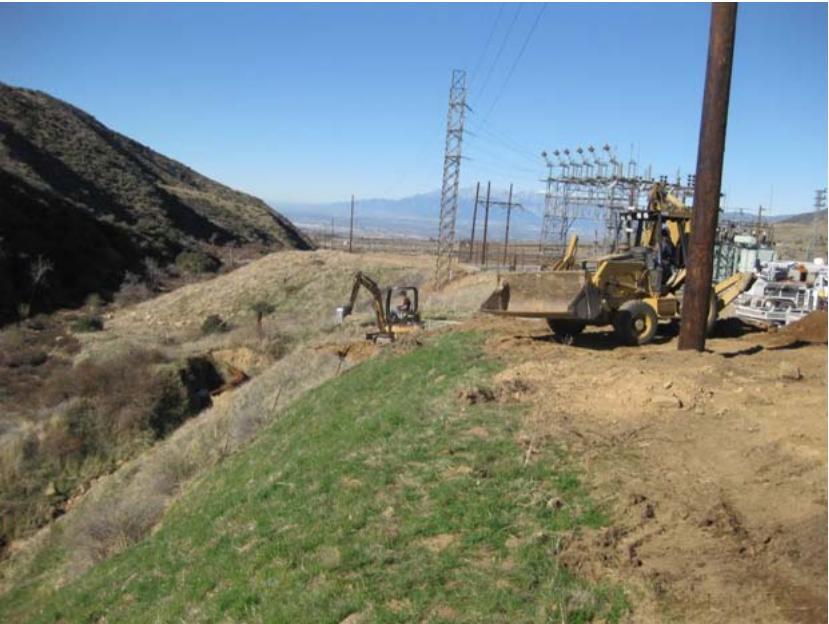
Figure 3: At Zanja Substation, erosion control measures were applied to the slope between the new power pole that was previously installed outside the existing station and the ravine to the south. The photograph faces westward.

Erosion control measures were applied to the slope between the new power pole that was previously installed outside the existing station and the ravine to the south of it (see Figure 3).

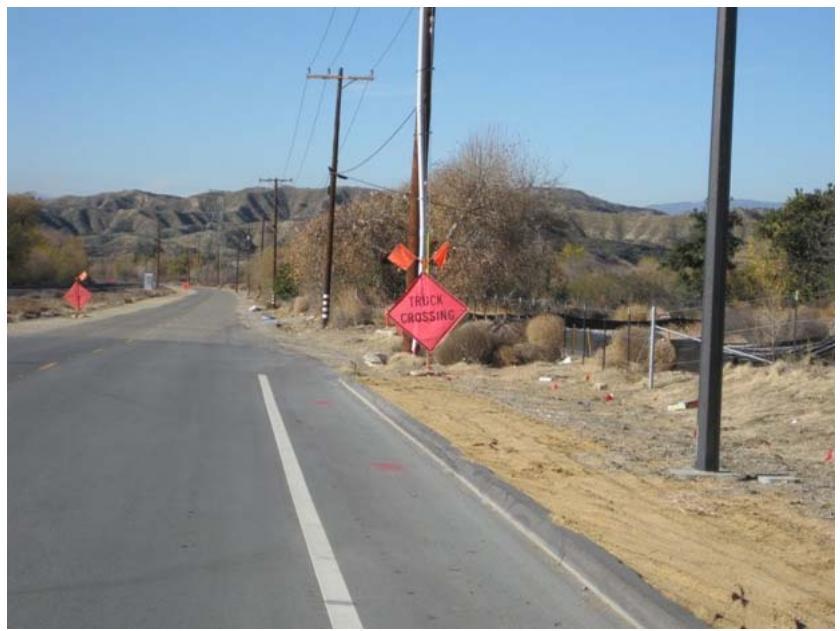
Figure 4: The entrance to the mobile water tower next to San Timoteo Canyon Road north of El Casco Substation (to the right of the photograph) is now marked with safety signs, as is San Timoteo Canyon Road for considerable distance is both directions from the entrance. The photograph faces westward.

- The entrance to the mobile water tower next to San Timoteo Canyon Road north of El Casco Substation that is one of the water sources for the Project is now marked with safety signs, as is San Timoteo Canyon Road for considerable distance is both directions from the entrance (see Figure 4).

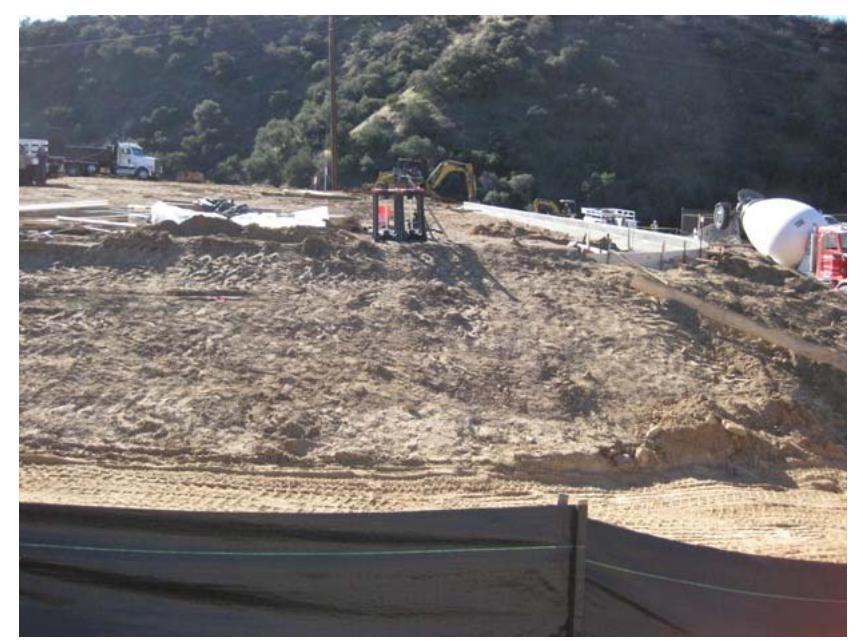
Figure 5: At Zanja Substation, the spoils from the berm excavation for the expansion of the station have been spread over an adjacent field, which appears to be used as a staging area. The photograph faces southward. The existing substation is to the right of the photograph.

- It has previously been noted by CPUC that the disturbed area at the Zanja Substation work site may exceed one acre. A WDID permit from the State Water Resources Control Board was not requested for this site by SCE because it originally was thought to produce a ground disturbance of less than one acre, thus voiding the need for a permit. During the subject week, CPUC EM Lynn Stafford determined that the disturbed area currently is approximately 1.75 acres, and may increase with the future improvement to the access road. The disturbed area includes a field upon which spoils were spread, and which appears to be used as a staging area (see Figure 5), and a portion of the pre-existing substation (see Figure 2). Project Memorandum #3 was issued on January 14 for use of the subject area as a parking and staging area. Variance Request #10 was submitted on January 14 to request approval to use the subject area. SCE is also applying for a WDID permit. The subject variance request is under review.

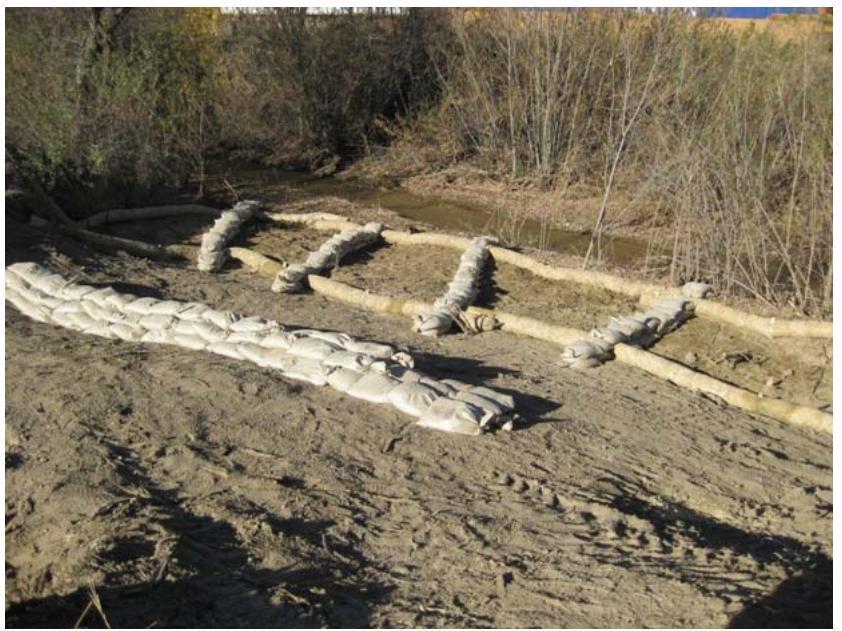
Figure 6: At El Casco Substation, riparian vegetation was cleared to the edge of San Timoteo Creek in preparation for the building of a concrete baffle which will direct and reduce the flow of run-off water (see Figure 1) to the creek. In anticipation of predicted winter storm events, the cleared riparian area was fitted with a network of straw wattling and sandbags during the subject week to prevent erosion in case the creek rises before the baffle structure can be built.
