Valley – Ivyglen Subtransmission Project CPUC Minor Project Refinement Form

Proposal to Expand the Boundaries of the General Disturbance Area:

Proposal to Revise Telecommunications Fiber Optic Line in VIG7 – De Palma Road:

Paleontological Resources Notice to Proceed Request #2: Concordia Yard and Added Workstations for the Valley Ivyglen Subtransmission Line Project (VIG4 through VIG8)

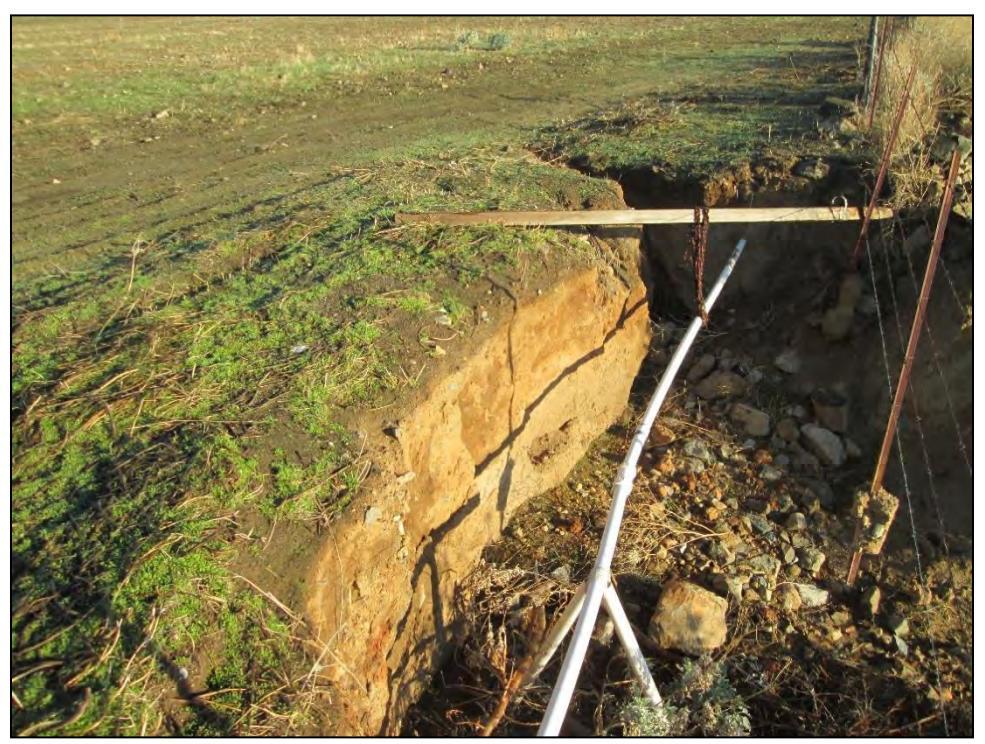
Photo 5. Concordia Yard paleontological field survey (conducted December 10, 2019): drainage channel exposure of middle to early Pleistocene-age very old axial-channel deposits (Qvoa), consisting primarily of sands and gravels. Larger cobbles and occasional boulders can be observed within the wash. Partially buried pipelines are exposed within the channel and near the top of the wash. View facing to the north.

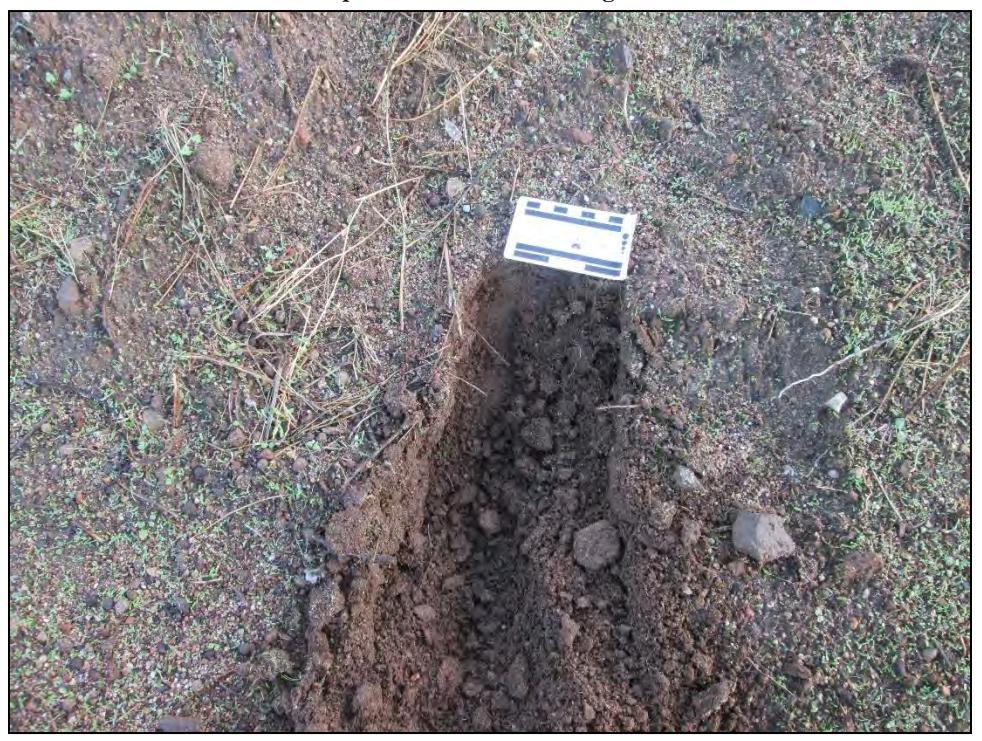
Photo 6. Concordia Yard paleontological field survey (conducted December 10, 2019): weathered middle to early Pleistocene-age very old axial-channel deposits (Qvoa) as seen at and near the surface along the north end of the western side of the proposed Concordia Yard. View facing down.
