## **PROJECT MEMORANDUM PG&E ATLANTIC-DEL MAR REINFORCEMENT PROJECT**

**To:** Jensen Uchida, CPUC  
**From:** Vida Strong, Aspen Project Manager  
**Date:** March 2, 2006  
**Subject:** Weekly Report #45: February 19, 2006 – February 25, 2006  
**CPUC Environmental Monitor (EM):** Heather Stiles

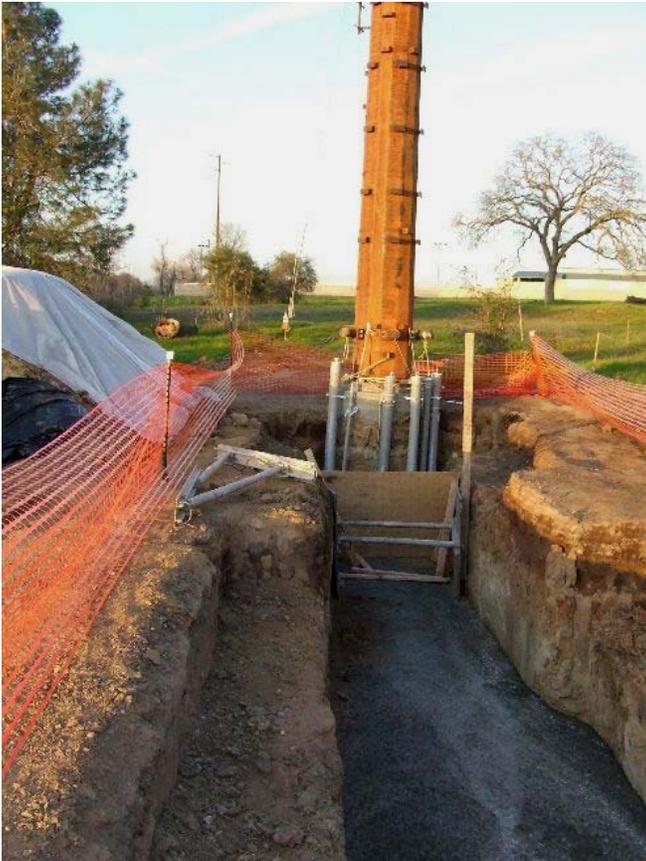
**Figure 1** – Tie-in to Transition Structure #9, February 24, 2006.

Interstate Safety began the installation of PVC conduit North of Midas Avenue within the vault 4/Transition Pole #9 connection (see Figure 1). Thermal concrete was poured; however, additional concrete will be required to sufficiently cover the trench. Once the concrete is delivered and poured, the remainder of the trench will be backfilled with thermal slurry and native material.

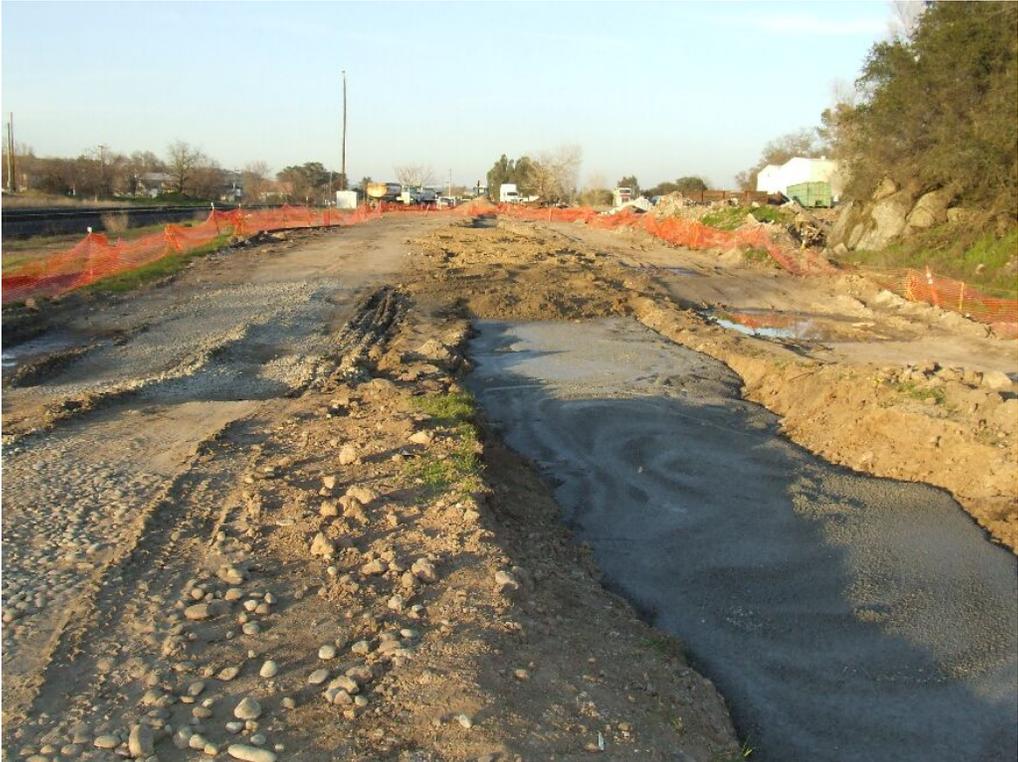
**Figure 2** – Construction progress west of Rocklin Rock, February 24, 2006.

Construction continued west of Rocklin Rock, north of Farron Drive. Trench excavation was completed during the previous week and crews completed the installation of PVC conduit, thermal concrete, and thermal slurry within the trenched area (see Figure 2). In addition, backfilling was completed in the trench using native soil and the area was compacted and restored to original grade. Placement of topsoil materials will occur after construction and wire pulling activities have been completed.

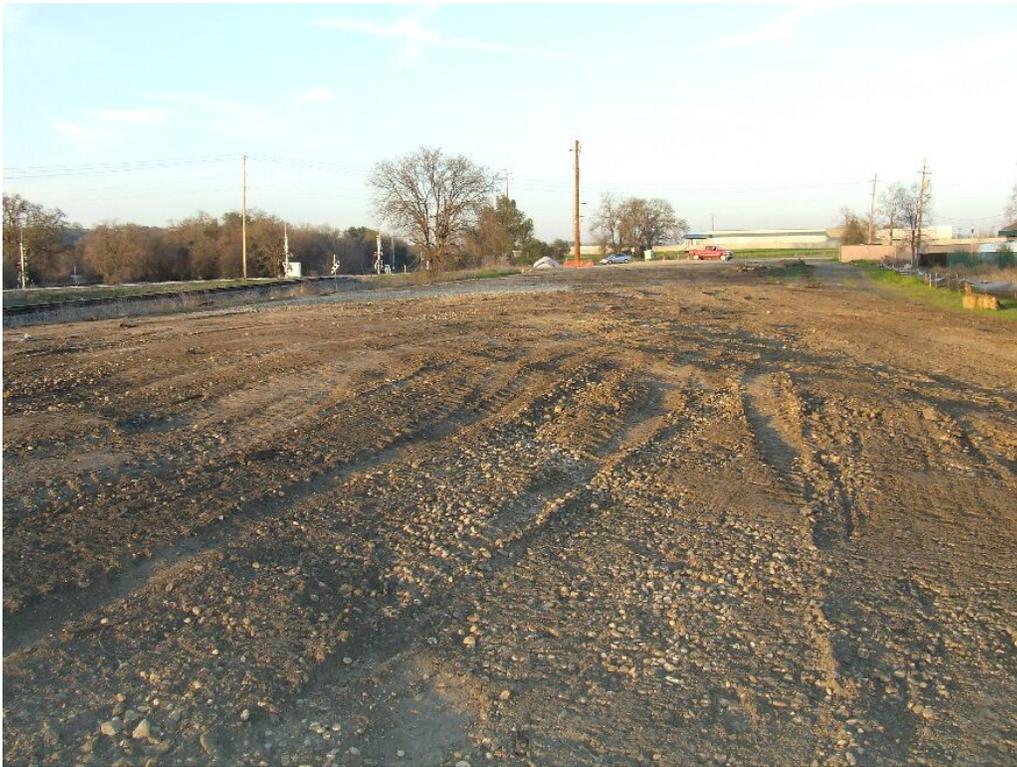
**Figure 3** – Backfilled and graded trench between Drainage #30 and Midas Road, February 24, 2006.

During the previous week, Zayas commenced the trench line tie-in operations from Vault 4 to the area directly adjacent to the Drainage #30 bank. Crews used extreme caution and care excavating slowly and hand digging some portions. After the PVC conduit tie-ins, thermal concrete and top slurry were poured one foot at a time as to not overwhelm the fragile bank. No damage to the bank or drainage occurred throughout these operations. During the subject week, Zayas crews completed backfilling the Drainage 30/Midas Avenue trench with native soil material. The area was compacted and restored to original grade (see Figure 3). All construction materials have been removed from this area and erosion control measures were deemed satisfactory.
