PROJECT MEMORANDUM PG&E ATLANTIC-DEL MAR REINFORCEMENT PROJECT

To: Jensen Uchida, CPUC
From: Vida Strong, Aspen Project Manager
Date: April 13, 2006
Subject: Weekly Report #51: April 2, 2006 – April 8, 2006
CPUC Environmental Monitor (EM): Anne Sweet Coronado

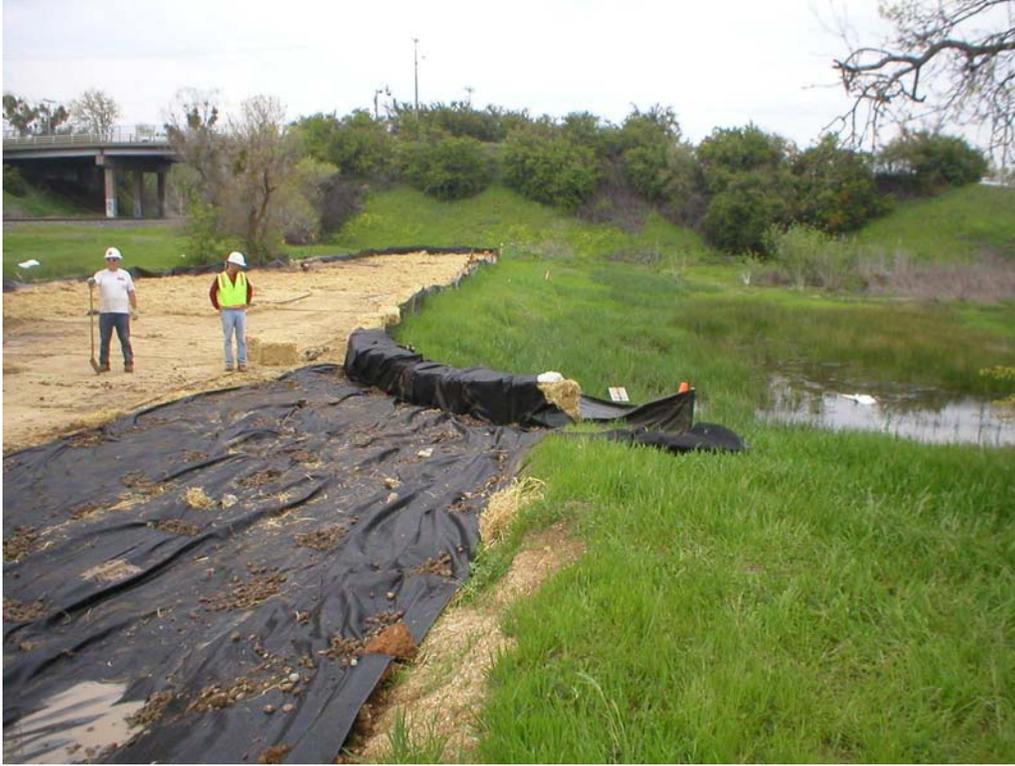
Figure 1 – Erosion controls installed to filter the storm water runoff from the alignment into the adjacent wetland, April 7, 2006.

Previously, the PG&E EI also recommended to Zayas that a straw bale and filter fabric lined detention basin be constructed to trap more sediment laden storm water runoff entering the municipal sewers. During the subject week silt laden water continued to enter the adjacent wetland near Vault 1 through the previously installed sediment fence and sandbags. In addition, Zayas planned to remove numerous steel trench plates which were covering muddy and saturated soils along the adjacent alignment. On April 6th, the CPUC EM notified the crews that sediment was already breaching the existing erosion controls and that the problem required immediate attention. In addition, if increased sediment entered the wetland area due to the removal of the steel plates a non-compliance would be issued. On April 7th, prior to the on-set of rain, the Zayas crew did remove the plates, but immediately covered the exposed muddy areas with straw. The down sloping areas which drain toward the wetland were secured with new hay bales and filter fabric was laid over the area (see Figure 1). The CPUC EM returned to the site on April 8th, and noted that the new erosion control measures were functioning well and that the water entering the wetland was running clear of sediment.
