## **PROJECT MEMORANDUM PG&E ATLANTIC-DEL MAR REINFORCEMENT PROJECT**

**To:** Jensen Uchida, CPUC  
**From:** Vida Strong, Aspen Project Manager  
**Date:** April 21, 2006  
**Subject:** Weekly Report #52: April 9, 2006 – April 15, 2006  
**CPUC Environmental Monitor (EM):** Heather Stiles

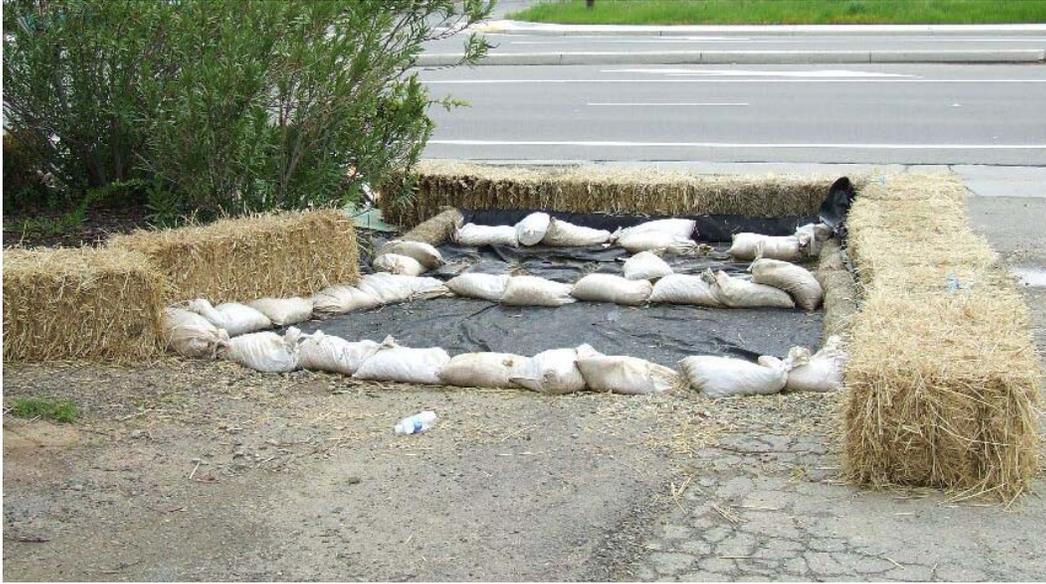
**Figure 1** – Erosion controls installed to filter the storm water runoff from the construction yard into the street and storm gutters, April 14, 2006.

Superintendent Bert Austin and his crews worked on two containment basins located near the construction yard on Pacific Street. Previously, it was evident that stormwater runoff was carrying sediment from the project into the municipal storm gutters along Pacific. Although there were containment basins to trap the runoff, the basins had (for a variety of reasons) become ineffective. To remedy the problems, the crews had removed the accumulated sediments from the old basins, and rebuilt the containment basins using a combination of straw bales, sandbags, and filter fabric (see Figure 1). The structures were evaluated during the CPUC EM visit. The structures had trapped new sediments and the municipal storm gutter along Pacific Avenue appeared clean, indicating that the barriers were effective. Also, the erosion control measures installed last week near vault 1 and 4 (described in last week's report) appeared to be continuing to function effectively.
