Visual Contrast Rating Data Sheet

Devers-Palo Verde 2 Transmission Line Project

Key Viewpoint <div style="text-align: center; font-size: 1.2em; font-weight: bold;">6</div>

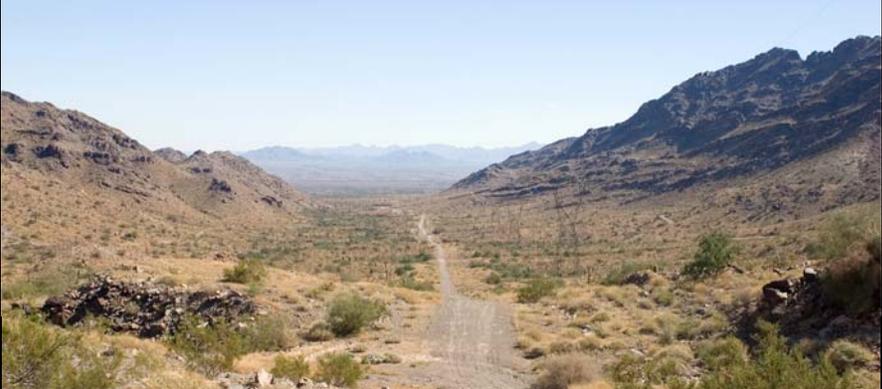
Location Pipeline Road, just south of Copper Bottom Pass in the Dome Rock Mountains, viewing to the east-southeast.	
VRM Class <div style="text-align: center; font-size: 1.2em; font-weight: bold;">III</div>	
Analyst Michael Clayton	
Date October 23, 2005

LANDFORM / WATER	VEGETATION	STRUCTURES
Form	Same	Same	Geometric and complex to simple linear
Line	Same	Same	Vertical and diagonal for structures, to curvilinear for conductors
Color	Same	Same	Light gray
Texture	Same	Same	Smooth

LANDFORM / WATER				VEGETATION				STRUCTURES			
	NONE	WEAK	MODERATE	STRONG	NONE	WEAK	MODERATE	STRONG	NONE	WEAK	MODERATE	STRONG
Form	4				4						4	
Line	4				4						4	
Color	4				4					4		
Texture	4				4					4

Term: <input type="checkbox"/> Short <input checked="" type="checkbox"/> Long	Level of Change: <input type="checkbox"/> Very Low <input type="checkbox"/> Low <input checked="" type="checkbox"/> Moderate <input type="checkbox"/> High
Does the Project Design Meet VRM Objectives? <input checked="" type="checkbox"/> Yes <input type="checkbox"/> No
